City of Milwaukee  
DPW, ISD, FDM

2011 Recreational Facilities  
Condition Assessment Program

#### Facility Condition Assessment Program Summary for Recreational Facilities 100% of Play Areas (Based on conditions as of 12.01.2012)

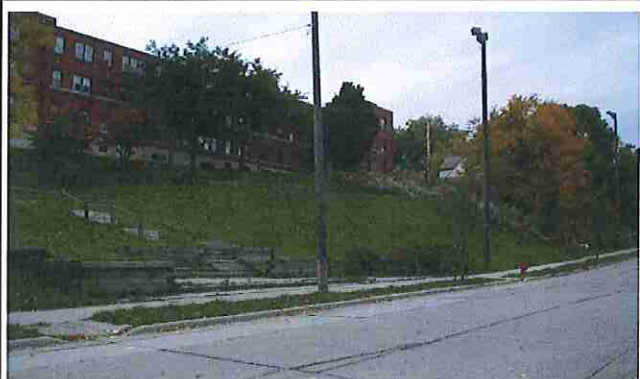
## 1st & Hadley Passive Area 100 East Hadley Street

Current Replacement Value *	\$220,265
Rating Number *	4
Total Area	29,152 SF
Facility Constructed	1978
Last Reconstruction	1999
ADA Accessible	No

Item	Type	Quantity	Unit	Condition *	Remarks
<b>Grounds</b>					
Pervious Surface	Grass	24,014	SF	4	Heavy vegetation
Impervious Surface	Concrete/Lannon stone/Timber	5,138	SF	1	Stairs are a hazard
Benches/Picnic Tables	N/A		EA		
Fencing	4' Chain Link	100	LF	6	
Lighting	N/A				
Plumbing/Drainage	N/A				
Plumbing/Drink., Spigot	N/A				
Monuments	N/A				
<b>Structures</b>					
Play Equipment	N/A		EA		
Swing Set	N/A		EA		
Resilient Surfacing	N/A		SF		
Play Surfacing	N/A		SF		
Edging	N/A		EA		
<b>Tennis Courts</b>					
Surface	N/A				
Post/Nets	N/A				
<b>Basketball Courts</b>					
Surface	N/A				
Post/Backboard	N/A				
<b>Baseball Diamonds</b>					
Surface	N/A				
Bleachers / Benches	N/A				
Back Stops	N/A

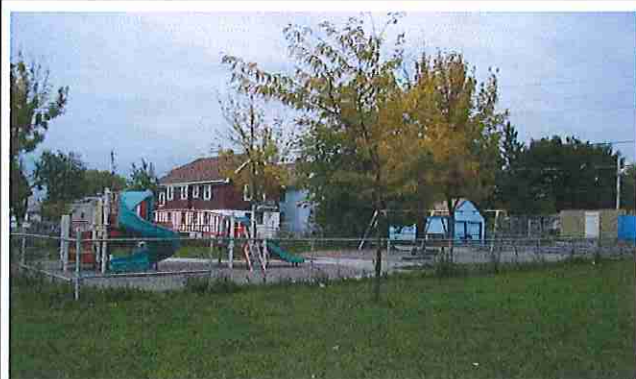
## Keefe & Palmer Play Area 117 East Keefe Avenue

Current Replacement Value *	\$104,384
Rating Number *	6
Total Area	6,939 SF
Facility Constructed	1992
Last Reconstruction	1992
ADA Accessible	No

- Constructed on the former site of a torn down drug house, this is the only totlot that has resilient surfacing under the play structure and swing set.
- It is not cost effective to retrofit the non wheelchair compliant play structure due to the resilient surface.
- Painting the resilient surface is recommended every five years.

Item	Type	Quantity	Unit	Condition *	Remarks
<b>Grounds</b>					
Pervious Surface	Grass	3,672	SF	7	
Impervious Surface	Asphalt	1,411	SF	7	
Benches/Picnic Tables	Expanded Metal Bench	3	EA	7	
Fencing	4' Chain Link	285	LF	4	
Lighting	N/A				
Plumbing/Drainage	N/A				
Plumbing/Drink., Spigot	N/A				
Monuments	N/A				
<b>Structures</b>					
Play Equipment	Burke	1	EA	5	
Swing Set	Infant/Belt	4	EA	7	1 Unit
Resilient Surfacing	Poured in Place	1,856	SF	7	
Play Surfacing	N/A		SF		
Edging	N/A		EA		
<b>Tennis Courts</b>					
Surface	N/A				
Post/Nets	N/A				
<b>Basketball Courts</b>					
Surface	N/A				
Post/Backboard	N/A				
<b>Baseball Diamonds</b>					
Surface	N/A				
Bleachers / Benches	N/A				
Back Stops	N/A

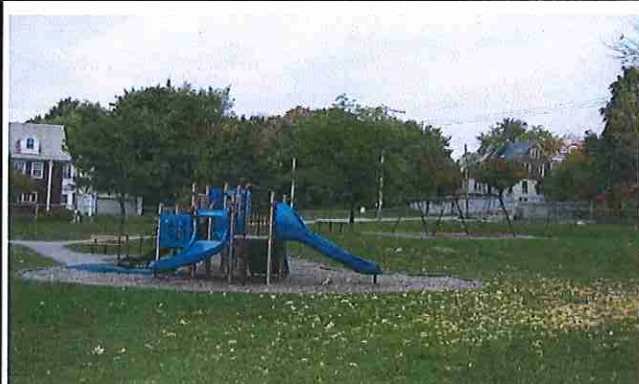
## 1st & Wright Play Area 2470 North 1st Street

Current Replacement Value *	\$170,219
Rating Number *	6
Total Area	25,385 SF
Facility Constructed	1984
Last Reconstruction	1999
ADA Accessible	Yes

- A large area with the play structure and swing set at the north end. This site is currently used as a play area for nearby daycare centers.
- The resilient surface is in need of some minor repairs and the woodchips are in need of replenishment.

Item	Type	Quantity	Unit	Condition *	Remarks
<b>Grounds</b>					
Pervious Surface	Grass	22,262	SF	7	
Impervious Surface	Asphalt	776	SF	7	
Benches/Picnic Tables	Plastic Bench	2	EA	7	
Fencing	4' Chain Link	518	LF	5	
Lighting	N/A				
Plumbing/Drainage	Catch Basin	1	EA	7	
	Drain Tile	166	LF	N/A	
Plumbing/Drink., Spigot	N/A				
Monuments	N/A				
<b>Structures</b>					
Play Equipment	Burke	1	EA	6	
Swing Set	Infant/Belt	4	EA	7	1 Unit
Resilient Surfacing	Poured in Place	97	SF	5	
Play Surfacing	EWF**	2,250	SF	5	
Edging	Plastic-6' Section	43	EA	6	
<b>Tennis Courts</b>					
Surface	N/A				
Post/Nets	N/A				
<b>Basketball Courts</b>					
Surface	N/A				
Post/Backboard	N/A				
<b>Baseball Diamonds</b>					
Surface	N/A				
Bleachers / Benches	N/A				
Back Stops	N/A

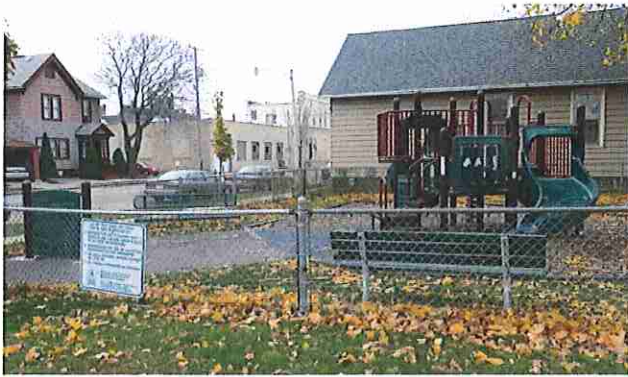
4th & Mineral Play Area 937 South 4th Street

Current Replacement Value *			\$77,499		
	Rating Number *			8		
	Total Area			2,992 SF		
	Facility Constructed			1971		
	Last Reconstruction			2010		
	ADA Accessible			Yes		
<p>- A small site with a play structure. During reconstruction building debris had to be removed and drainage stone installed. Due to changes in standards the area was too small to support a swing set.</p> <p>- As with all Recreation Facilities there is a need for regular inspections and maintenance of woodchip levels.</p>

Item	Type	Quantity	Unit	Condition *	Remarks	
<b>Grounds</b>						
Pervious Surface	Grass	2,647	SF	8		
Impervious Surface	Asphalt	229	SF	9		
Benches/Picnic Tables	Expanded Metal Bench	1	EA	8		
	Wood Bench	1	EA	6		
Fencing	4' Chain Link	178	LF	6		
Lighting	N/A					
Plumbing/Drainage	N/A					
Plumbing/Drink., Spigot	N/A					
Monuments	N/A					
<b>Structures</b>						
Play Equipment	Burke	1	EA	9	1 Play Panel	
Swing Set	N/A		EA			
Resilient Surfacing	Poured in Place	116	SF	9		
Play Surfacing	EWf**	652	SF	8		
Edging	Plastic-6' Section	17	EA	9		
<b>Tennis Courts</b>						
Surface	N/A					
Post/Nets	N/A					
<b>Basketball Courts</b>						
Surface	N/A					
Post/Backboard	N/A					
<b>Baseball Diamonds</b>						
Surface	N/A					
Bleachers / Benches	N/A					
Back Stops	N/A

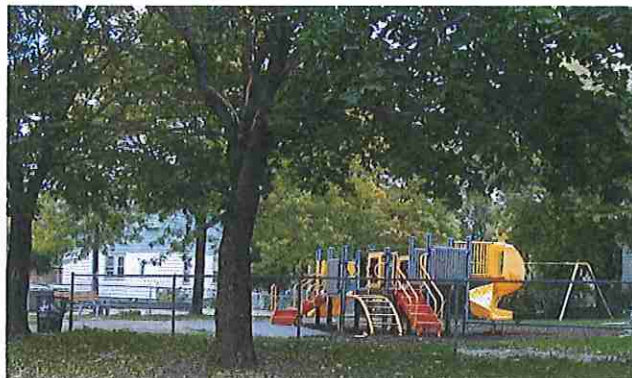
## 5th & Randolph Play Area 3460 North 5th Street

Current Replacement Value *	\$89,302
Rating Number *	6
Total Area	9,380 SF
Facility Constructed	1980
Last Reconstruction	1995
ADA Accessible	No

- The resilient surface is in need of some minor repairs and the woodchips are in need of replenishment.

Item	Type	Quantity	Unit	Condition *	Remarks
<b>Grounds</b>					
Pervious Surface	Grass	5,459	SF	5	
Impervious Surface	Asphalt	1,809	SF	7	
Benches/Picnic Tables	Plastic Bench	3	EA	6	
	Wood Bench	1	EA	5	
Fencing	4' Chain Link	336	LF	6	
	Guard Rail	32	LF	7	
Lighting	N/A				
Plumbing/Drainage	N/A				
Plumbing/Drink., Spigot	N/A				
Monuments	N/A

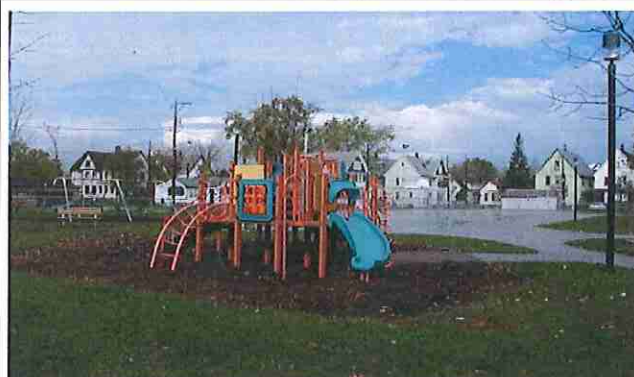
## 12th & Wright Play Area 2435 North 12th Street

Current Replacement Value *	\$367,638
Rating Number *	6
Total Area	57,372 SF
Facility Constructed	1947
Last Reconstruction	1996
ADA Accessible	Yes

- A large area that includes a play structure, swing set and two basketball courts. The basketball courts were reconstructed and the perimeter fence was replaced in 1998.
- The woodchips are becoming overgrown with weeds and are in need of replacement. Cleaning the asphalt surface of glass needs to be done on a regular basis.

Item	Type	Quantity	Unit	Condition *	Remarks
<b>Grounds</b>					
Pervious Surface	Grass	35,151	SF	6	
Impervious Surface	Asphalt	14,191	SF	7	
Benches/Picnic Tables	Wood Bench	4	EA	5	
Fencing	4' Chain Link	338	LF	7	
	6' Chain Link	300	LF	7	
	10' Chain Link	224	LF	7	
Lighting	Light Pole	3	EA	N/A	Non-operational
Plumbing/Drainage	Catch Basin	1	EA	7	
	Drain Tile	221	LF	N/A	
Plumbing/Drink., Spigot	N/A				
Monuments	N/A				
<b>Structures</b>					
Play Equipment	Burke	1	EA	6	
Swing Set	Infant/Belt	4	EA	7	1 Unit
Resilient Surfacing	Poured in Place	139	SF	6	
Play Surfacing	EWF**	2,691	SF	3	
Edging	Plastic-6' Section	46	EA	6	
<b>Tennis Courts</b>					
Surface	N/A				
Post/Nets	N/A				
<b>Basketball Courts</b>					
Surface	Asphalt	5,200	SF	7	
Post/Backboard	Steel	4	EA	6	(2) Full Courts
<b>Baseball Diamonds</b>					
Surface	N/A				
Bleachers / Benches	N/A				
Back Stops	N/A

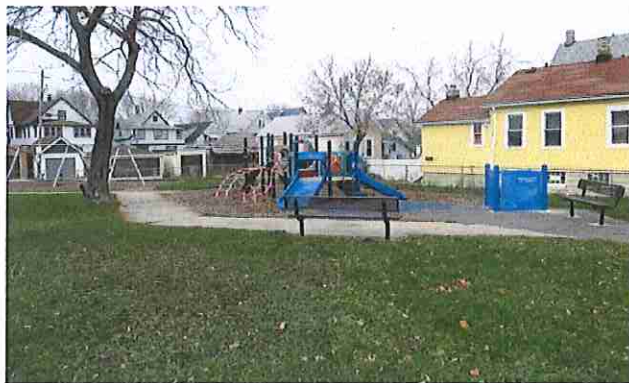
## 13th & Lapham Play Area 1300 West Lapham Boulevard

Current Replacement Value *	\$89,379
Rating Number *	7
Total Area	10,404 SF
Facility Constructed	1972
Last Reconstruction	2010
ADA Accessible	Yes

- A small area that includes a play structure and a swing set. Major repairs have been done to the chain link fence several times because of vehicle accidents.
- The asphalt path is heaving because of tree roots and will need replacement.

Item	Type	Quantity	Unit	Condition *	Remarks
<b>Grounds</b>					
Pervious Surface	Grass	6,648	SF	7	
Impervious Surface	Asphalt	1,365	SF	3	Path Heaving
Benches/Picnic Tables	Expanded Metal Bench	3	EA	7	
Fencing	4' Chain Link	376	LF	7	
Lighting	N/A				
Plumbing/Drainage	N/A				
Plumbing/Drink., Spigot	Meter Pit	1	EA	7	
Monuments	N/A				
<b>Structures</b>					
Play Equipment	Burke	1	EA	6	2 Play Panels
Swing Set	Infant/Belt	4	EA	9	1 Unit
Resilient Surfacing	Poured in Place	106	SF	9	
Play Surfacing	EWF**	2,285	SF	8	
Edging	Plastic-6' Section	42	EA	8	
<b>Tennis Courts</b>					
Surface	N/A				
Post/Nets	N/A				
<b>Basketball Courts</b>					
Surface	N/A				
Post/Backboard	N/A				
<b>Baseball Diamonds</b>					
Surface	N/A				
Bleachers / Benches	N/A				
Back Stops	N/A

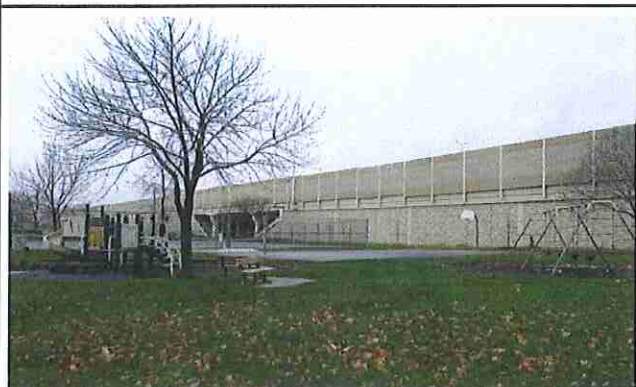
## 16th & Edgerton Play Area 5057 South 16th Street

Current Replacement Value *	\$294,032
Rating Number *	5
Total Area	45,220 SF
Facility Constructed	1982
Last Reconstruction	1995
ADA Accessible	No

- A large area with a play structure, swing set, basketball court and tennis courts. The tube slide and one back board has been removed at the request of neighbors because of late night activity.
- The Highway expansion 40 feet east, did not replicate the drainage creating a problem.
- ADA retrofit and maintenance cannot be done, the structure manufacturer is no longer in business.
- The resilient surface and woodchips are in need of replacement.

Item	Type	Quantity	Unit	Condition *	Remarks
<b>Grounds</b>					
Pervious Surface	Grass	25,470	SF	5	Water Ponding
Impervious Surface	Asphalt	141	SF	3	
Benches/Picnic Tables	Plastic Bench	3	EA	6	
Fencing	10' Chain Link	411	LF	5	
Lighting	N/A				
Plumbing/Drainage	Catch Basin	1	EA	7	
	Drain Tile	601	LF	N/A	
Plumbing/Drink., Spigot	N/A				
Monuments	N/A				
<b>Structures</b>					
Play Equipment	Park Structures	1	EA	3	
Swing Set	Infant/Belt	4	EA	5	1 Unit
Resilient Surfacing	Poured in Place	194	SF	2	Large Hole
Play Surfacing	EWF**	2,340	SF	1	
Edging	Plastic-6' Section	42	EA	5	
<b>Tennis Courts</b>					
Surface	Asphalt	12,945	SF	6	Color Coated
Post/Nets	Steel	2	EA	4	Posts Heaving
<b>Basketball Courts</b>					
Surface	Asphalt	4,130	SF	6	
Post/Backboard	Steel	2	EA	6	(1) Half Court
<b>Baseball Diamonds</b>					
Surface	N/A				
Bleachers / Benches	N/A				
Back Stops	N/A

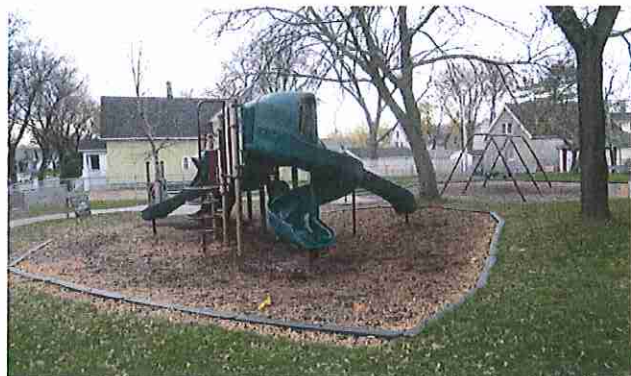
## 16th & Hopkins Play Area 1601 West Hopkins Street

Current Replacement Value *	\$51,449
Rating Number *	7
Total Area	8,109 SF
Facility Constructed	1980
Last Reconstruction	2002
ADA Accessible	Yes

Item	Type	Quantity	Unit	Condition *	Remarks
<b>Grounds</b>					
Pervious Surface	Grass	5,337	SF	7	
Impervious Surface	Asphalt	604	SF	7	
Benches/Picnic Tables	Expanded Metal Bench	2	EA	7	
Fencing	4' Chain Link	344	LF	6	
	Guard Rail	23	LF	7	
Lighting	N/A				
Plumbing/Drainage	N/A				
Plumbing/Drink., Spigot	N/A				
Monuments	N/A				
<b>Structures</b>					
Play Equipment	Burke	1	EA	5	2 Play Panels
Swing Set	Infant/Belt	4	EA	7	1 Unit
Resilient Surfacing	Poured in Place	125	SF	7	
Play Surfacing	EWF**	2,043	SF	6	
Edging	Plastic-6' Section	39	EA	6	
<b>Tennis Courts</b>					
Surface	N/A				
Post/Nets	N/A				
<b>Basketball Courts</b>					
Surface	N/A				
Post/Backboard	N/A				
<b>Baseball Diamonds</b>					
Surface	N/A				
Bleachers / Benches	N/A				
Back Stops	N/A

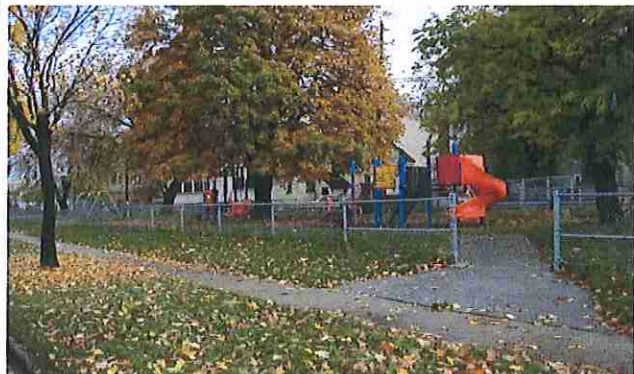
## 17th & Vine Play Area 1800 North 17th Street

Current Replacement Value *	\$176,627
Rating Number *	6
Total Area	21,375 SF
Facility Constructed	1975
Last Reconstruction	1994
ADA Accessible	No

Item	Type	Quantity	Unit	Condition *	Remarks
<b>Grounds</b>					
Pervious Surface	Grass	8,711	SF	6	
Impervious Surface	Asphalt	1,637	SF	6	
Benches/Picnic Tables	Plastic Bench	4	EA	6	
Fencing	4' Chain Link	488	LF	7	
	10' Chain Link	406	LF	7	
Lighting	N/A				
Plumbing/Drainage	N/A				
Plumbing/Drink., Spigot	N/A				
Monuments	N/A				
<b>Structures</b>					
Play Equipment	Park Structures	2	EA	5	
Swing Set	Infant/Belt	4	EA	7	1 Unit
Resilient Surfacing	Poured in Place	445	SF	6	
Play Surfacing	EWF**	3,277	SF	6	
Edging	Plastic-6' Section	58	EA	4	
<b>Tennis Courts</b>					
Surface	N/A				
Post/Nets	N/A				
<b>Basketball Courts</b>					
Surface	Asphalt	7,305	SF	7	Seal Coated in 2006
Post/Backboard	Steel	4	EA	6	(2) Full Courts
<b>Baseball Diamonds</b>					
Surface	N/A				
Bleachers / Benches	N/A				
Back Stops	N/A

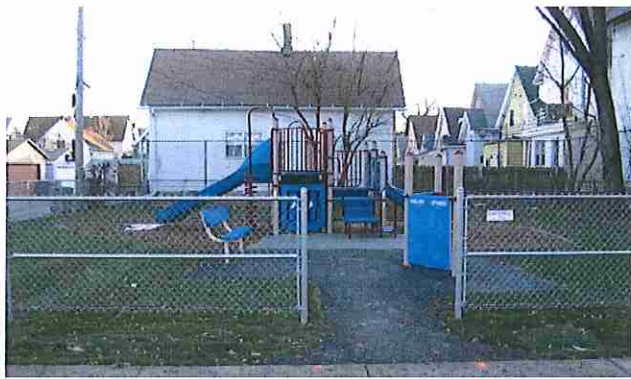
## 18th & Washington Play Area 1825 West Washington Street

Current Replacement Value *	\$73,301
Rating Number *	7
Total Area	4,562 SF
Facility Constructed	1964
Last Reconstruction	2006
ADA Accessible	Yes

Item	Type	Quantity	Unit	Condition *	Remarks
<b>Grounds</b>					
Pervious Surface	Grass	3,573	SF	7	
Impervious Surface	Asphalt	223	SF	8	
Benches/Picnic Tables	Expanded Metal Bench	3	EA	8	
Fencing	4' Chain Link	137	LF	8	
	10' Chain Link	114	LF	7	
Lighting	N/A				
Plumbing/Drainage	N/A				
Plumbing/Drink., Spigot	N/A				
Monuments	N/A				
<b>Structures</b>					
Play Equipment	Burke	1	EA	8	2 Play Panels
Swing Set	N/A		EA		
Resilient Surfacing	Poured in Place	82	SF	8	
Play Surfacing	EWf**	684	SF	7	
Edging	Plastic-6' Section	17	EA	7	
<b>Tennis Courts</b>					
Surface	N/A				
Post/Nets	N/A				
<b>Basketball Courts</b>					
Surface	N/A				
Post/Backboard	N/A				
<b>Baseball Diamonds</b>					
Surface	N/A				
Bleachers / Benches	N/A				
Back Stops	N/A

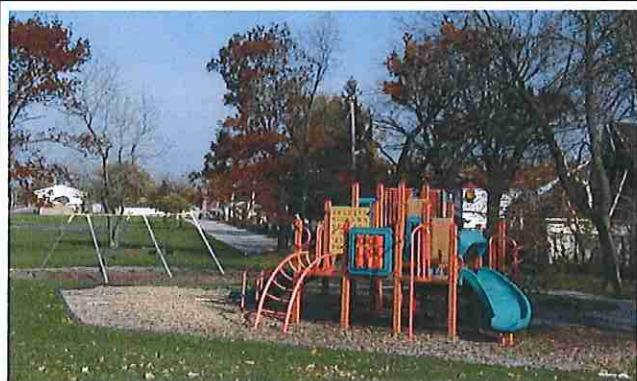
## 20th & Olive Play Area 1970 West Olive Street

Current Replacement Value *	\$274,749
Rating Number *	6
Total Area	46,134 SF
Facility Constructed	1970
Last Reconstruction	1996
ADA Accessible	Yes

Item	Type	Quantity	Unit	Condition *	Remarks
<b>Grounds</b>					
Pervious Surface	Grass	38,221	SF	6	
Impervious Surface	Asphalt	1,083	SF	7	
Benches/Picnic Tables	Plastic Bench	3	EA	5	
	Expanded Metal Bench	2	EA	5	
Fencing	6' Chain Link	221	LF	7	
Lighting	N/A				
Plumbing/Drainage	N/A				
Plumbing/Drink., Spigot	N/A				
Monuments	N/A				
<b>Structures</b>					
Play Equipment	Burke	1	EA	7	
Swing Set	Infant/Belt	4	EA	7	1 Unit
Resilient Surfacing	Poured in Place	139	SF	6	
Play Surfacing	EWF**	2,691	SF	6	
Edging	Plastic-6' Section	46	EA	6	
<b>Tennis Courts</b>					
Surface	N/A				
Post/Nets	N/A				
<b>Basketball Courts</b>					
Surface	Asphalt	4,000	SF	5	
Post/Backboard	Steel	2	EA	6	(1) Full Court
<b>Baseball Diamonds</b>					
Surface	N/A				
Bleachers / Benches	N/A				
Back Stops	N/A

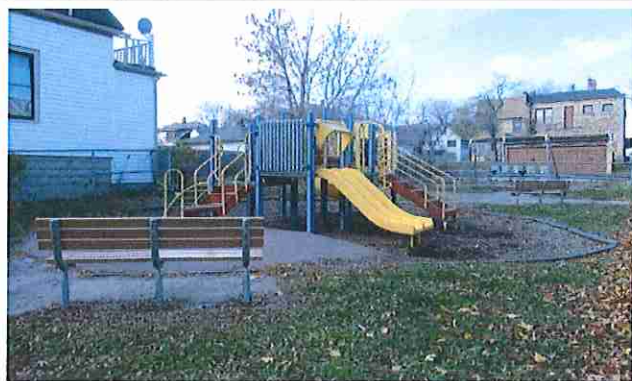
## 21st & Keefe Play Area 2105 West Keefe Avenue

Current Replacement Value *	\$67,182
Rating Number *	6
Total Area	5,922 SF
Facility Constructed	1980
Last Reconstruction	1995
ADA Accessible	No

Item	Type	Quantity	Unit	Condition *	Remarks
<b>Grounds</b>					
Pervious Surface	Grass	3,402	SF	5	
Impervious Surface	Asphalt	666	SF	6	
Benches/Picnic Tables	Plastic Bench	2	EA	7	
Fencing	4' Chain Link	233	LF	6	
	Guard Rail	53	LF	7	
Lighting	N/A				
Plumbing/Drainage	N/A				
Plumbing/Drink., Spigot	N/A				
Monuments	N/A				
<b>Structures</b>					
Play Equipment	Burke	1	EA	6	
Swing Set	Infant	2	EA	7	1 Unit
Resilient Surfacing	Poured in Place	270	SF	6	
Play Surfacing	EWf**	1,584	SF	6	
Edging	Plastic-6' Section	35	EA	6	
<b>Tennis Courts</b>					
Surface	N/A				
Post/Nets	N/A				
<b>Basketball Courts</b>					
Surface	N/A				
Post/Backboard	N/A				
<b>Baseball Diamonds</b>					
Surface	N/A				
Bleachers / Benches	N/A				
Back Stops	N/A

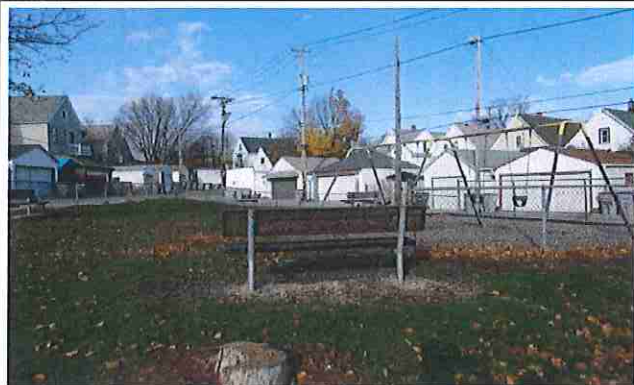
## 21st & Rogers Play Area 2018 South 21st Street

Current Replacement Value *	\$76,999
Rating Number *	6
Total Area	7,804 SF
Facility Constructed	1935
Last Reconstruction	1992
ADA Accessible	No

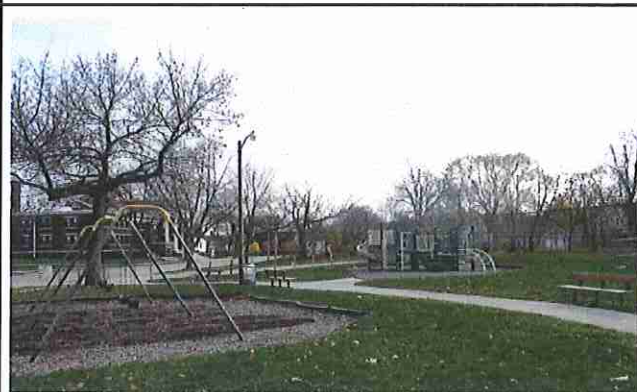
## 26th & Medford Play Area 2476 North 26th Street

Current Replacement Value *	\$141,407
Rating Number *	5
Total Area	19,776 SF
Facility Constructed	1949
Last Reconstruction	1994
ADA Accessible	No

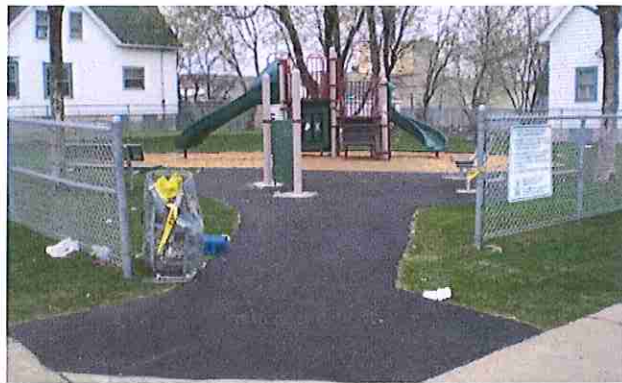
## 29th and Meinecke Play Area 2403 North 29th Street

Current Replacement Value *	\$59,783
Rating Number *	8
Total Area	4,612 SF
Facility Constructed	1993
Last Reconstruction	2009
ADA Accessible	Yes

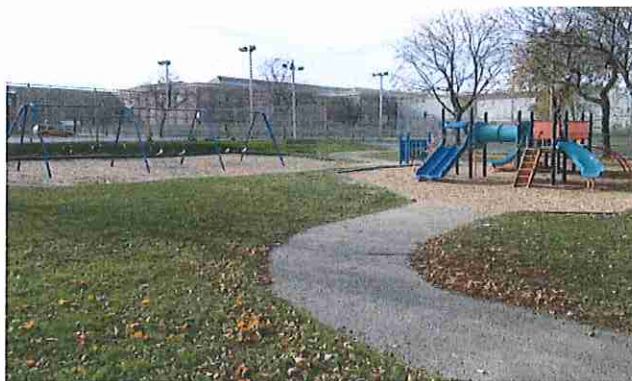
## 29th and Melvina Play Area 2835 West Melvina Street

Current Replacement Value *	\$323,870
Rating Number *	7
Total Area	42,264 SF
Facility Constructed	1980
Last Reconstruction	2008
ADA Accessible	Yes

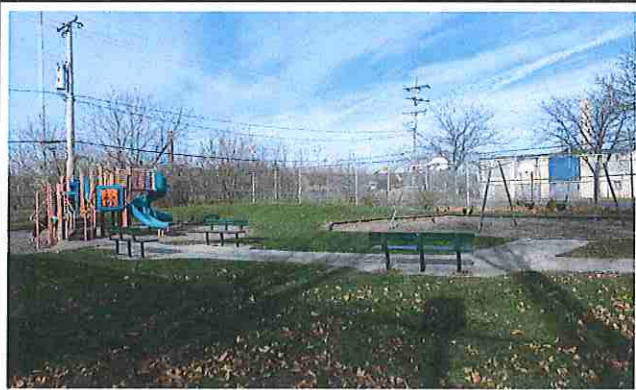
## 30th and Cawker Play Area 2929 North 30th Street

Current Replacement Value *	\$170,171
Rating Number *	6
Total Area	23,428 SF
Facility Constructed	1981
Last Reconstruction	1997
ADA Accessible	Yes

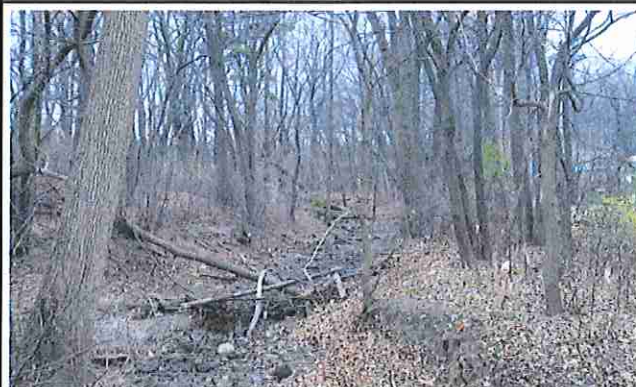
## 30th and Fardale Passive Area 3101 West Fardale Avenue

Current Replacement Value *	\$1,437,073
Rating Number *	5
Total Area	343,950 SF
Facility Constructed	1960
Last Reconstruction	
ADA Accessible	No

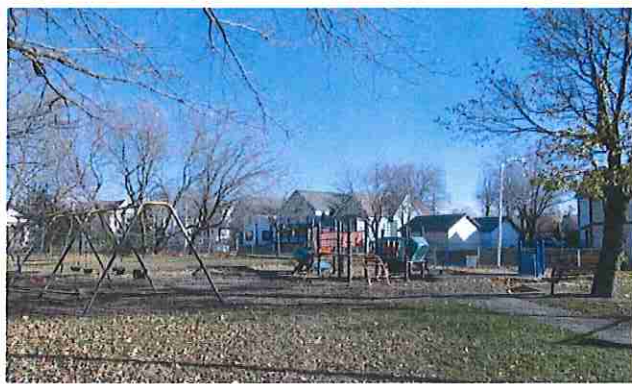
## 30th and Galena Play Area 3002 West Galena Street

Current Replacement Value *	\$109,207
Rating Number *	6
Total Area	12,173 SF
Facility Constructed	1976
Last Reconstruction	2008
ADA Accessible	Yes

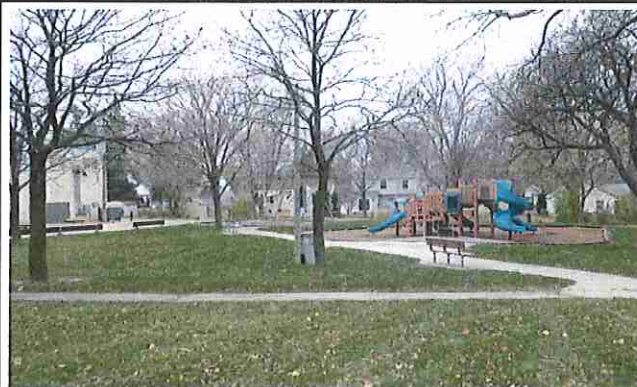
## 51st and Stack Play Area 5201 West Stack Drive

Current Replacement Value *	\$400,136
Rating Number *	6
Total Area	55,780 SF
Facility Constructed	1955
Last Reconstruction	1996
ADA Accessible	Yes

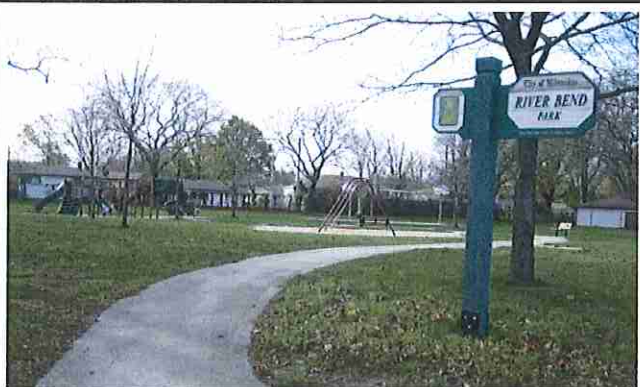
Current Replacement Value *		\$326,924			
	Rating Number *		7			
	Total Area		48,825 SF			
	Facility Constructed		1959			
	Last Reconstruction		2003			
	ADA Accessible		Yes			
<p>- A large site with a play structure, swing set and benches. There are drainage issues on this site even though drain tile was added during the 2003 reconstruction. The goal posts on the basketball court and posts for the play panels are heaving.</p> <p>- The drinking fountain's needs to be replaced, because vandals broke the mounting brackets.</p>
