# Certificate of Appropriateness

**Property** 1702 N. HUMBOLDT AV. **Brady Street Historic District**  
**Description of work** The church, rectory and garage will be tuck-pointed in areas as needed. Test panels will be done in inconspicuous places on the buildings for HPC staff to review and approve. On the school, the chimney in the back of the building will be demolished, decked-in and roofed-over with shingles to match.

**Date issued** 10/31/2014 **PTS ID** 98733 **COA, tuckpointing, removal of chimney on school**

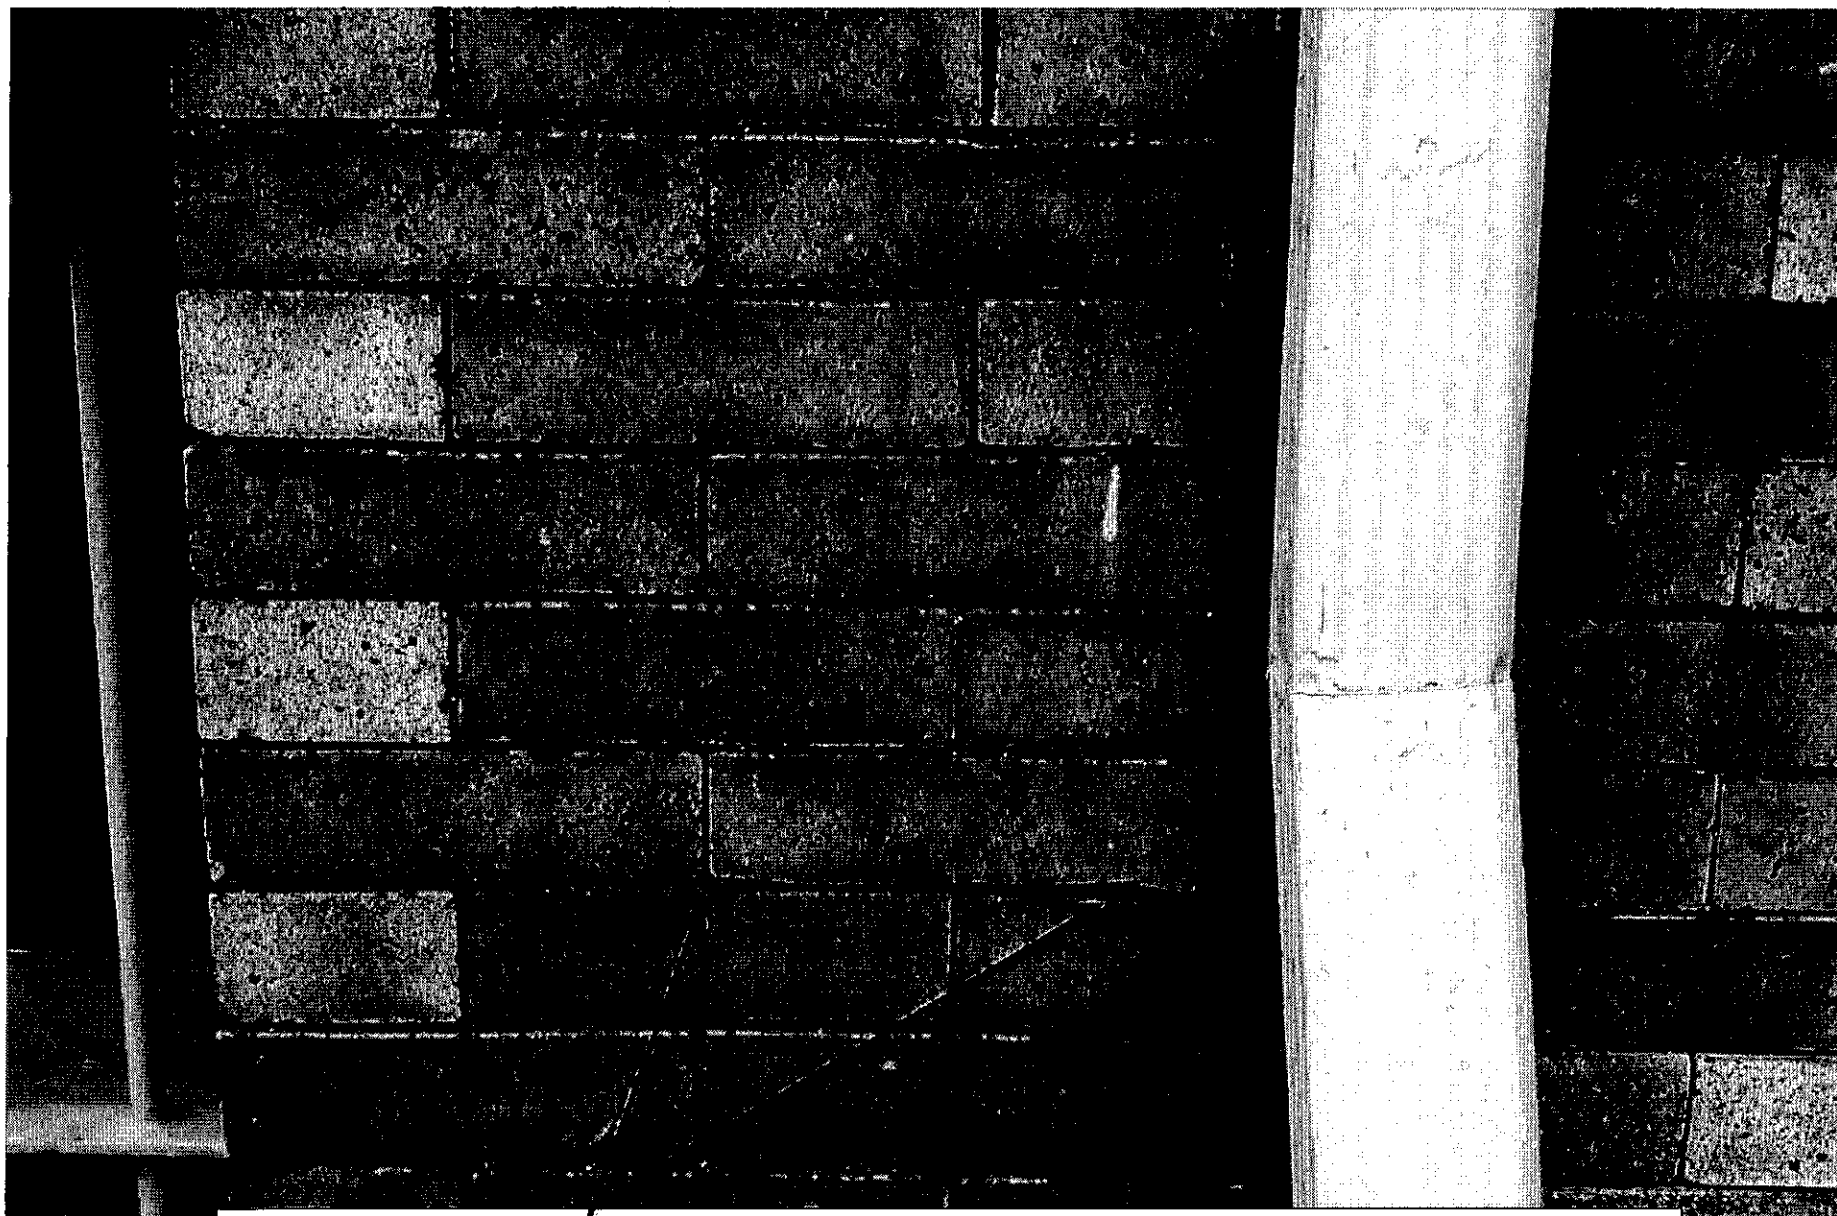
**This test panel on the rectory (East Elevation) shows some wobble in the butter joint that was cut and re-pointed. This must be avoided and only mortar that is missing, loose or deteriorated should be replaced. Otherwise the color and texture of the replacement mortar in this panel is acceptable.**

For removal of butter joint mortar on the rectory, choose the technique that makes the least impact on the masonry. The use of hand tools is always recommended. Grout keys work well to remove mortar from butter joints unless they are extremely thin. A caulking cutter or an air-powered stone chisel set up for repointing can also be used. Most grinding wheels are too large for use on butter joints and tend to wobble creating nicks in the edges of the brick.

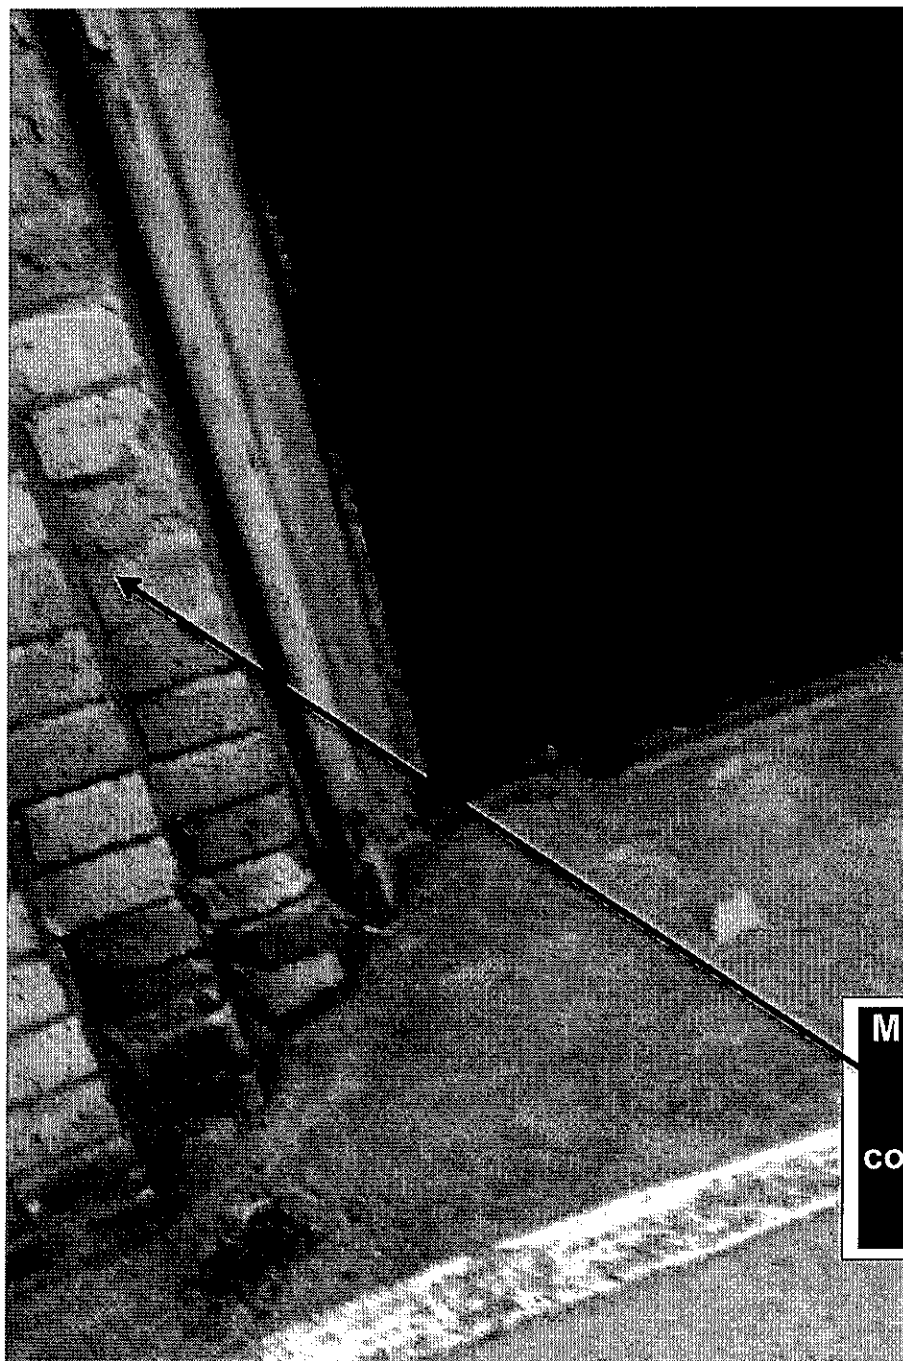
Mortar sample on church is acceptable in terms of color, texture and joint width and finish. Where new bricks are needed, they must be common cream brick of the same size, color and texture as the originals.
