Façade Critical Examination Ordinance Report

2015 Follow-up

City of Milwaukee
North Point Water Tower

August 5, 2015

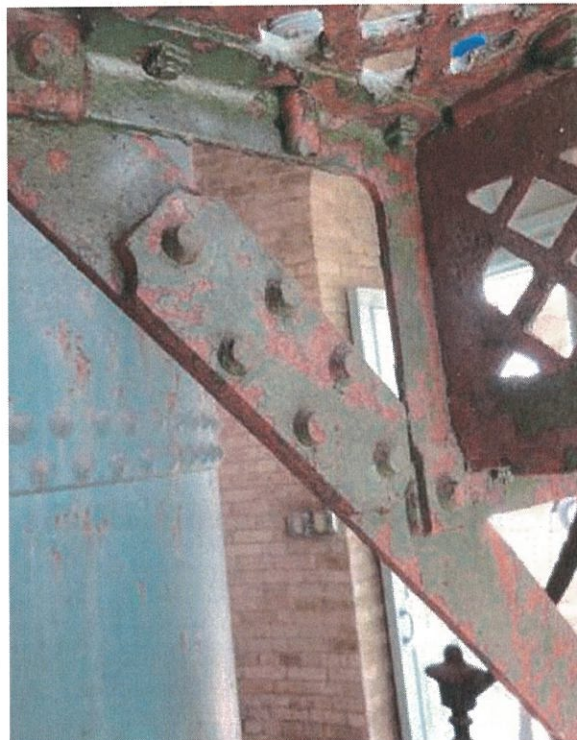
**S21**

The stringers are typically spliced together with a 7"x2.5" plate using 6 rivets every 11 to 12 steps (Photo S21).

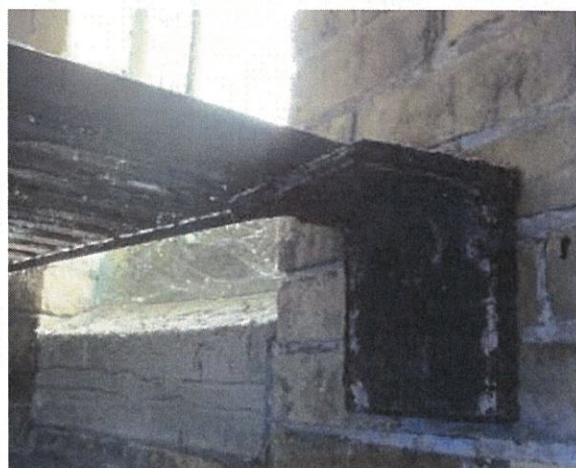
S36

Four of these eight angles were observed to cantilever from the standpipe. In addition, two steel angles were observed to be supported by steel clips at the masonry brick wall (Photo S36)

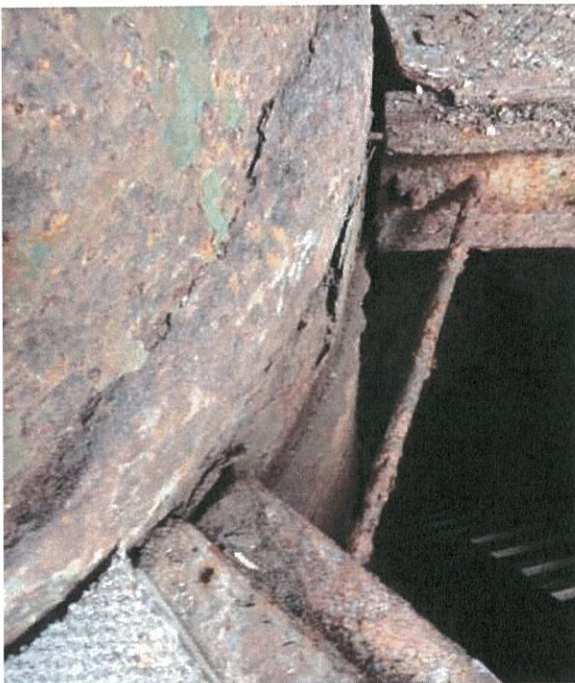
A stiffened checkered plate formed the deck over the radial beams. The checkered plate along with the steel framing was observed to be corroded (Photos S40 and S41).

- Platform at grade: We recommend that the checkered plate be replaced with a galvanized steel checkered plate. The existing structural steel framing should be cleaned and painted per the repair procedure described below.

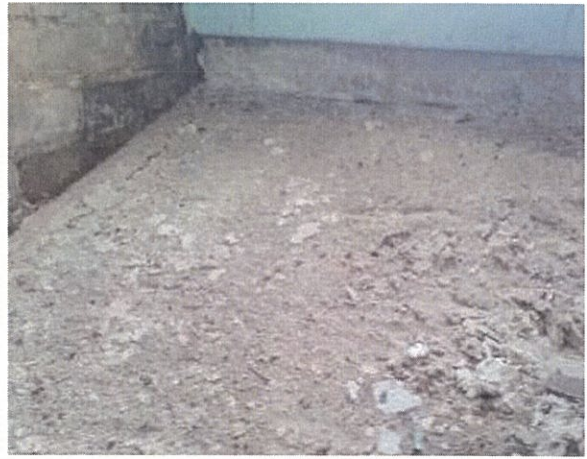
**T34**

Deterioration at window sill due to moisture infiltration (North of East windows)

Grade: Moderate

Remedy moisture infiltration from windows, clean and remove loose / flakey stone material from sill

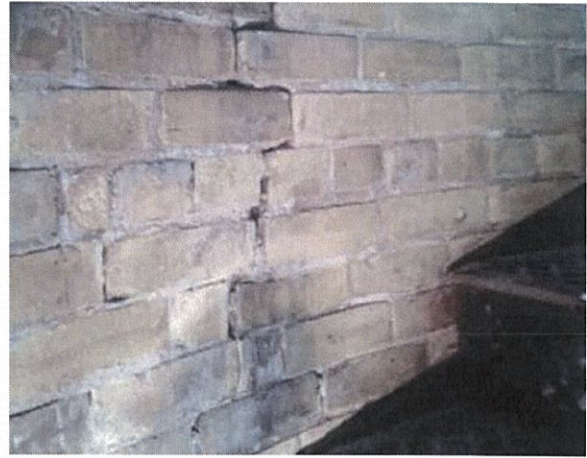
**T95**

Crack occurs above South window, 71' A.G.P. (above ground platform) up to 92' A.G.P. (approx. 1/8") horizontal crack

Grade: Moderate

Replace fractured bricks, repoint mortar joints

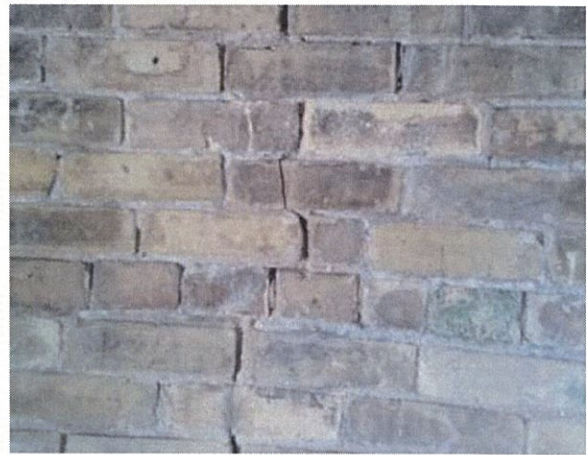
**T95
A**

Crack in common brick, through mortar joints and brick. Crack is above South window, movement appears to be horizontal (minimal movement)

Grade: Moderate

Replace fractured bricks, repoint mortar joints

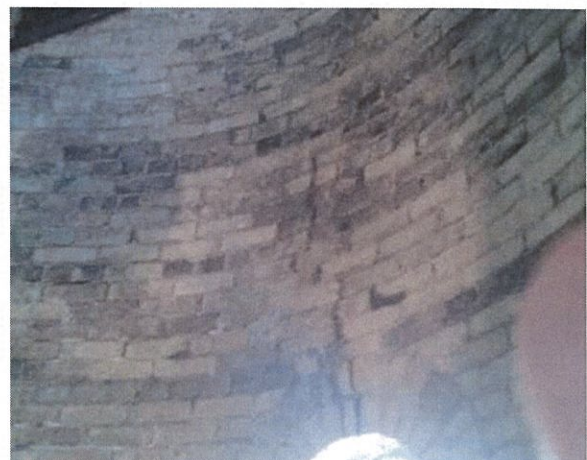
**T95
B**

Crack continues approximately 3' above window

Grade: Minor

Replace fractured bricks, repoint mortar joints

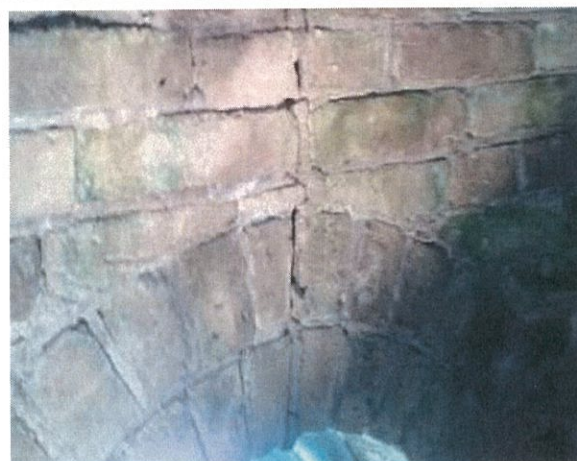
T179

Crack occurs above West window at 116' A.G.P., Horiz. movement (1/16")

Replace fractured bricks, repoint mortar joints

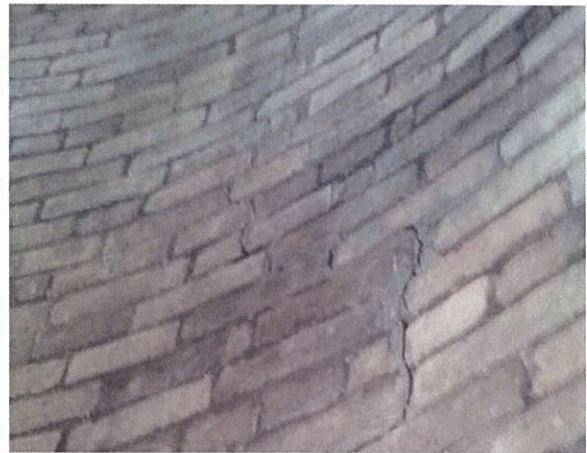
**T187
B**

Grade: Moderate

Replace fractured bricks, repoint mortar joints

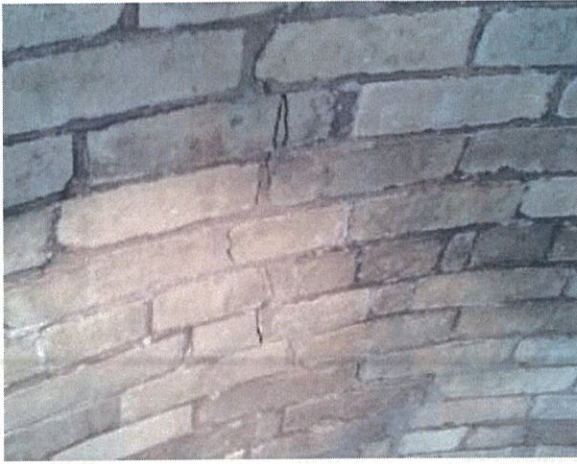
T200

Crack occurs above North window, extends from 124' A.G.P. to 128' A.G.P.

Replace fractured bricks, repoint mortar joints

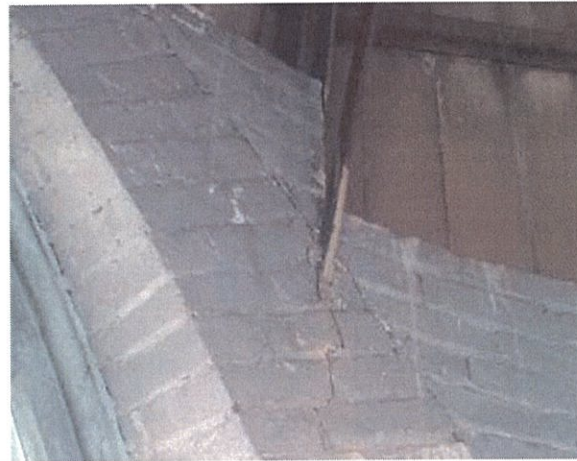
T212

Cracked arch, East (right) side of North window

Replace fractured bricks, repoint mortar joints

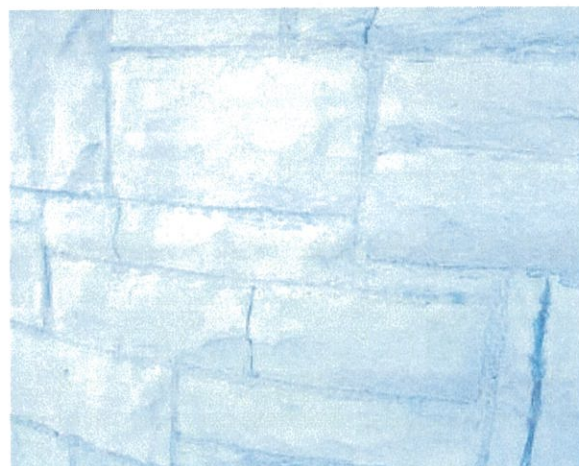
W12

Approx. (5) stones split and/or mechanically routed and missing mortar

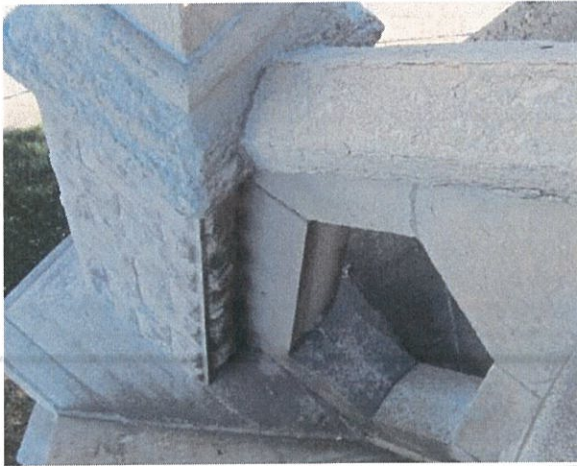
W24

Flying Buttress 1: Cracked upper arch piece, missing mortar

Grade: Severe

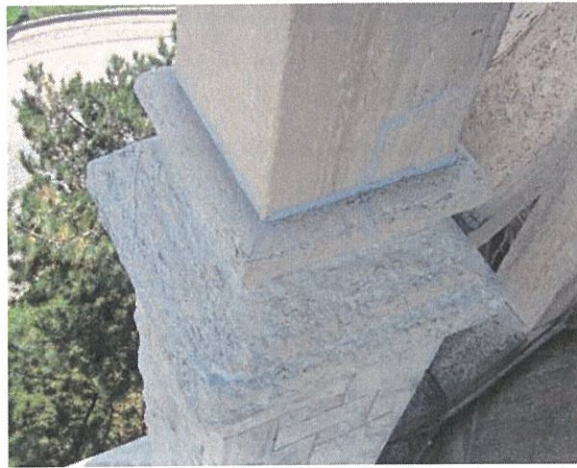
W25

Large Stone Finial 1: Cracked mid cap piece

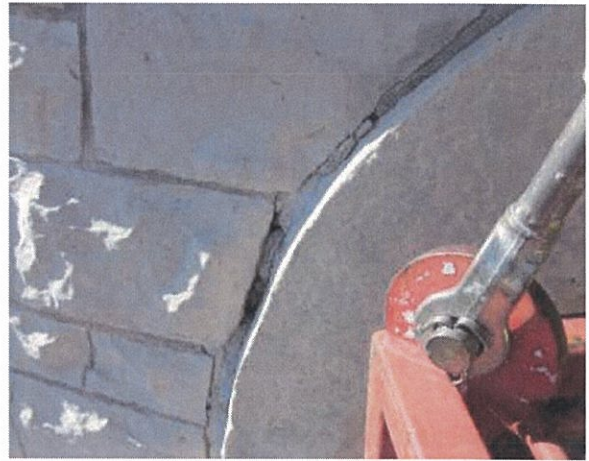
**N5**

Window 9: Stone sill cracked (entire depth)

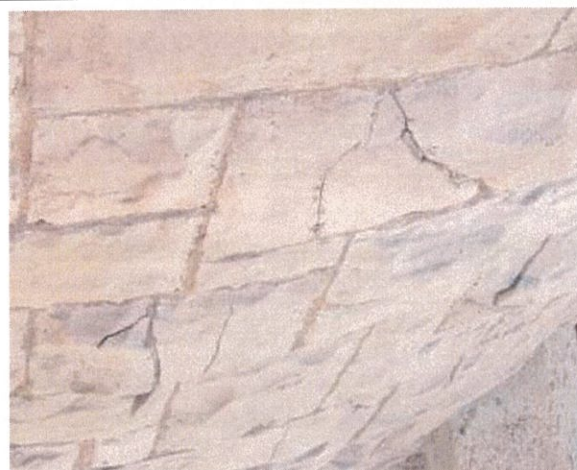
N9

Approx. (10) stones split and/or mechanically routed and missing mortar

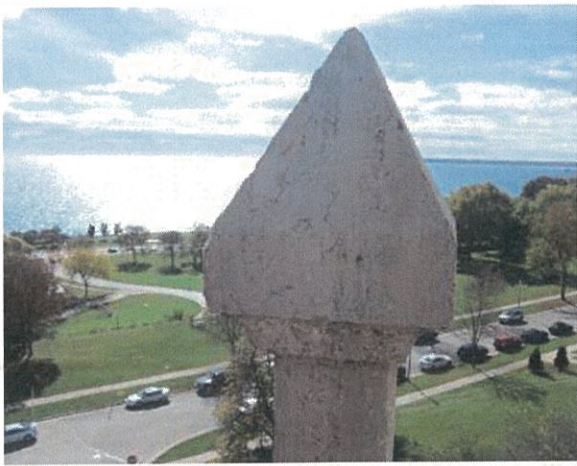
N12

Stone Finial 2: Stone is spalling, splitting, shearing

Grade: Severe

Replace stone and repoint mortar joints

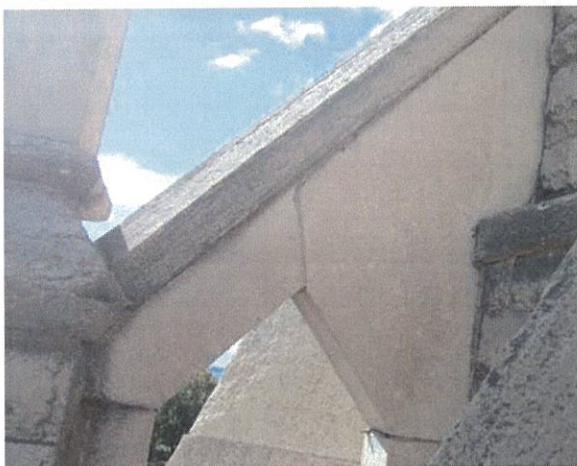
N13

Flying Buttress 2: Cracked upper arch piece, missing mortar

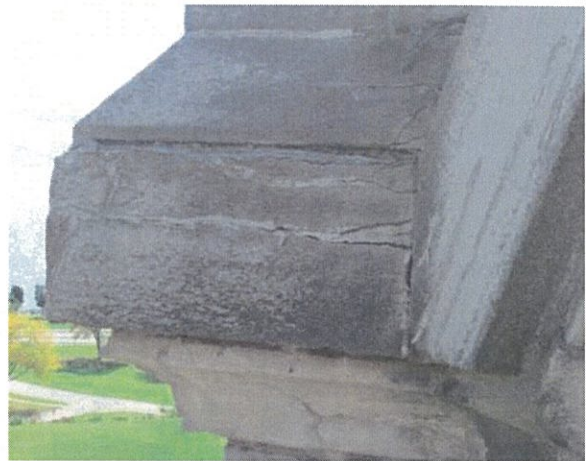
**N15**

Deteriorated mortar / sealant joints at top of gable ridge stone

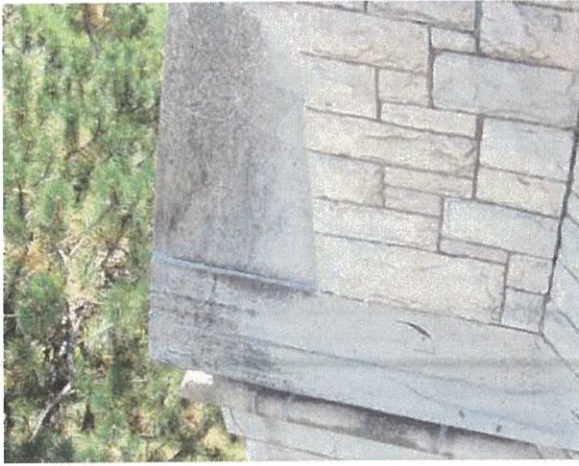
N17

Flying Buttrass 2: Cracked gable roof at North side (entire length)

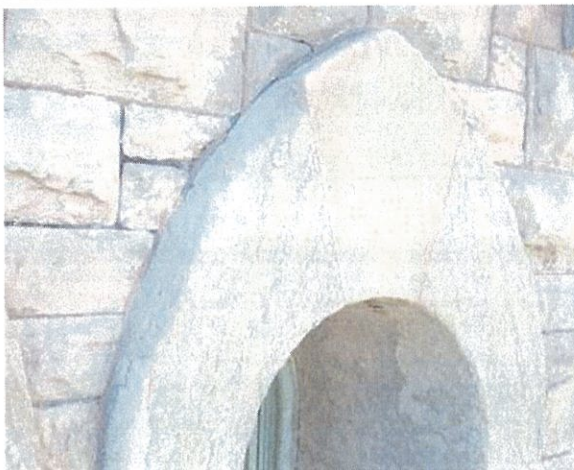
N19

Window 12: Stone arch / window casing: cracked (10" piece in hand)

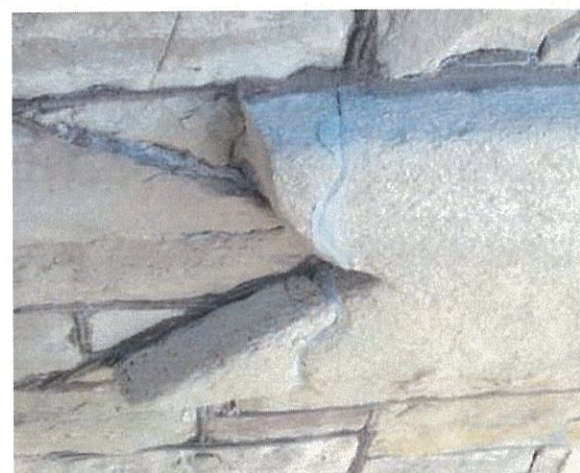
N26

1873 Flag Banner: cracked edges both ends

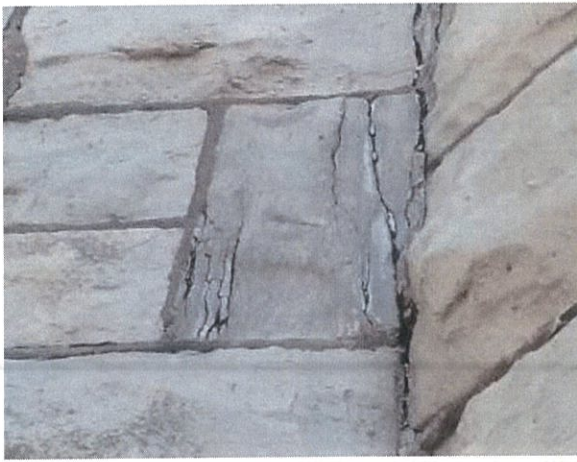
N31

Single stone has several vertical fractures

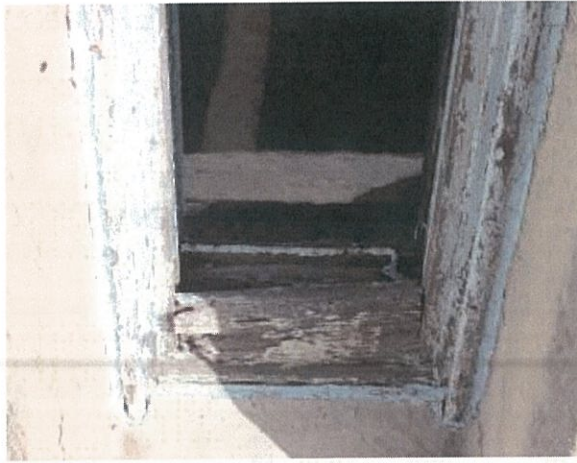
S1

Window 15: Wood window frame and sash is deteriorated / split / rotted. Peeling paint over entire surface

Updated Comment: Lower outer glass lite missing (6/24/15). Replace lower lite.

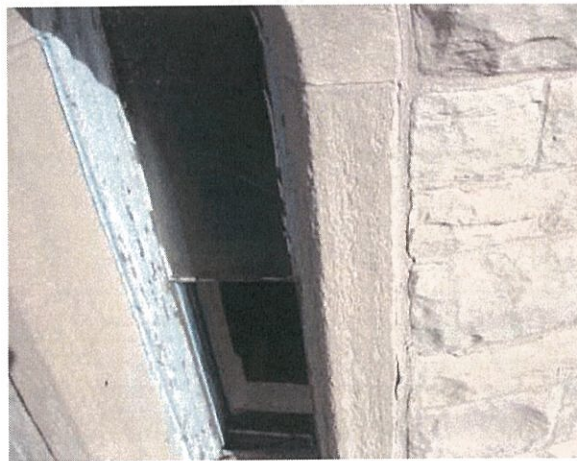
S2

Window 15: Mortar / sealant deteriorated or missing

Grade: Minor

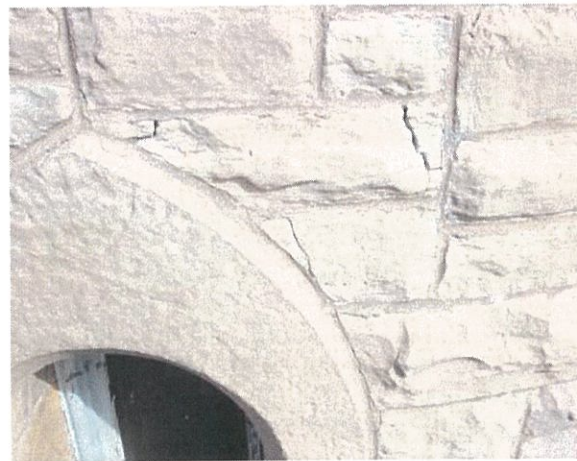
S3

Window 16: Approx. (5) stones split and/or mechanically routed and missing mortar

Grade: Moderate

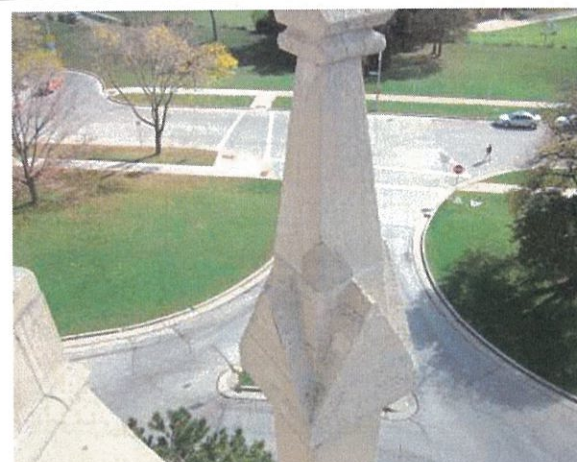
S4

Stone Finial 3: Upper sections / assembly: vertical and horizontal cracks throughout, large (10"x10"x6") mortar patches loose x2, spalling / flaking surface

Grade: Severe

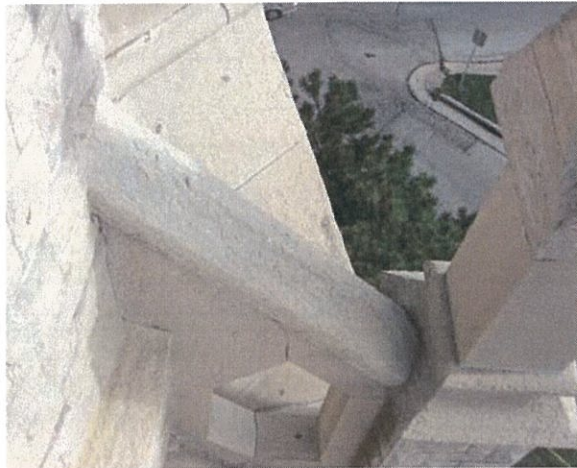
S5

Flying Buttress 3: Cracked upper arch piece, missing mortar

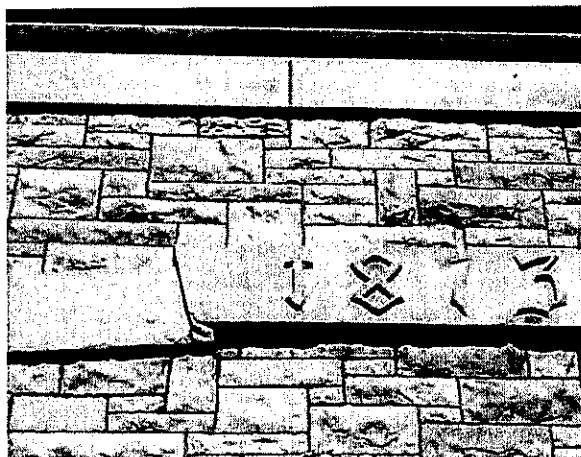
S10

Crack in dated stone work, once repaired

Grade: Minor

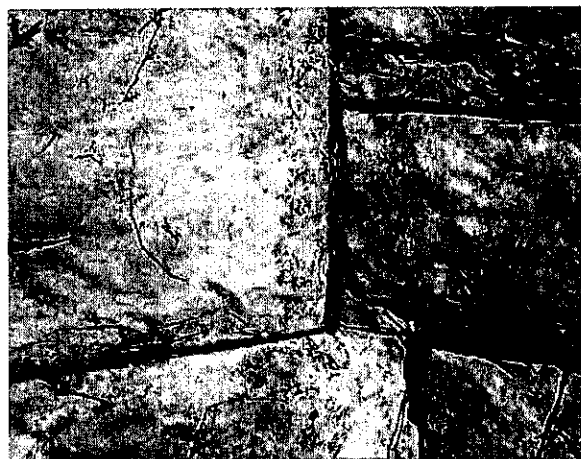
S11

Various locations of corner the tuck pointing has failed

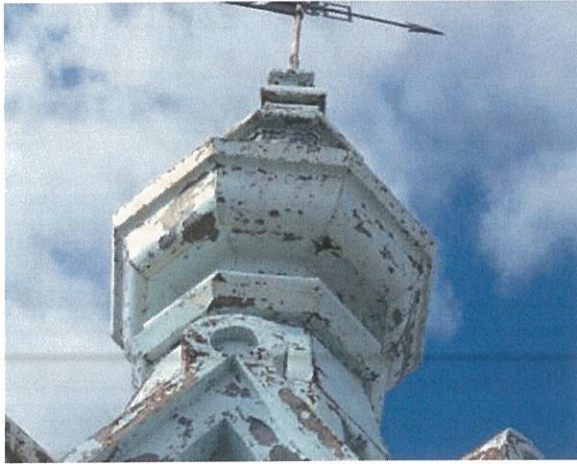
E1

Metal roof / finials: Exterior metal sheeting is intact. Peeling paint and spotting rust across entire surface

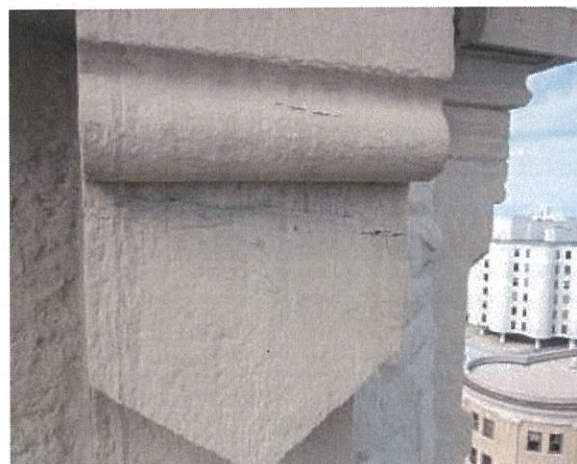
E3

Hairline cracking at corbel

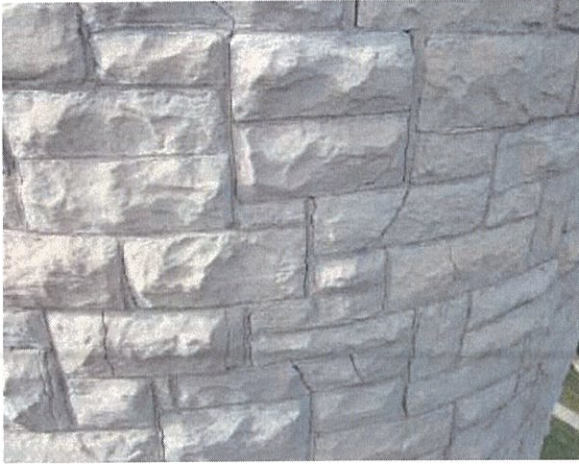
E5

Step cracking at stone and joint at approx. 130' level and extending down to 80' level

Grade: **Severe**

Repair stone and repoint mortar joints

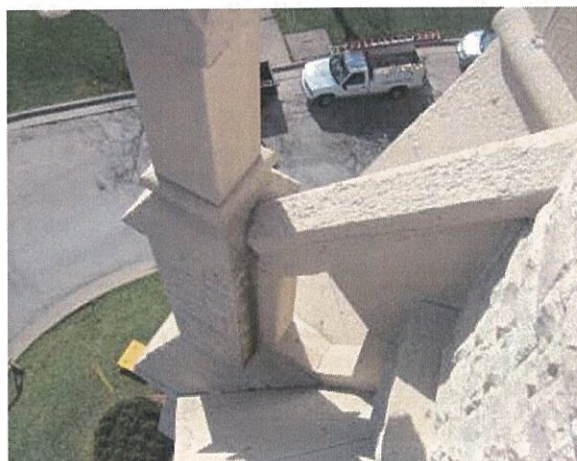
E8

Flying Buttress 2 & 3: Missing / deteriorated mortar joints along assembly (5-piece buttress), missing mortar joint at cap stone - tower interface

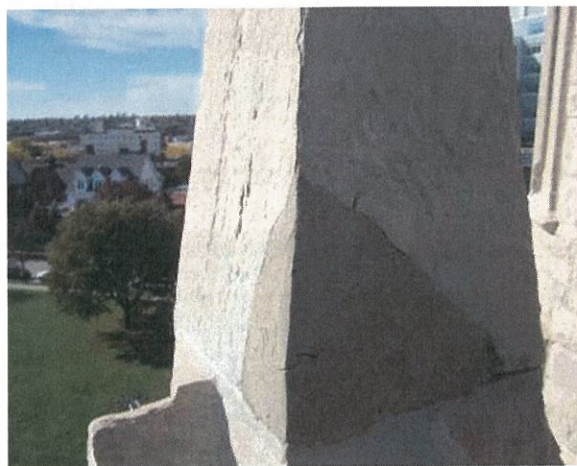
E9

Comment: Stone Finial 3: Upper sections / assembly: vertical and horizontal cracks through out, large (10"x10"x6") mortar patches loose x2, spalling / flaking surface

Action: Replace stone and repoint mortar joints

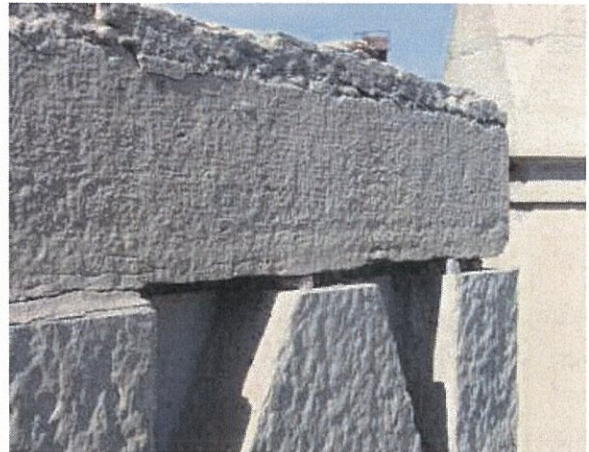
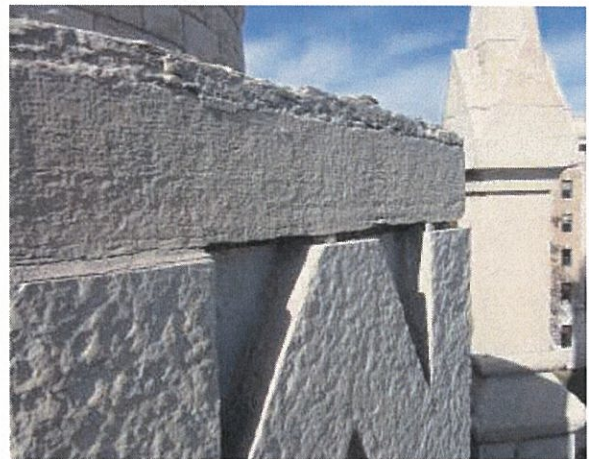
Stone Finial 3: Cracked base section

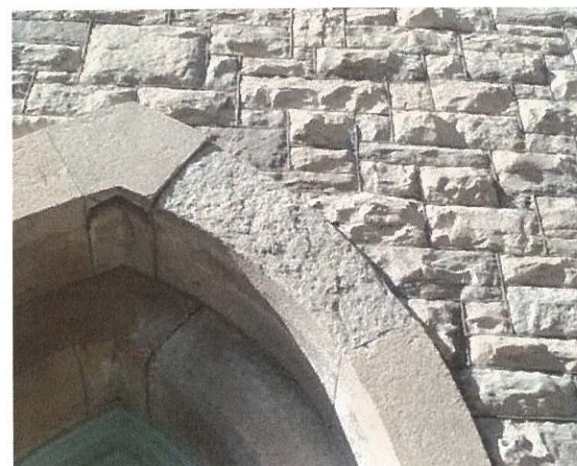
E14

Upper portion of arch is deteriorated. Face of stone is delaminated 3/4" - 1" less than adjacent stones
