CERTIFICATE OF APPROPRIATENESS APPLICATION FORM

CAMP SPRING PARK

3216-18 W. MCKINLEY BLVD.

Lead – Based Paint
Risk Assessment Report

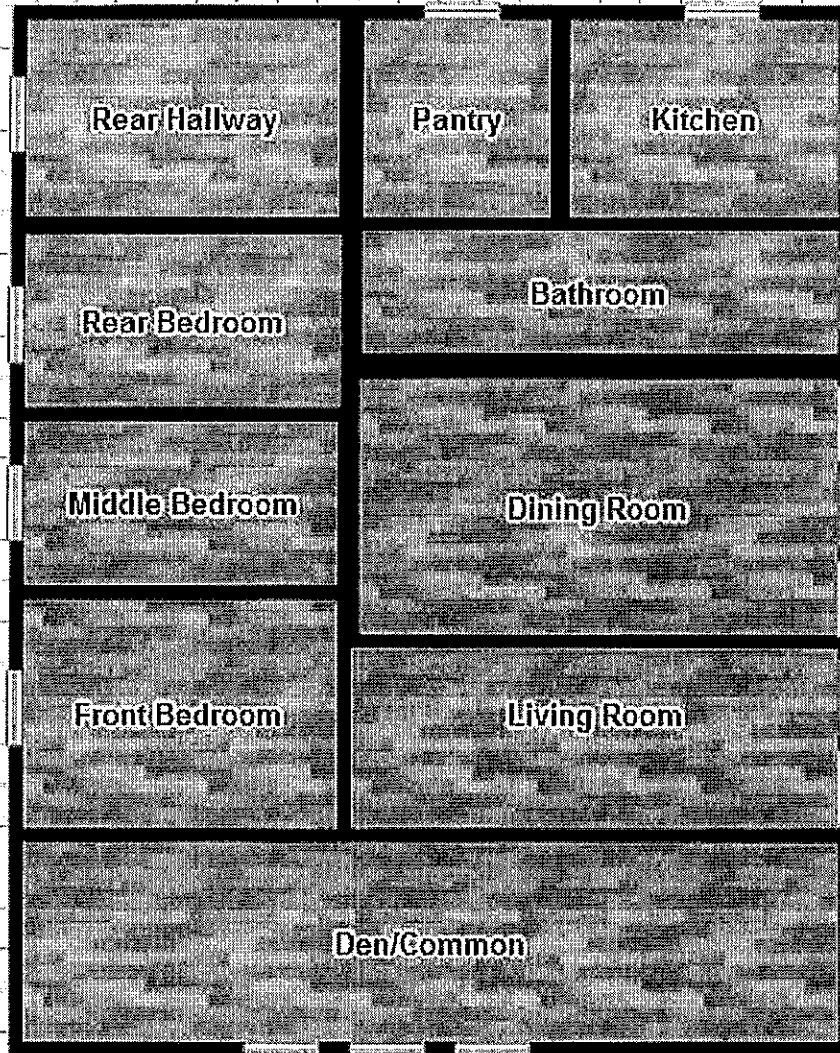
Floor Plan / Property Sketch

(Count) Replacement Restoration 15 Casement Glass Block No-Lead Sills Trough

***ALL WINDOWS MUST BE RESTORED PER
HISTORIC PRESERVATION***

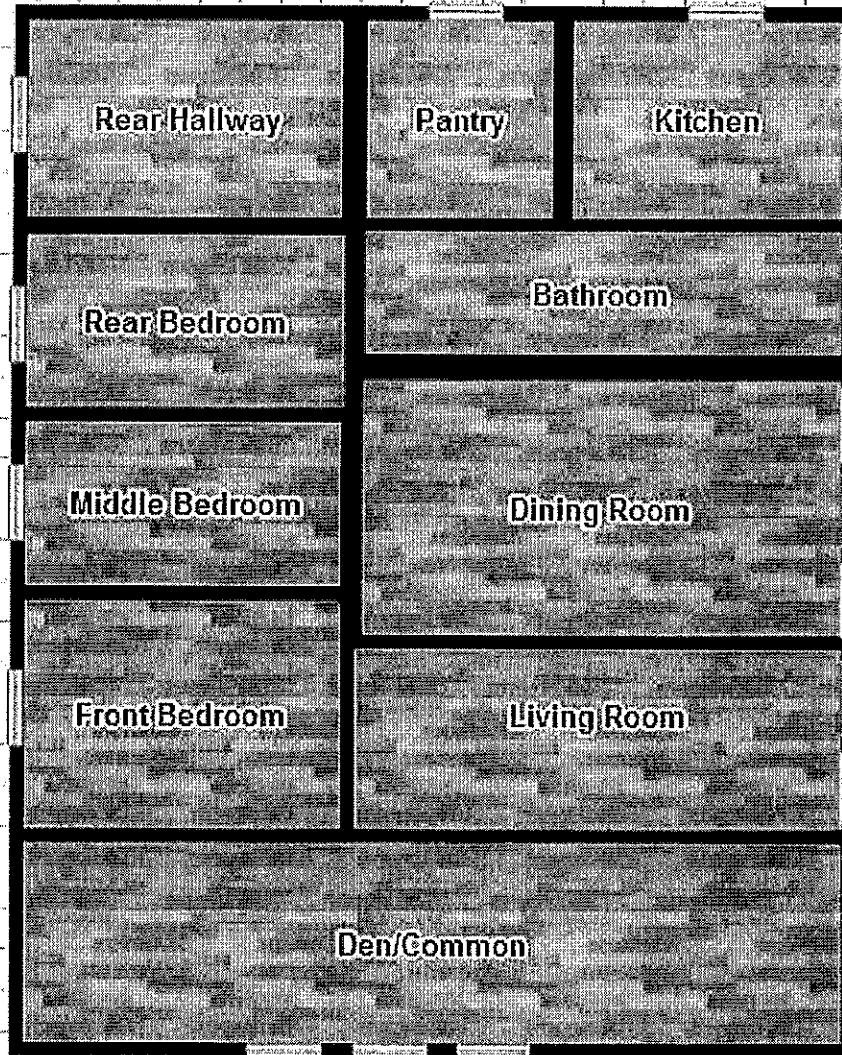
Floor Plan / Property Sketch

(Count) Replacement Restoration 18 Casement Glass Block No-Lead Sills Trough

Broken Glass Pane

***ALL WINDOWS MUST BE RESTORED PER
HISTORIC PRESERVATION***
