Certificate of Appropriateness

705 W. HISTORIC MITCHELL ST. Mitchell Street Historic District

PTS ID 113862 COA Repair Cornice

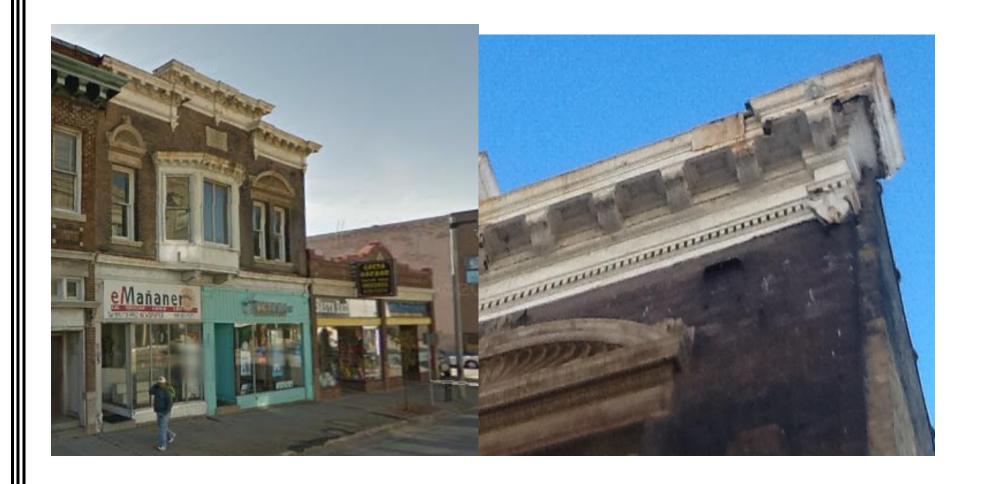
705-707 W. Historic Mitchell Street showing façade. At right a detail of the cornice.

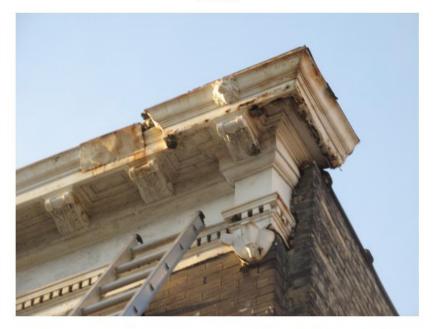
Photo 2

Upper Cornice – West End - improper repair - rusted holes in metal

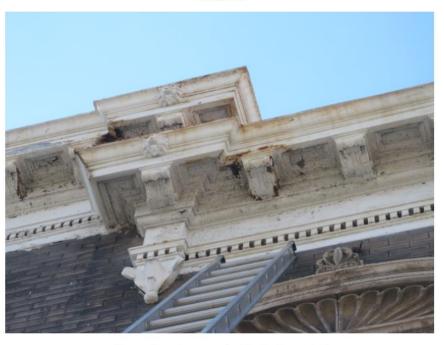
Upper Cornice – rusted holes in metal

Condition before restoration.

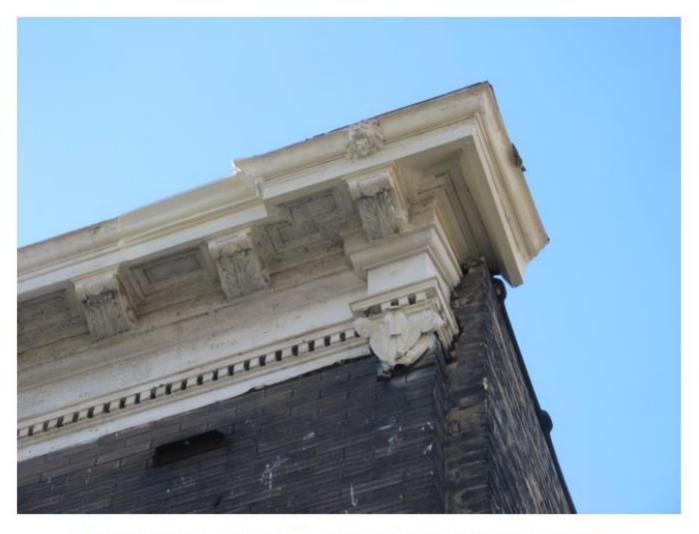
Photo 3

Upper Cornice – West End – repaired with formed sheet metal

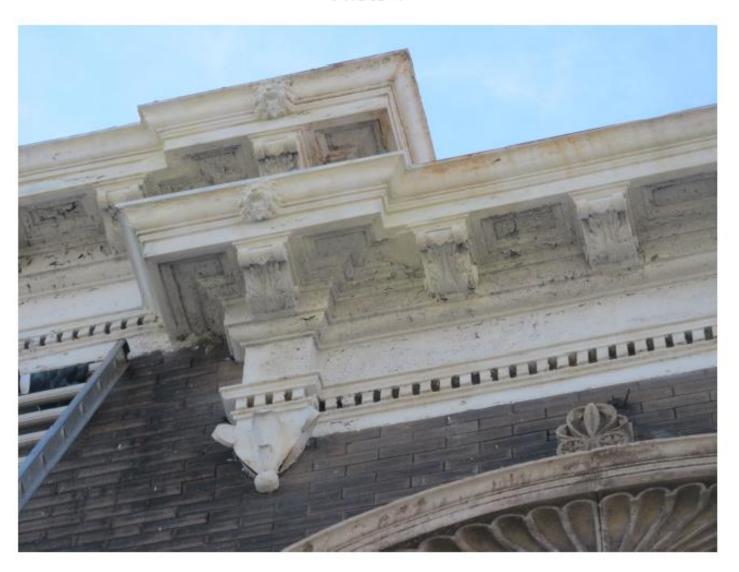
Photo 4

Upper Cornice – repaired with formed sheet metal
