2691 N. Lake Drive: Roof and Porch Repair, Appropriate Application 2017

Supporting Documentation: Annotated Photographs

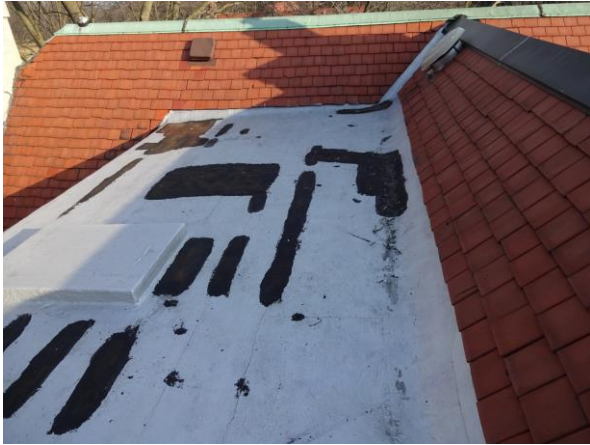
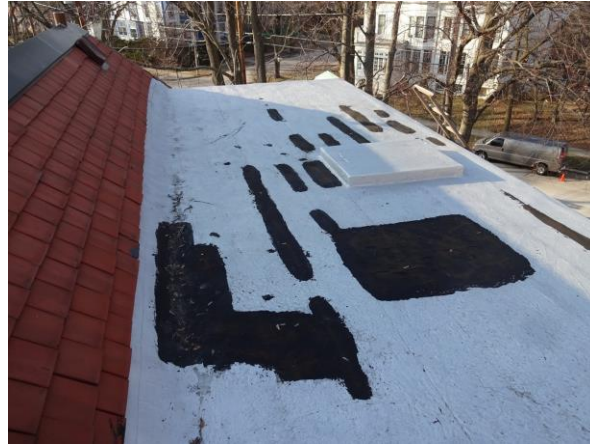
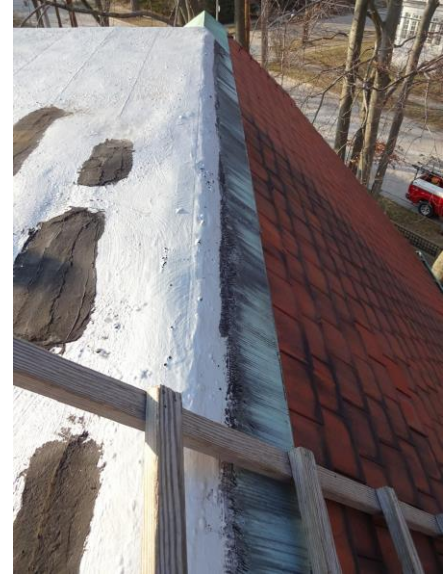
Flat Roof, North Side: Black areas indicate patches for former leaks.

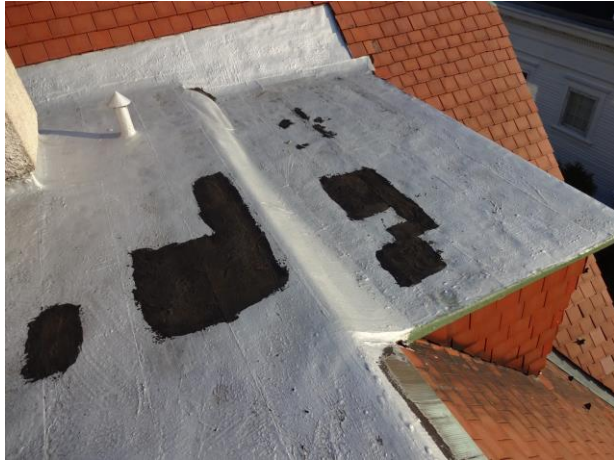
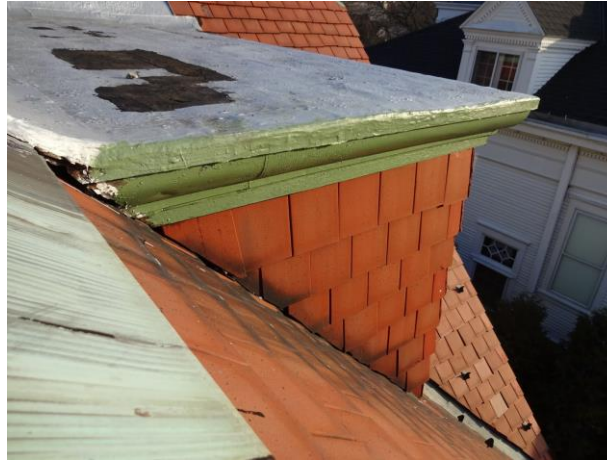
Flat Roof: South Side: Black areas indicate patches for former leaks.

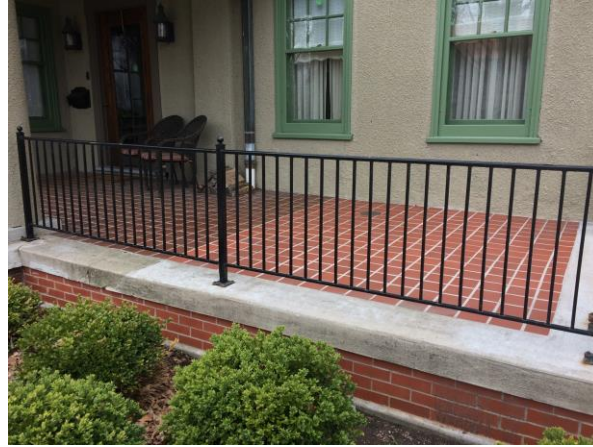
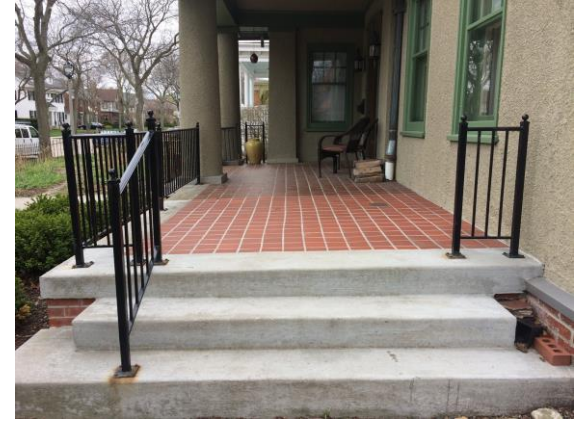
Only a portion of the the brick

facing and concrete borders

were replaced In 2007 by

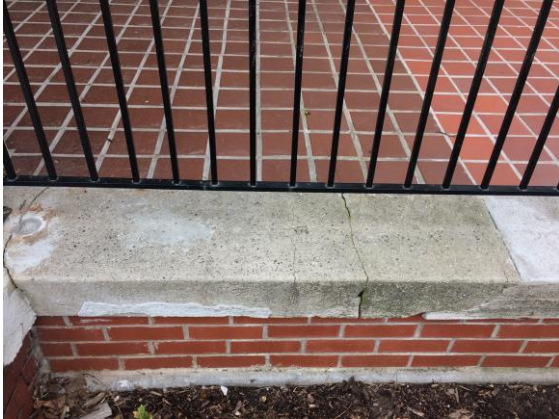
Close up of seam between
old and new concrete
crumbling mortar

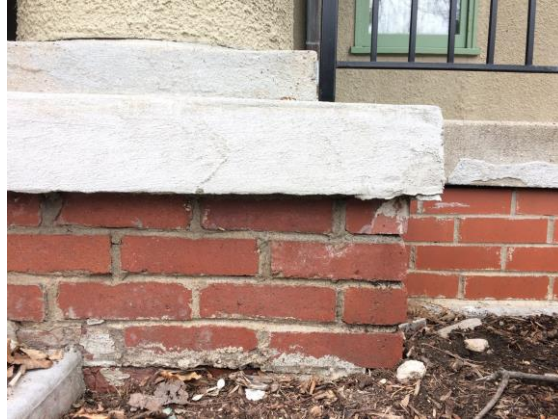
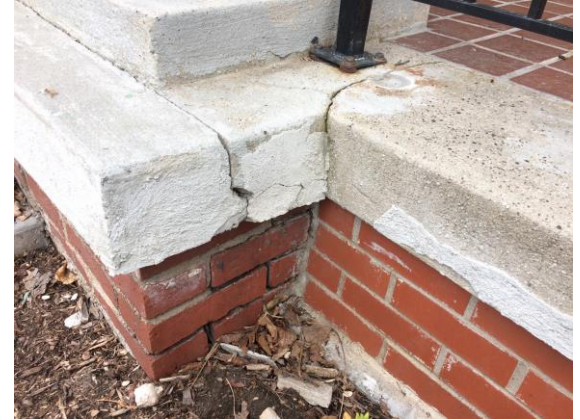
Close ups of old and new brick facing, failing patched concrete,
and
