2691 N. Lake Drive: Roof and Porch Repair, Appropriate Application 2017

Supporting Documentation: Annotated Photographs

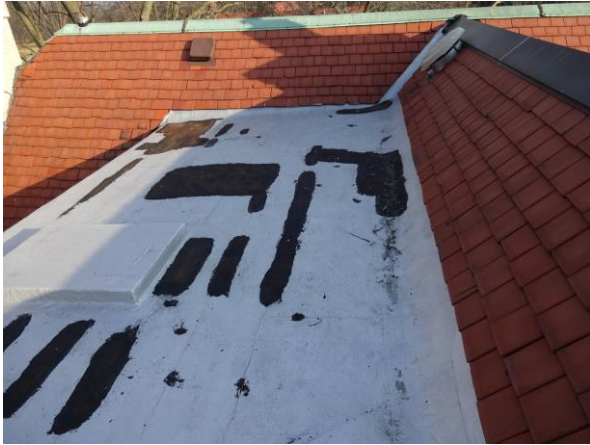
Facing East

Flat Roof, North Side: Black areas indicate patches for former leaks.

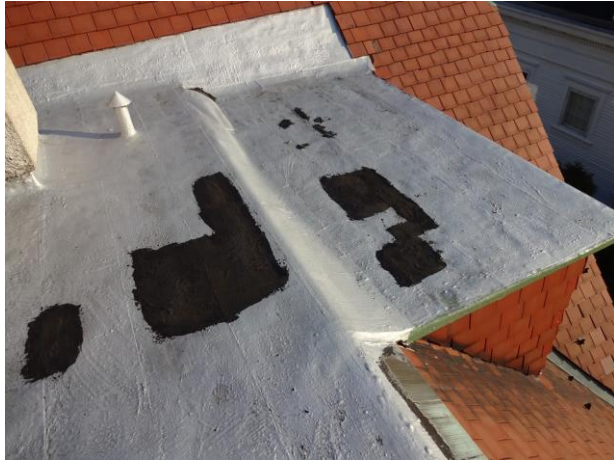
Facing South East

Flat Roof: South Side: Black areas indicate patches for former leaks.

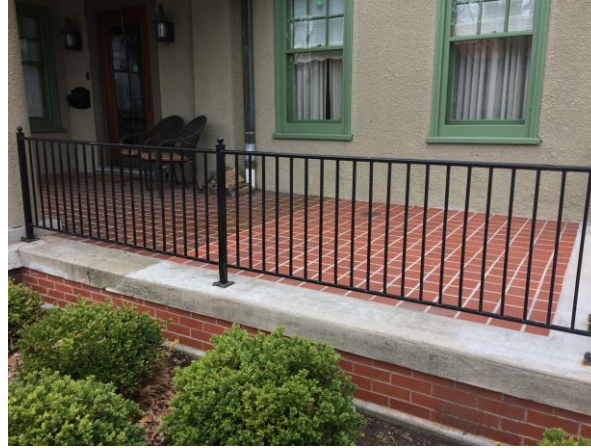
View of replacement

Only a portion of the the brick

facing and concrete borders

were replaced In 2007 by

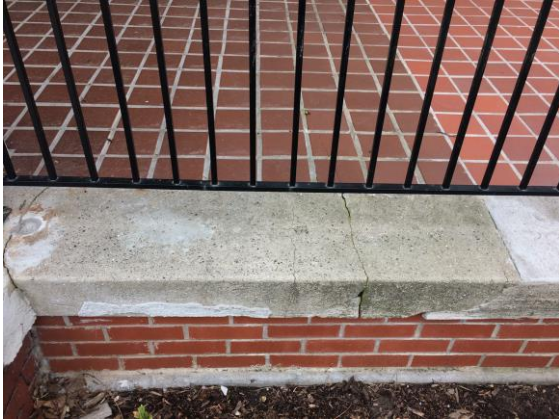
Close up of seam between
old and new concrete
crumbling mortar

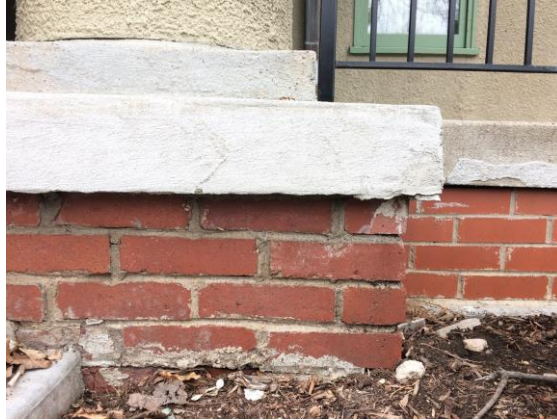
Close ups of old and new brick facing, failing patched concrete,
and

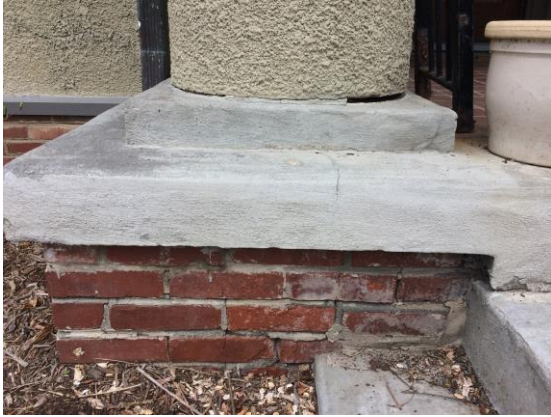
Close up of east face of south porch column,
porch

Brick facing and crumbling mortar
crumbling mortar

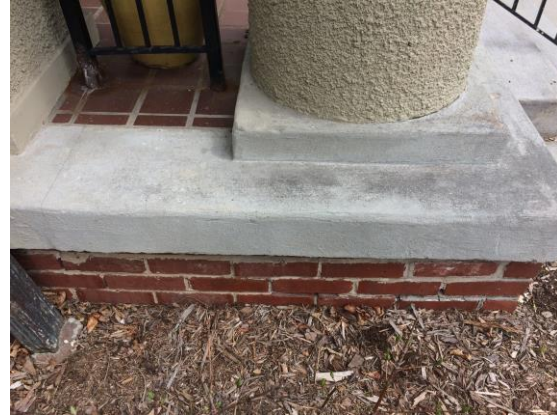
Close up of south face of south
column, brick, and
