East view of turret

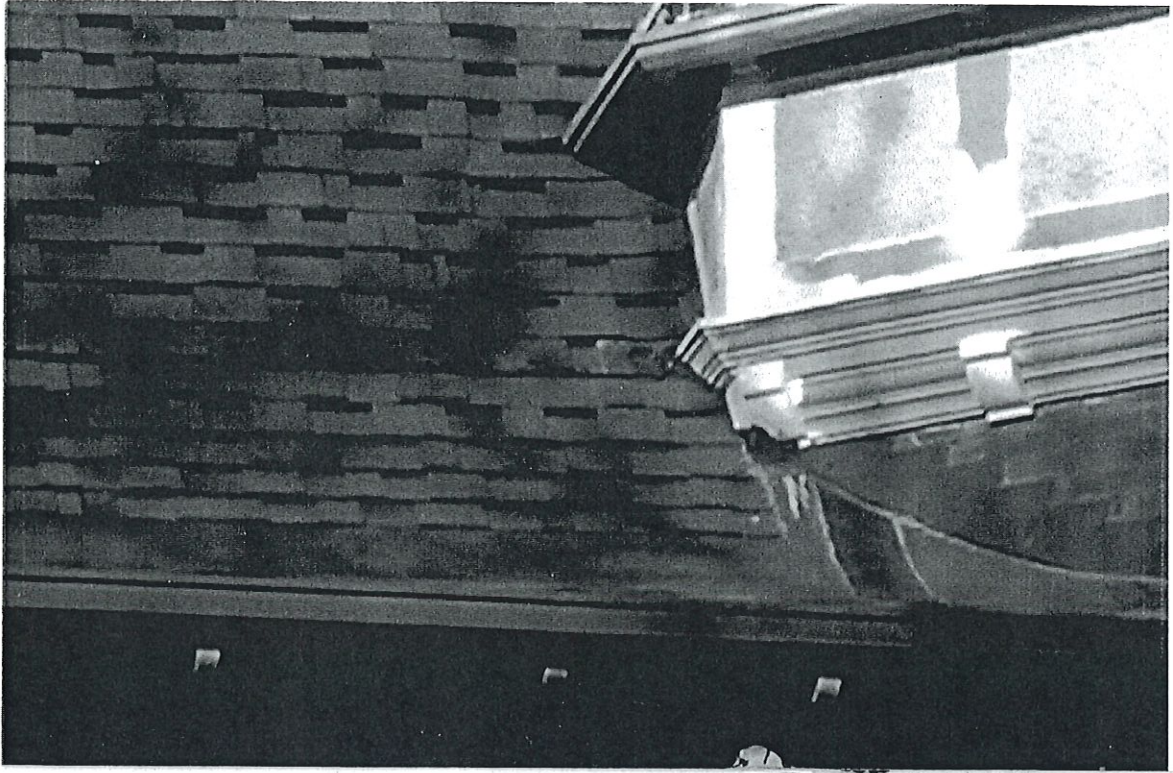
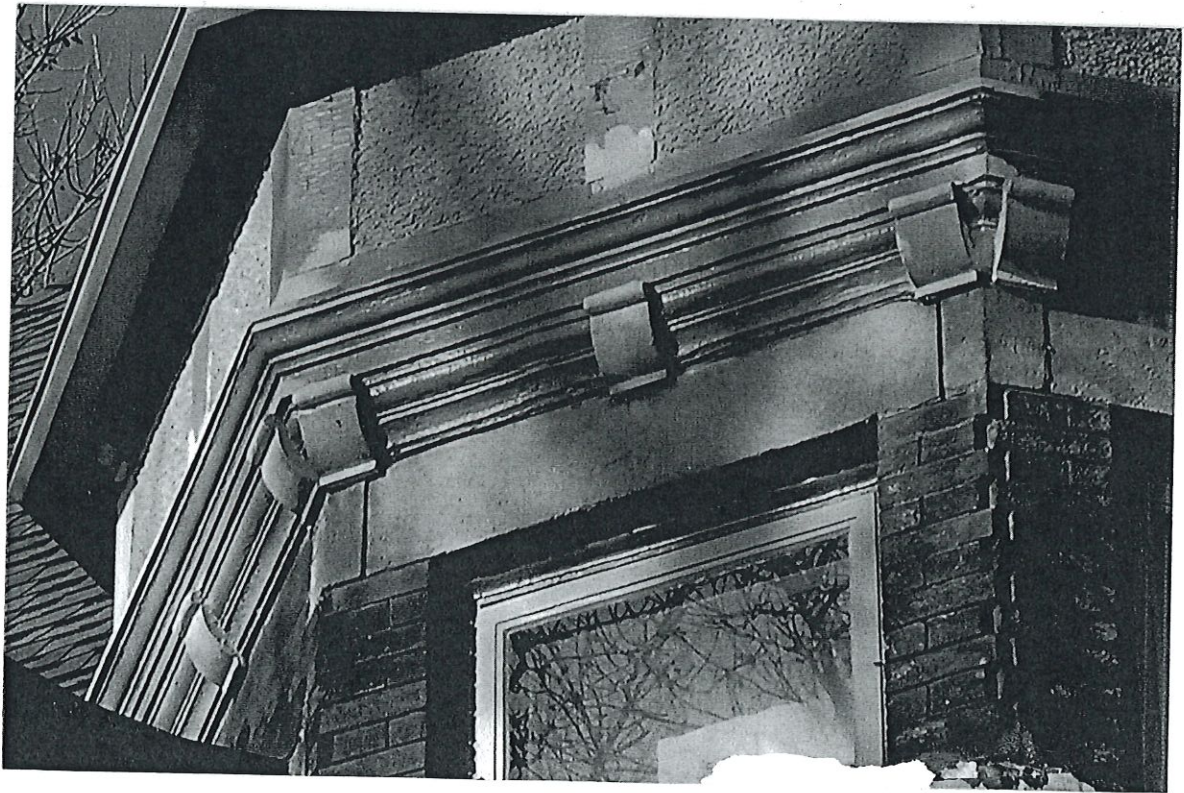
East Side . b1

East View of turret

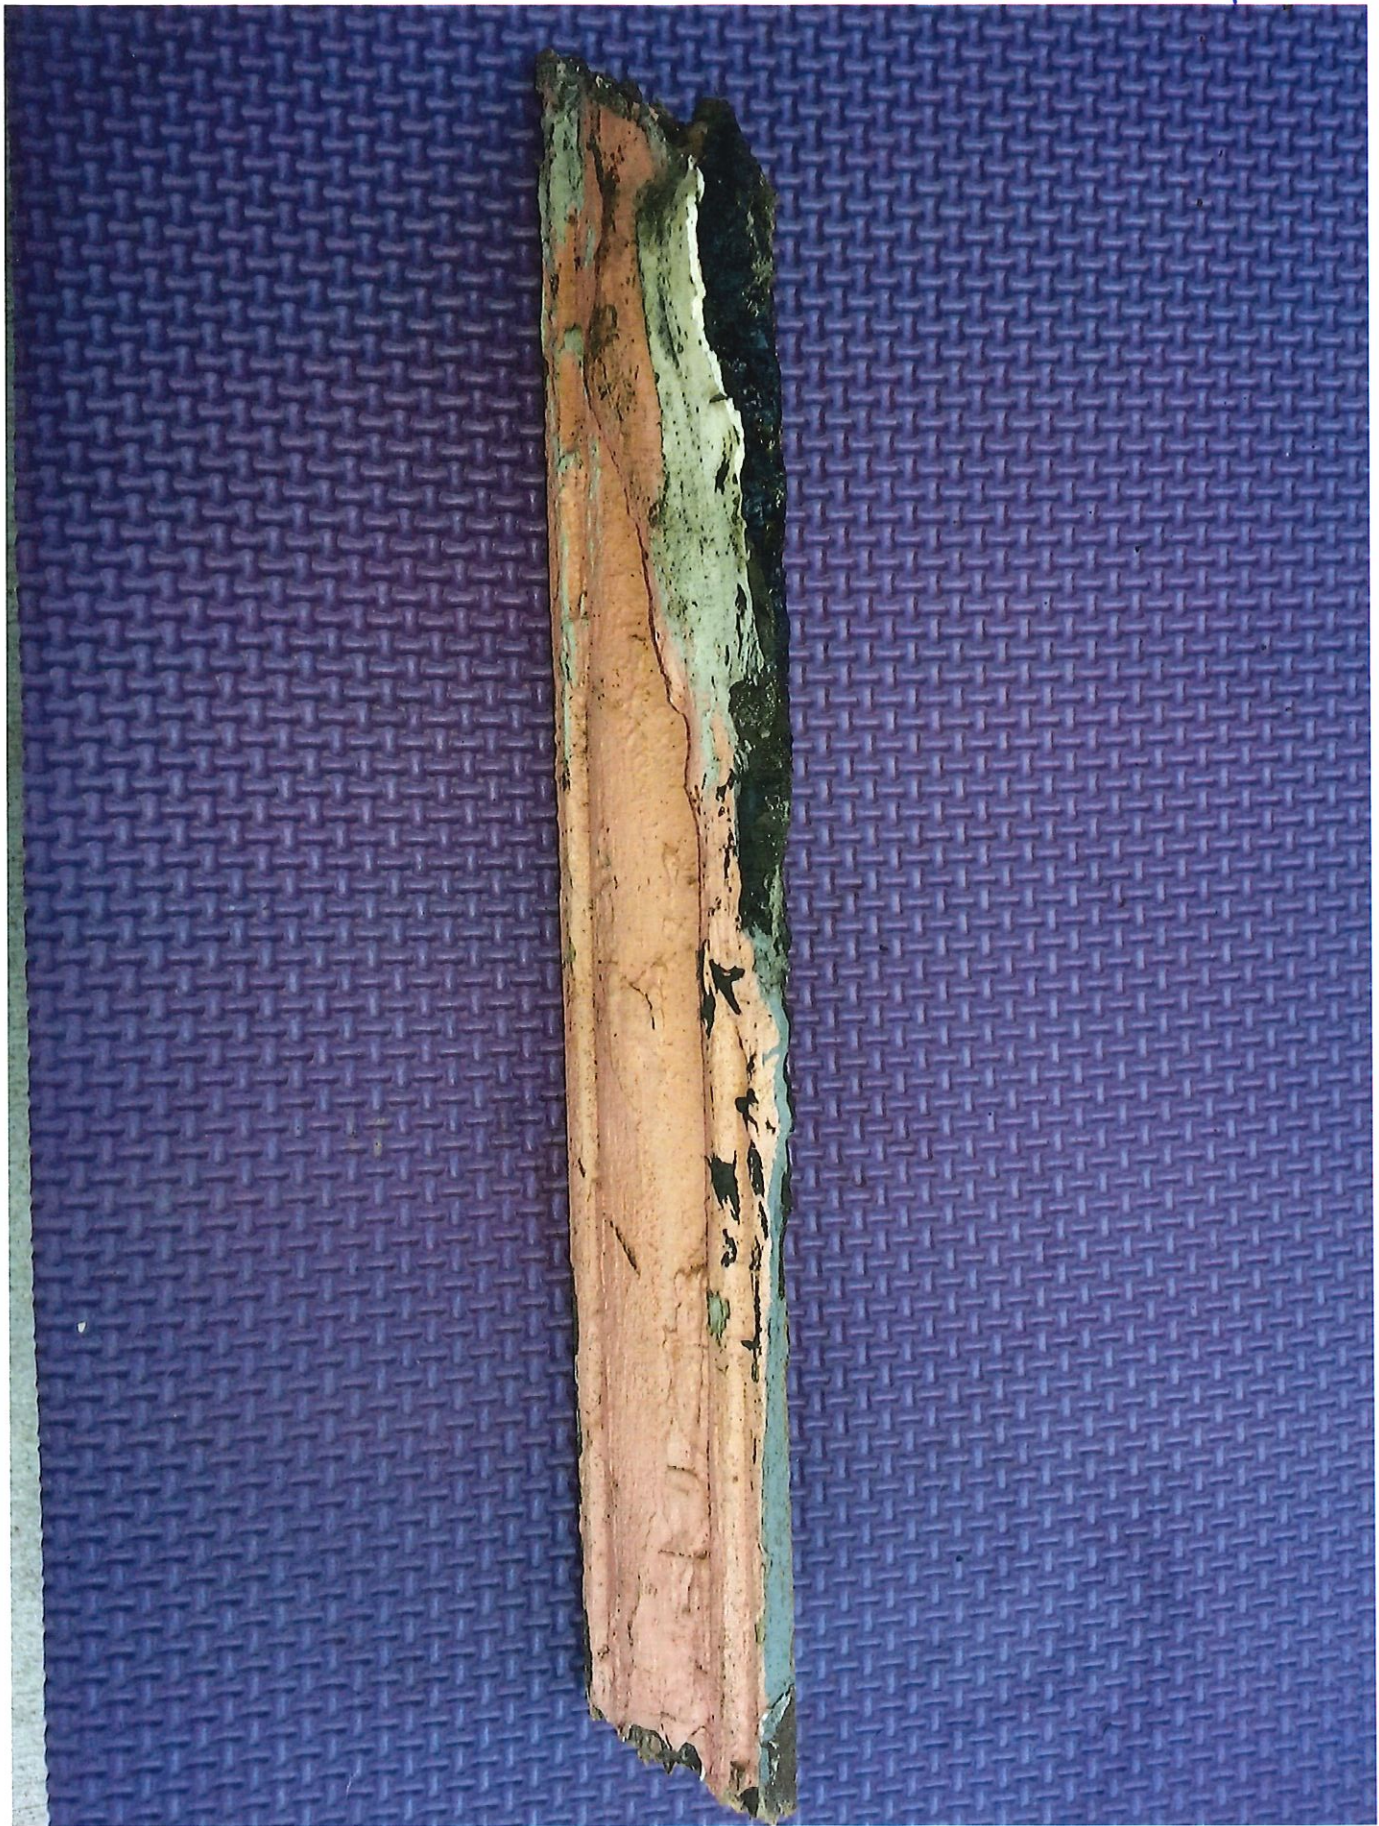
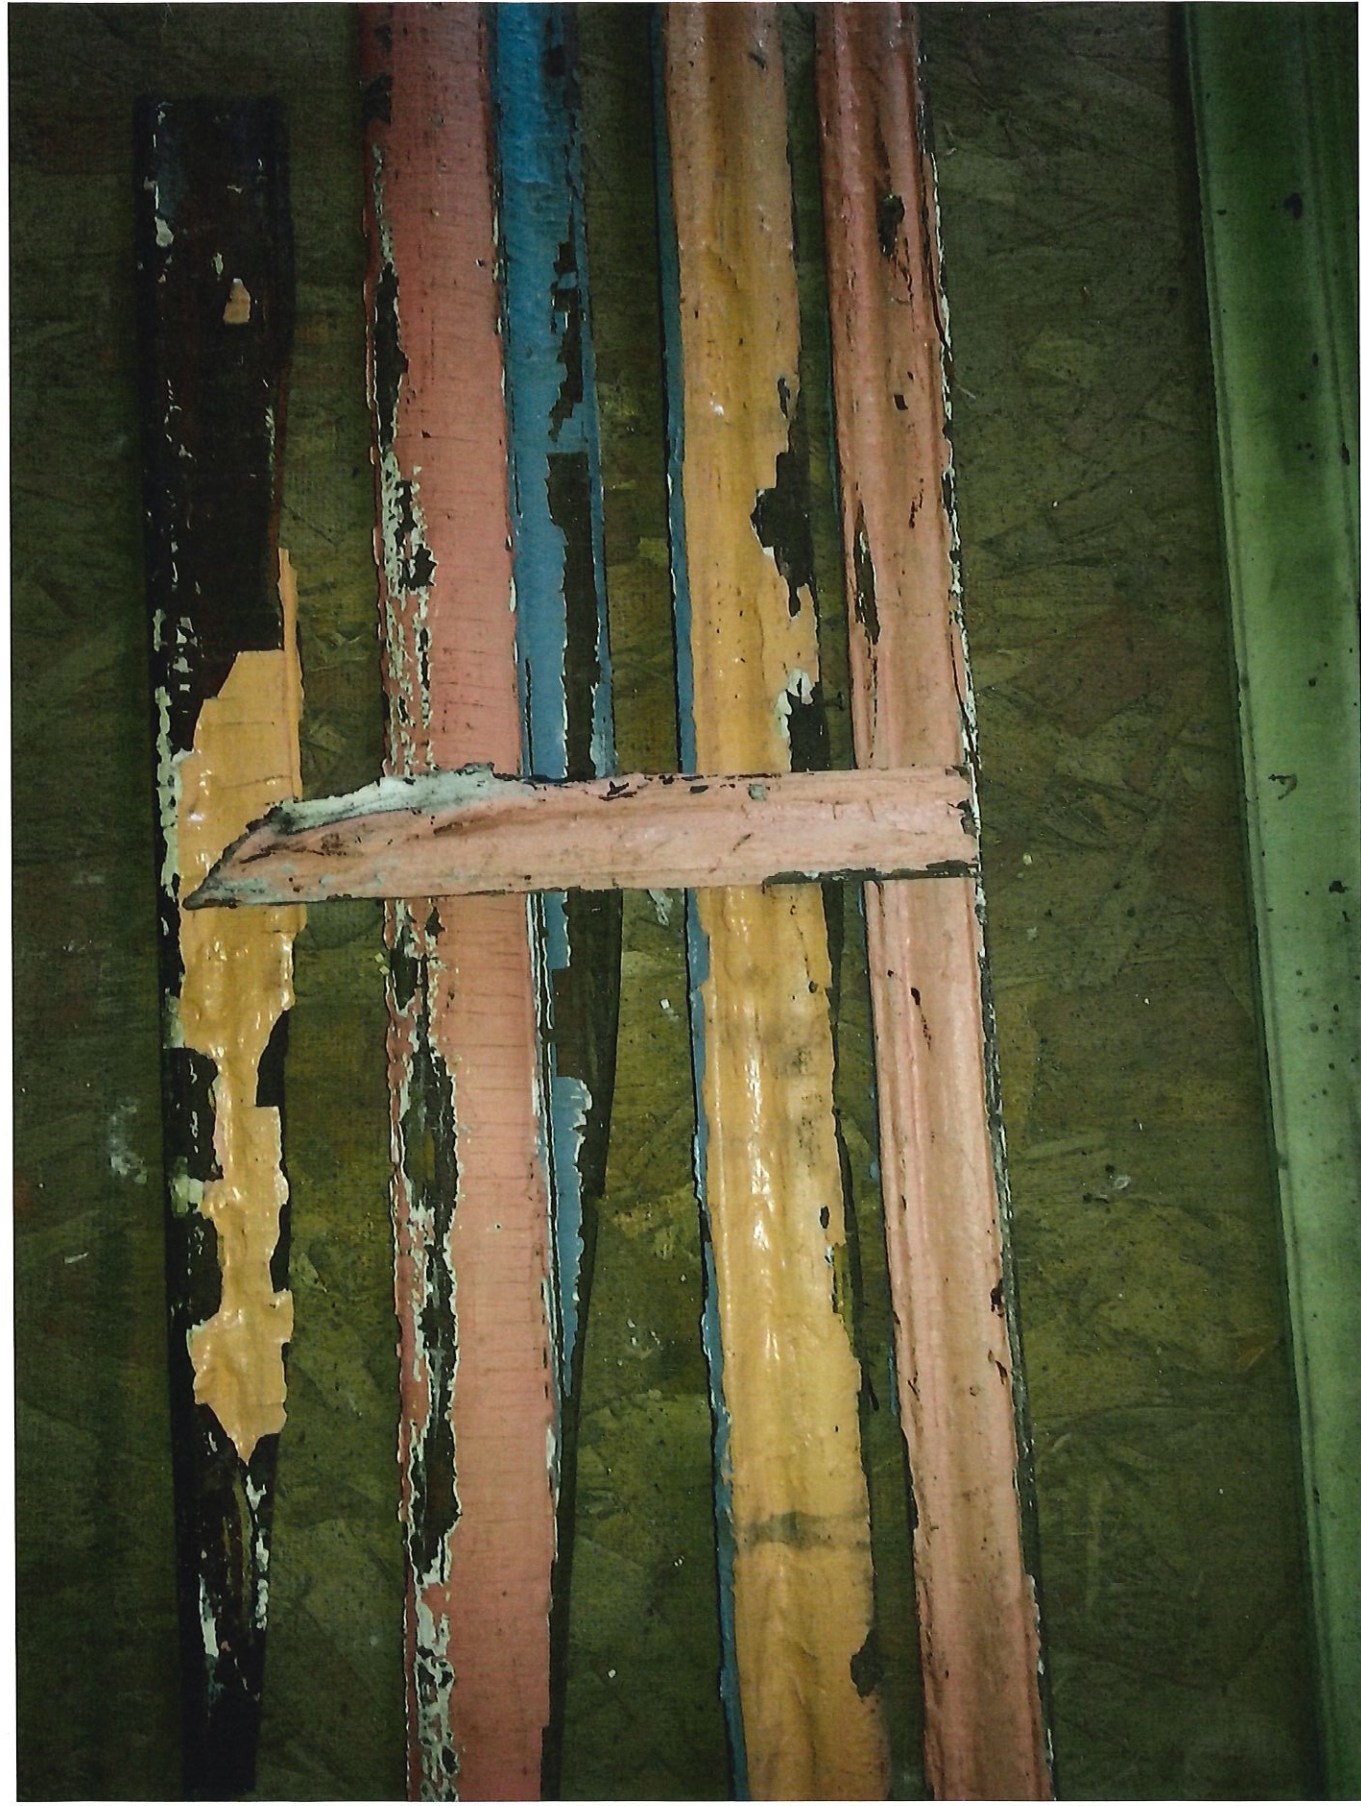
b3  
turret trim

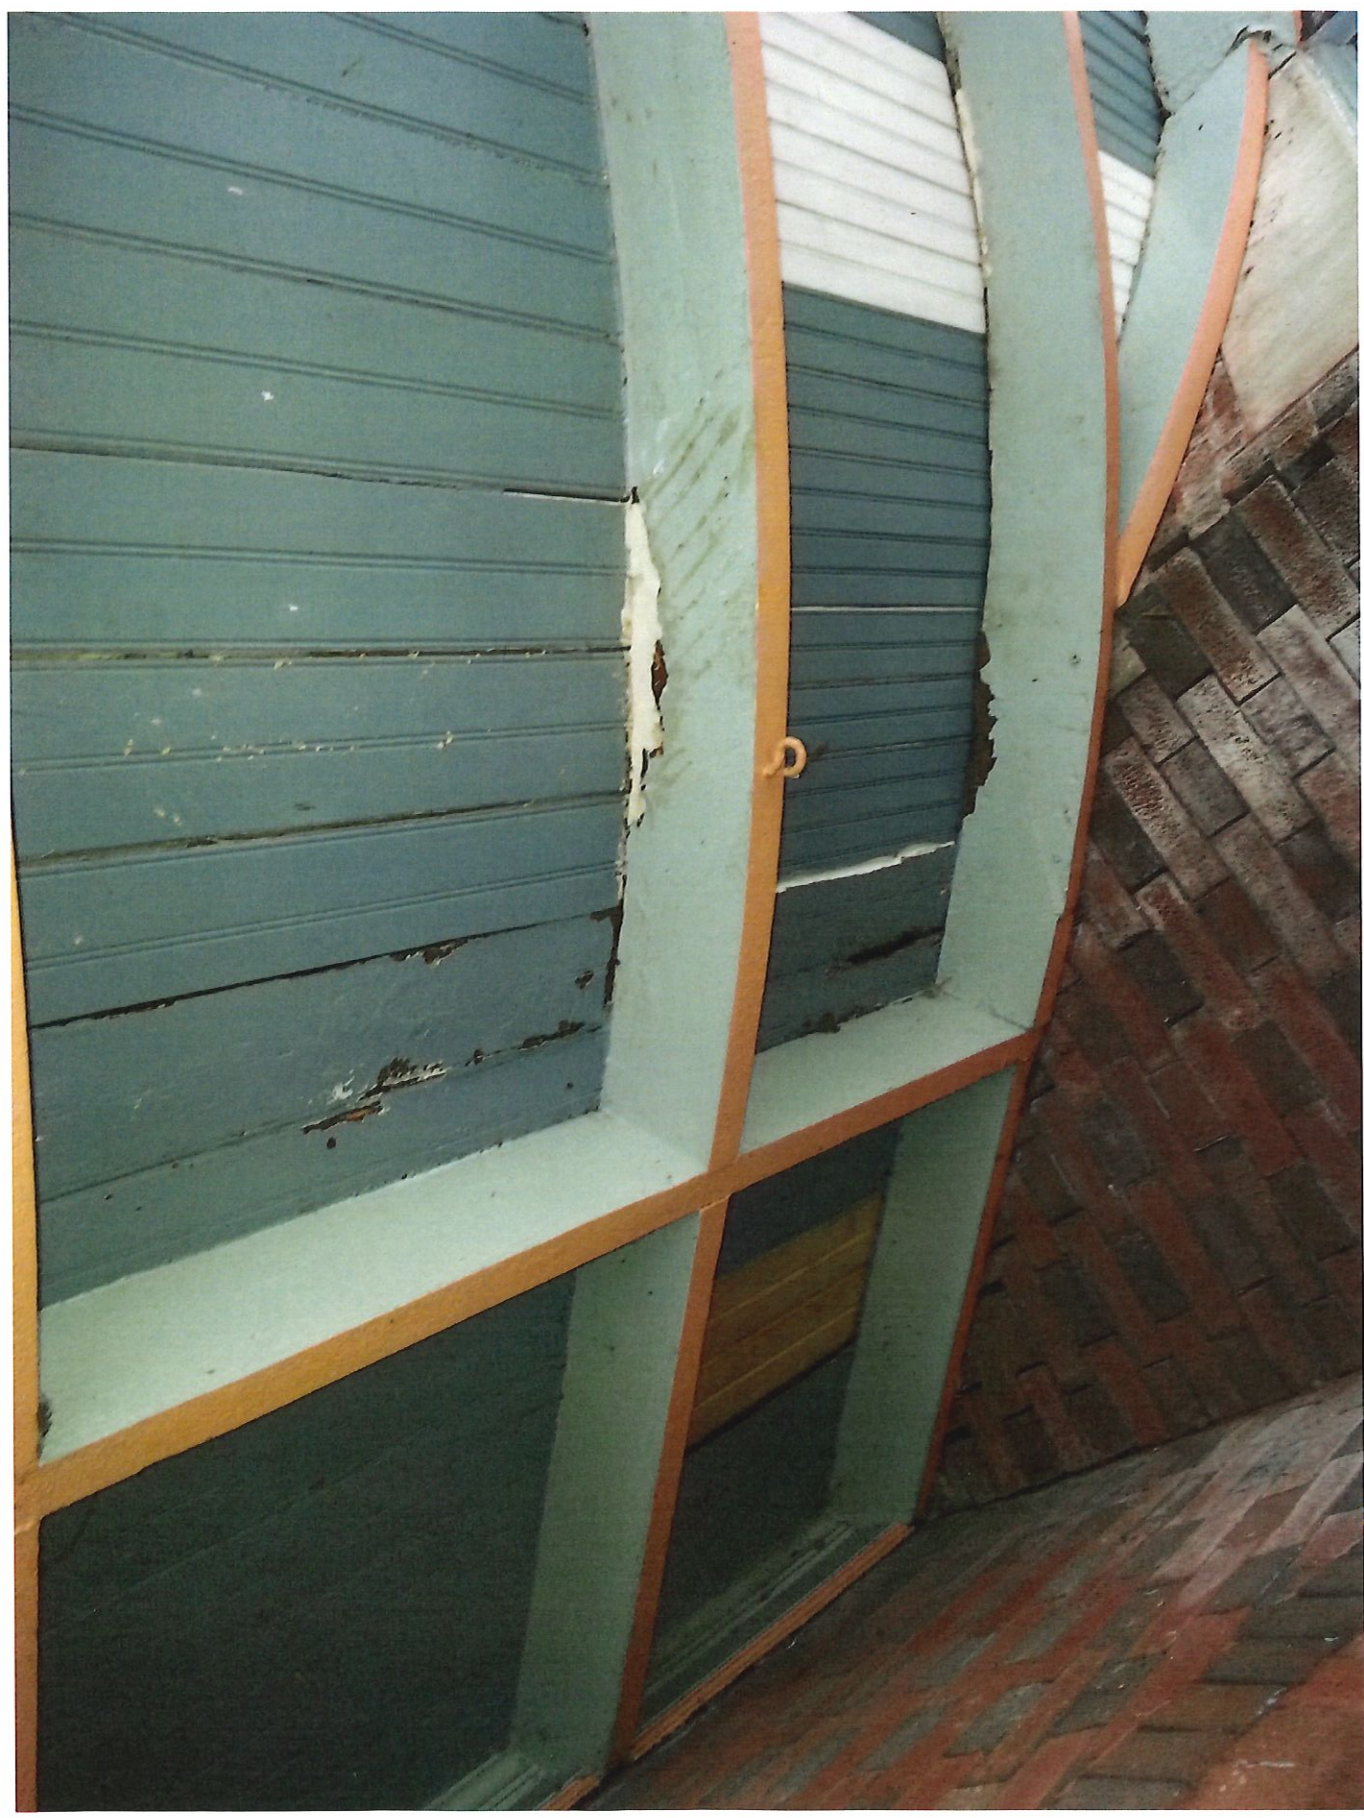
b4  
turret trim

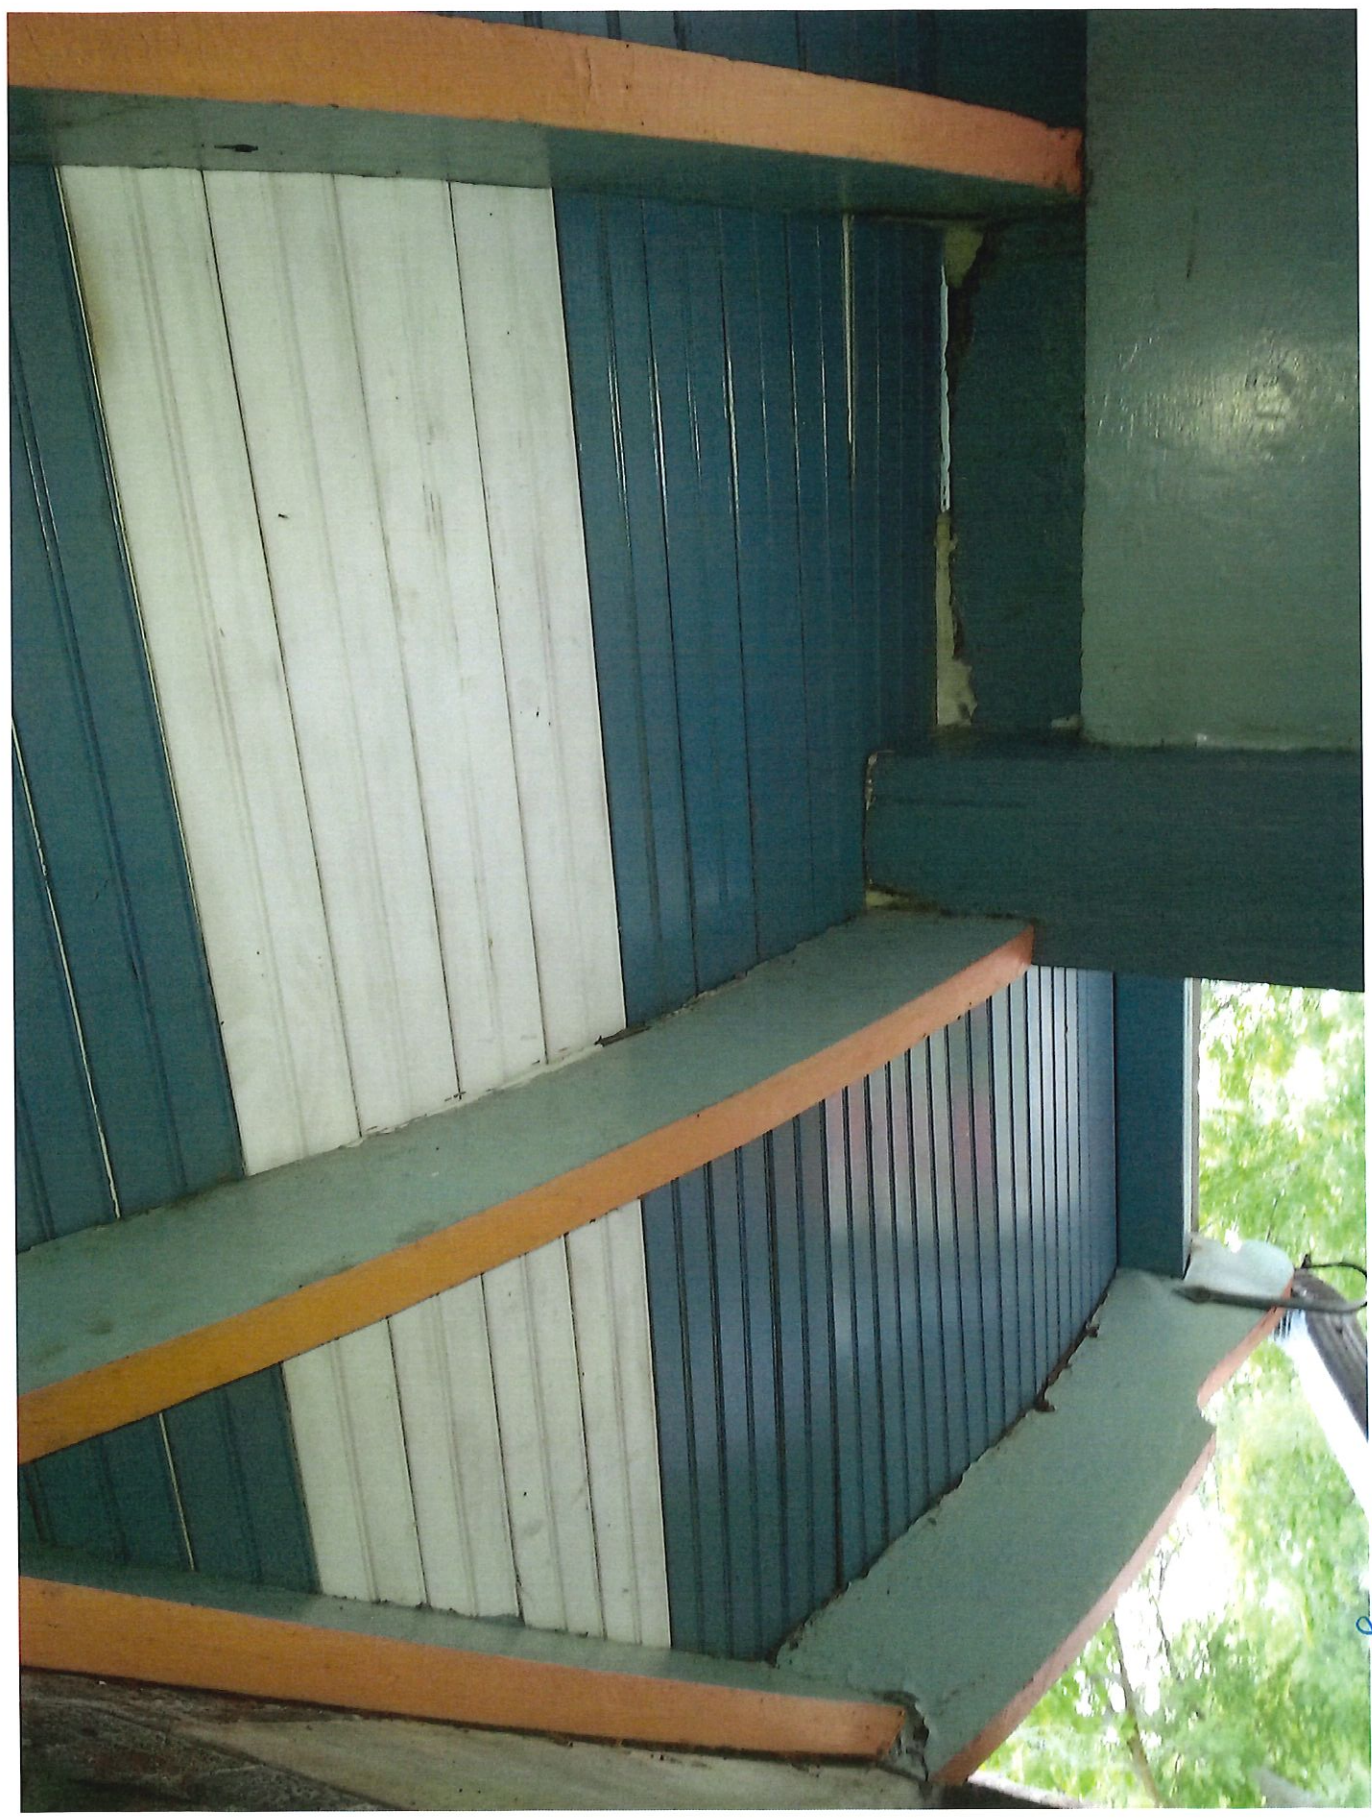
East Side C1  
Consumption Perch  
Feeding

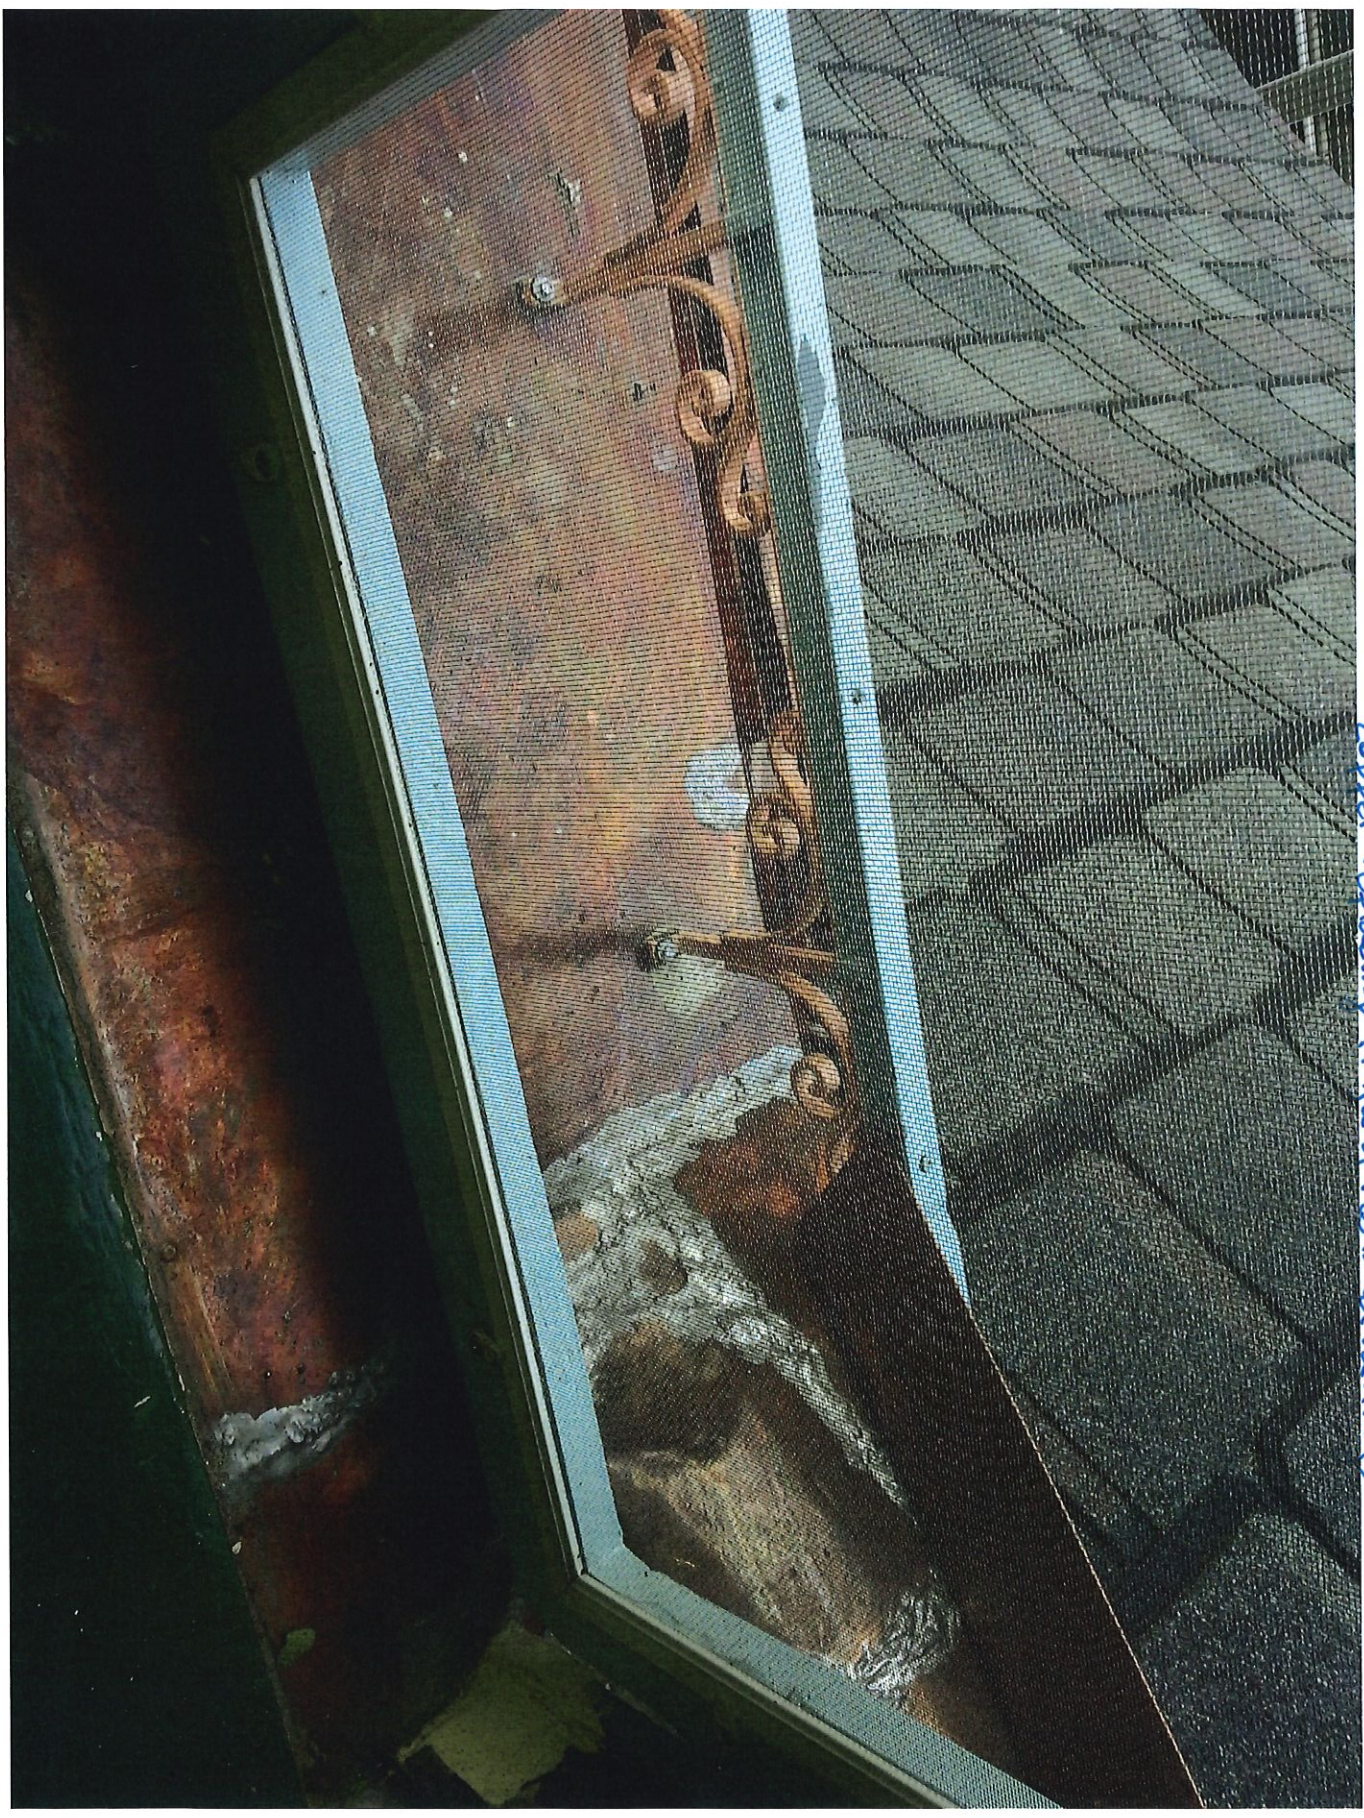
East Side  
CZ  
Construction Rock  
rooting

new base beneath turret  
copper replacing fin and restored sailing ID

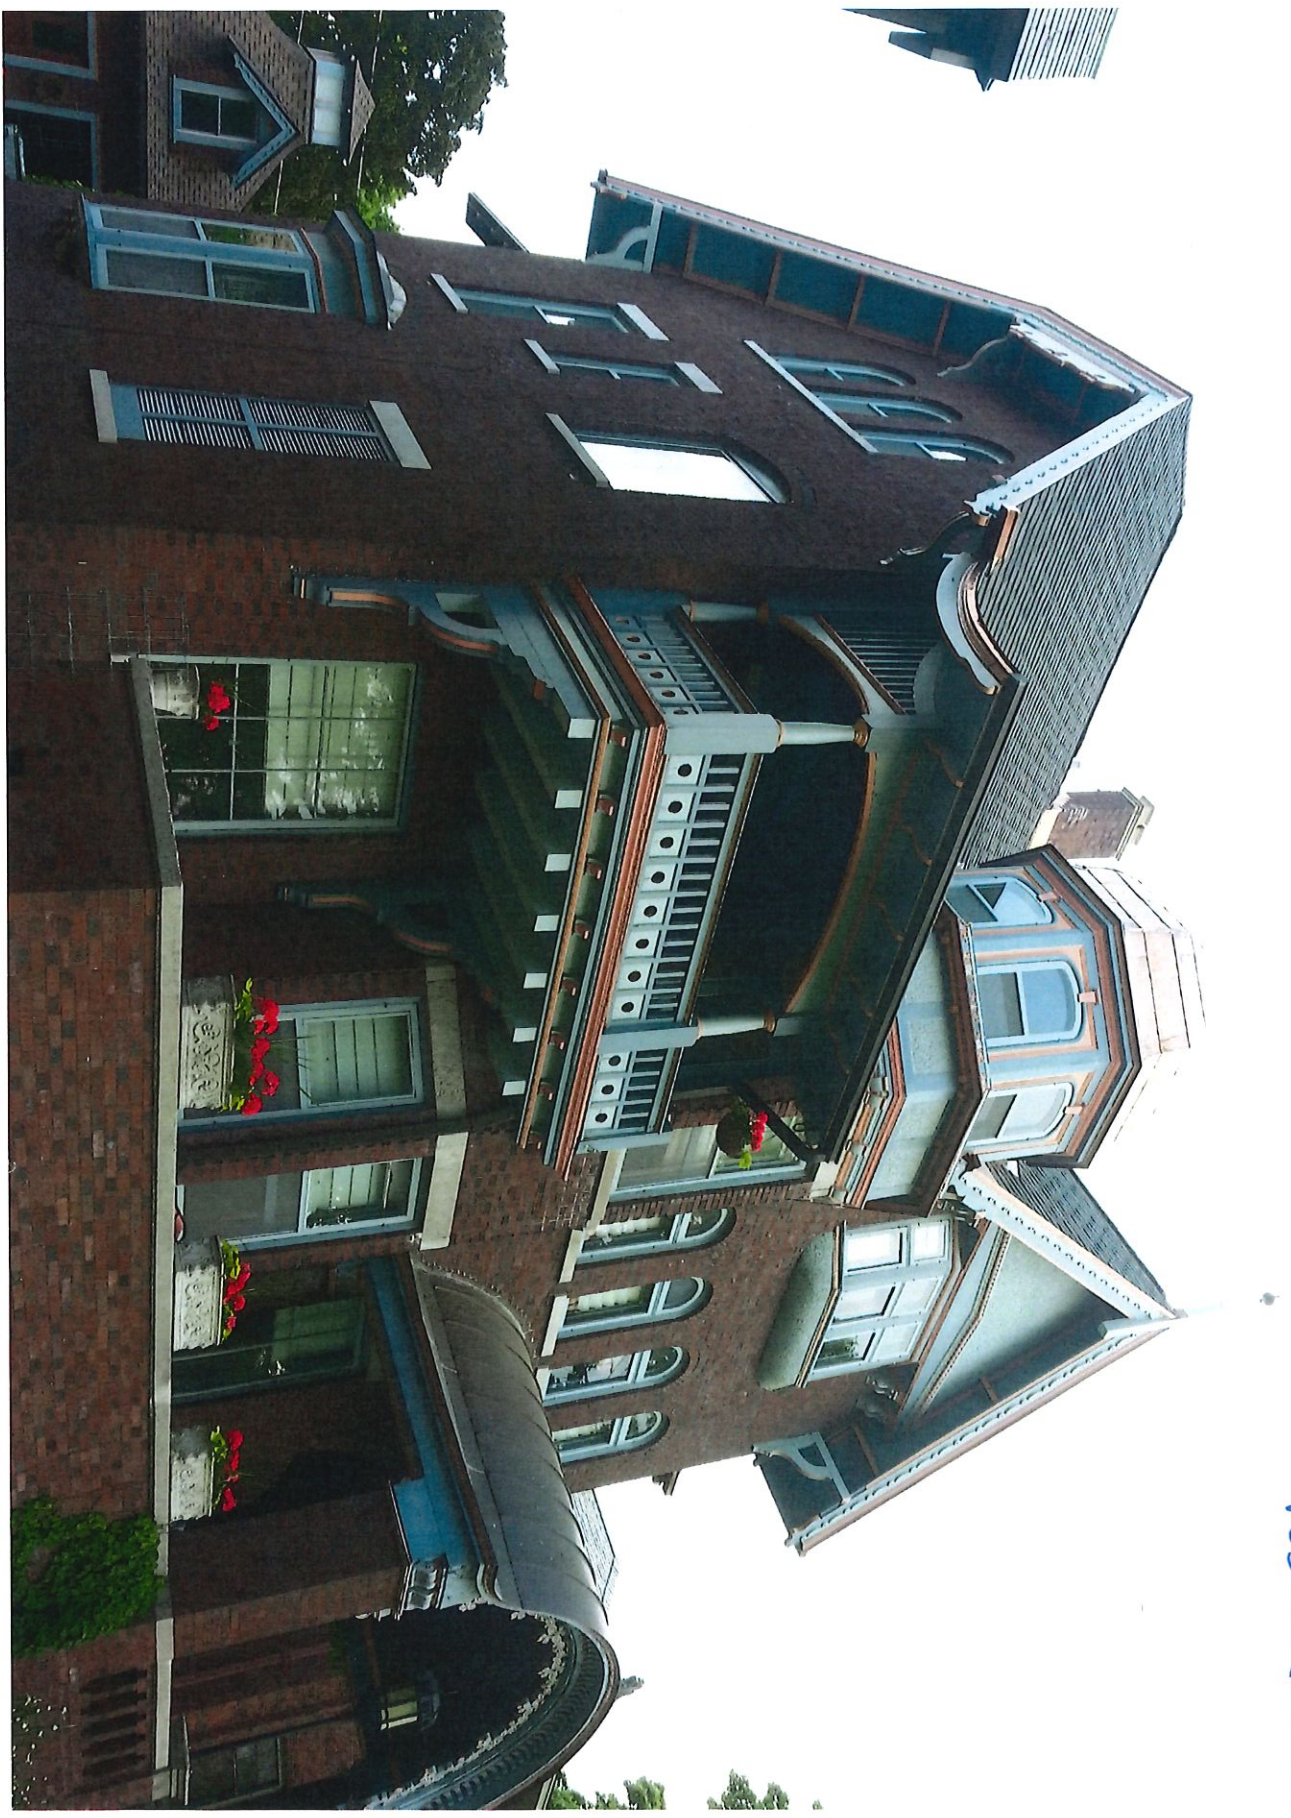
E1  
East view turret  
restoration complete

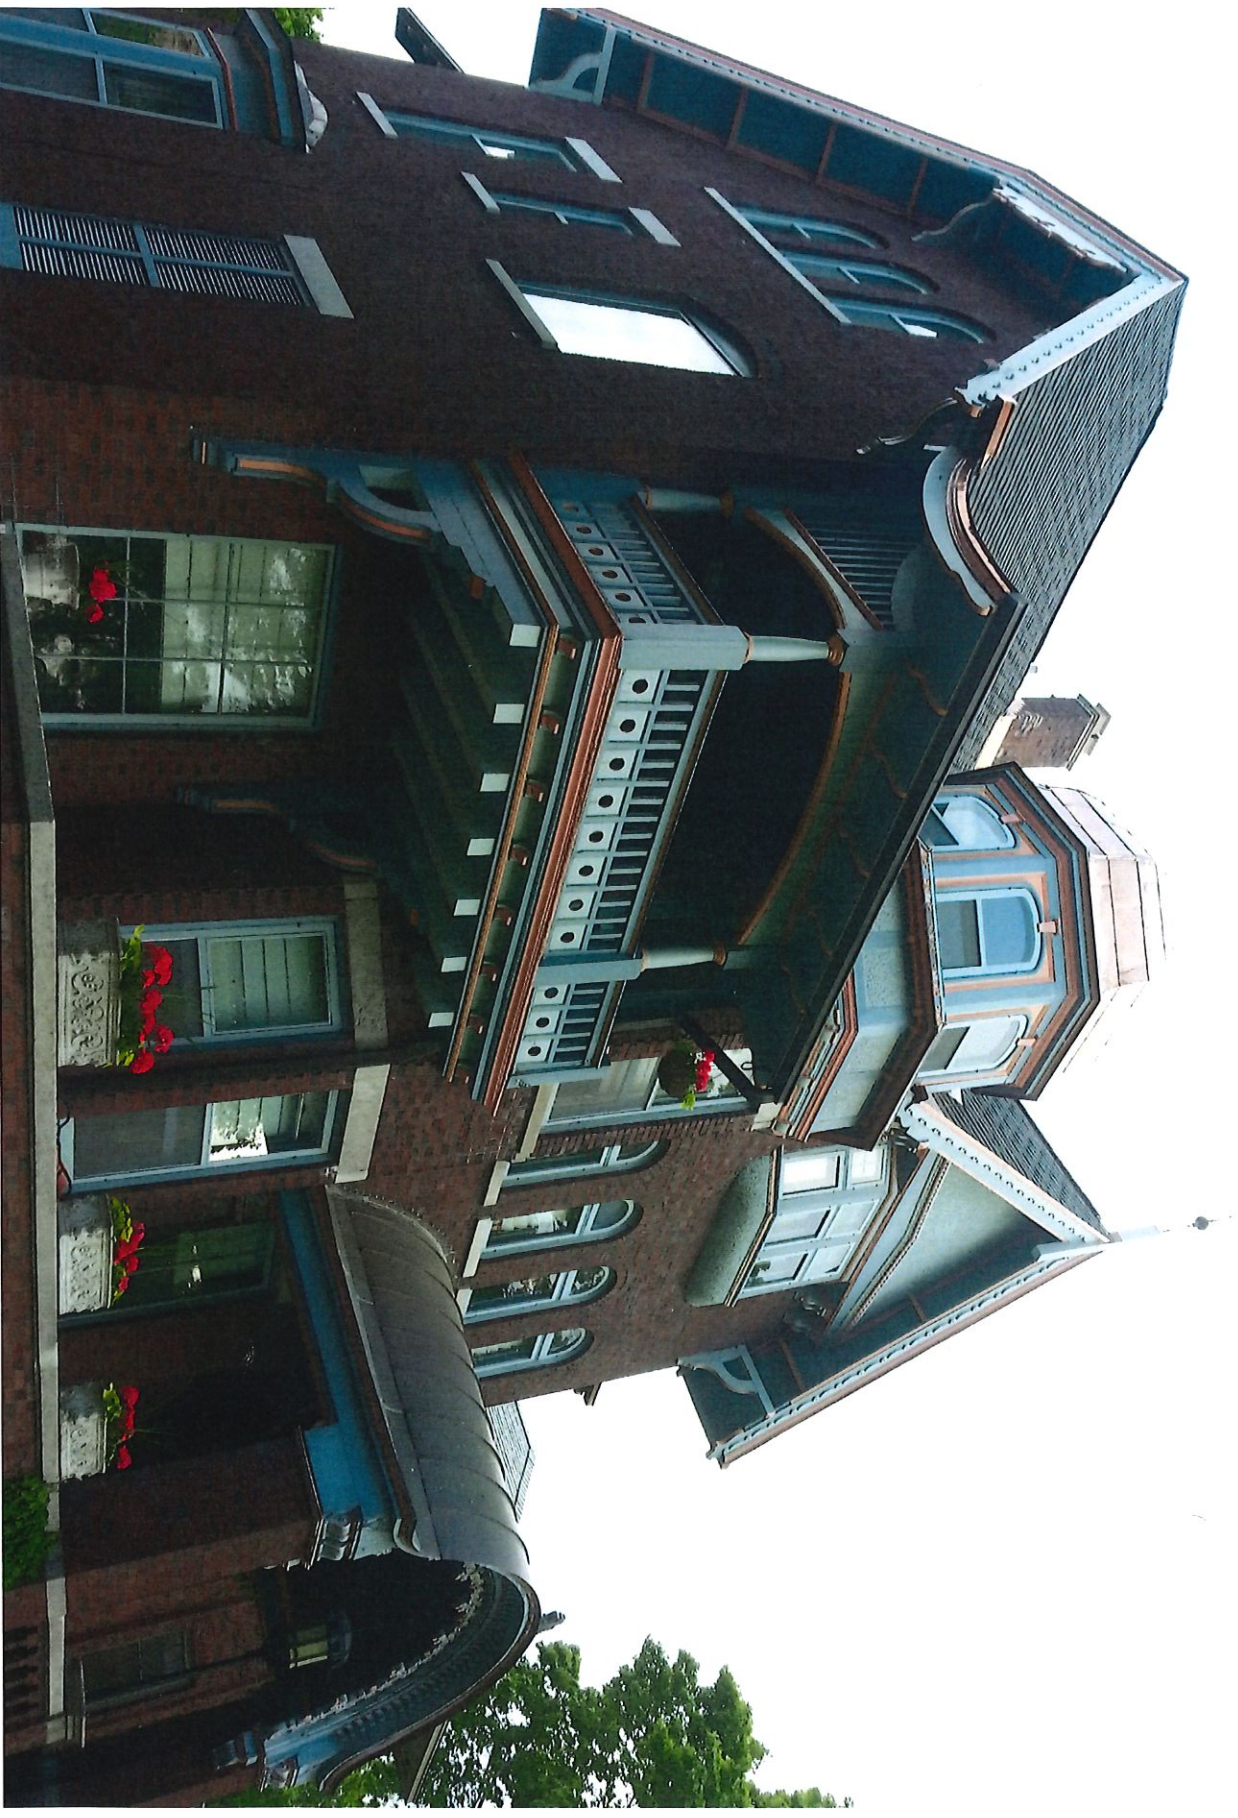
E2  
East view turret  
restoration complete.
