Certificate of Appropriateness

Property 2623 N. WAHL AV. North Point North Historic District CCF #170588
Description of work Reinstall original lamppost on front porch. Repair roof structure and underside of roof of front sleeping porch per attached applicant narrative. Replace roof of turret with copper, repair windows, sills, various trimwork, and decorative railing per attached applicant narrative.

Date issued 7/20/2017 PTS ID 114320 COA: turret, porch, and lamppost

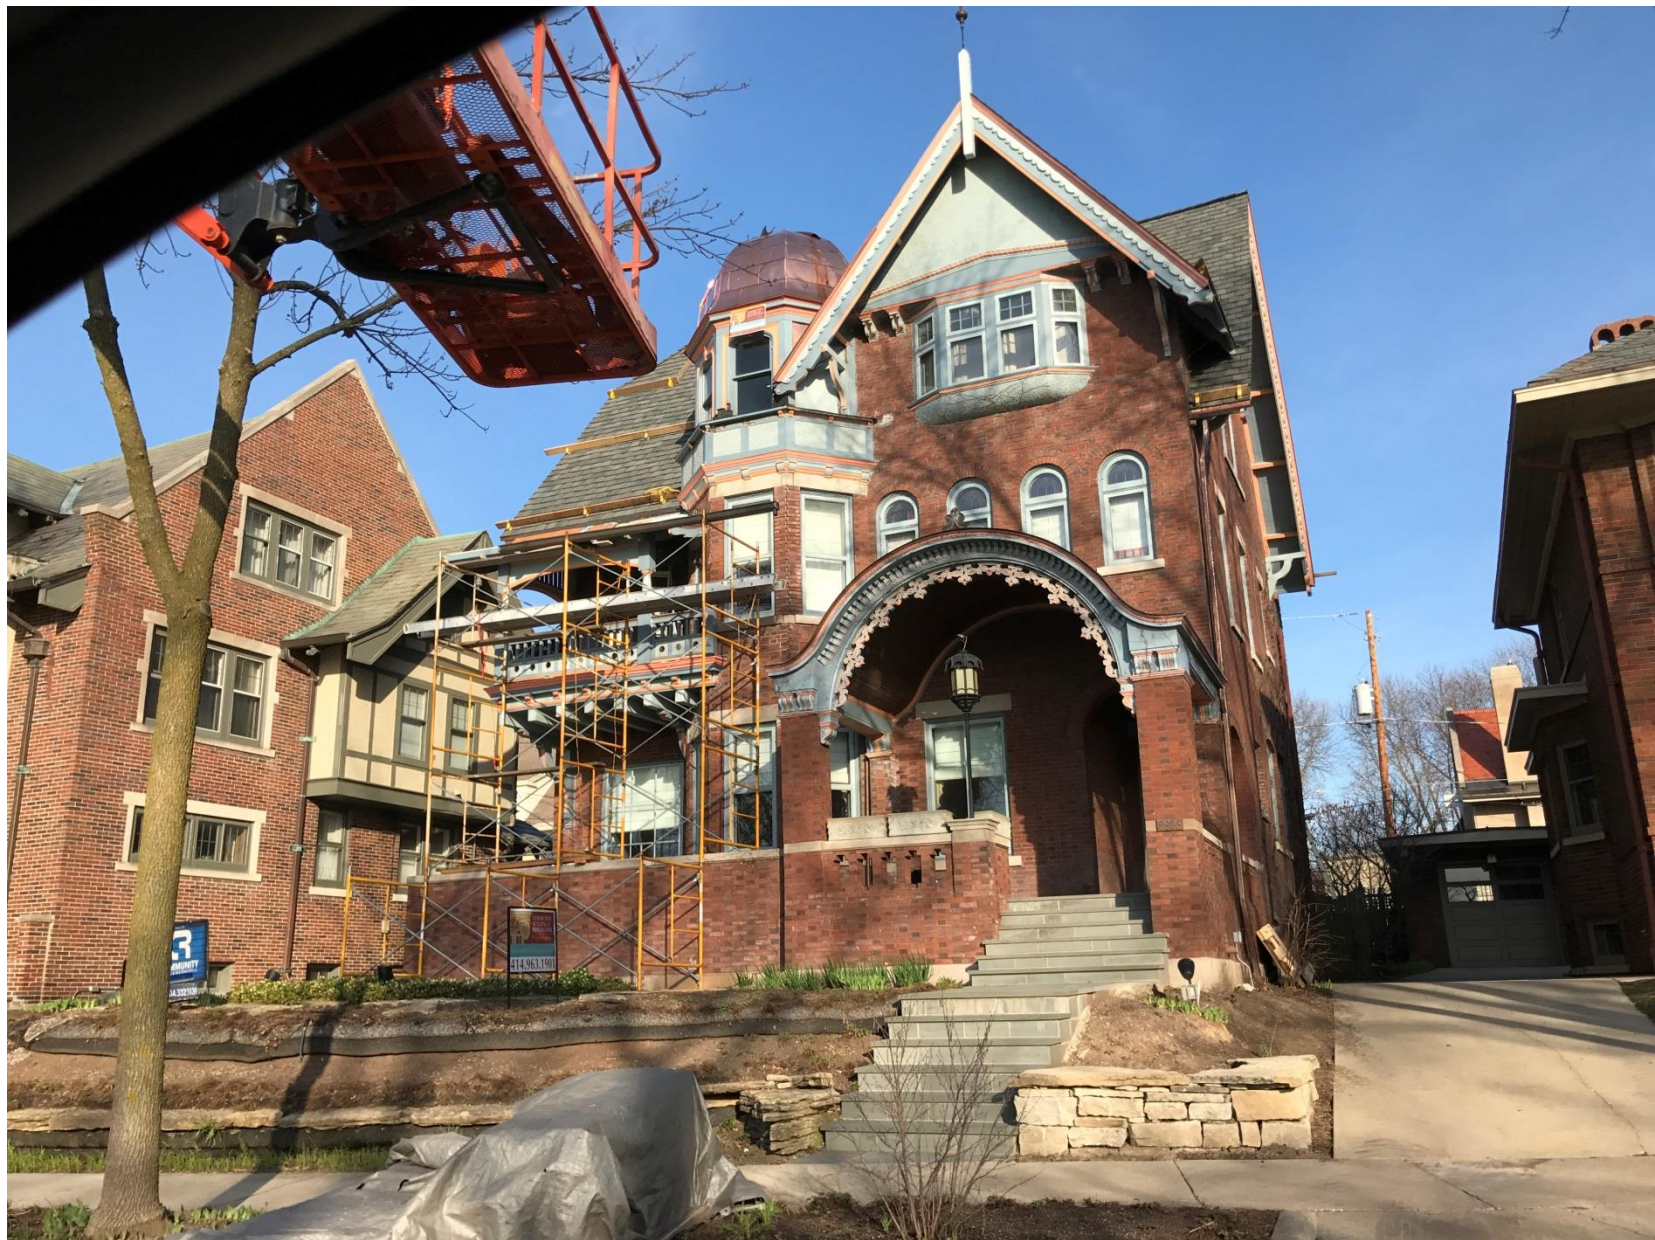
Conditions as of April 18, 2017. Note lamppost on porch at stairs.

Remove failed existing torch down roofing from valley above and around turret; remove rubber roof membrane from over the consumption porch (not original), remove tin metal cladding from the turret that runs from window sills over ledge and towards the roof/wall transition (not original). Remove and replace existing tin metal panels from turret roof (not original) with copper. Remove mini faux rail, sandblast and repaint. Install ice and water barrier on exposed wood as needed. At window sills, perform necessary wood removal and restoration as needed to properly flash new roofing and old tin metal work with copper. Remove and replace consumption porch ceiling beaded board as needed. Repair roof over consumption porch, capping with copper d-edging. Rebuild all of the above with copper, soldering as needed. This includes a new saddle/valley above the turret and connecting into the back section of its roof, new ledge just beneath turret's windows (copper as original), new flashing behind and around turret window sills (copper as original), new roof/wall transition to copper roof on consumption porch (as original), copper box-style gutters on turret and on consumption porch (as original), and new flat-seamed copper roof on turret (as original). Reinstall stripped, powder coated, and repainted original mini-faux rail.

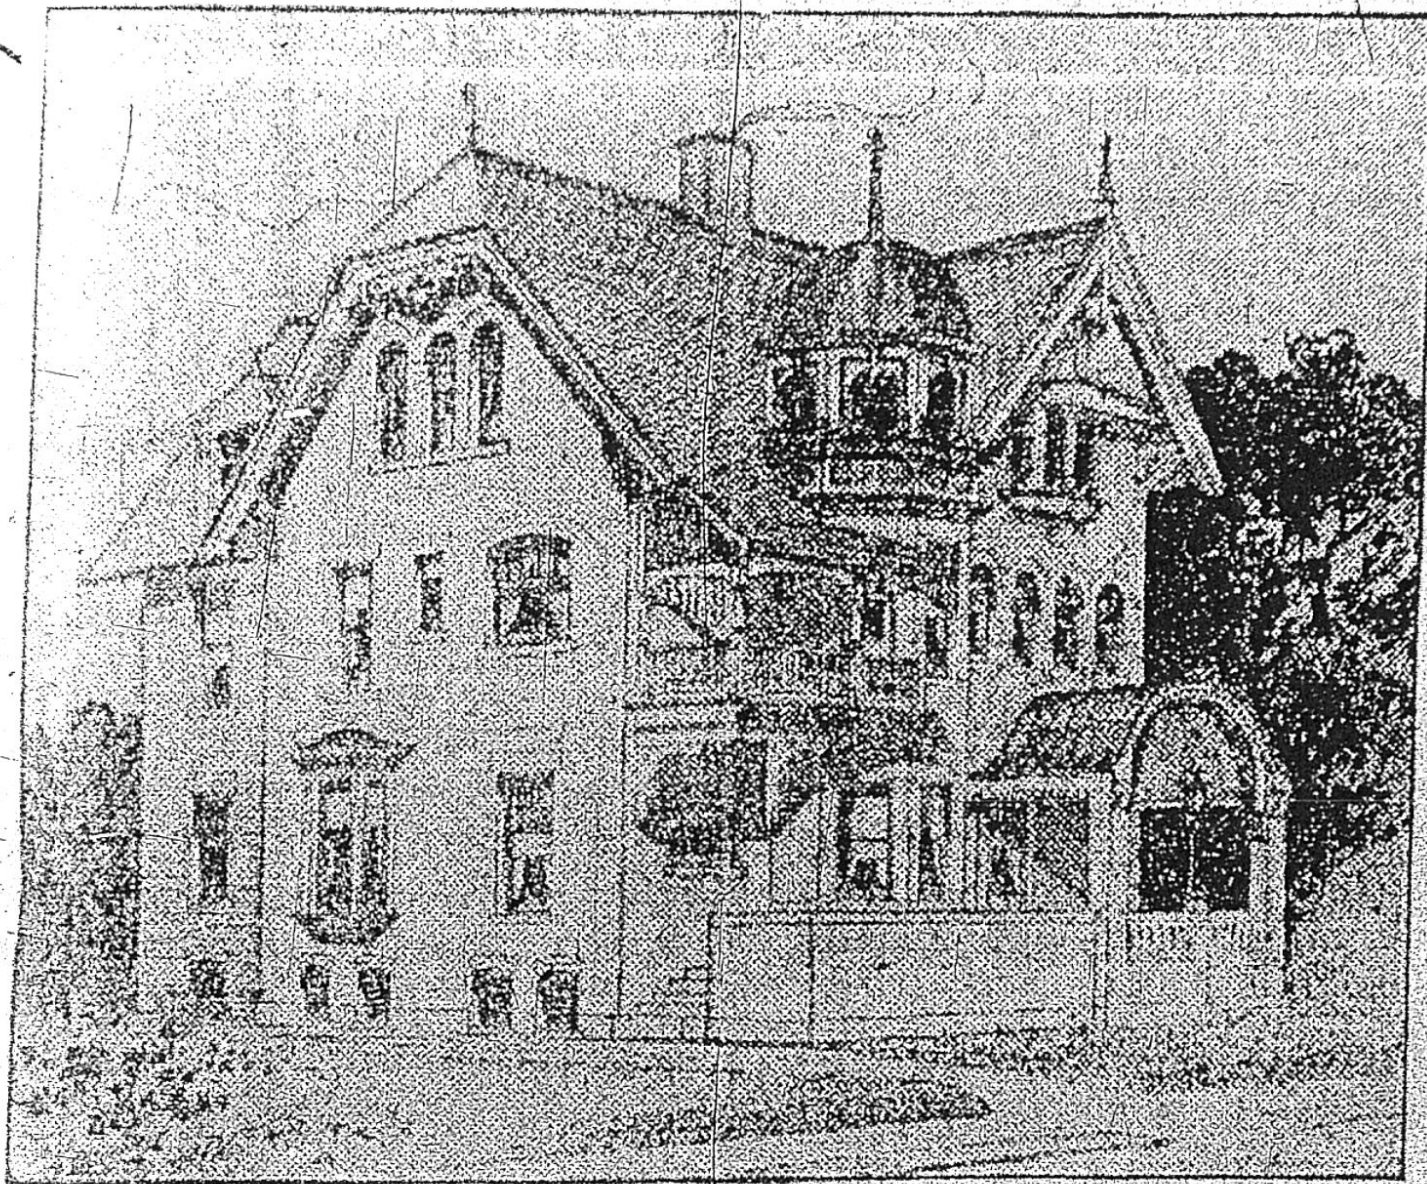
1902 *Evening Wisconsin* image showing original condition of turret and presence of porch lamppost

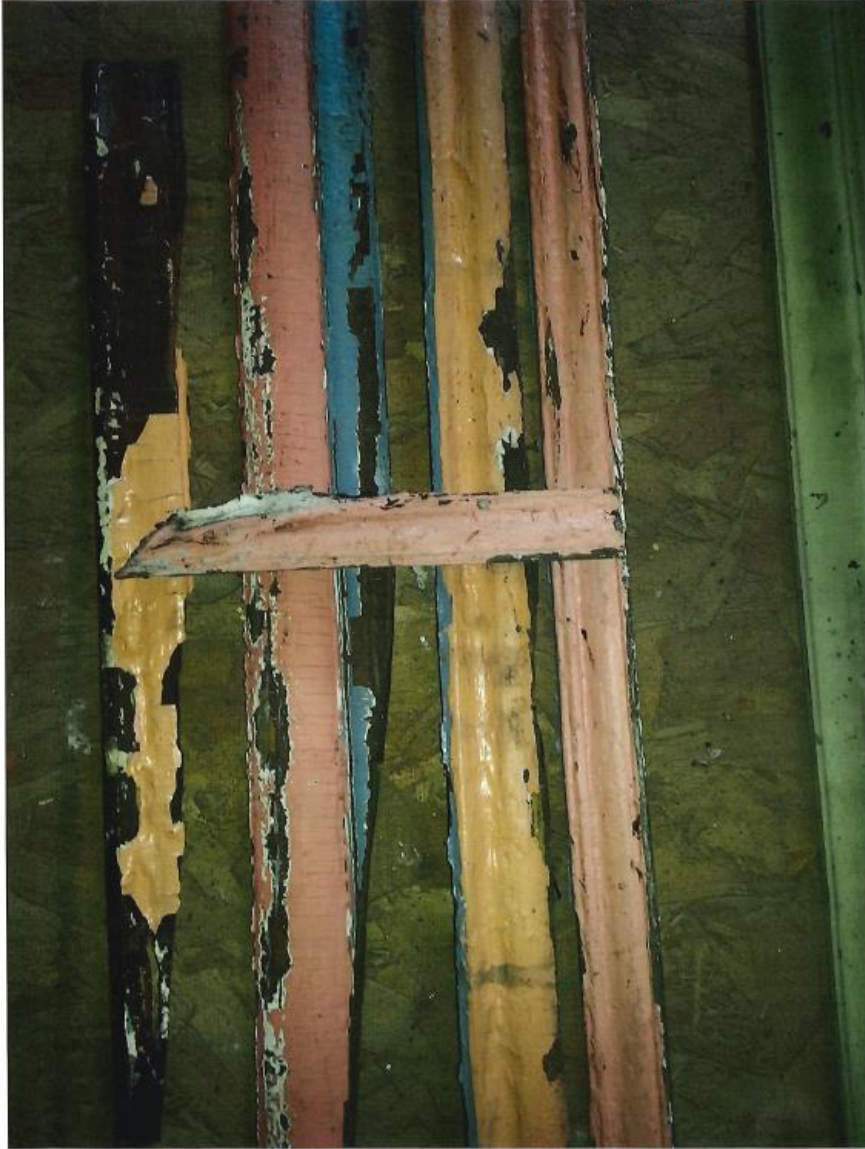
b4
turret trim

Condition of trim work on turret

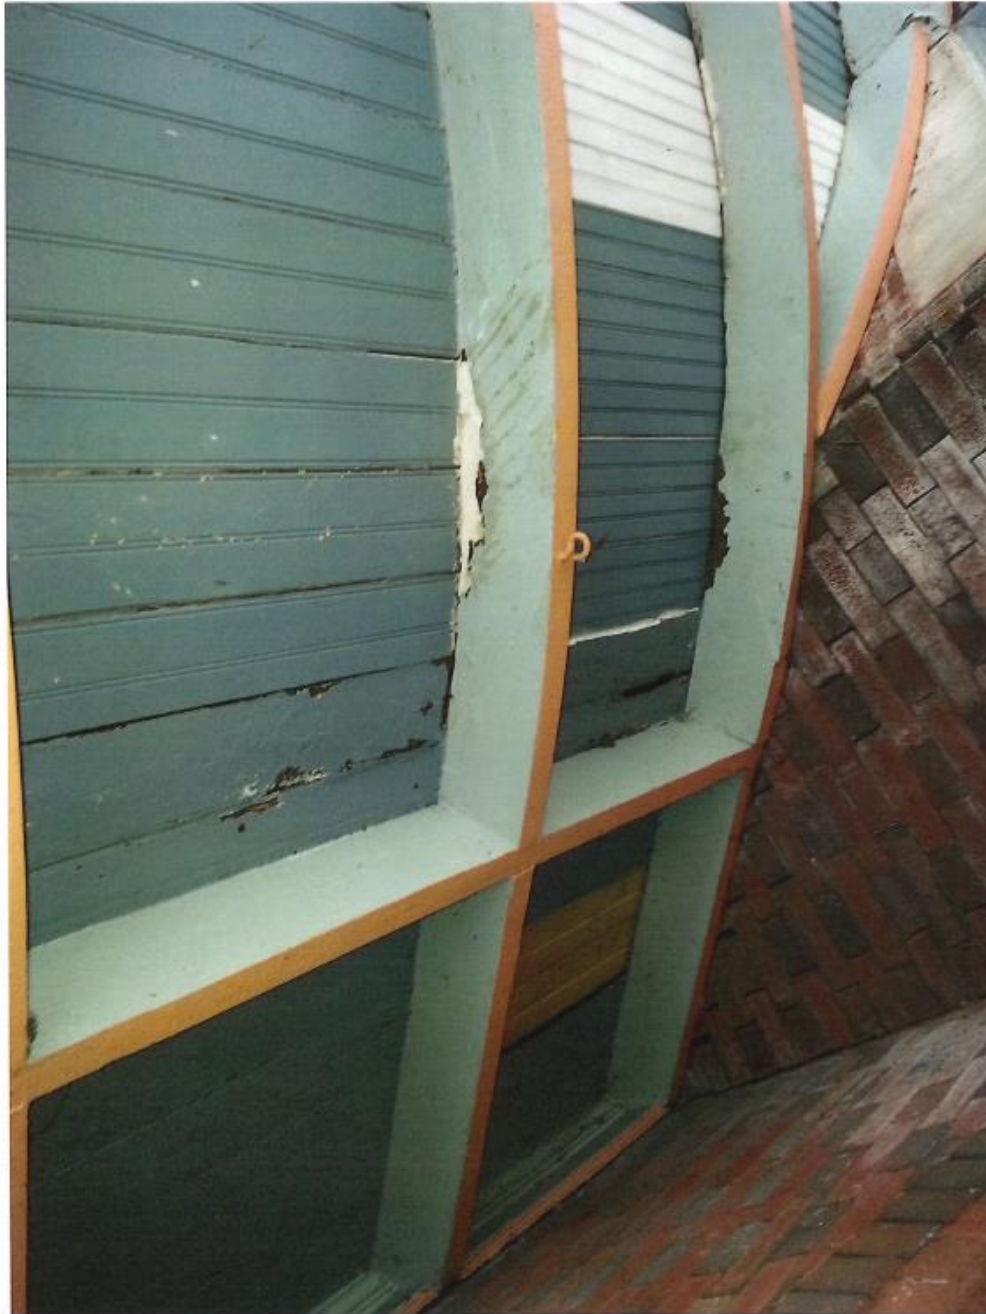
East Side C1
Consumption Perch
Roofing

Underside of sleeping porch roof
requiring repair

New ledge beneath turret window sills d2
copper replacing tin and restored railing

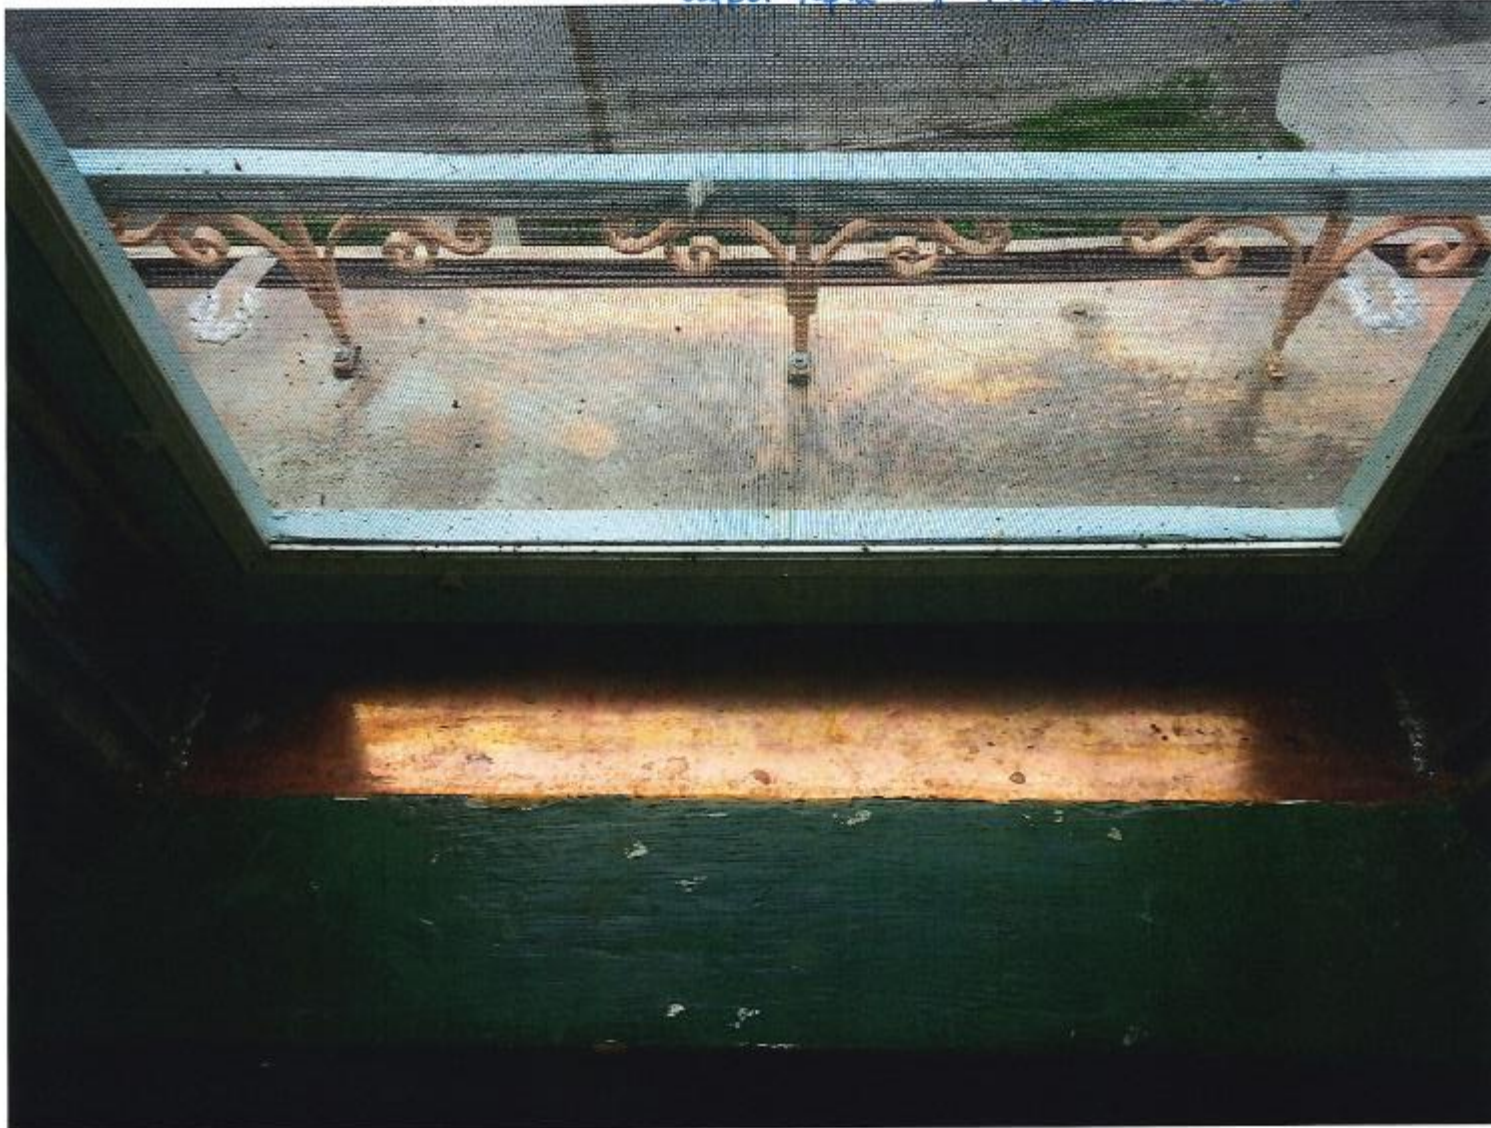
E2
East view turret
restoration complete.

New ledges on turret and railing before removal and repair

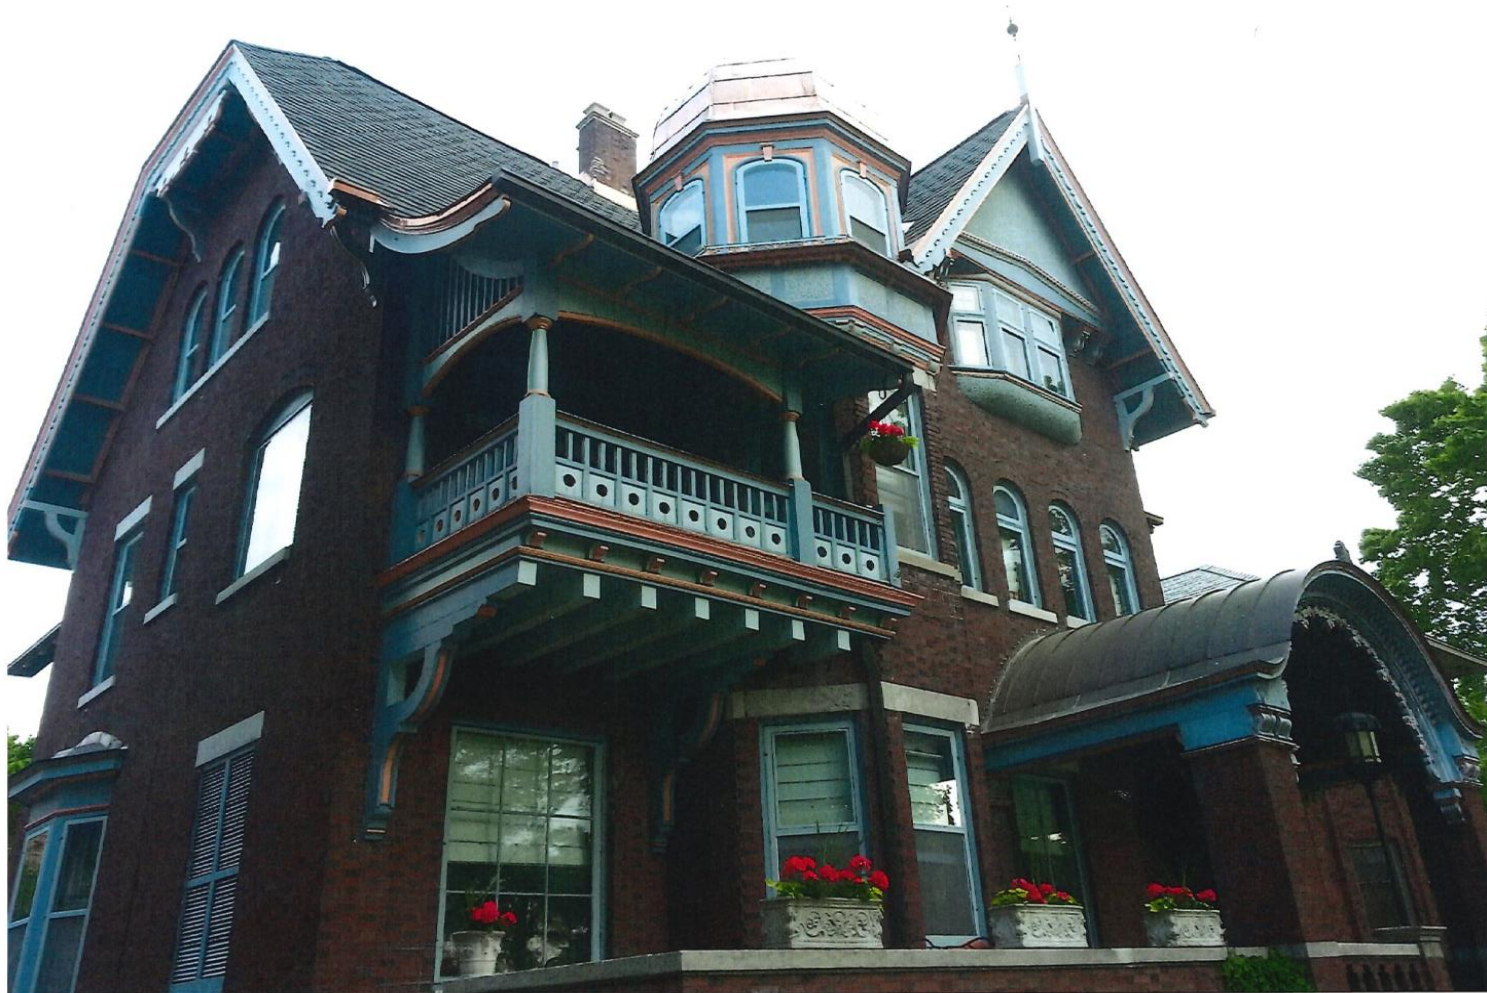
Work complete, except for reinstallation of turret railing.
