**The Home Inspector**[\(http://www.startribune.com/variety/homegarden/blogs/Reuben\\_Saltzman/\)](http://www.startribune.com/variety/homegarden/blogs/Reuben_Saltzman/)

## Many problems with installations of LP SmartSide siding

By Reuben Saltzman | OCTOBER 6, 2015 — 6:19AM

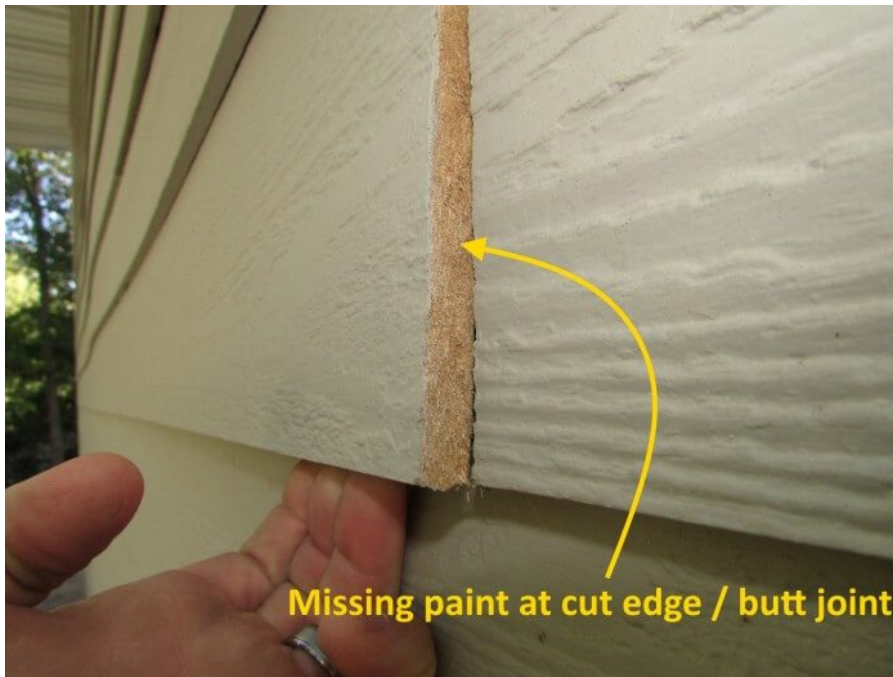
Without a doubt, the most common installation error that I find with LP SmartSide® is missing paint at the cut edges. The manufacturer requires all exposed surfaces to be primed and painted.

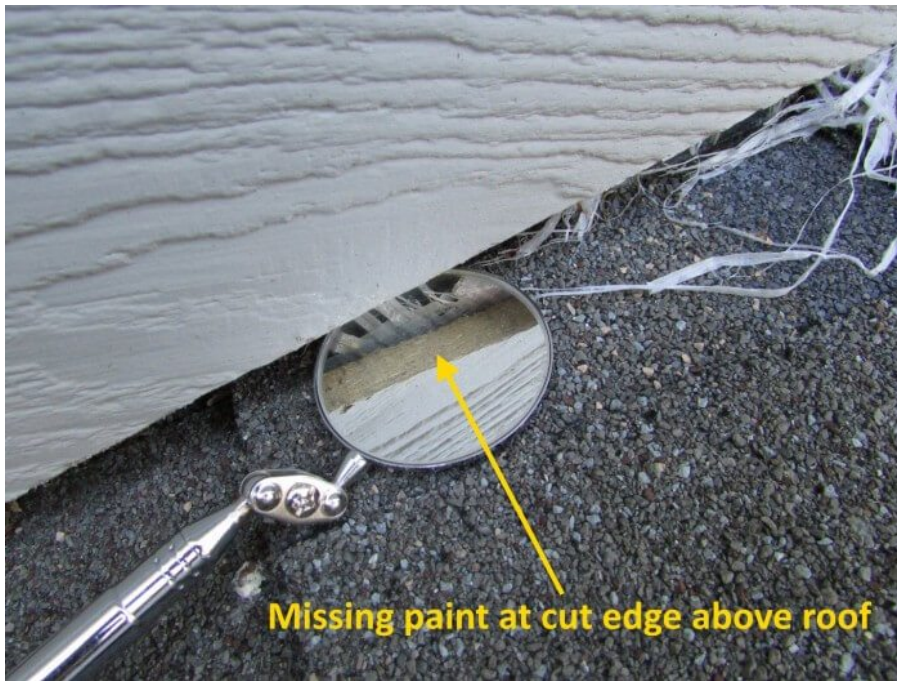
**Missing paint at cut edge above roof**

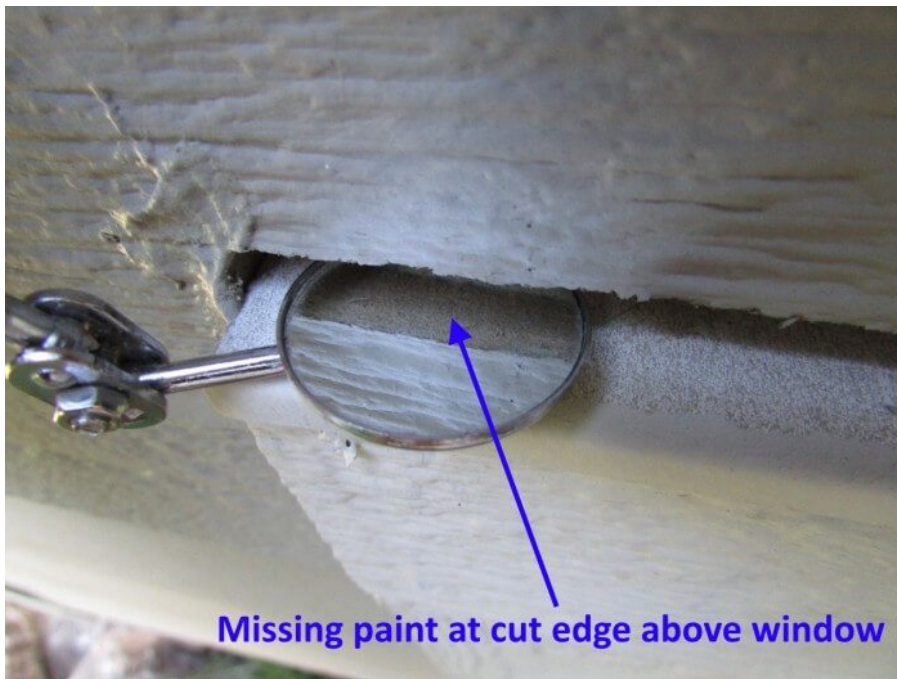
**Missing paint at cut edge above window**

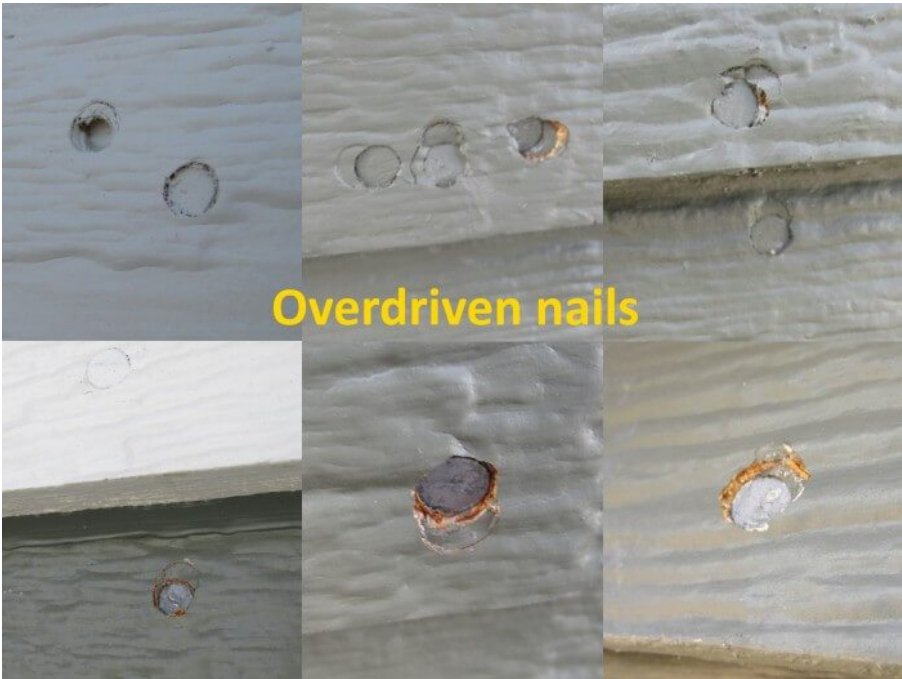
This is another common defect. Here's a small collage of overdriven nails.

The diagram below shows the appropriate repair methods for overdriven nails.

| CONDITION | | CORRECTION | |
| Snug | | OK | |
| Flush | | OK | |
| Visible fiber | | Paint | |
| Countersunk 1/16-1/8 IN. | | Apply sealant | |
| Countersunk more than 1/8 in. | | Apply sealant and re-nail | |

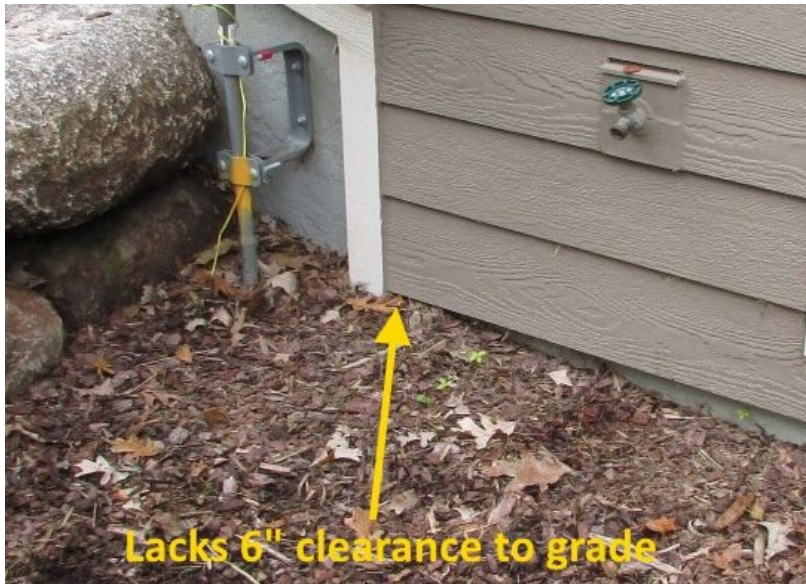
The manufacturer requires 6" of clearance from the siding to the finished grade. It seems that almost every home has one or two areas where this clearance requirement isn't met.

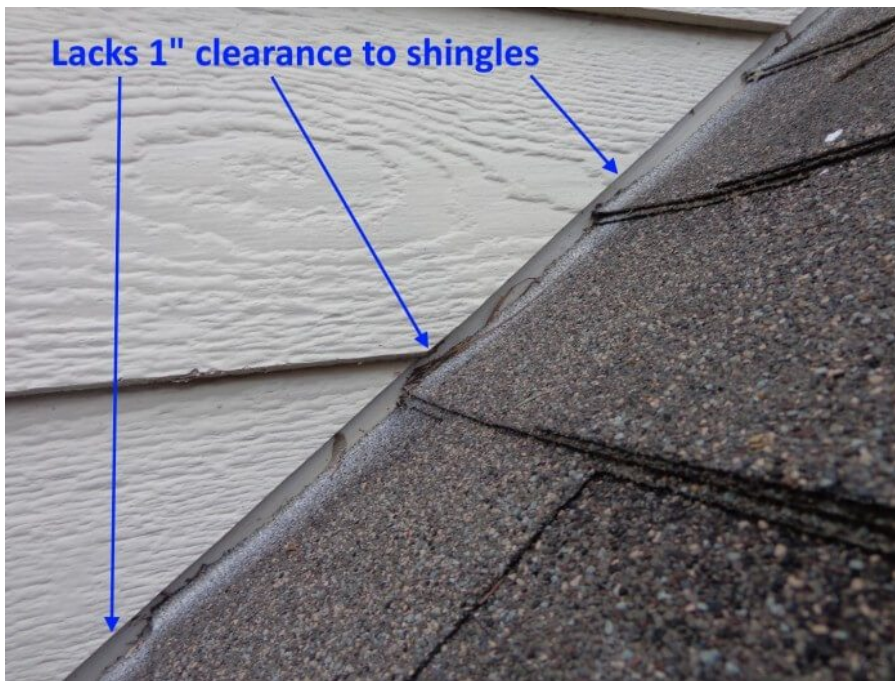
The manufacturer also requires 1" clearance to shingles. This is *usually* done right, but not always.

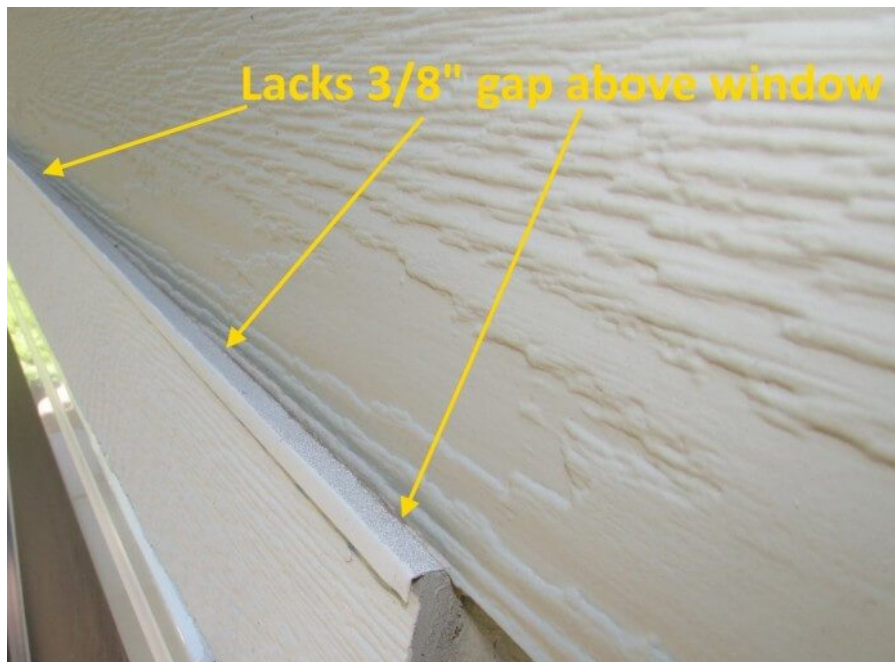
The manufacturer requires a 3/8" gap above windows and other similar penetrations.

This is rarely done.

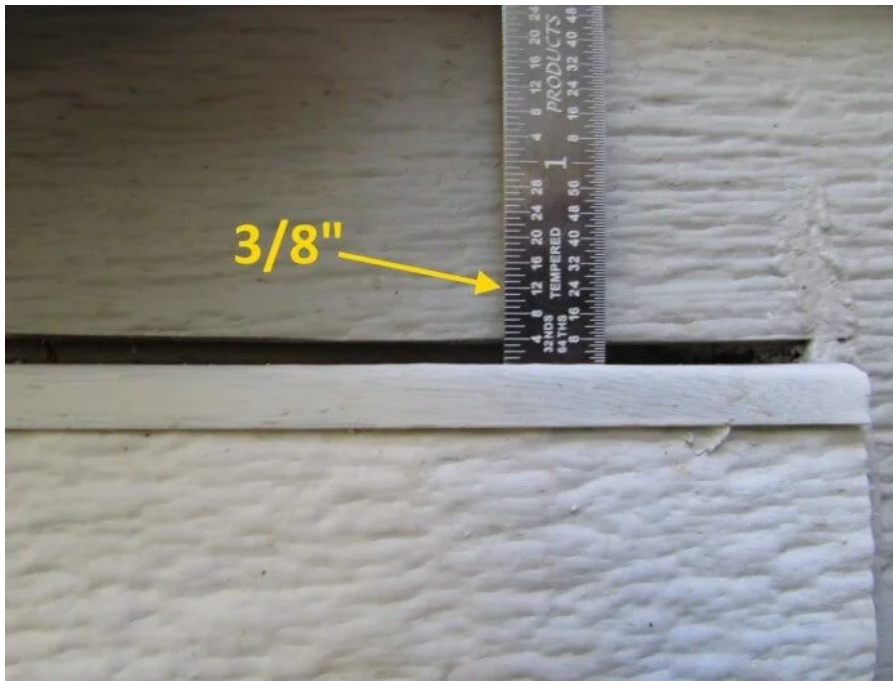
A 3/8" gap is a BIG gap. Even when a gap is left here, it's usually not what the manufacturer requires.

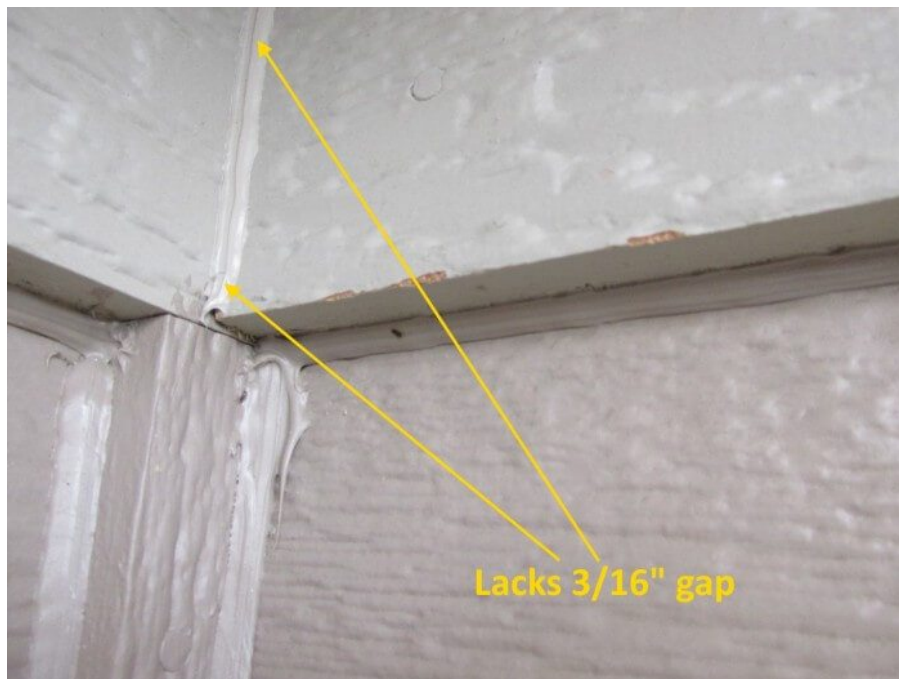
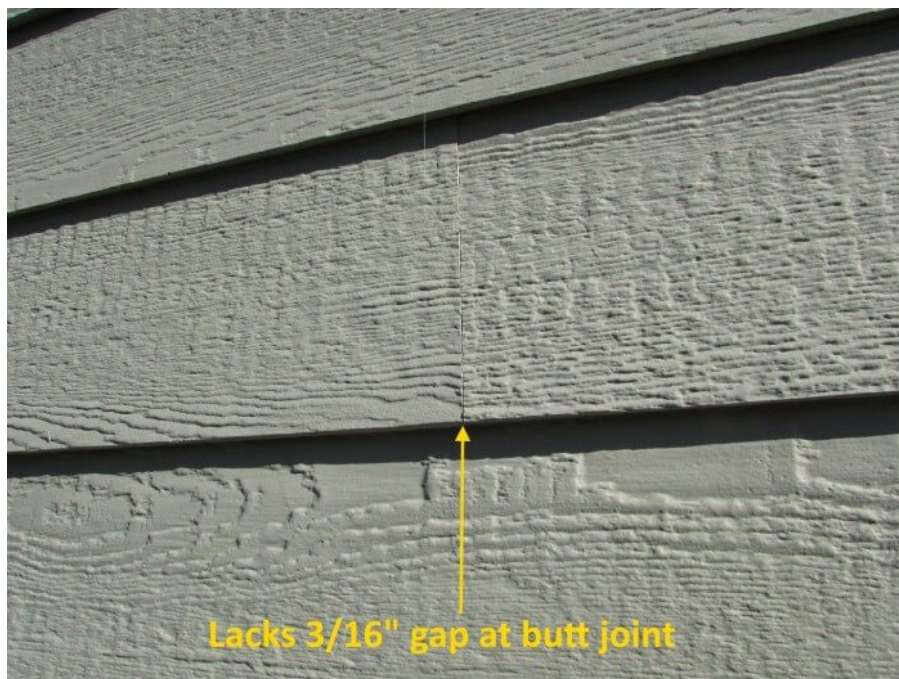
The manufacturer requires a 3/16" gap at the end of each piece of siding. This includes butt joints, and places where the siding terminates vertically against windows, doors, and other fixtures.

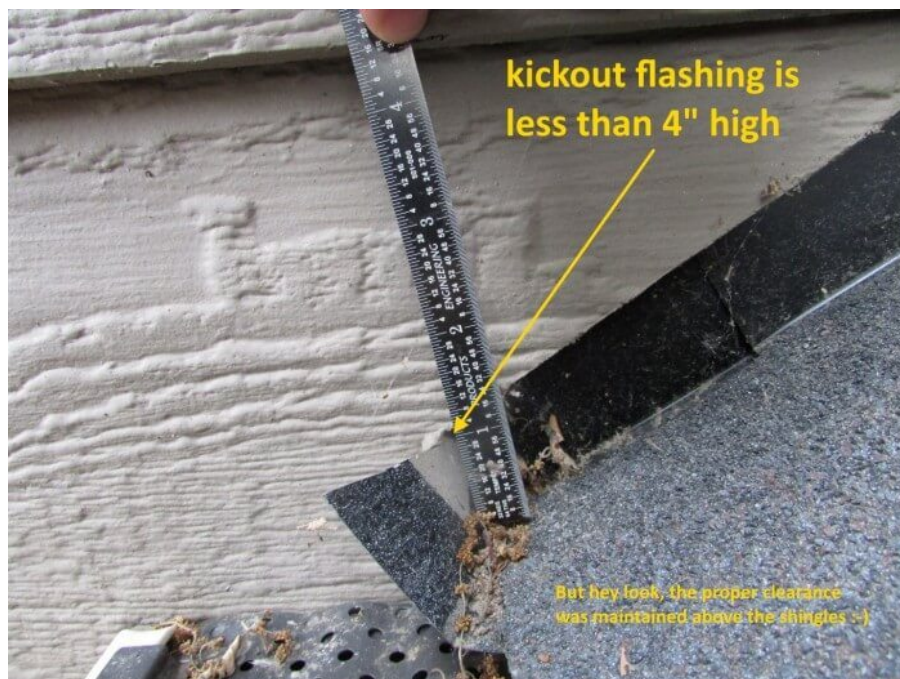
LP SmartSide® requires flashing to have a 4" upper leg. This means the kickout flashing needs to be 4" high. This usually isn't done.
