## The Home Inspector

# Many problems with installations of LP SmartSide siding

By Reuben Saltzman | OCTOBER 6, 2015 — 6:19AM

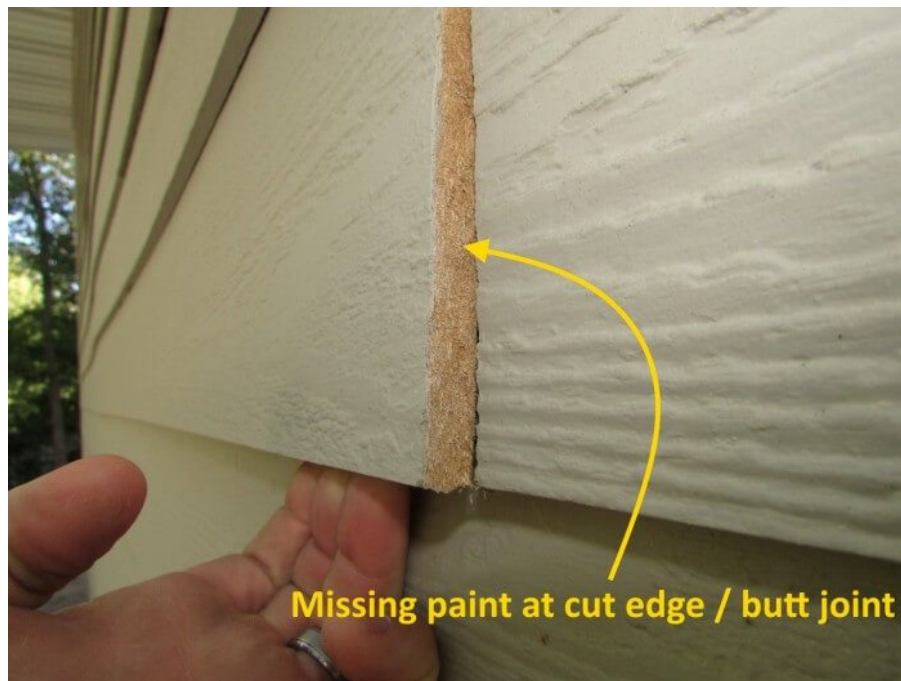
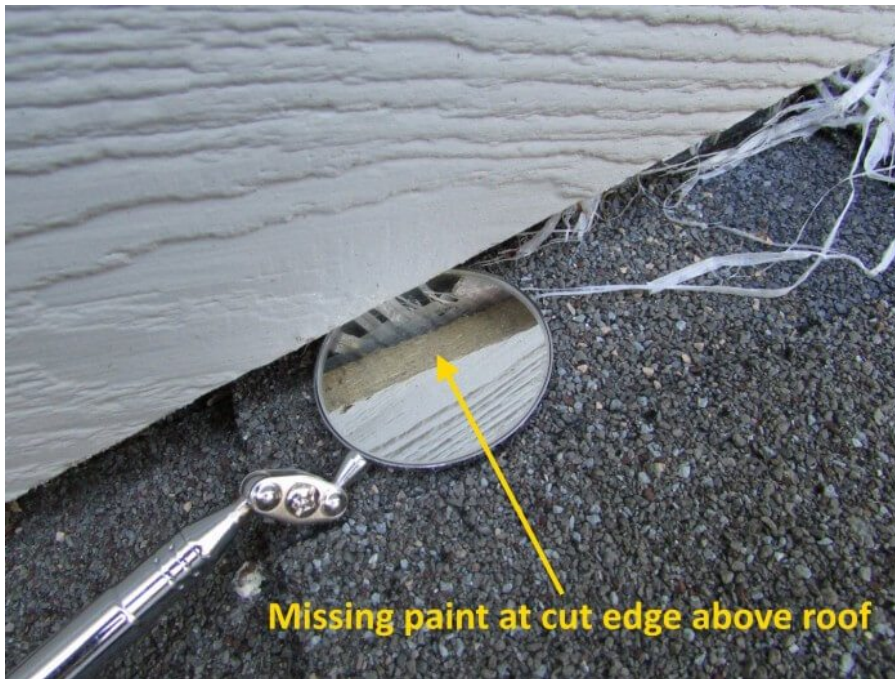
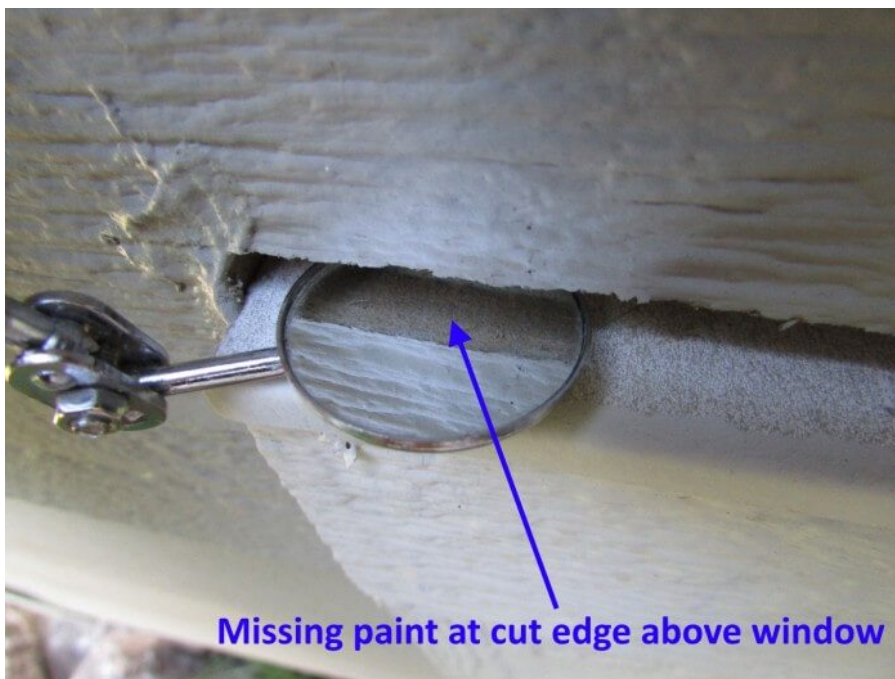
Without a doubt, the most common installation error that I find with LP SmartSide® is missing paint at the cut edges. The manufacturer requires all exposed surfaces to be primed and painted.

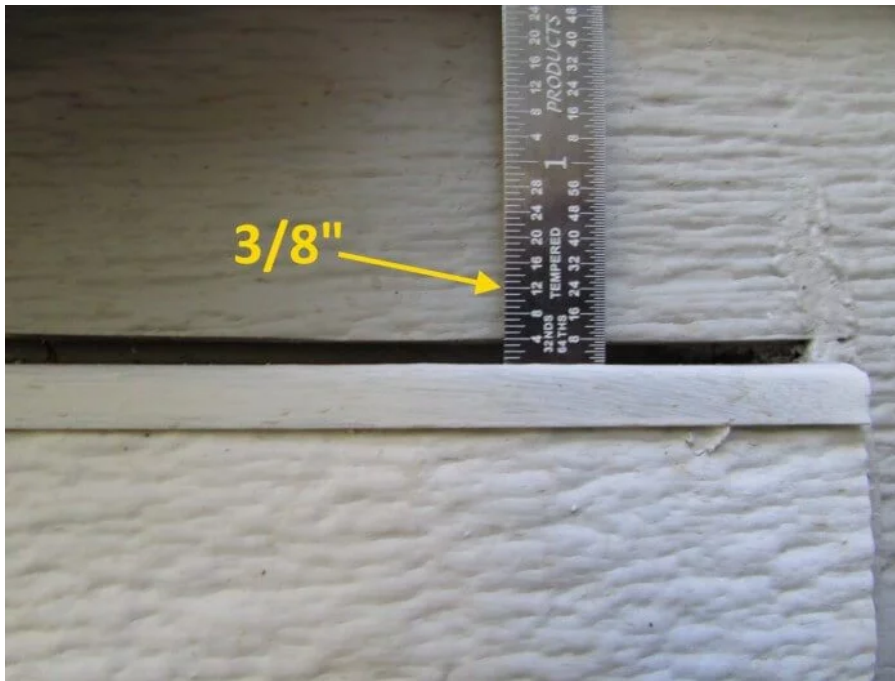
A 3/8" gap is a BIG gap. Even when a gap is left here, it's usually not what the manufacturer requires.

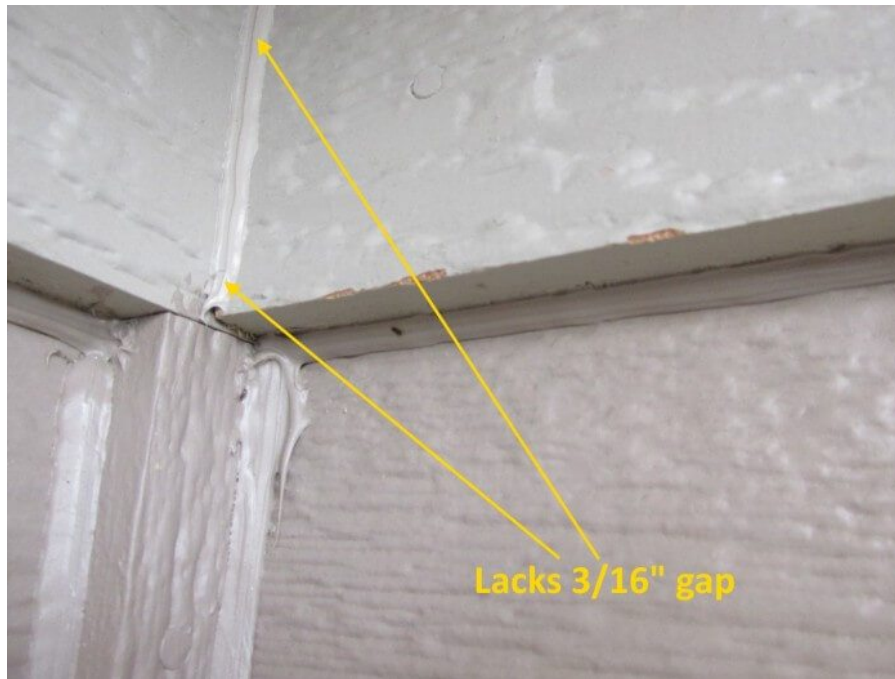
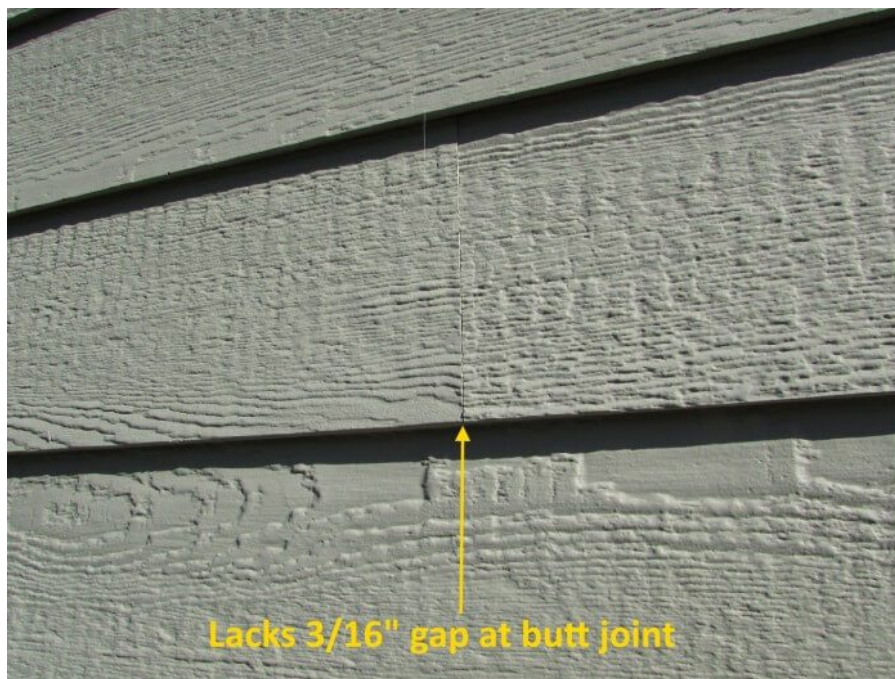
The manufacturer requires a  $3/16$ " gap at the end of each piece of siding. This includes butt joints, and places where the siding terminates vertically against windows, doors, and other fixtures.
