Certificate of Appropriateness

Property 729 W. HISTORIC MITCHELL ST. Mitchell Street HD

Description of work Masonry repairs per conditions below and project narrative on following page.

Date issued 8/10/2018 PTS ID 114601 COA: masonry repairs

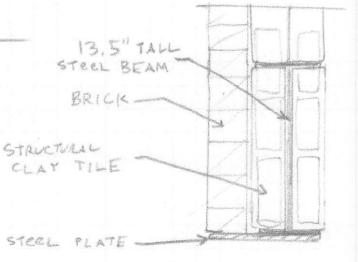
EXISTING CONSITIONS

* STEEL PLATE AND BOTTOM FLANGES ARC RUSTED SEVERELY ABOVE WINDOWS.
