# Certificate of Appropriateness

**Property** 3034 W. STATE ST. Concordia Historic District

**Description of work** Correct violations as indicated below on violation notice and in manner indicated.

**Date issued** 10/29/2019 PTS ID 114880 COA: Correct violations

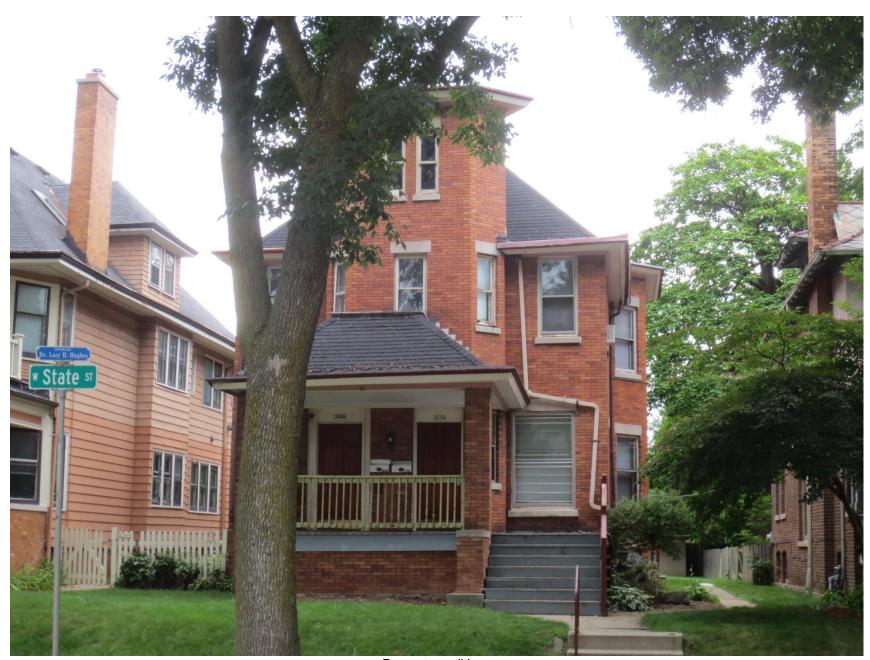
Present conditions

3) 275-32.3.g Replace defective boards in porch ceiling. bead board

Replace porch ceiling boards with new, painted wood beadboard per example below

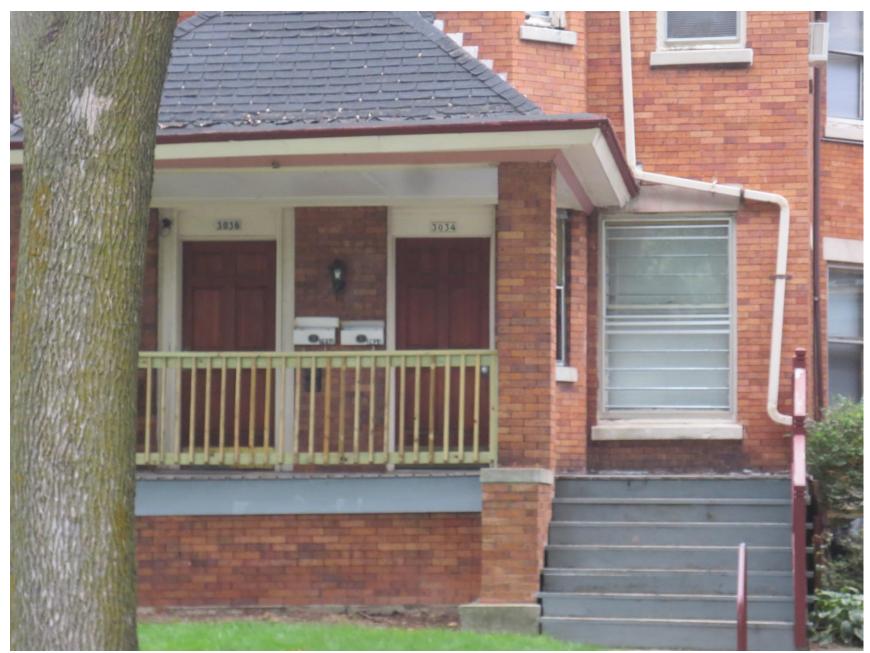
Porch Detail

4) 275-32.3.g Provide an approved guardrail for porch. use cedar balusters to match Violation Location: South Side circled style on p. 182 of As Good As New

Balusters shall be a painted, naturally rot resistant wood species and painted. The same design shall be used to replace the stair railing at the east of the porch.

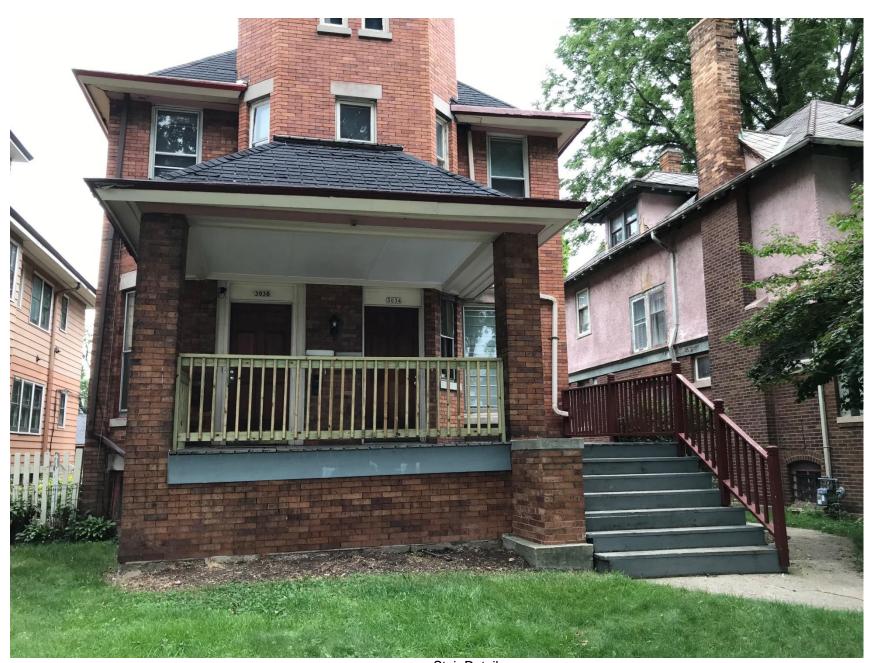
Stair Detail

5) 275-32.3.g Replace defective porch floor boards and secure to supporting structure. New Natural wood lation Location: South Side Vouglas First or other hatural wood

Replace porch decking with new Douglas fir center-match flooring. Maximum acceptable board width is 5.5".

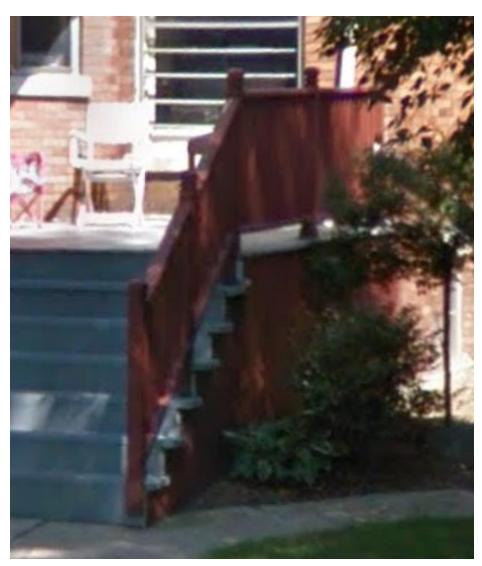
8) 275-32.3.g Repair or remove defective skirting around porches. (Southeast portion)

Skiriting on east side of porch consists of plywood or OSB that has detached from the structure. There are two optiosn for repair:

- 1. Rebuild as a flat brick wall to match foundation.
- 2.Build tightly spaced skirting as shown below to infill the area construct a proper string to match.
