General

Asphalt Shingles

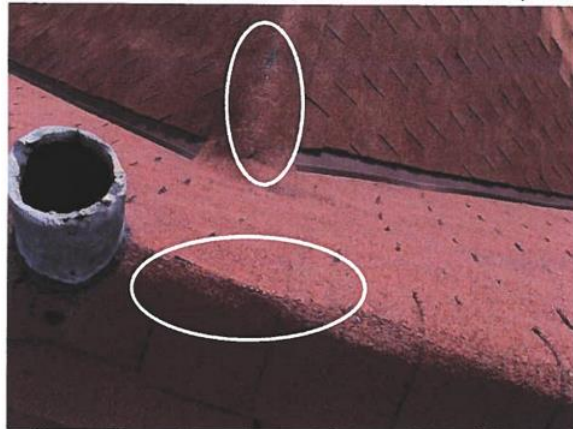
SIG 21: The shingles covering the roof of this home appeared to be at or near the end of their useful lives. The Inspector recommends you consult with a qualified roofing contractor to discuss options and costs for replacement.

Split ridge shingles

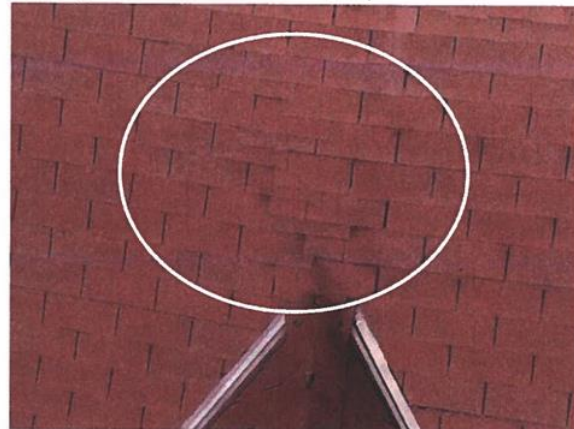
Shingles improperly laid

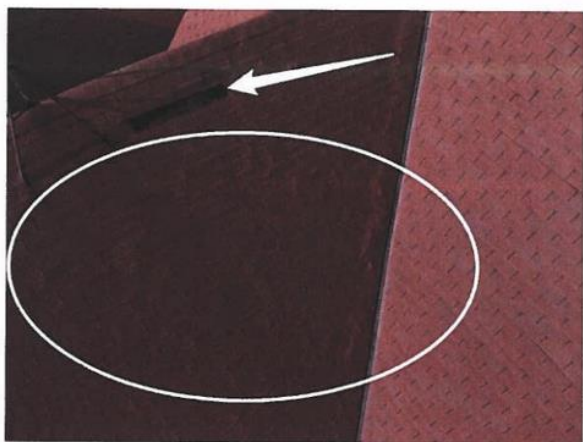
Shingles lifting and curling, one example of missing shingles

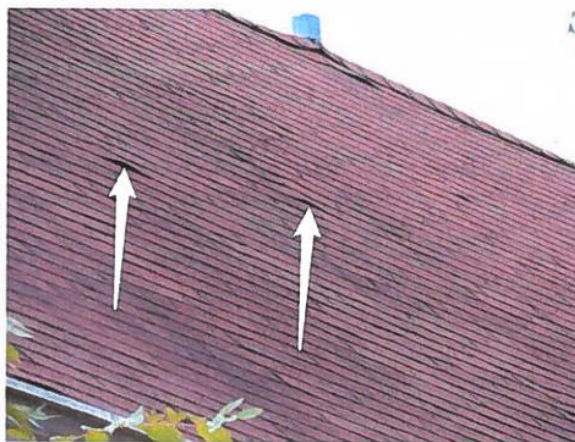
Many lifting shingles

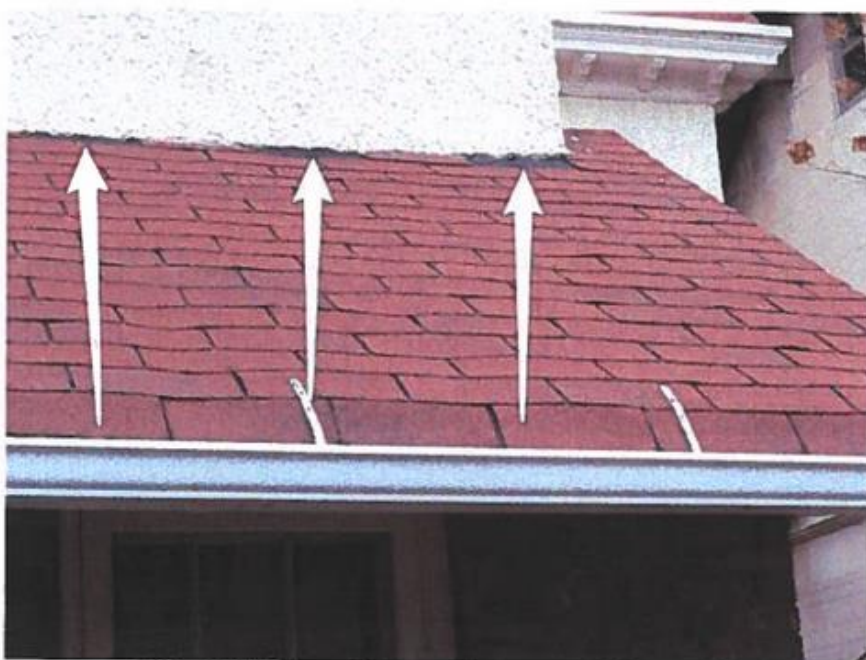
Multiple missing shingles at rear

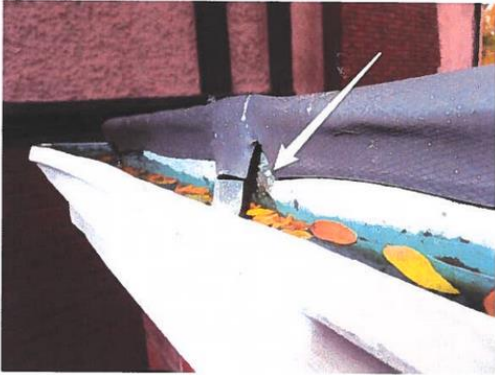
22: The edges didn't have a termination bar installed and they weren't sealed as is typically recommended. No damage was noted as a result but you should contact a qualified roofer regarding correction to prevent damage from wind and water getting under the roof.

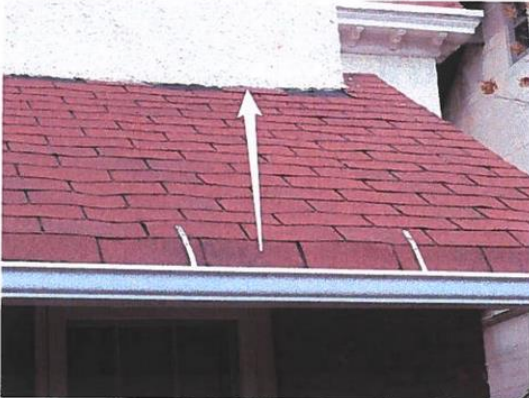
Rear of house

23: CONDITION: The siding was too close to the roofing material to verify the installation of proper headwall flashing. Confirmation would have to be made by a qualified contractor.

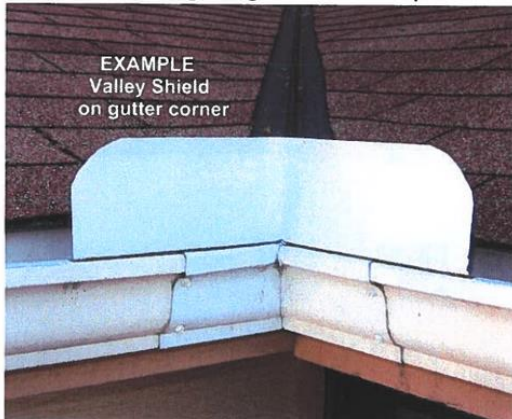
24: CONDITION: Valley shields at the corners of gutter were missing. These are designed to prevent roof drainage from overshooting the gutters. The inspector recommends installation of valley shields.

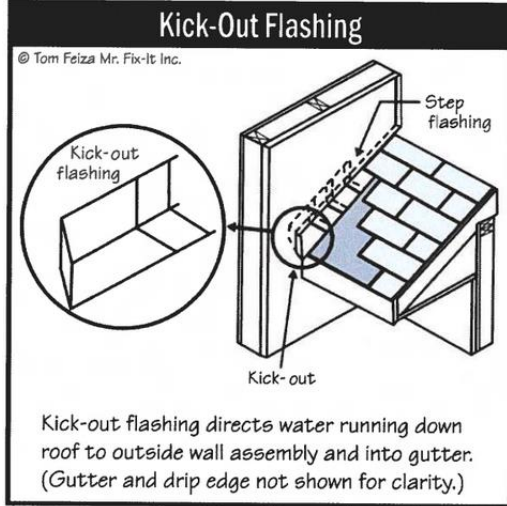
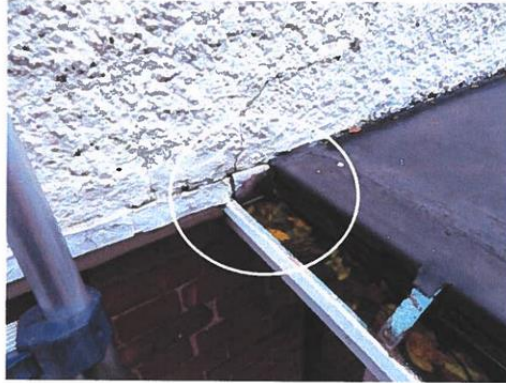
25: CONDITION: The building had no kick-out flashing installed where walls extended past roof edges. Kick-out flashing is designed and installed to divert water from behind the exterior wall covering at areas of the building where a sidewall extends out past a connecting roof eave. This condition may allow moisture intrusion of the exterior wall covering. Long term moisture intrusion can cause damage from wood decay. The Inspector recommends that you consult with a qualified roofing contractor to discuss options and costs for adding this flashing.

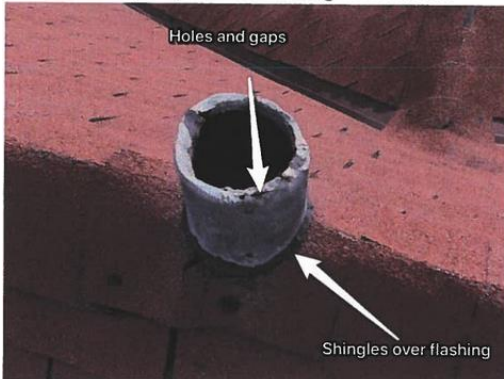
SIG 26: FLASHING: Plumbing roof vent penetration flashings were improperly installed - the shingles were installed over the base of the shingles. This may cause roof leakage and result in moisture intrusion of the roof assembly. The vent flashing was also damaged and had holes and gaps which could lead to leaks. The inspector recommends correction by a qualified roofing contractor.
