1. **HISTORIC NAME OF PROPERTY OR HISTORIC DISTRICT:** (if known)  
Concordia Historic District

**ADDRESS OF PROPERTY:**  
1009-1011 North 33rd St, Milwaukee, WI 53208

**1009-1011 NORTH 33RD STREET: CONCORDIA HISTORIC DISTRICT**  
Certificate of Appropriateness Application Submission  
October 16, 2014

## **Project Overview: Synopsis of Key Items**

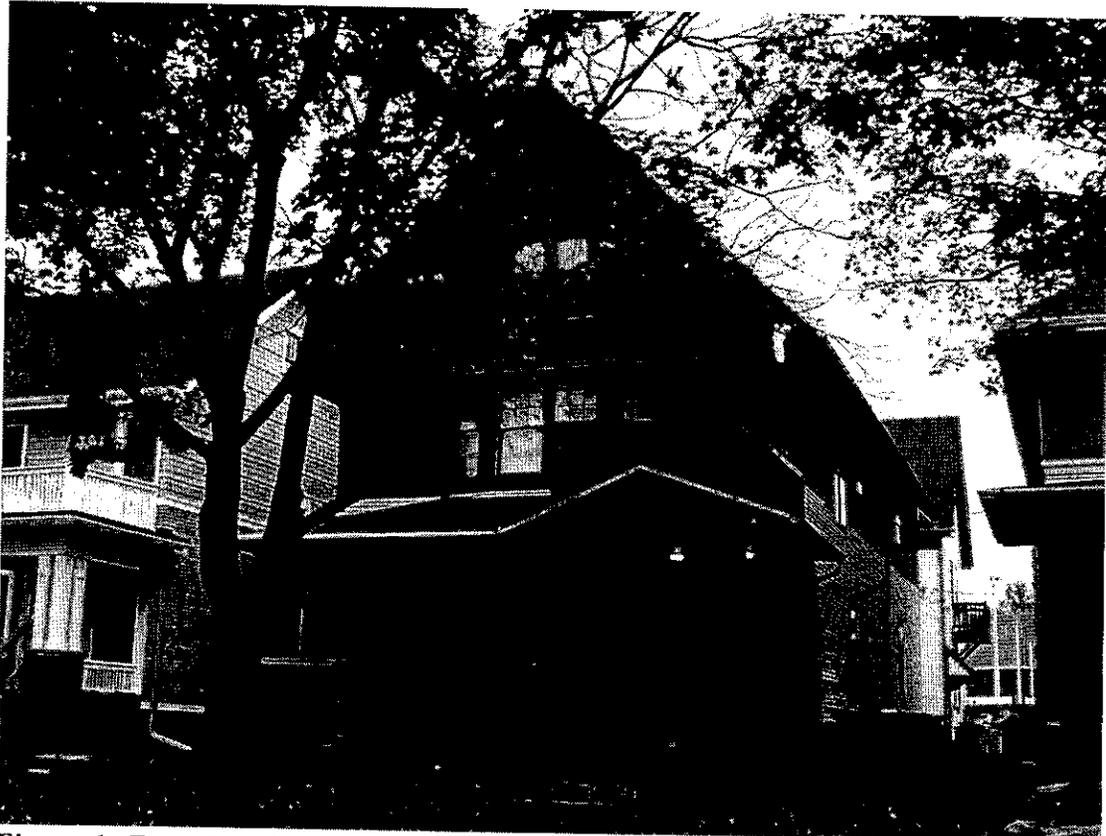
**Figure 1:** East elevation and north elevation from North 33rd Street. Brown aluminum exterior storm/screen units are not original and will either be reused or replaced in kind. East elevation windows will be restored.

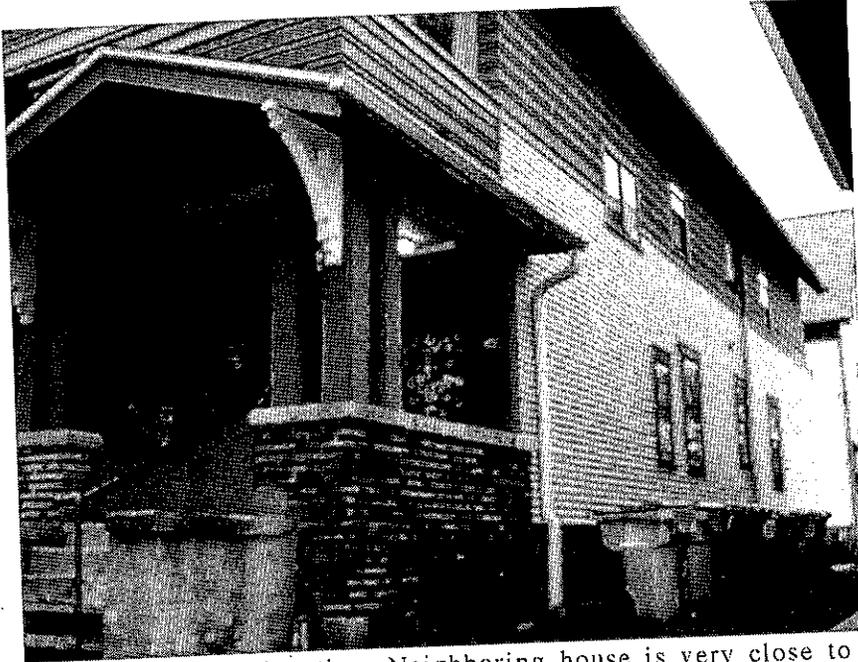
**Figure 2:** North elevation. Neighboring house is very close to the duplex, limiting visibility of north windows. Windows to be replaced at this location.

- Replace all north elevation window sashes and sash pockets with Marvin wood replacement windows.
- Repair frames (jambs, casing, etc.) as necessary.
- Original wood storms no longer exist and will not be replicated.

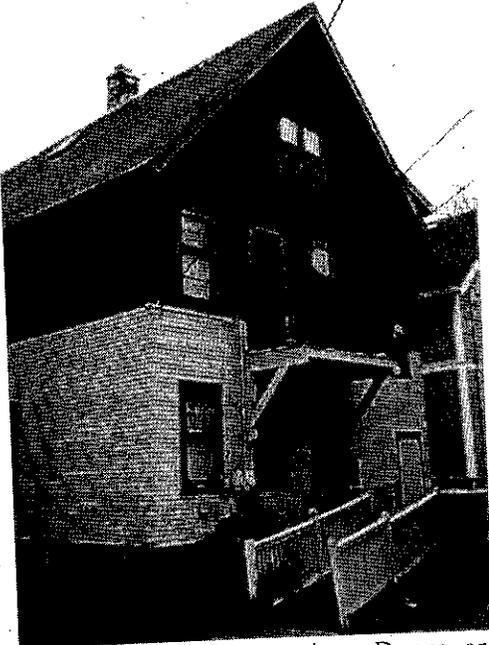
**Figure 3:** West elevation. Doors are not original. Most windows are 6-over-1 true divided lite, but some mullions are missing. Windows to be replaced at this location.

- Replace all west elevation window sashes and sash pockets with Marvin wood replacement windows.
- Repair frames (jambs, casing, etc.) as necessary.
- Original wood storms no longer exist and will not be replicated.

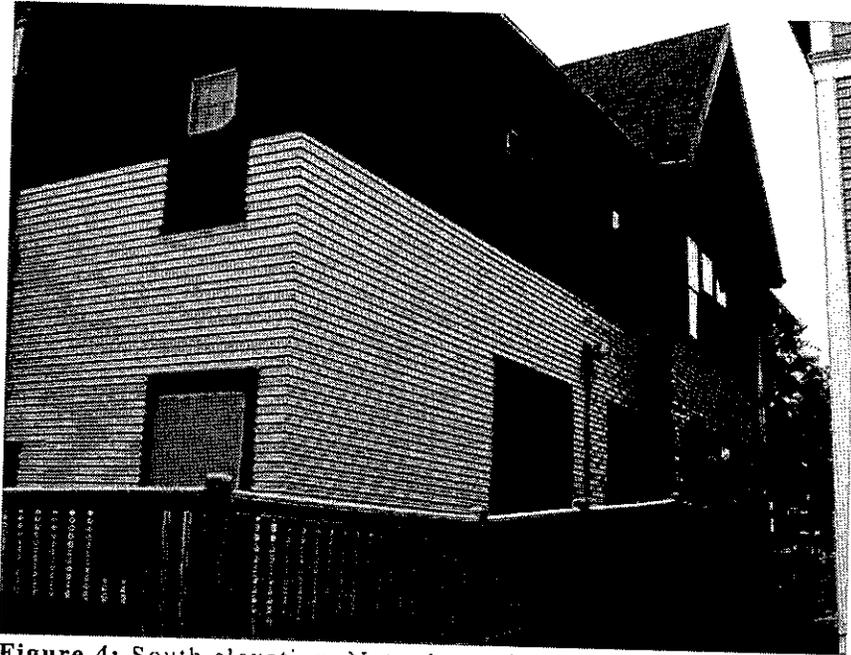
**Figure 4:** South elevation. Note the projecting gabled bay and the window turned into a door for ADA accessibility. Windows to be replaced at this location.

- Replace all south elevation window sashes and sash pockets with Marvin wood replacement windows.
- Repair frames (jambs, casing, etc.) as necessary.
- Original wood storms no longer exist and will not be replicated.

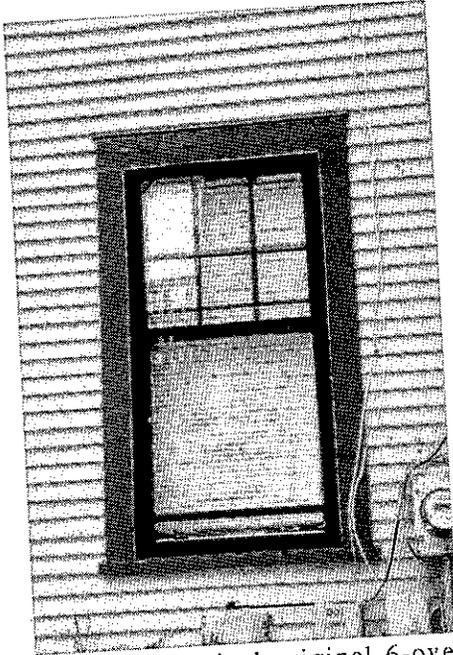
**Figure 6:** Typical original 6-over-1 true-divided-light double hung window. Windows to be sympathetically replaced on the north, south, and west elevations.

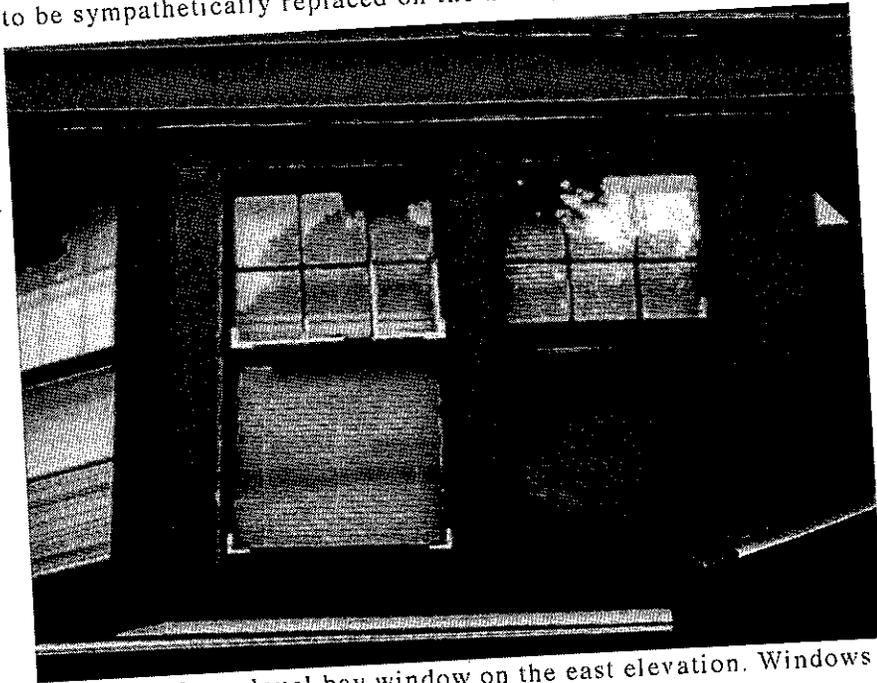
**Figure 7:** Upper level bay window on the east elevation. Windows to be restored at this location.

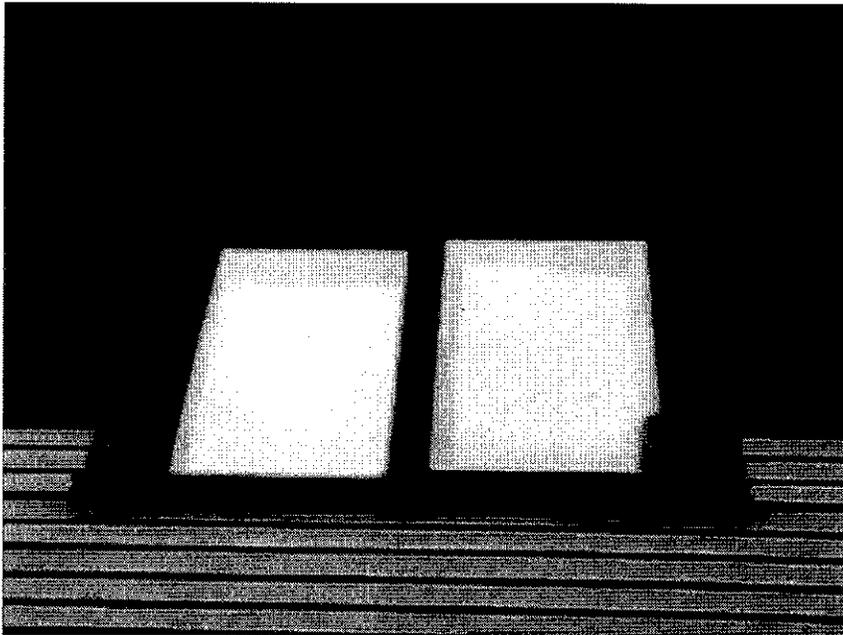
**Figure 8:** Modern double casement window on the north elevation. This window will be replaced with a sympathetic wood casement unit.

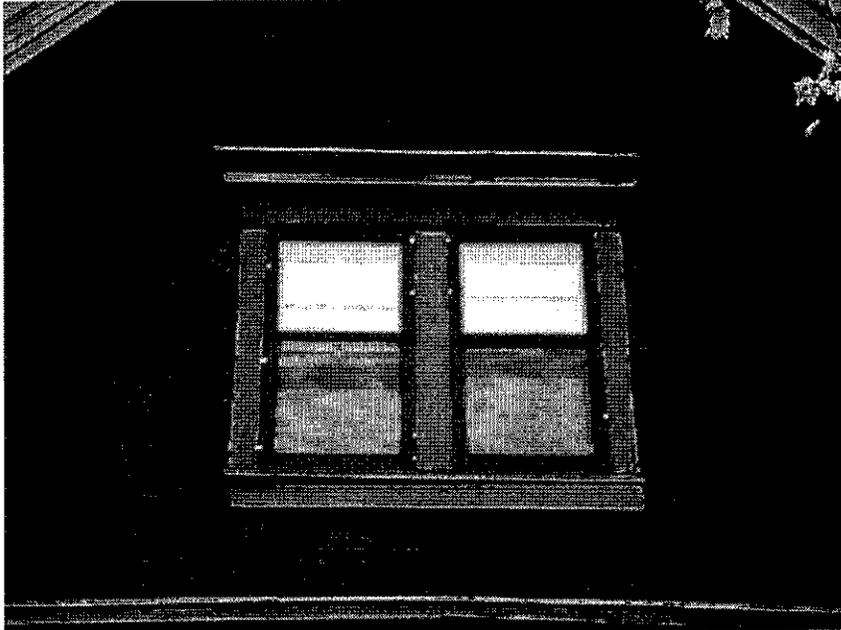
**Figure 10:** Attic windows, east elevation. Mullions have been reconfigured to form 4-over-1 and 2-over-1 true divide lights. Windows to be restored at this location.

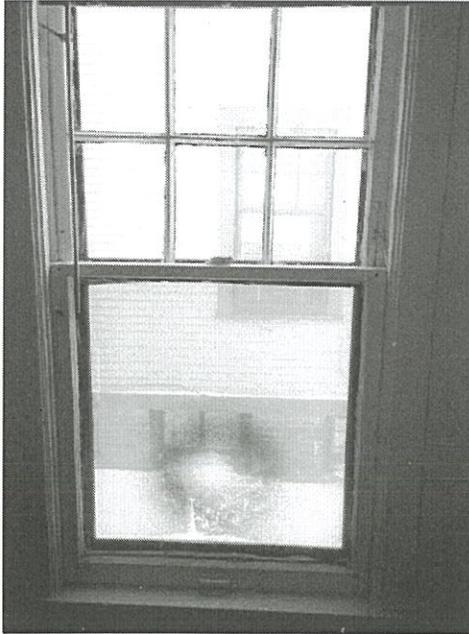
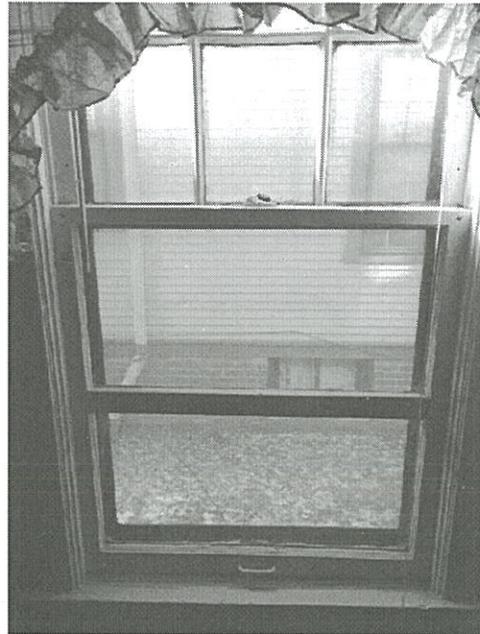
**Figures 12 and 13:** Interior views of typical double hung windows - painted.

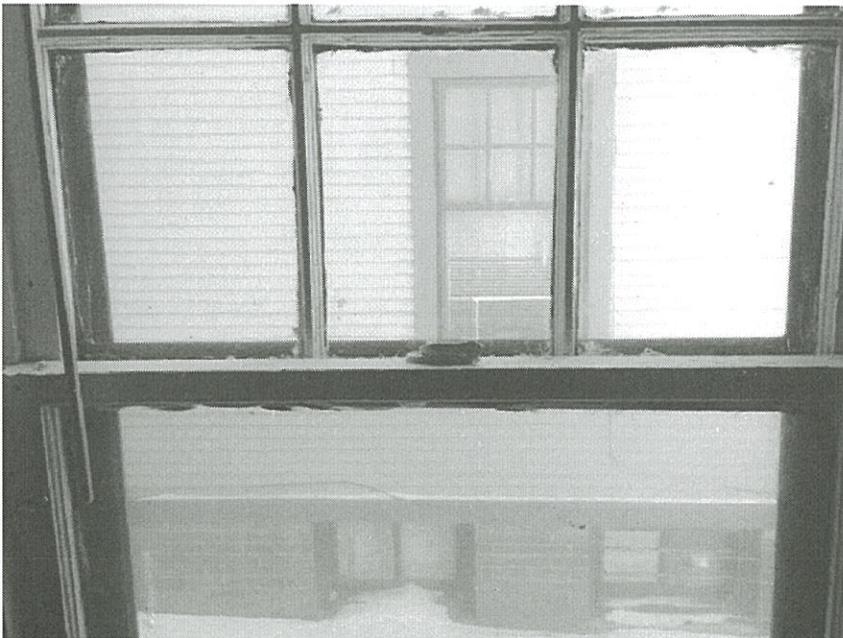
**Figure 14:** Interior view of window. Sash cords and weights have been removed.

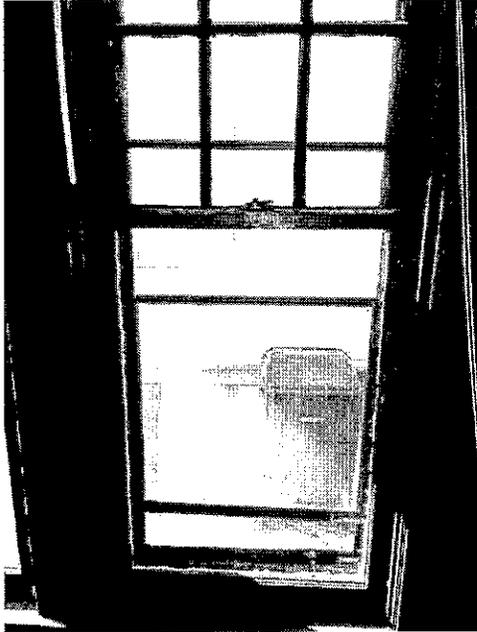
**Figure 15:** Interior view of stained double hung window.
