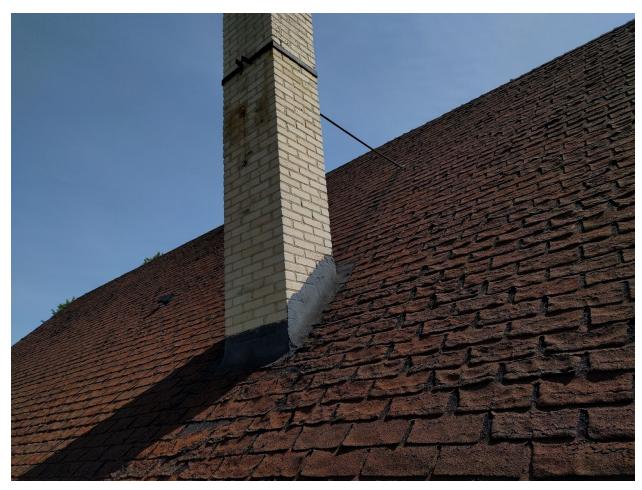
Chimney to be removed.

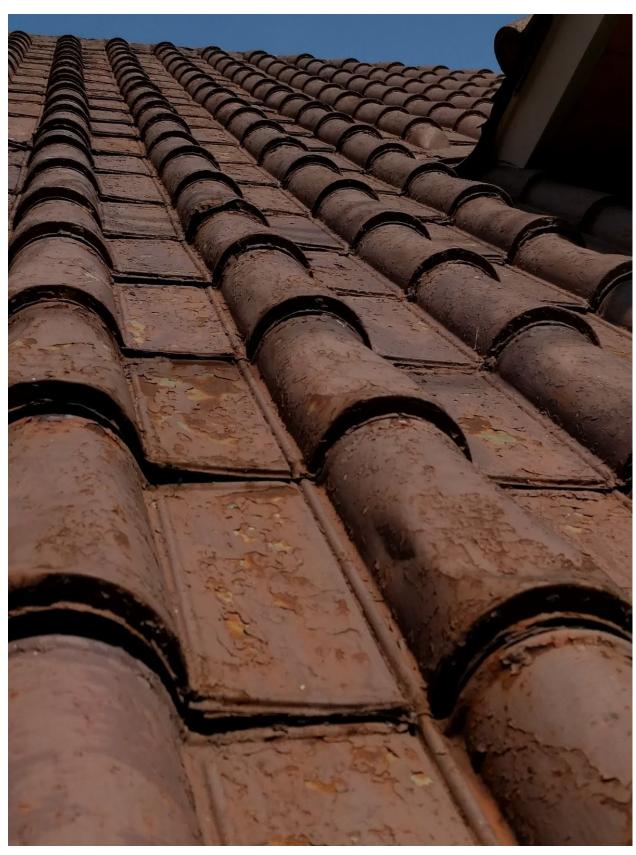
Close up of the condition of metal tile.

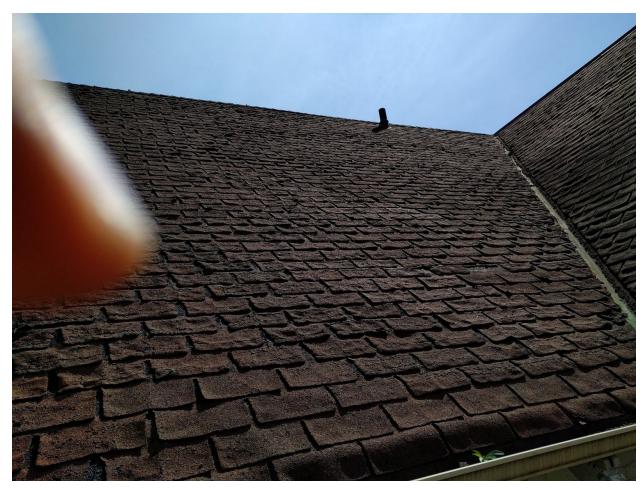
Current Shingles
