Certificate of Appropriateness

2433 N. Wahl Ave., North Point North Historic District

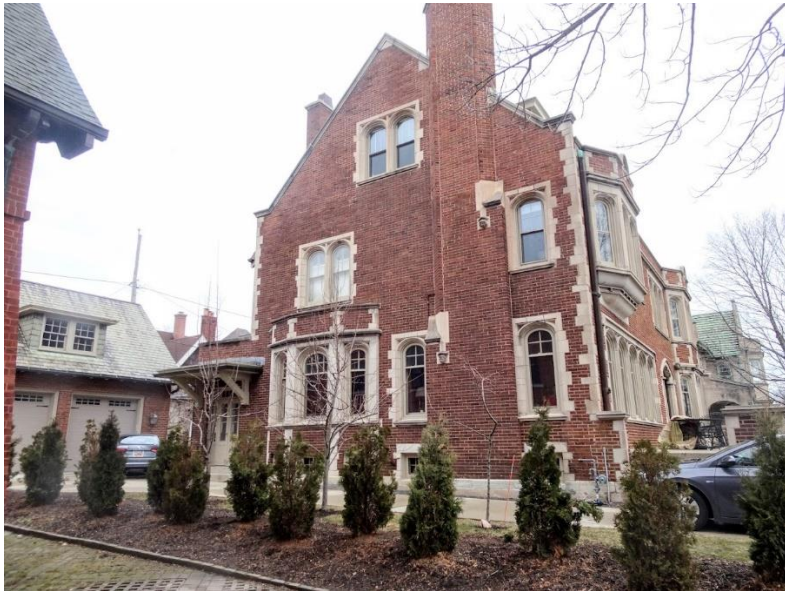
SE corner downspout to be replaced

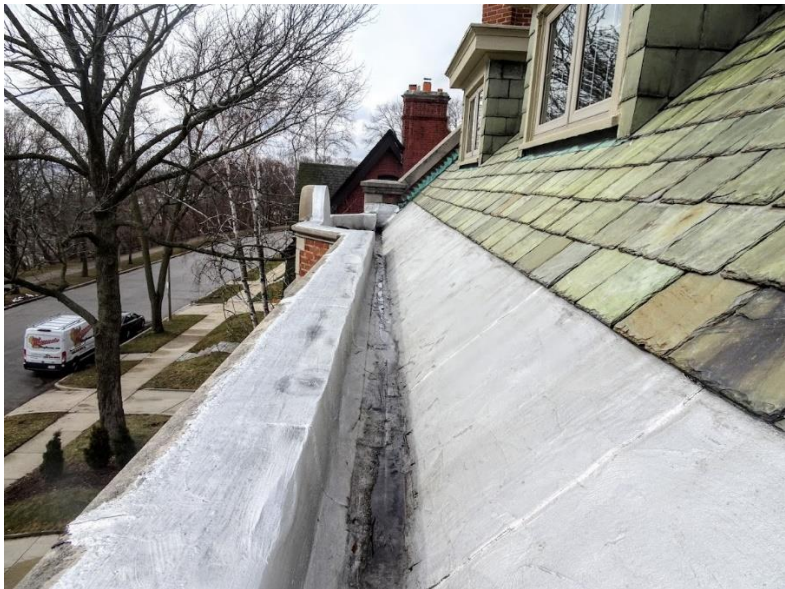
Roof trough to be patched

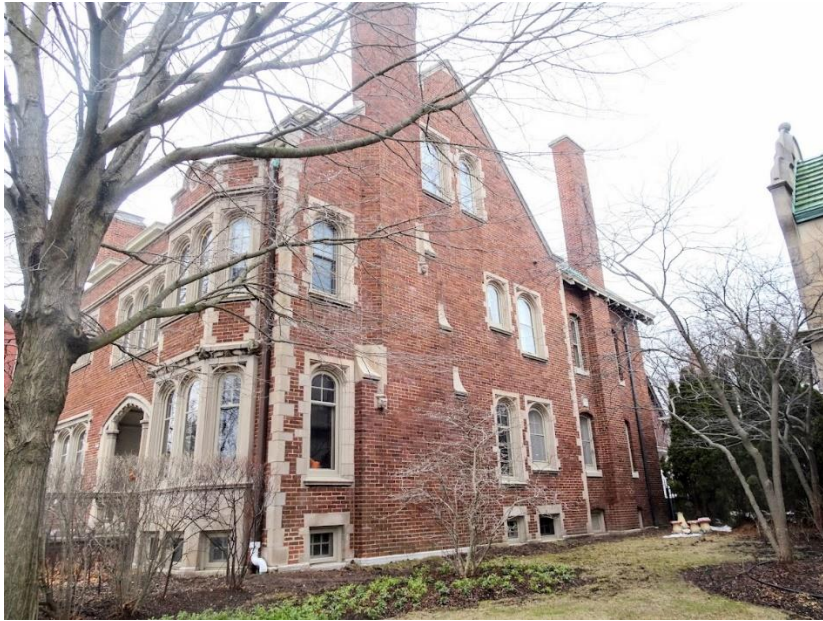
North elevation gutter and downspout to be replaced

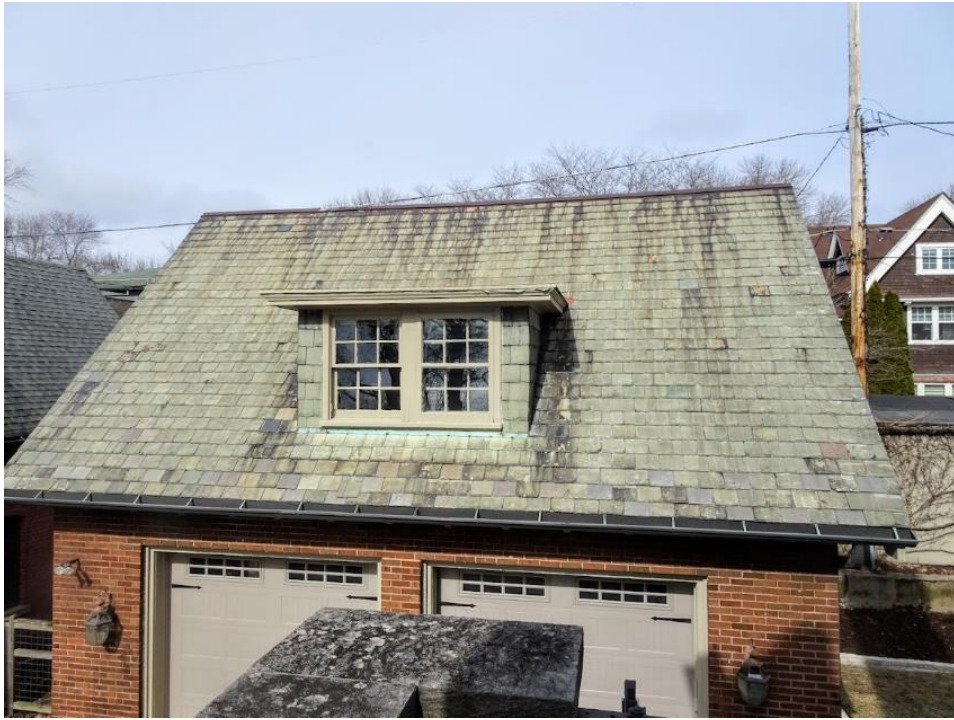
Rusted tin flashing to be replaced with new 20 ounce ridge.
