LIVING WITH HISTORY

Certificate of Appropriateness

Property	1681 N. PROSPECT AV.
Description of work	<p>The project is replacement of the slate roof and copper gutter system and repair of the exterior bricks and stone masonry.</p> <p>The work is removing the existing slate roof, the gutters and downspouts. The slate will be replaced in kind using dark grey Buckingham slate. Note that the grey slate on the tower is original. The green and grey slate on the rest of the house was installed about 10 years ago and the roof has failed. New and old slate photos are attached. New waterproofing underlayments will be installed.</p> <p>The half round copper gutters will be replaced with half round copper gutters.</p> <p>The tower finial is deteriorated and will be replaced with a brass and copper replica. Ridges, including terminal finials will match the historic. See attached photograph.</p> <p>A low-profile cross snow fence will be installed above the glass bay on the south elevation to prevent snow and ice damage.</p> <p>On the west chimney the mortar joints will be repointed, and the five top courses rebuilt. The southeast chimney will be rebuilt. The existing brick will be reused for a

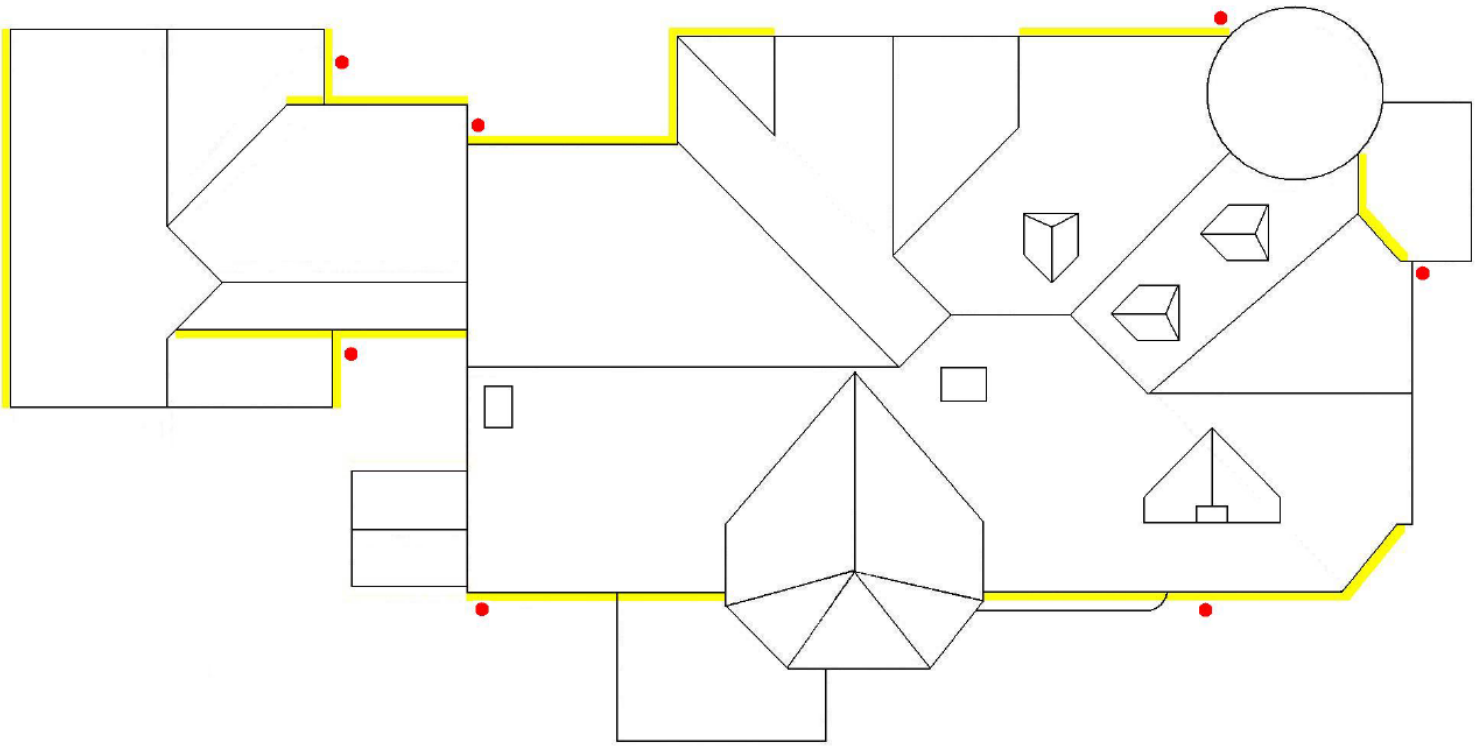
Roof plan with gutters and downspouts. New copper half-round gutters and corrugated copper downspouts will be installed. They will be similar to existing.

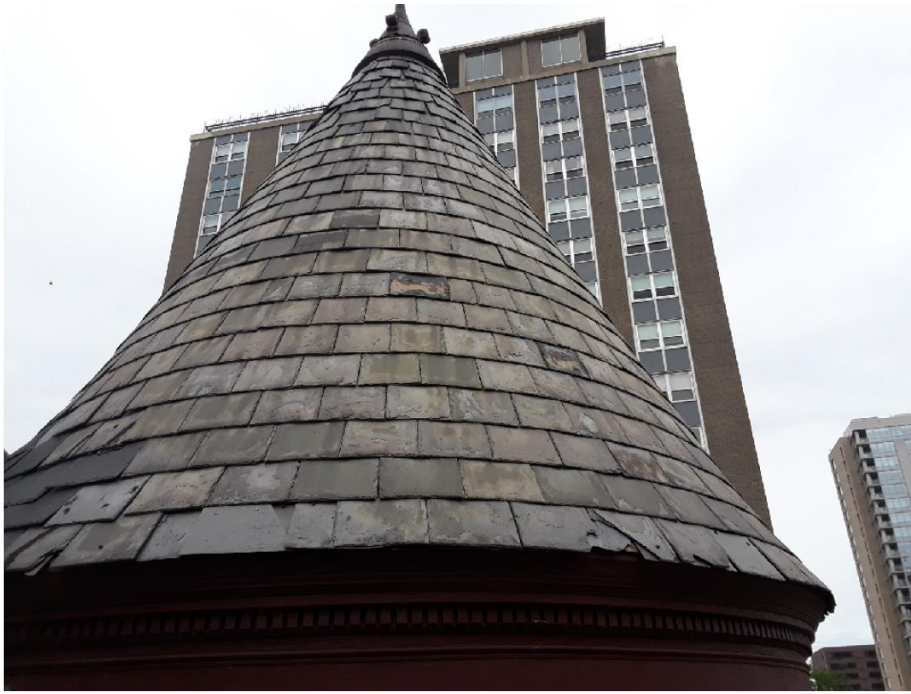
The new slate roof will match the original 1880 roof which is still on the tower. Buckingham Virginia slate will be used.

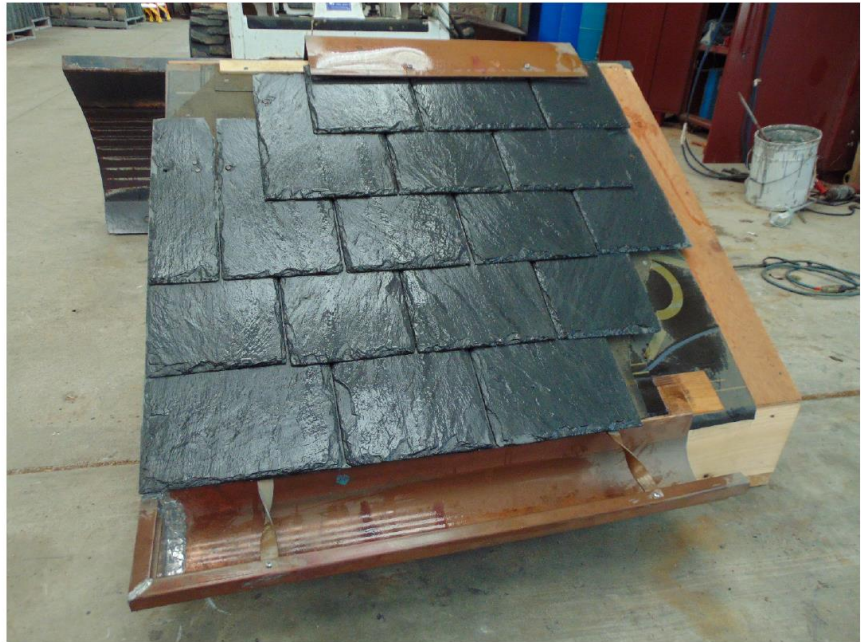
Here is a sample board for the Buckingham slate roof and copper gutter. Other examples of Milwaukee Buckingham slate roofs are: Immanuel Presbyterian, 1100 N. Astor St. Gesu Church, 1145 W. Wisconsin Ave. St. James Episcopal, 833 W. Wisconsin Ave.

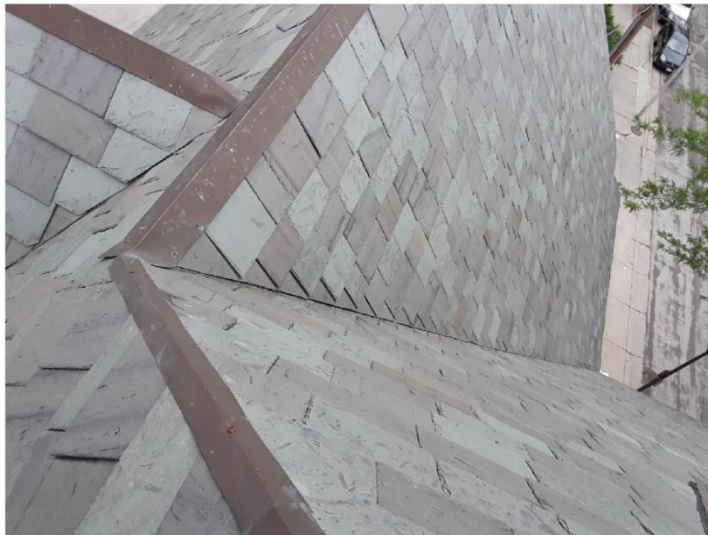
The current slate was installed about 10 years ago and the roof has failed. It is a mix of grey and green slate and not appropriate for this building.

Color is approved based on wet vs. dry sample photos and comparison to the Imanuel Presbyterian roof being used by staff as an example of dry conditions.

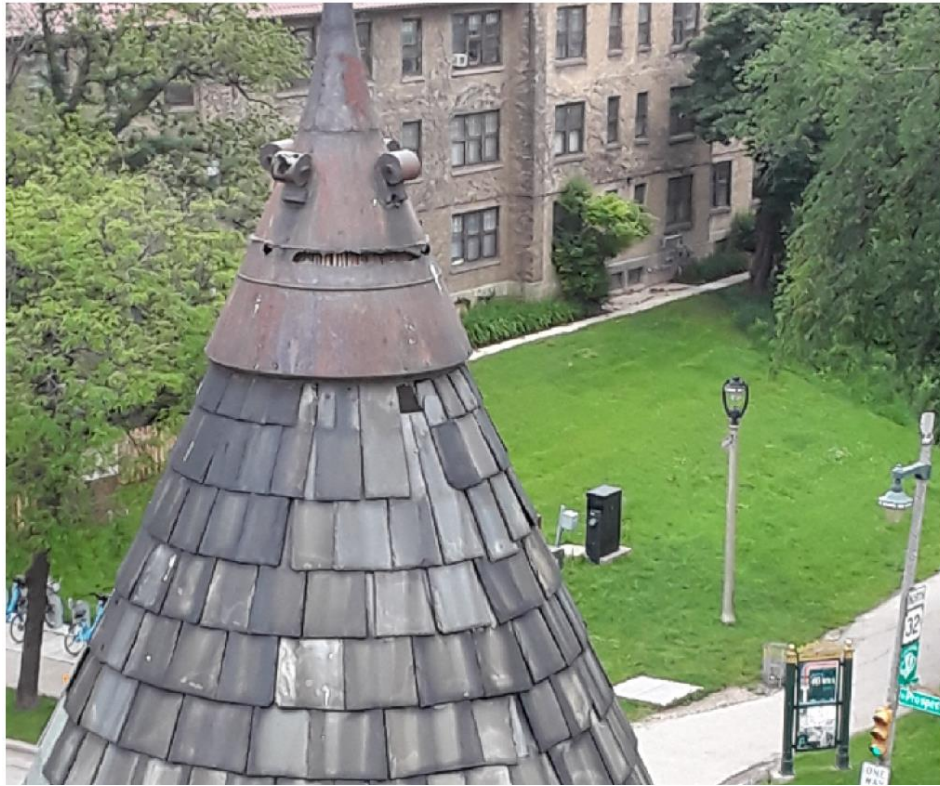
Damaged finial will be replicated exactly in new cuprous material.
