## **Project Description**

### **Roman Brodesser / Samuel & Mary Jo Radcliffe House 2912 East Bellevue Place, Milwaukee, WI 53211**

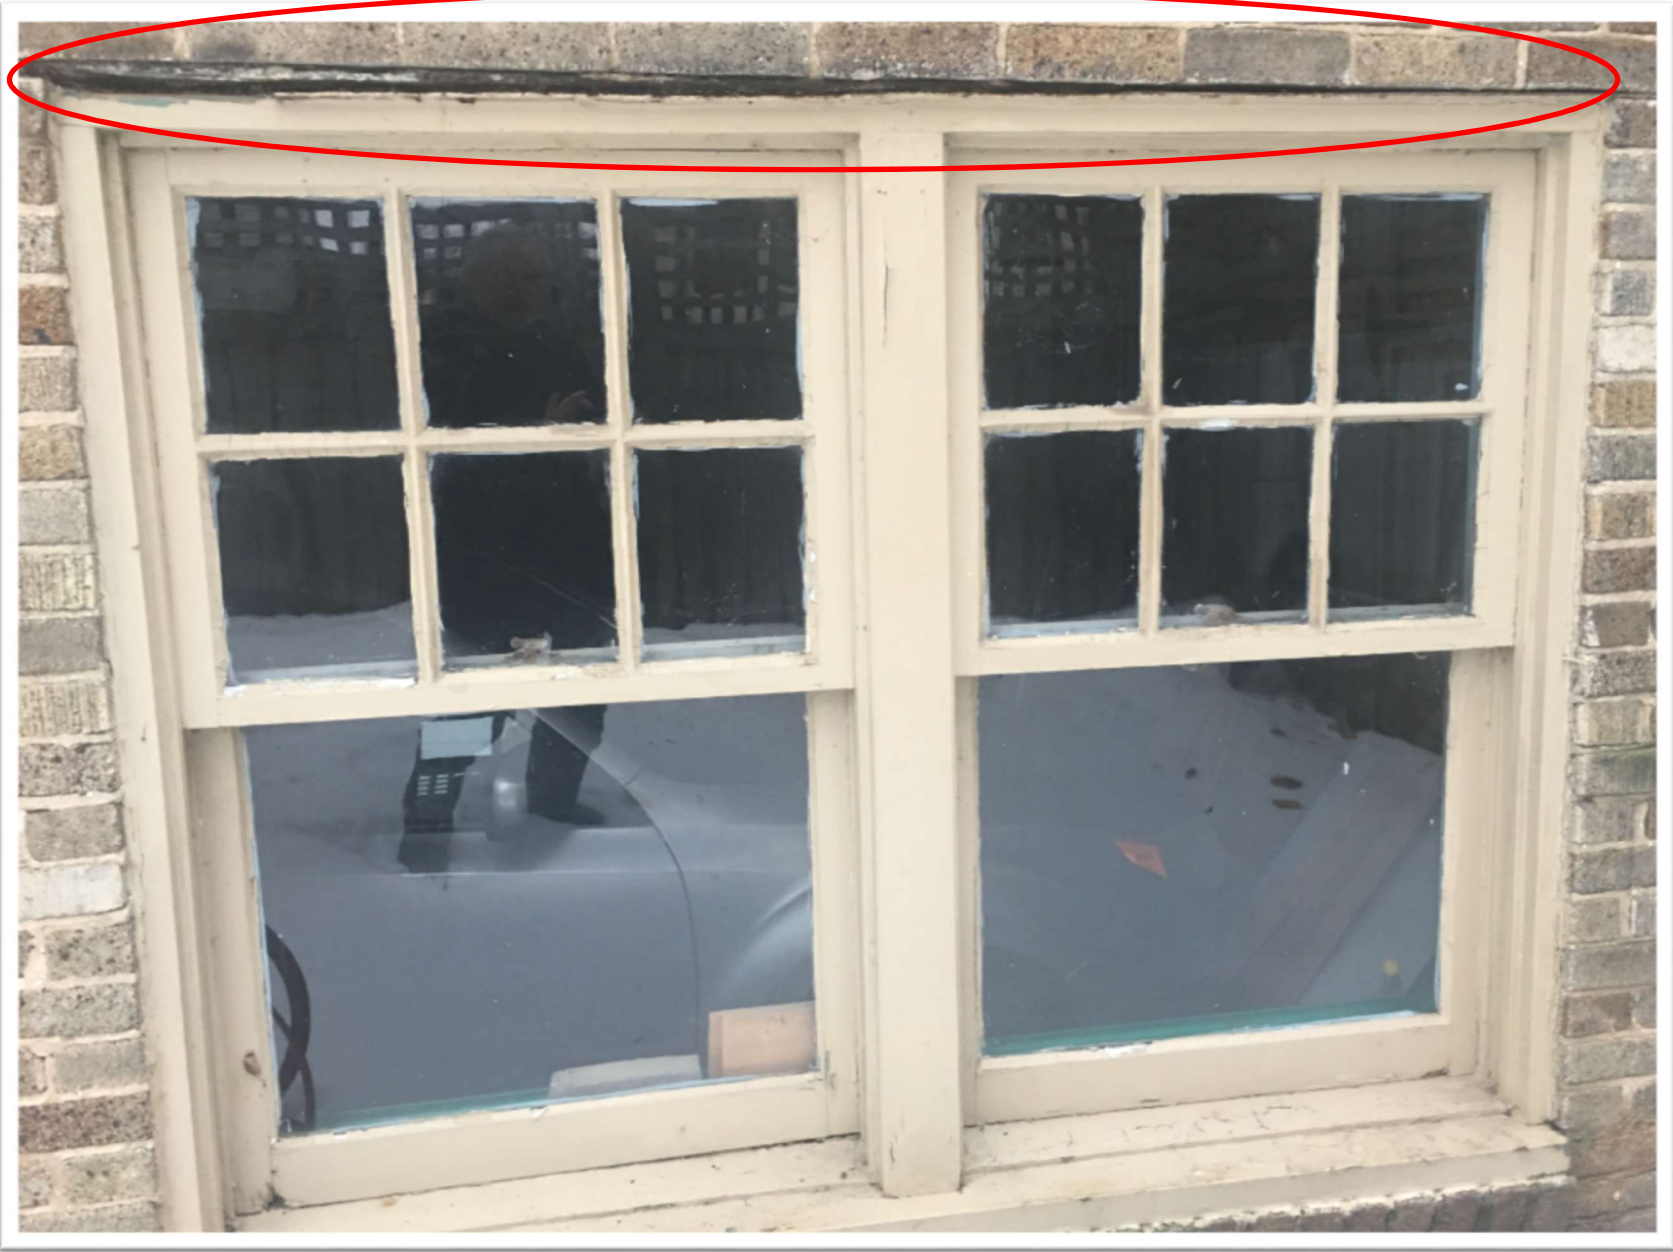
- ▶ Two steel lintels above window bays are rotted and will be replaced.
- ▶ Any requisite tuckpointing will match the existing mortar.
- ▶ The bay on the north elevation is on the first floor over windows in the garage (Figure 1).
- ▶ The bay on the south elevation is on the second floor over windows in the master bedroom (Figure 2).

Figure 1. First floor (garage) lintel to be replaced on north façade.

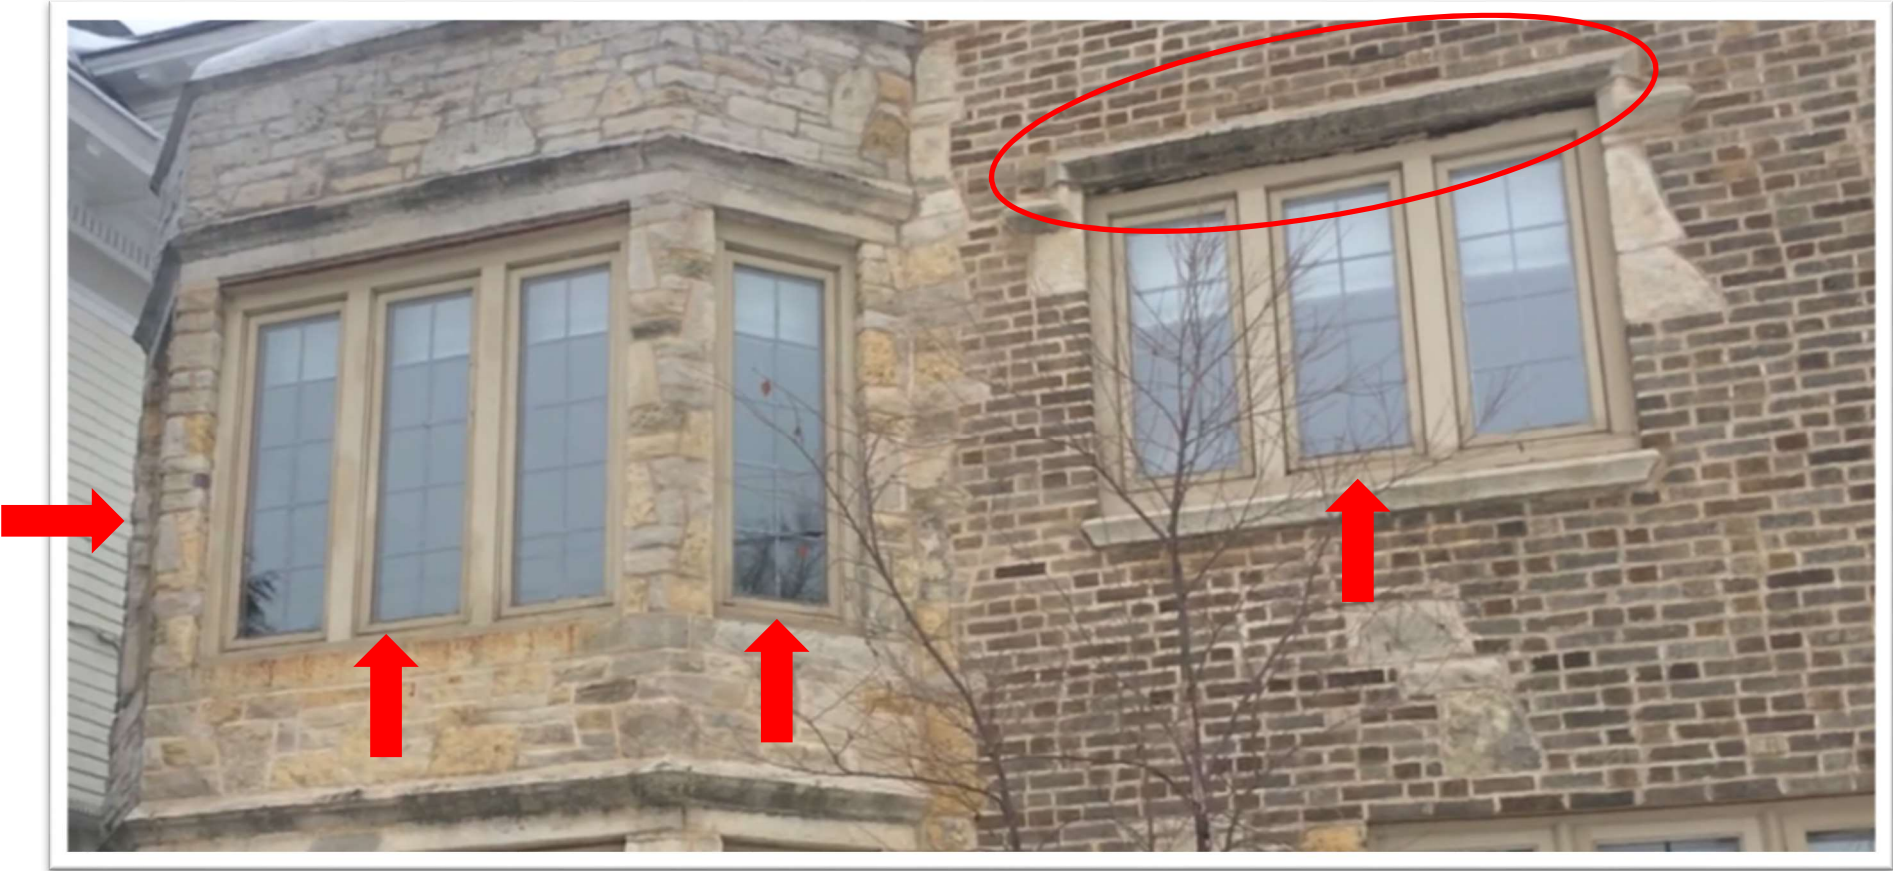
Figure 2. Pella casement windows to be replaced, and lintel to be replaced on south elevation.

- ▶ The non-original Pella casement windows on the second floor south elevation (facing the street) will be replaced with Marvin wood casements with lead overlays; these windows will be leaded the same as the originals (Figure 3).
- ▶ There are two banks of three windows and two single windows (Figure 2).
- ▶ The replacement Marvin windows will be the same models with the same lead overlays as those that were replaced in the kitchen (see Certificate of Appropriateness issued 7/3/2013) (Figure 4).
- ▶ The windows will be purchased from Lisbon Storm & Screen.

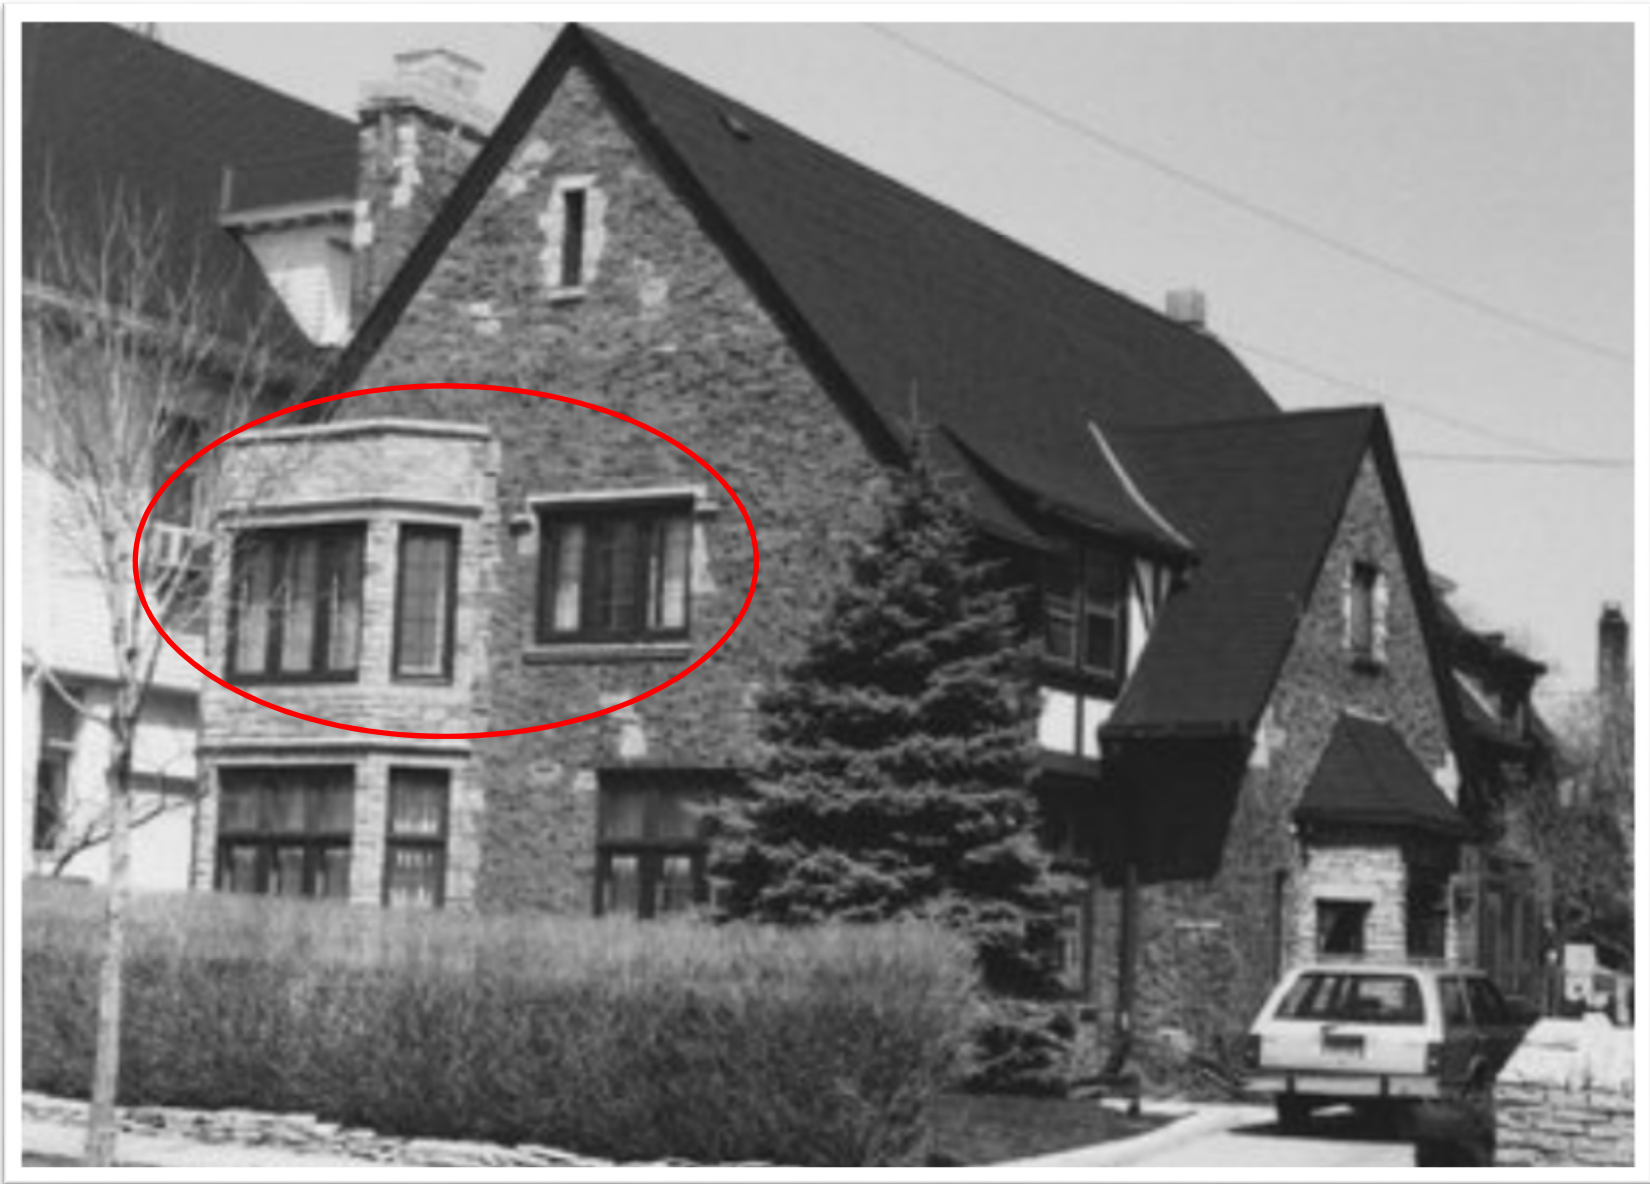
Figure 3. South and east elevations circa 1970's-80's, showing the presumed original windows that were later replaced with Pella casements.

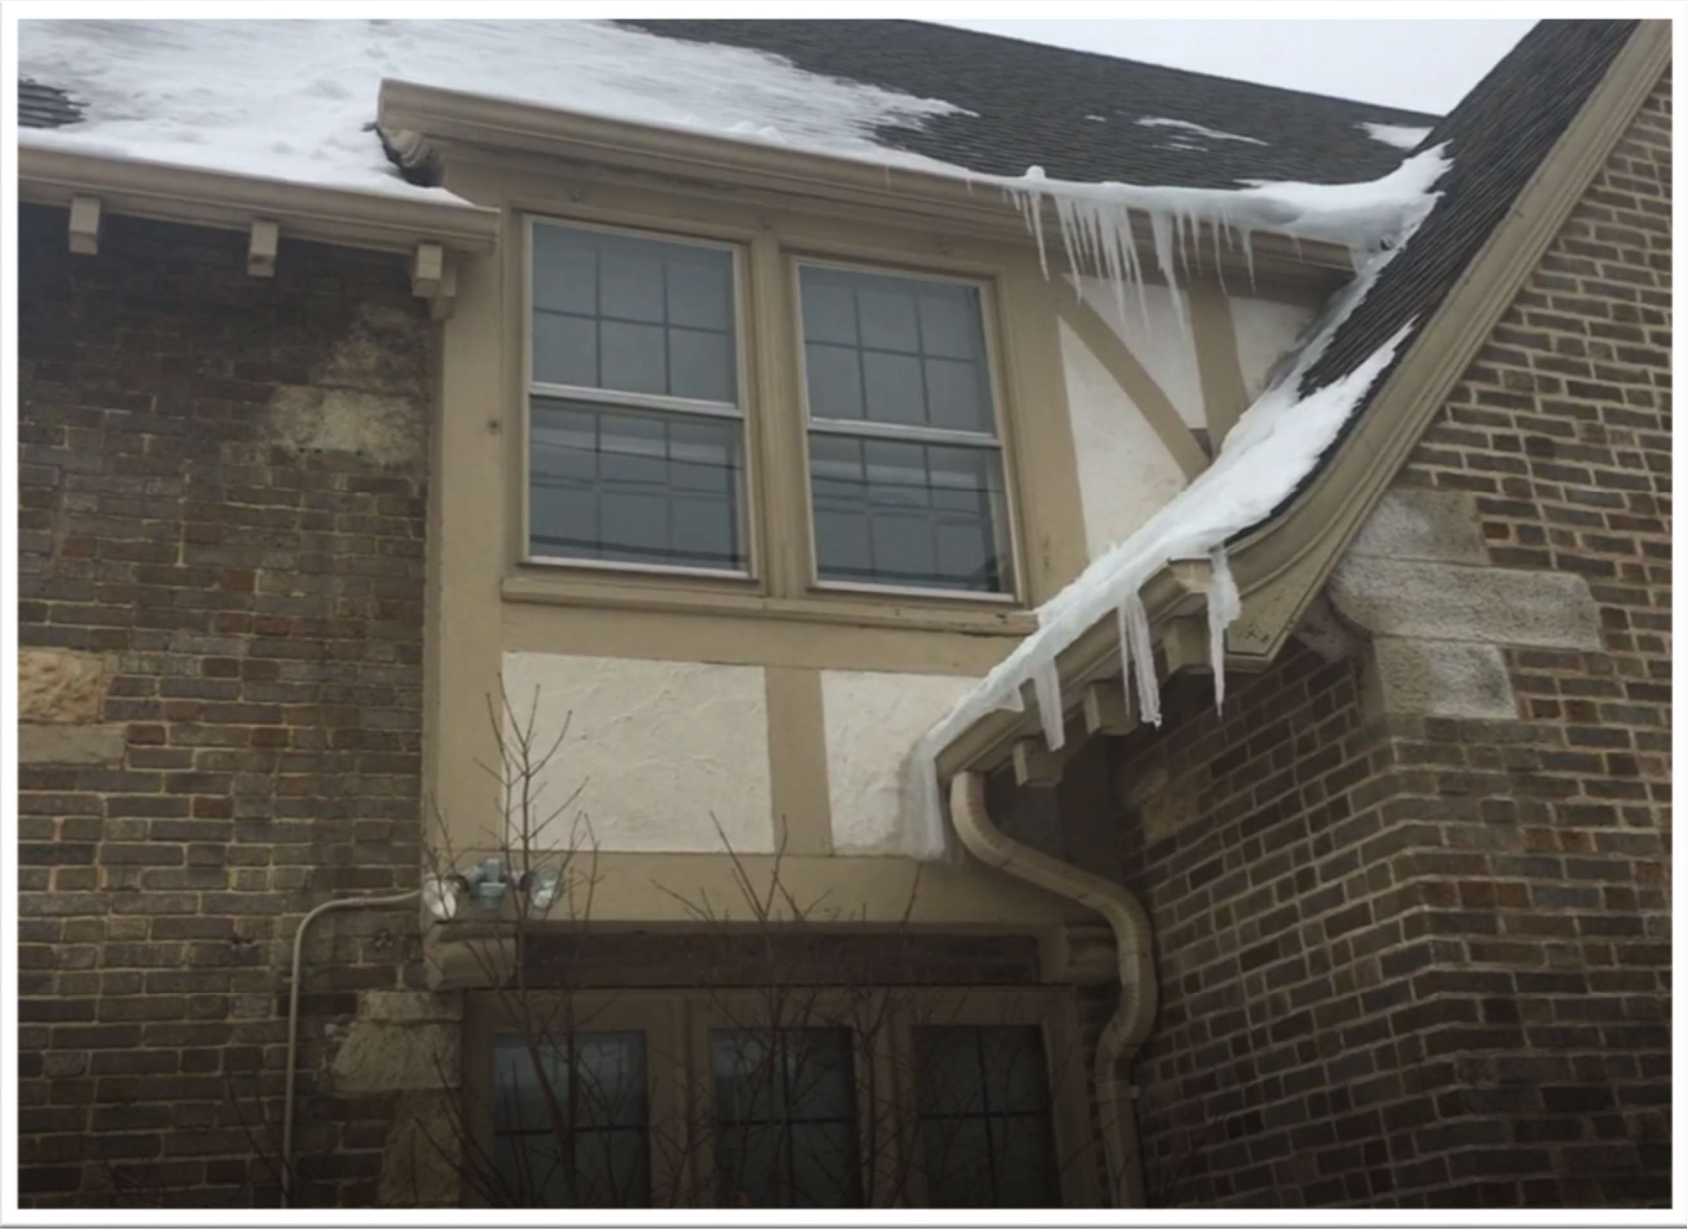
**Figure 6. Some of storm/screen combinations to be replaced on east elevation.**

- ▶ Non-original aluminum storm/screen combinations will be replaced with Marvin Ultimate wood storm/screen combinations (Figure 5).
- ▶ There are 19 second floor combinations and 7 first floor combinations to be replaced. None of the windows with new combinations are street-facing; they are on the north, east and west elevations (Figure 6 through Figure 9).
- ▶ The replacement storm/screens come primed and will be painted to match the rest of the exterior trim (see below).
- ▶ The combinations will be purchased from Lisbon Storm & Screen.

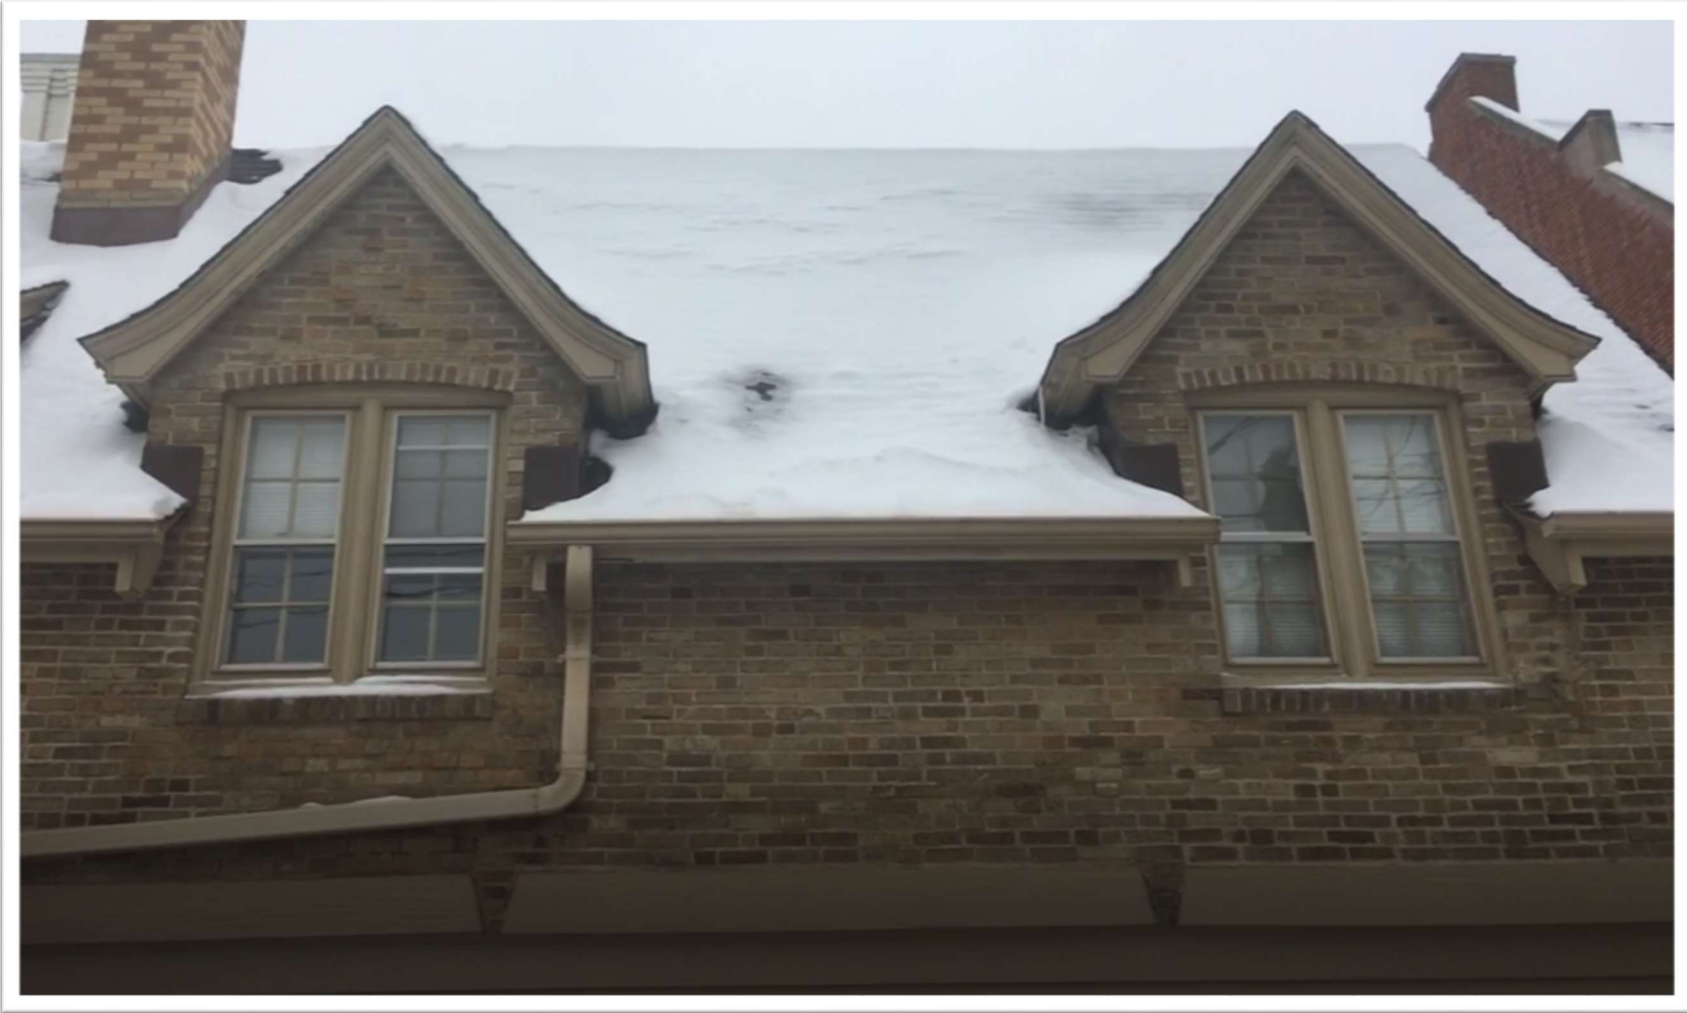
Figure 7. Some of storm/screen combinations to be replaced on east elevation.

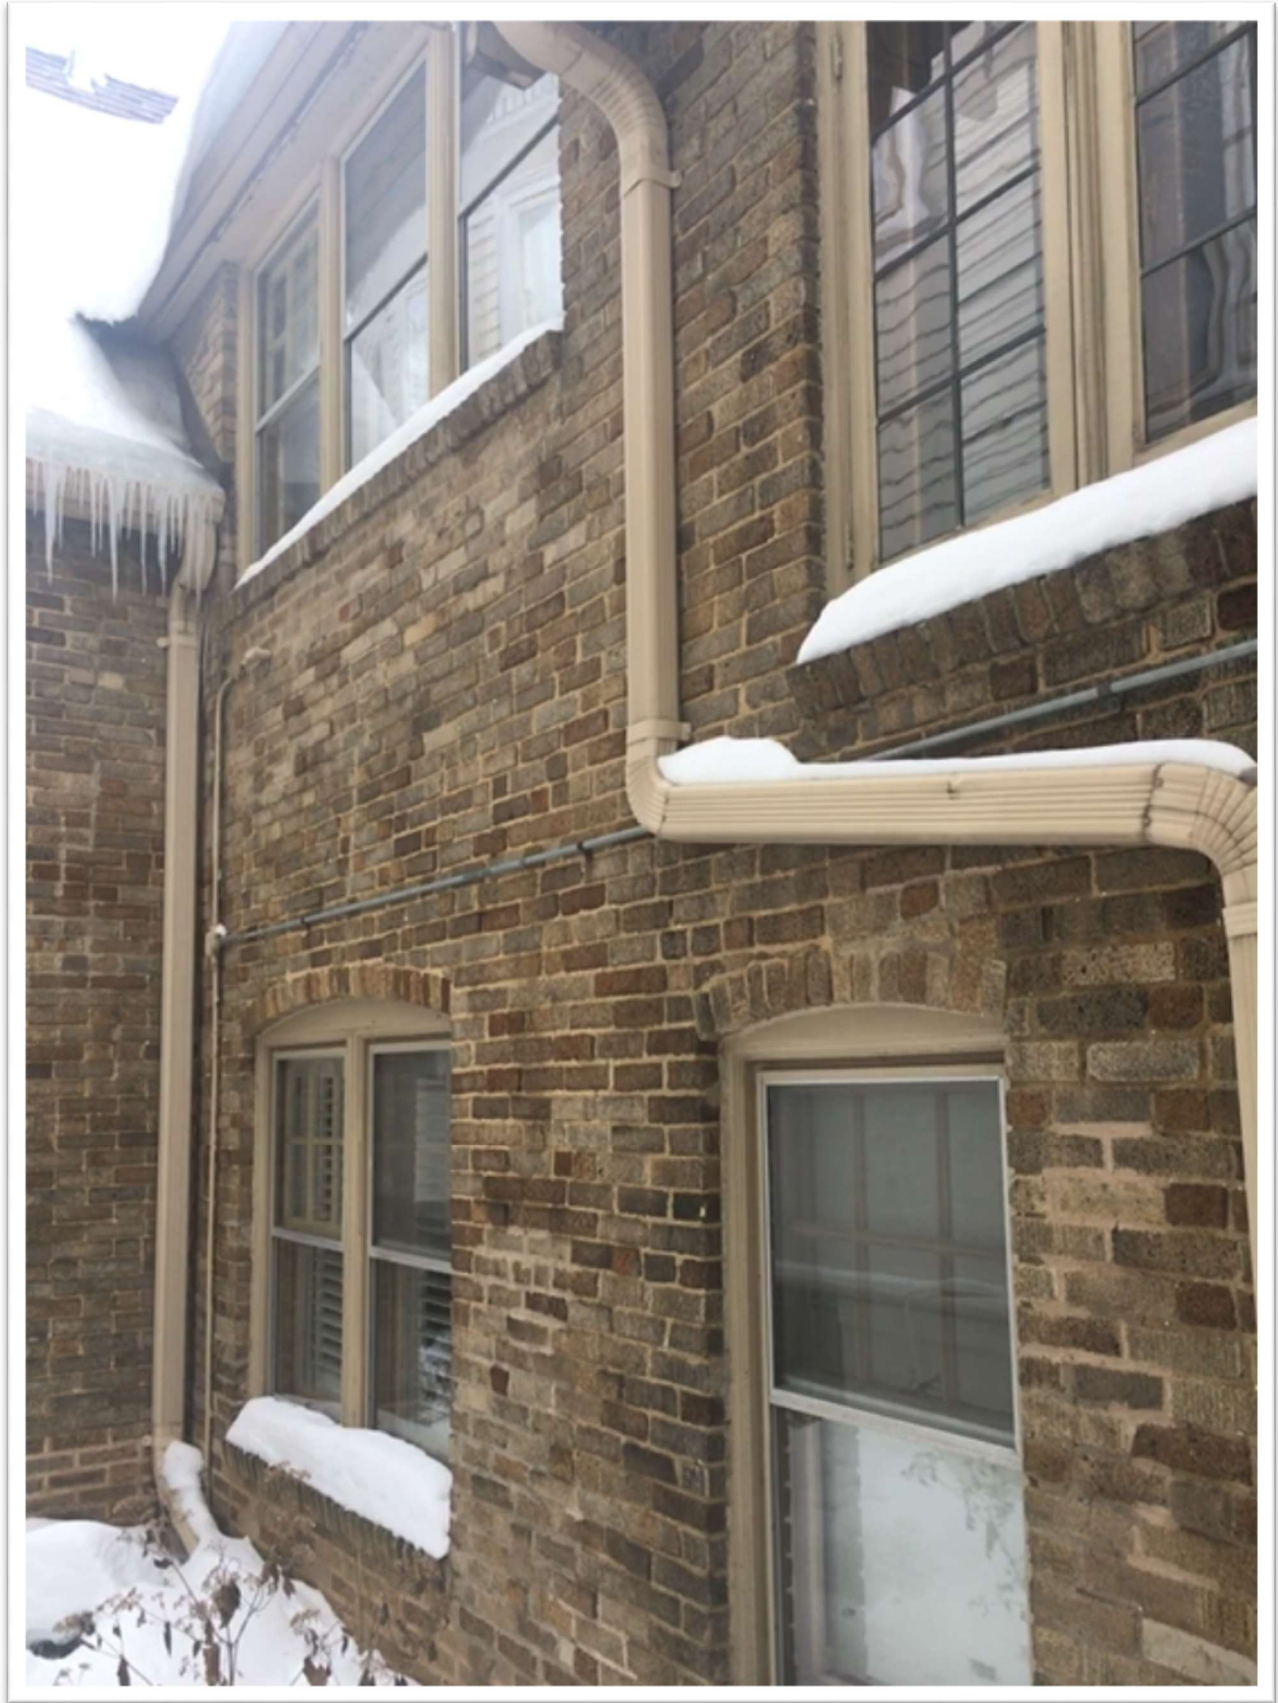
**Figure 8. Some of storm/screen combinations to be replaced on west elevation.**

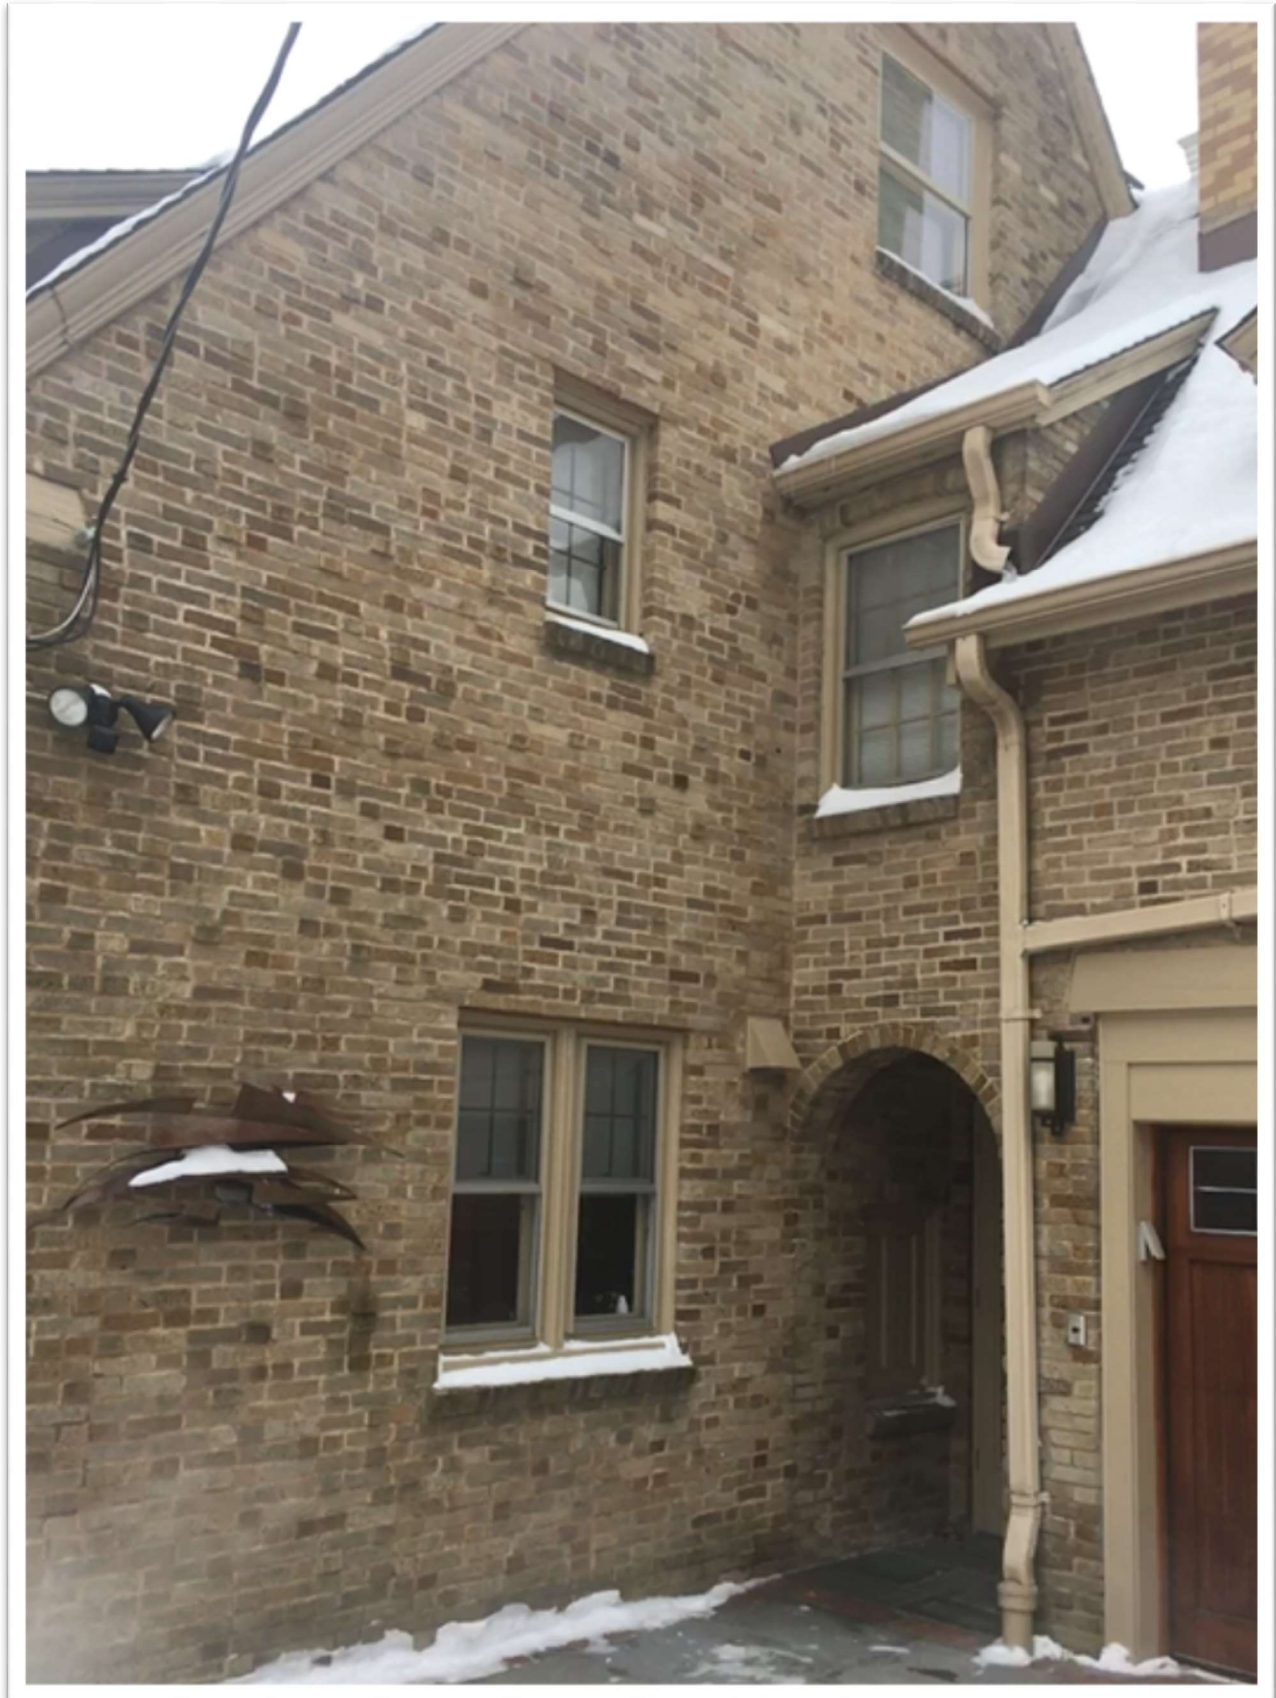
**Figure 9. Some of storm/screen combinations to be replaced on north and east elevations.**
