# Certificate of Appropriateness

<b>Property</b>	2633 - 2651 N. DOWNER AV.      Downer Avenue HD
<b>Description of work</b>	Remove secondary siding from upper half of Park Place elevation (stucco and wood sheet). Repoint underlying masonry. Option to clean underlying masonry (for power washing, 800psi max measured at the nozzle, fan tip held minimum 12" from building face, 400-600psi preferred). Chemical cleaning requires a city permit.  Restore prismastic glass transom with new panes and general repairs to caming.  Other structural work as described on application.
<b>Date issued</b>	9/18/2018      PTS ID 114632 COA: masonry and window repairs

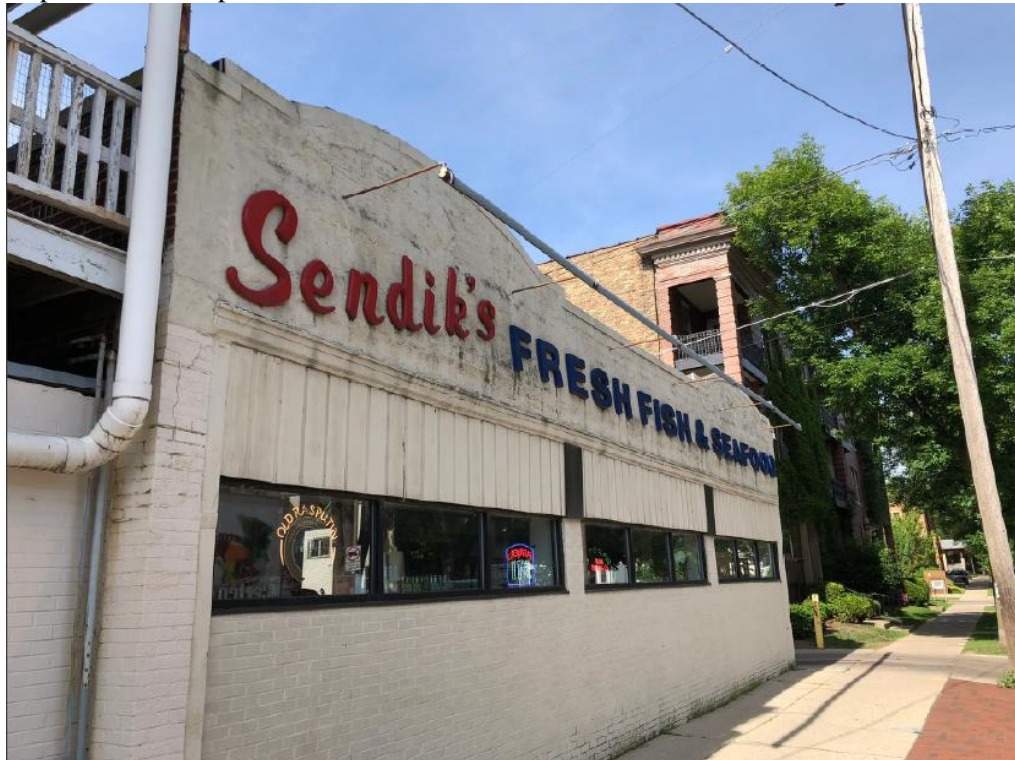
Affected elevation before start of work.

ON THE PARK AVE FACADE: PARAPET ABOVE STOREFRONT  
DETERIORATING / BOWING / STUCCO CRACKING (WATER  
GETTING BEHIND IT)

IN ORDER TO "MAINTAIN" PARAPET: STUCCO ADDED TO 1920'S  
BRICK PARAPET (IN 1980'S) NEEDS TO BE REMOVED AS  
TO NOT TRAP WATER EXPOSING NATIVE DECORATIVE LAYED  
BRICK.

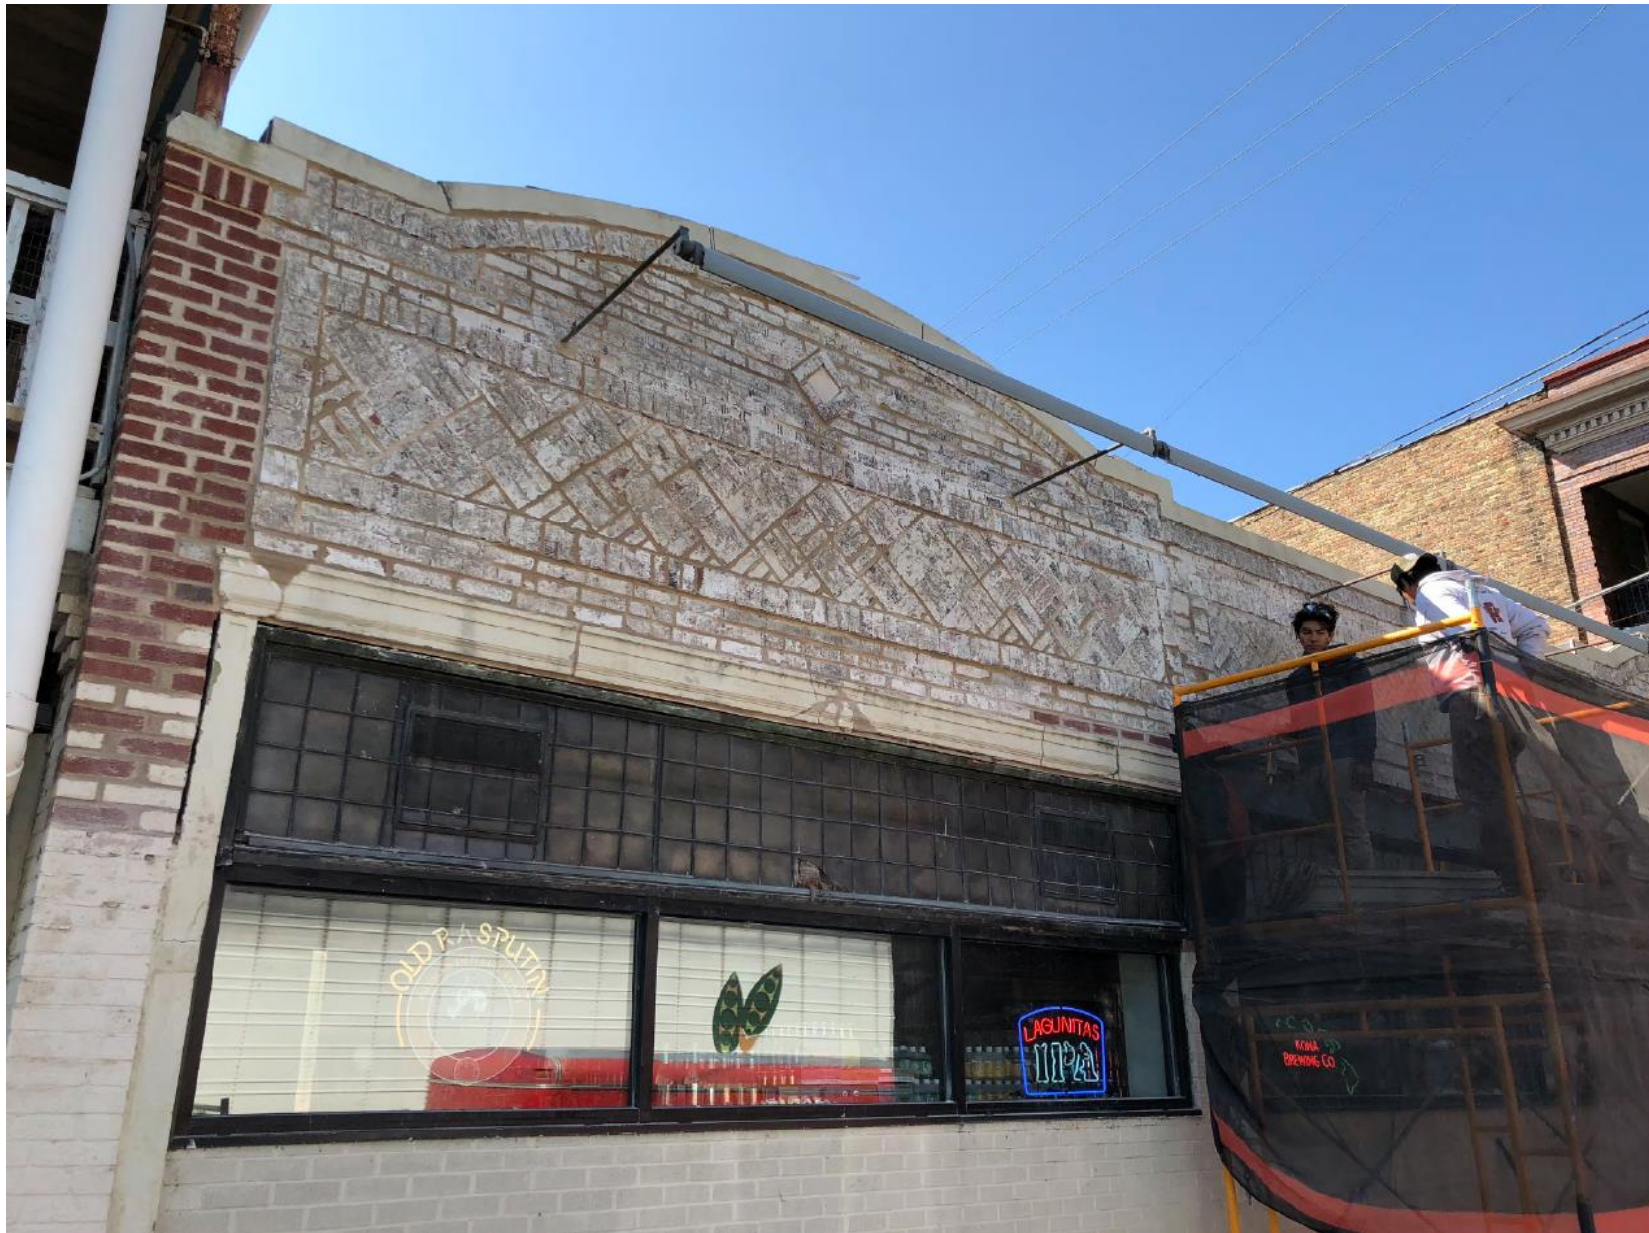
Work in progress showing decorative brick bonding, prismatic glass transom, and structural repairs at lintel and left column

BRICK + STONE "VENGE" LINTEL OVER STOREFRONT (3 COURSES)  
NEEDS TO BE REMOVED TEMPORARILY TO EXPOSE "LEDGE"  
LINTEL (STEEL) TO DETERMINE STRUCTURAL INTEGRITY DUE TO  
"RUST JACKING" BEHIND. ONCE LEDGE LINTEL EXPOSED, VERIFY  
1/4" THICKNESS & STRUCTURAL INTEGRITY OF SUPPORTING BEAM.  
AFTERWARDS, CLEAN LINTEL + LEDGE LINTEL, PRIME RUST INHIBITOR,  
FLASH, RELAY BRICK WITH MATCHING MORTAR. CLEAN BRICK TO  
BEST ABILITY (NON ABRASIVE), (REMOVE POINT IF POSSIBLE)  
TUCK POINT ENTIRE PARAPET TO STOP WATER PENETRATION.  
IN ORDER TO GET TO STONE + BRICK, 1980'S WOOD COVERING REMOVED  
EXPOSED ANTIQUE LEADED GLASS. PLAN TO LEAVE IT AS IS FOR NOW  
AND TRY TO RESTORE IF POSSIBLE.
