Certificate of Appropriateness

Milwaukee Historic Preservation Commission/200 E. Wells Street/Milwaukee, WI 53202/phone 414-286-5712/fax 414-286-3004

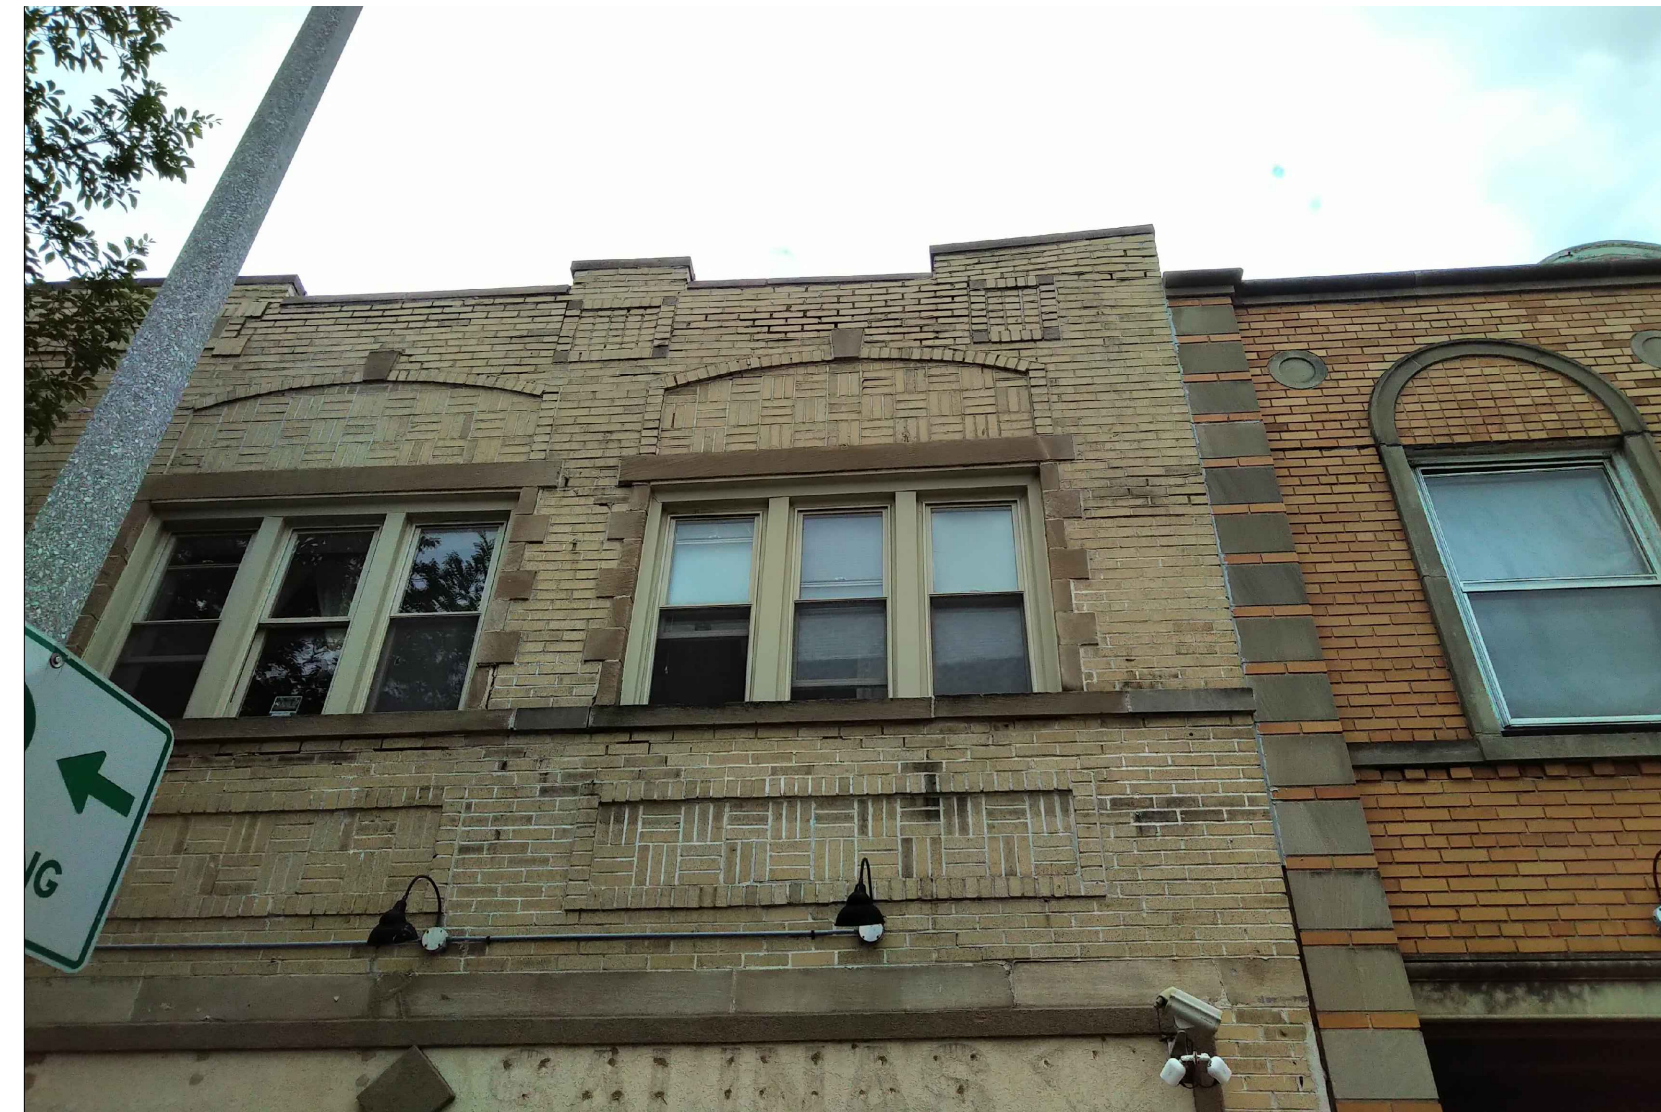
NOTABLE OPEN JOINTS AND MISSING MORTAR; MAJORITY OF BRICK FAILURE IS AT THE LIMESTONE SILL BELOW THE WINDOWS.

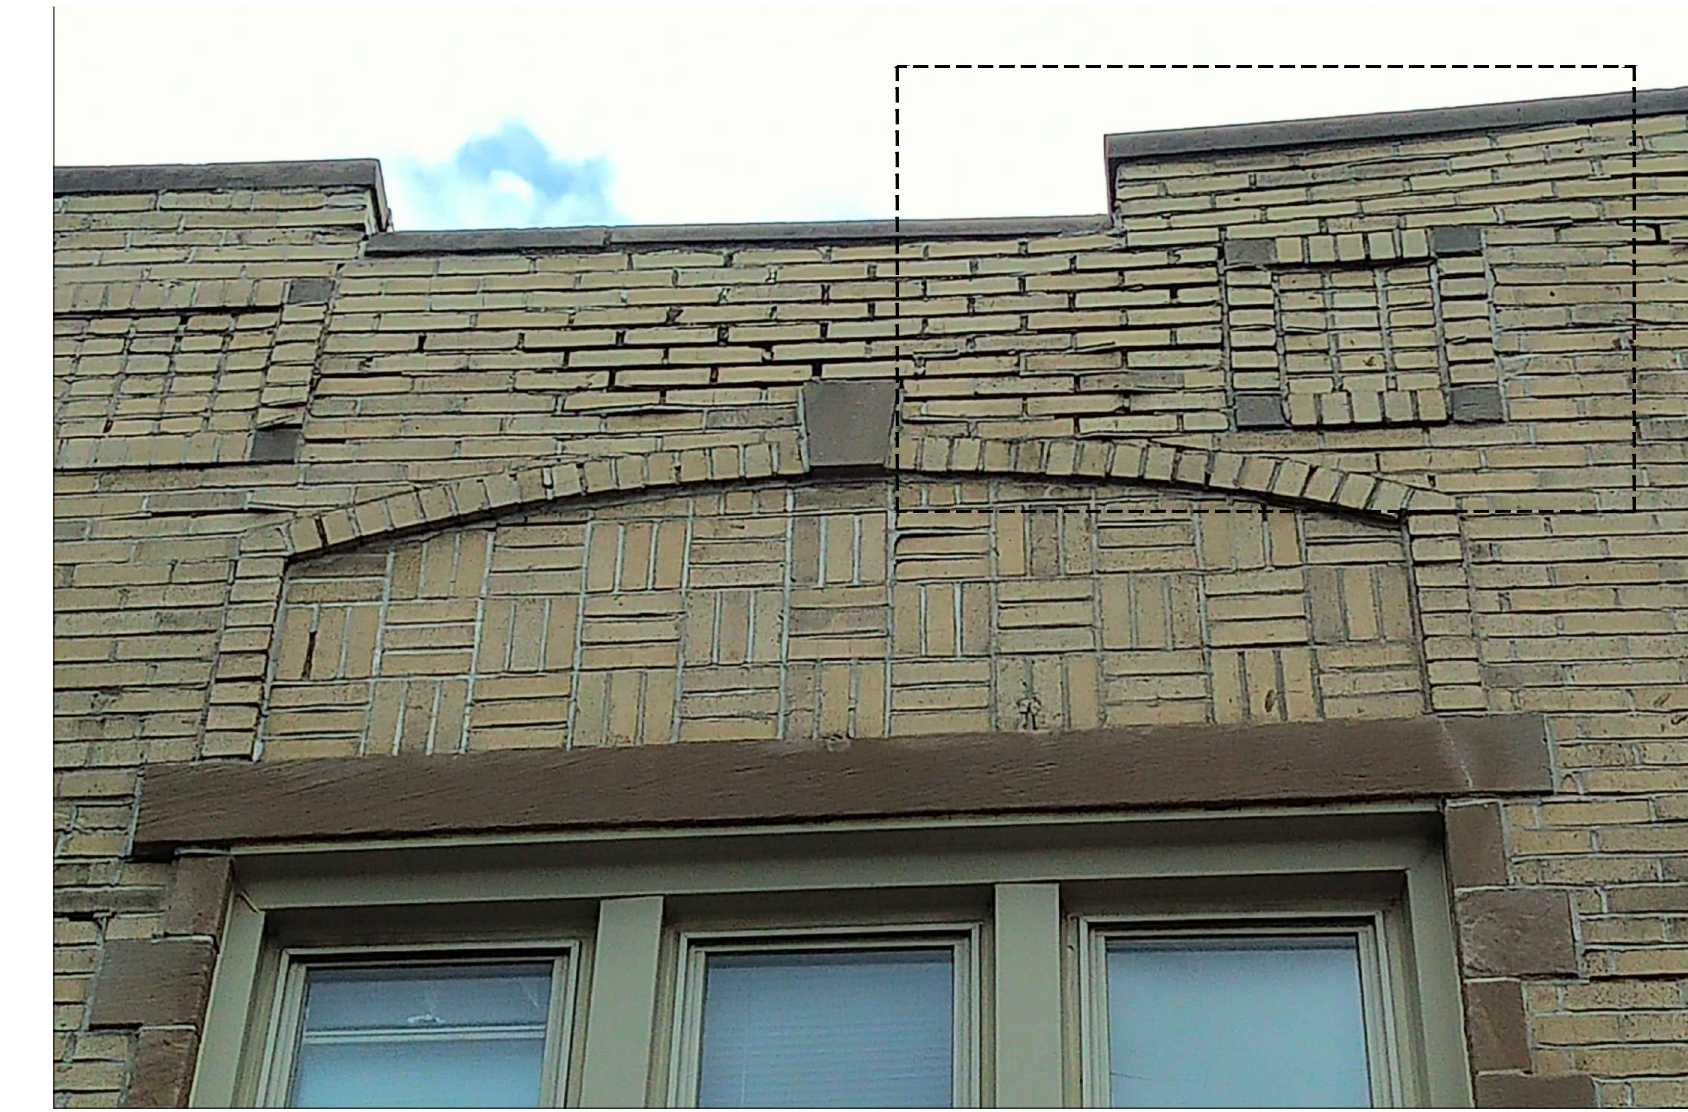
DETAIL ABOVE THE WEST WINDOW - OPEN JOINT AND IMPROPERLY POINTED JOINTS; NOTE THE AREA OF PARAPET MOVEMENT

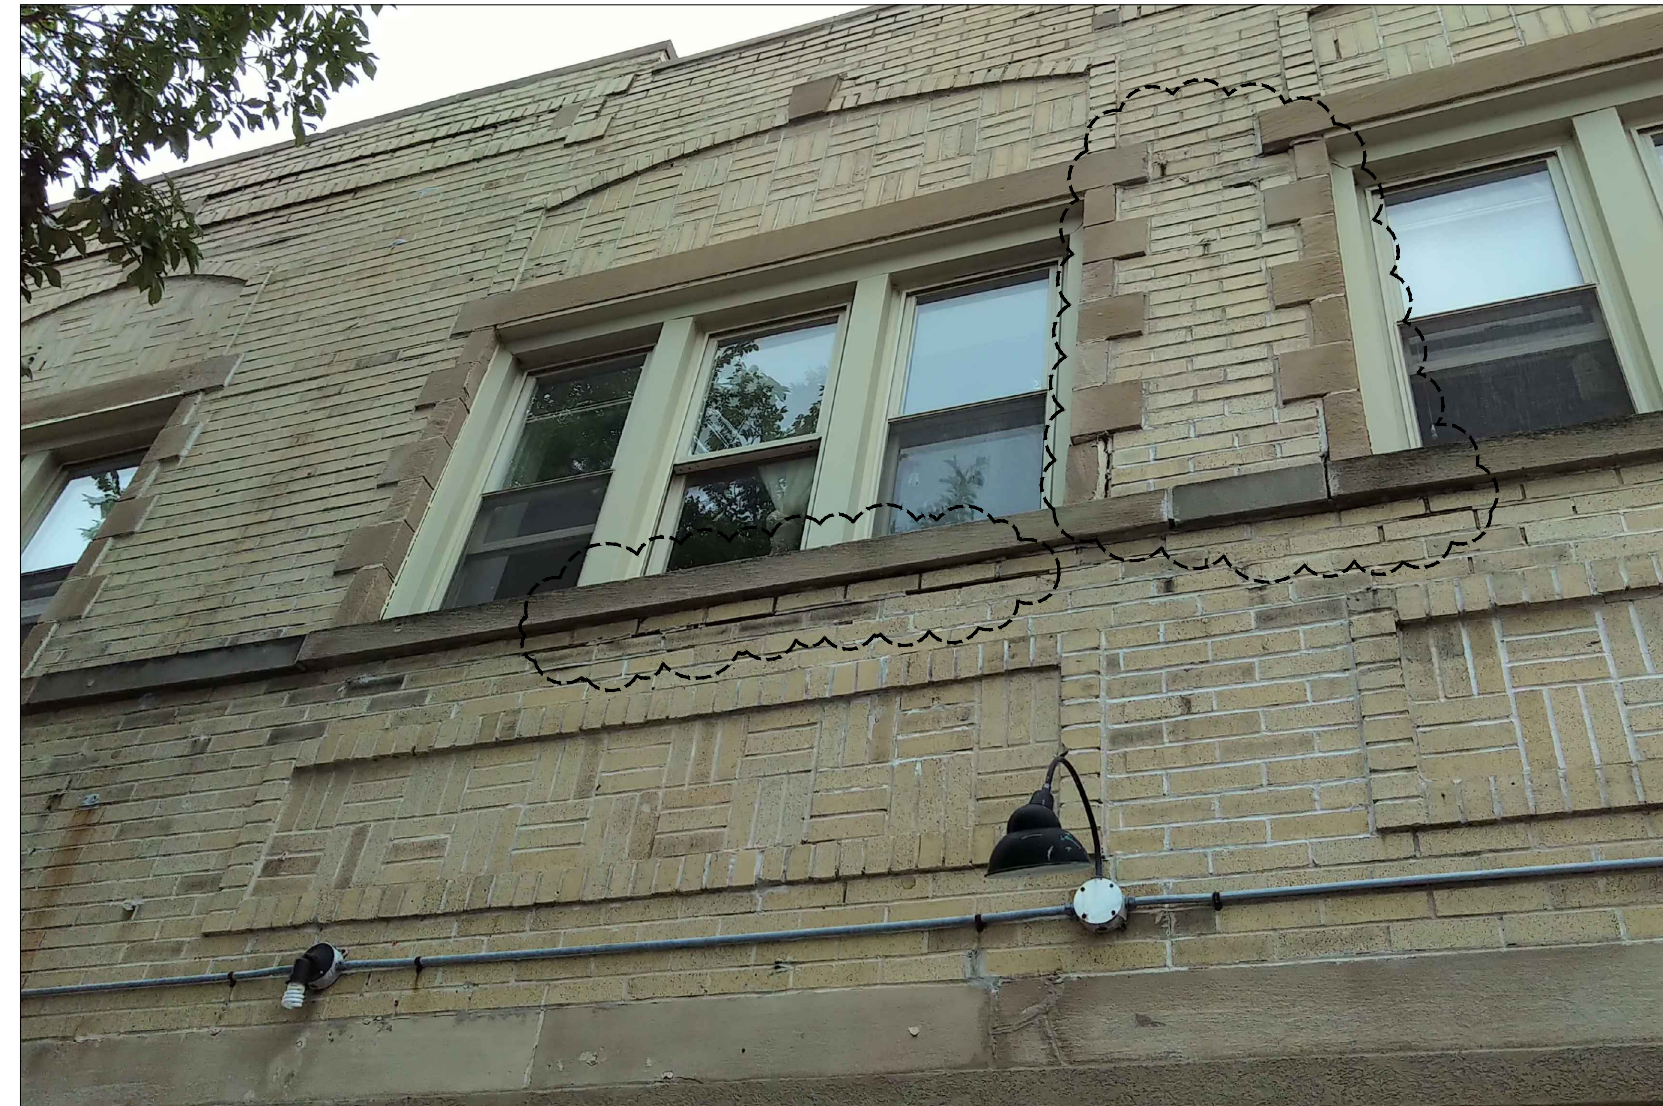
CONSIDERABLE MOVEMENT BETWEEN WINDOWS AND AT THE SILL - MORE OPEN JOINTS

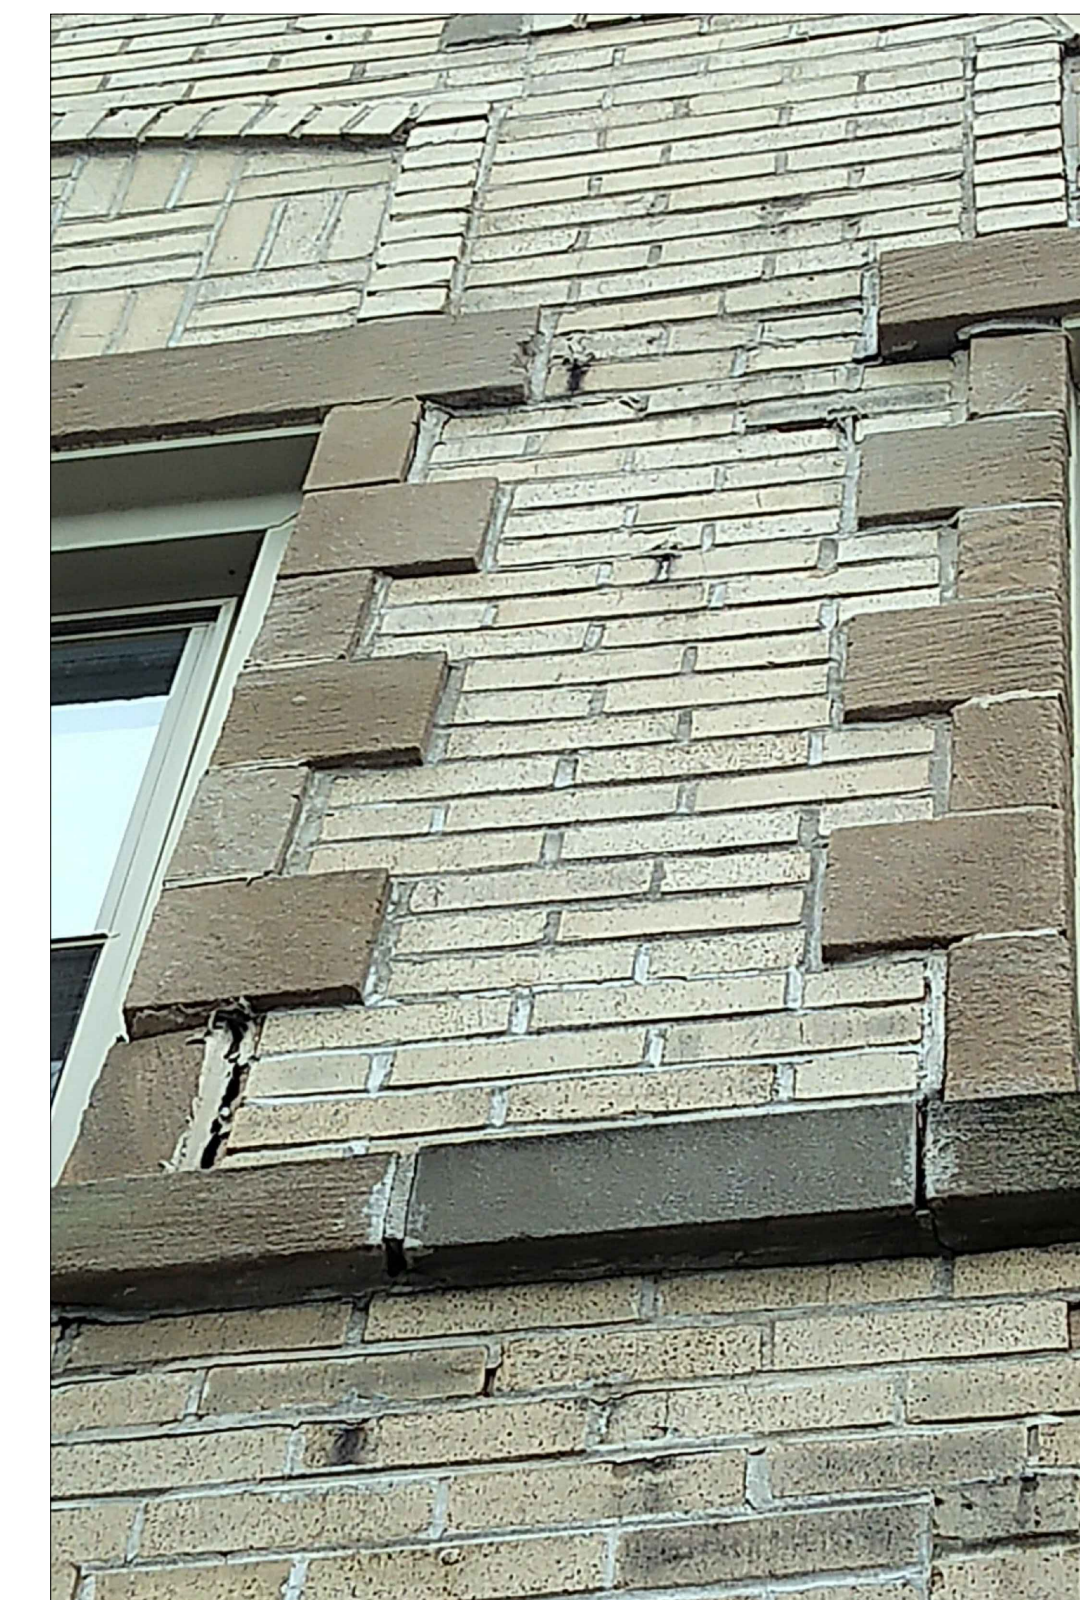
DETAIL OF OPEN JOINTS AND MOVEMENT BETWEEN WINDOWS - POOR ATTEMPTS AT REPAIR
