# Certificate of Appropriateness

### Turner Hall

## **FEMA Grant Safety and Security Project**

Certificate of Appropriateness Application  
Drawings and Photo Exhibits

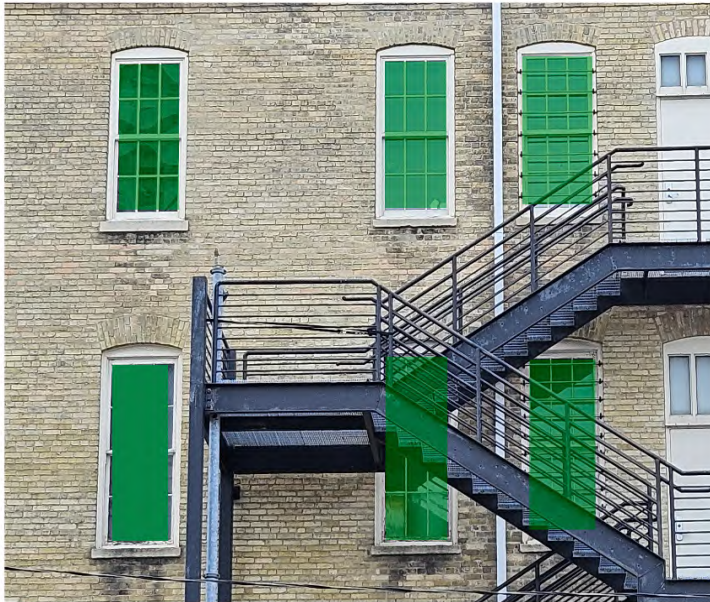
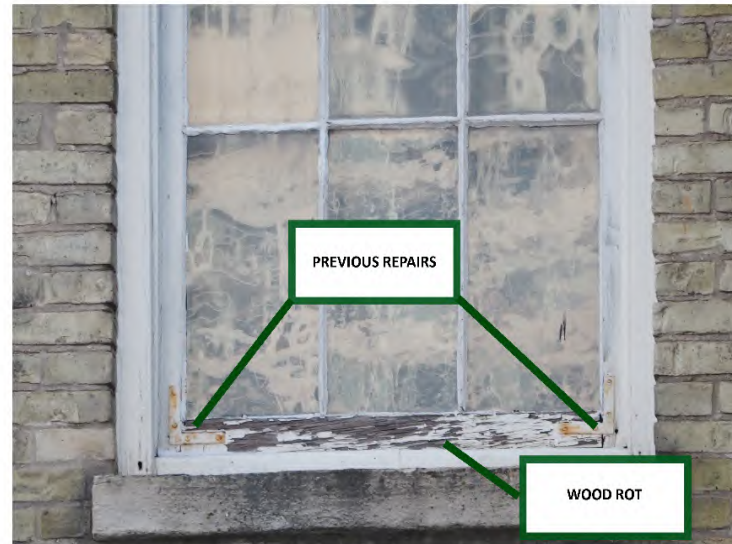
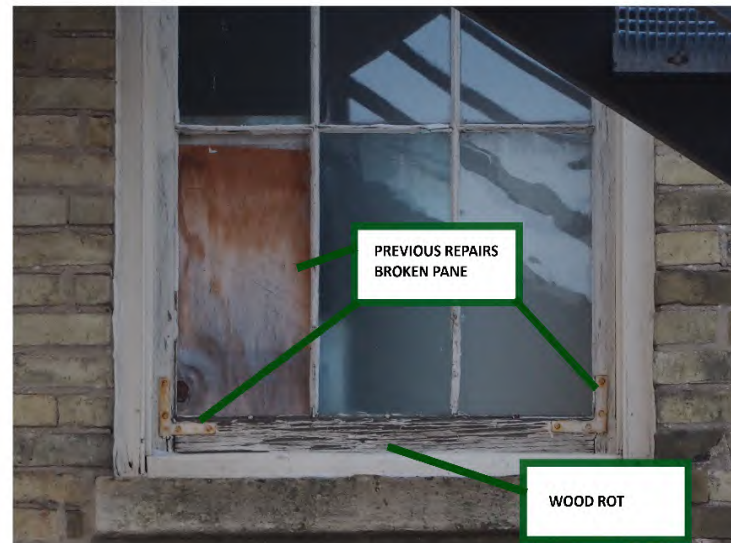
### NORTH ELEVATION - FIRE ESCAPE

-ORIGINAL WOOD WINDOWS AT NORTH FIRE ESCAPE. WEATHERING, WOOD ROT, AND PREVIOUS POOR QUALITY REPAIRS HAVE MADE IT INFEASIBLE TO REPAIR THE WINDOWS

-THE SCOPE OF WORK FOR THIS PROPOSES TO REPLACE THE WINDOWS IN KIND WITH NEW WOOD WINDOWS MATCHING THE ORIGINAL CONFIGURATION AND PROFILE WITH NEW LAMINATED SAFETY GLASS

**3** NEW WOOD WINDOWS REBUILT TO MATCH ORIGINALS. NEW GLAZING TO BE LAMINATED SAFETY GLASS

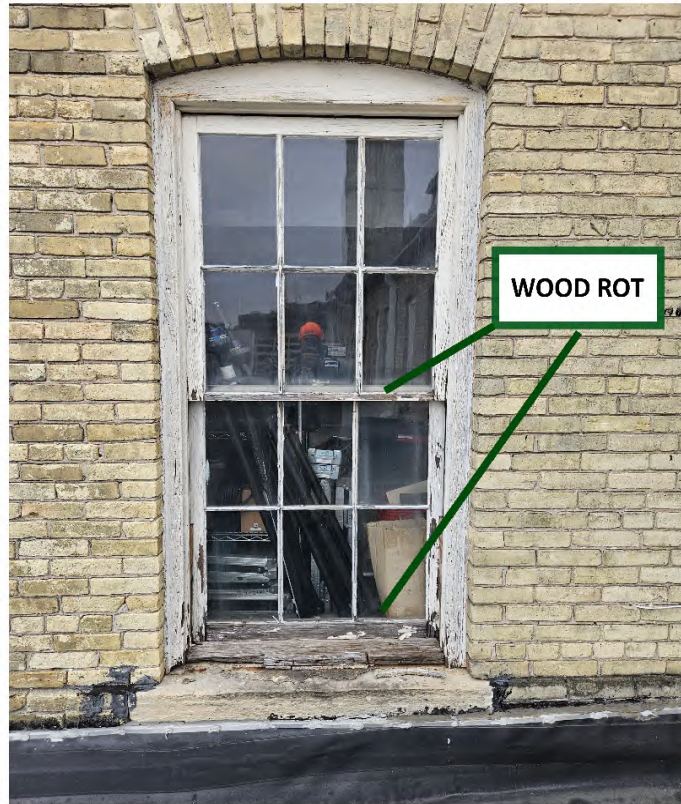
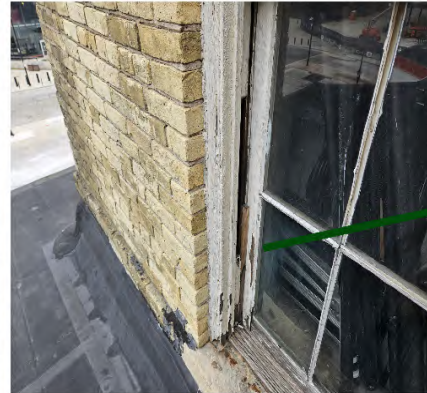
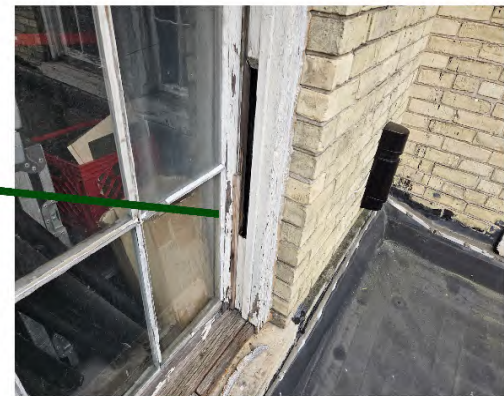
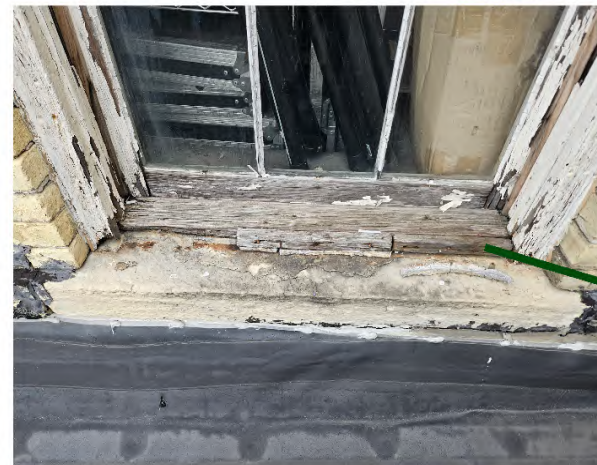
### NORTH ELEVATION - 3RD FLOOR

-ORIGINAL WOOD WINDOWS ON THIRD FLOOR. WEATHERING, WOOD ROT, AND PREVIOUS POOR QUALITY REPAIRS HAVE MADE IT INFEASIBLE TO REPAIR WINDOWS.

-THE SCOPE OF WORK FOR THIS PROPOSES TO REPLACE THE WINDOWS IN KIND WITH NEW WOOD WINDOWS MATCHING THE ORIGINAL CONFIGURATION AND PROFILE WITH NEW LAMINATED SAFETY GLASS

**3** NEW WOOD WINDOWS REBUILT TO MATCH ORIGINALS. NEW GLAZING TO BE LAMINATED SAFETY GLASS

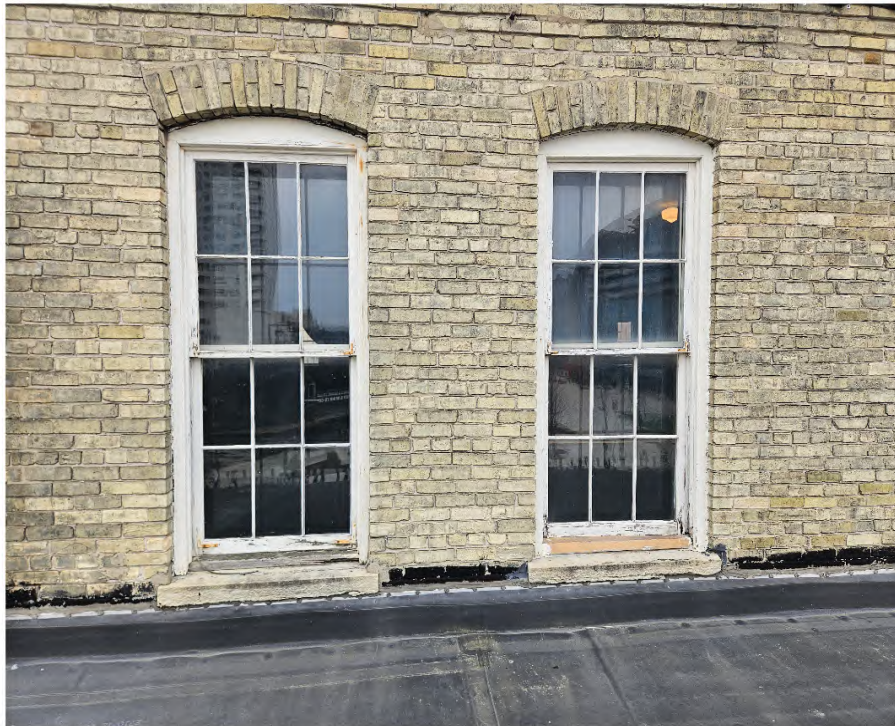
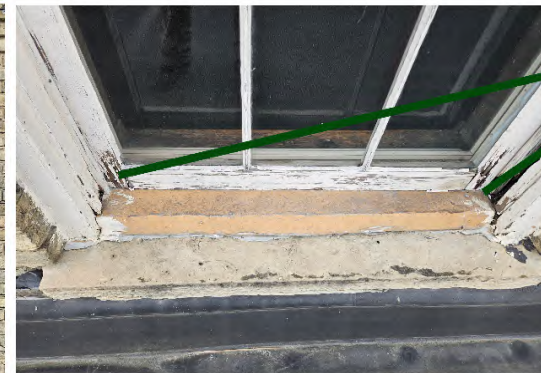
WOOD ROT  
POOR REPAIR

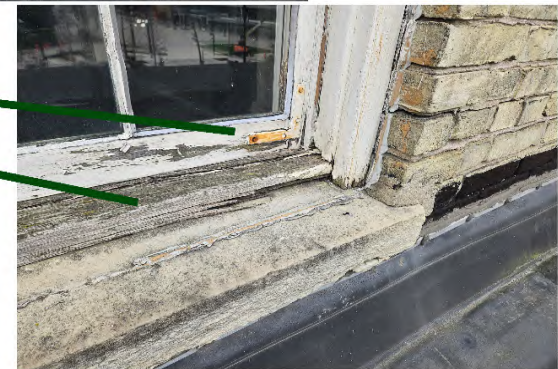
WOOD ROT  
POOR REPAIR

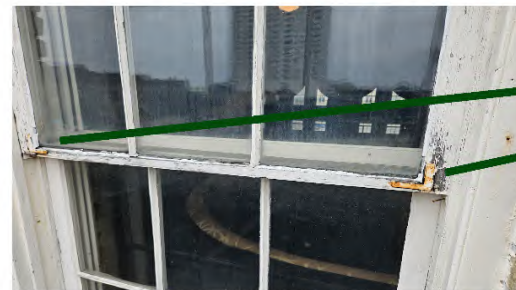
PREVIOUS  
REPAIR

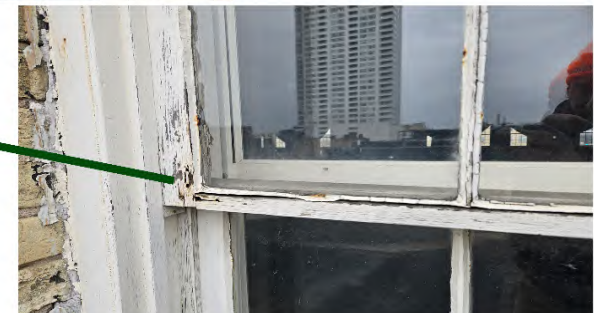
FAILED  
REPAIR

**3** NEW WOOD WINDOWS REBUILT TO MATCH ORIGINALS. NEW GLAZING TO BE LAMINATED SAFETY GLASS

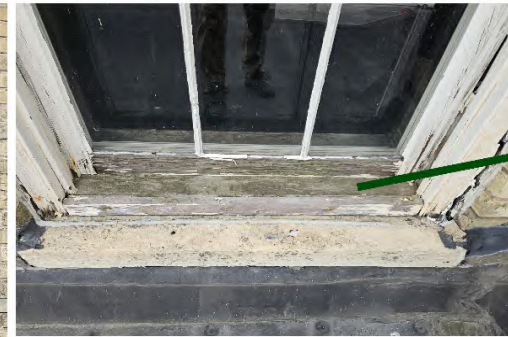
WOOD ROT

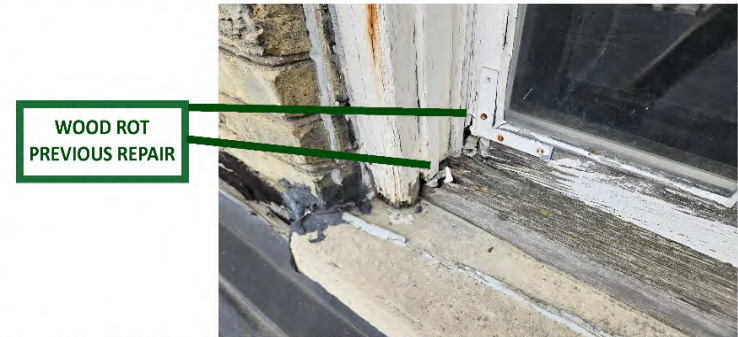
WOOD ROT  
PREVIOUS REPAIR

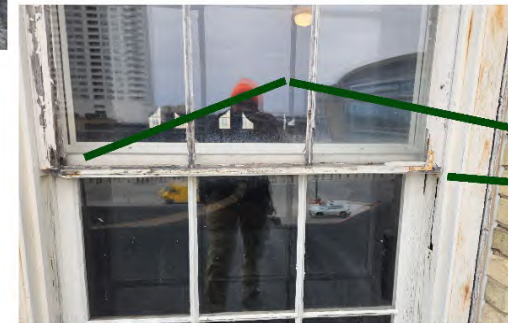
WOOD ROT  
PREVIOUS REPAIR

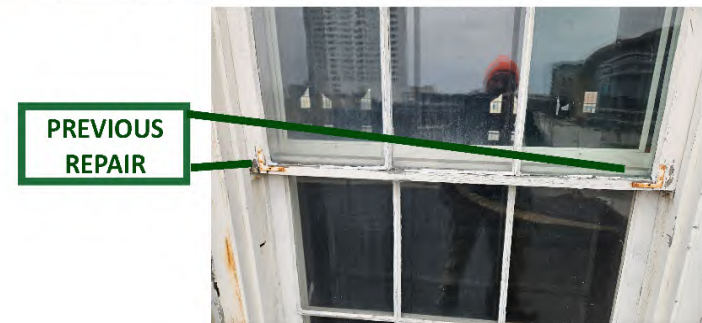
PREVIOUS  
REPAIR

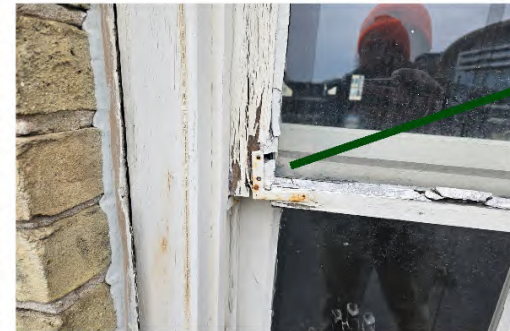
PREVIOUS  
REPAIR

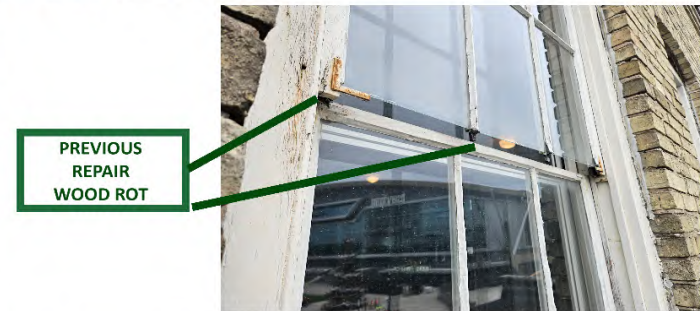
PREVIOUS  
REPAIR  
WOOD ROT

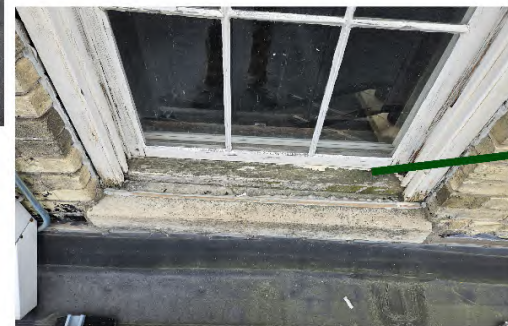
WOOD ROT

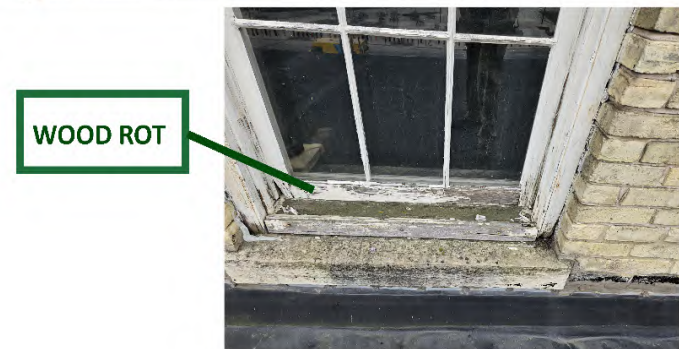
WOOD ROT

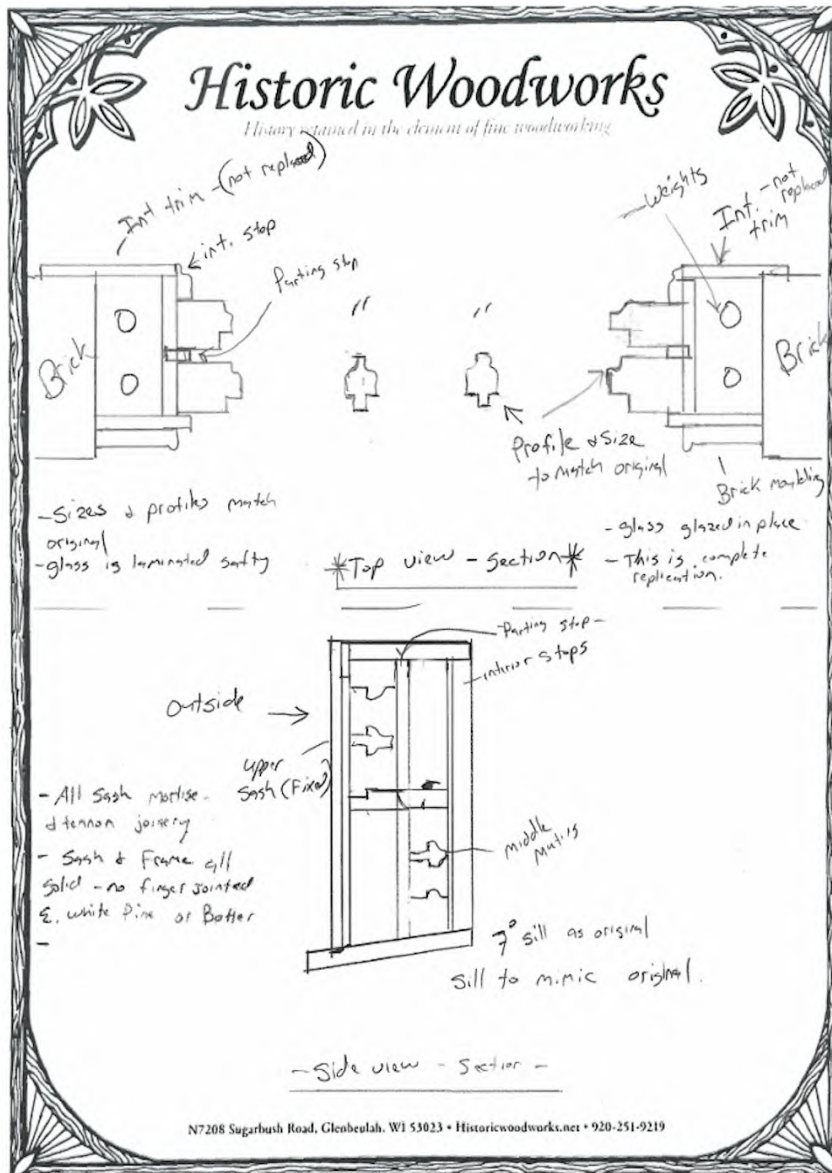
- ASSESSMENT OF WINDOWS DETERMINED THEY ARE NOT SALVAGEABLE
- NEW WINDOWS TO BE BUILT TO MATCH ORIGINALS
- WHITE PINE AND DOUGLAS FIR TO BE USED FOR THE MATERIALS
- REUSE OF EXISTING WINDOW WEIGHTS WHERE POSSIBLE
- NEW PANES TO BE LAMINATED SAFETY GLASS

NEW WOOD WINDOWS REBUILT TO MATCH ORIGINALS. NEW GLAZING TO BE LAMINATED SAFETY GLASS
