Certificate of Appropriateness

Turner Hall

FEMA Grant Safety and Security Project

Certificate of Appropriateness Application
Drawings and Photo Exhibits

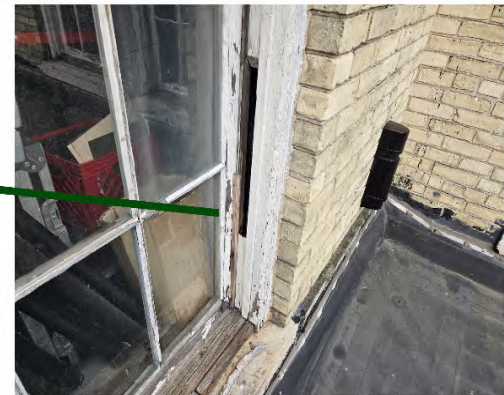
NORTH ELEVATION - 3RD FLOOR

-ORIGINAL WOOD WINDOWS ON THIRD FLOOR. WEATHERING, WOOD ROT, AND PREVIOUS POOR QUALITY REPAIRS HAVE MADE IT INFEASIBLE TO REPAIR WINDOWS.

-THE SCOPE OF WORK FOR THIS PROPOSES TO REPLACE THE WINDOWS IN KIND WITH NEW WOOD WINDOWS MATCHING THE ORIGINAL CONFIGURATION AND PROFILE WITH NEW LAMINATED SAFETY GLASS

3 NEW WOOD WINDOWS REBUILT TO MATCH ORIGINALS. NEW GLAZING TO BE LAMINATED SAFETY GLASS

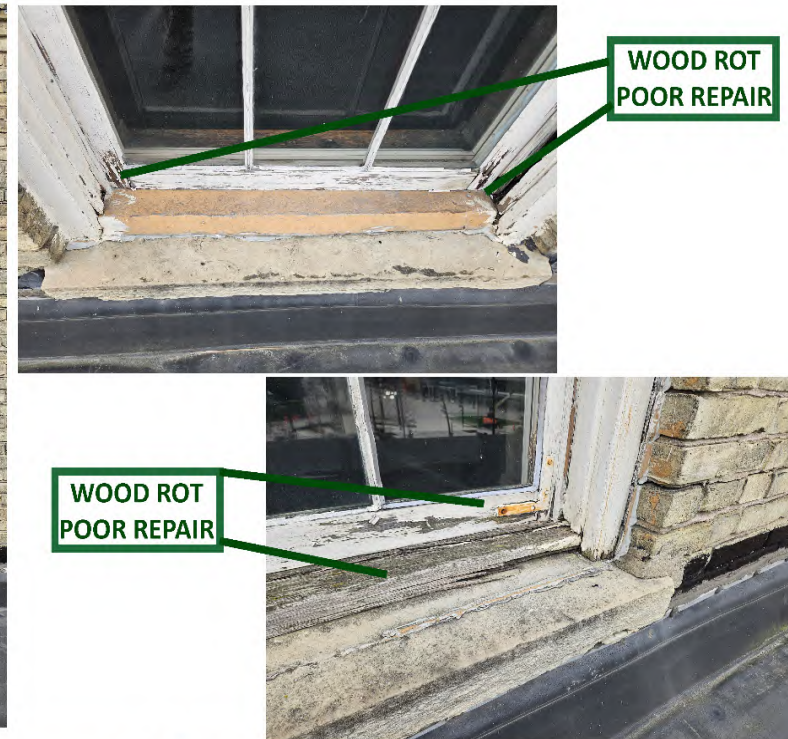
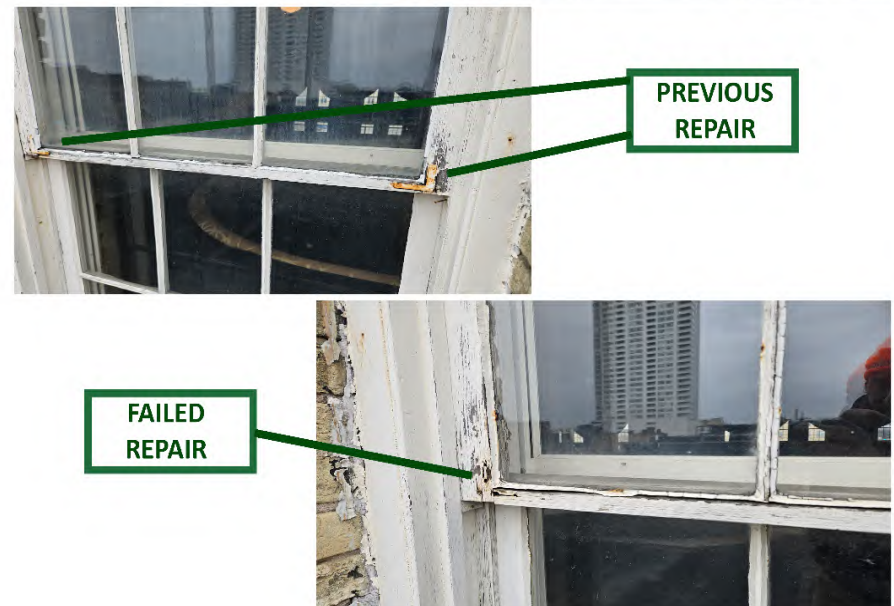
NORTH ELEVATION - 3RD FLOOR

-ORIGINAL WOOD WINDOWS ON THIRD FLOOR. WEATHERING, WOOD ROT, AND PREVIOUS POOR QUALITY REPAIRS HAVE MADE IT INFEASIBLE TO REPAIR WINDOWS.

-THE SCOPE OF WORK FOR THIS PROPOSES TO REPLACE THE WINDOWS IN KIND WITH NEW WOOD WINDOWS MATCHING THE ORIGINAL CONFIGURATION AND PROFILE WITH NEW LAMINATED SAFETY GLASS

- 3 NEW WOOD WINDOWS REBUILT TO MATCH ORIGINALS. NEW GLAZING TO BE LAMINATED SAFETY GLASS

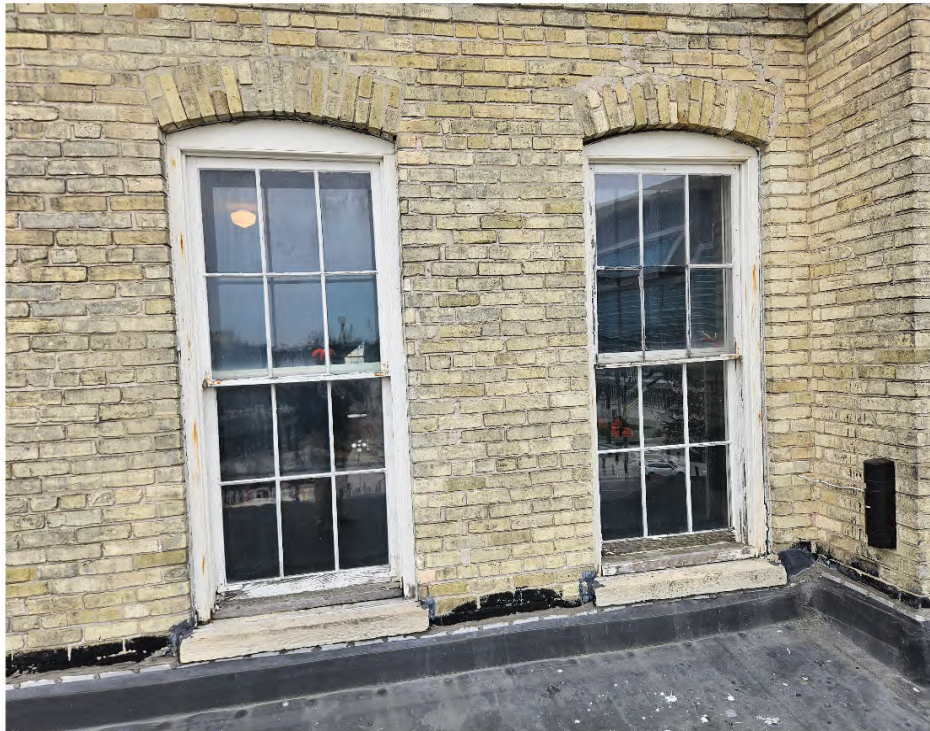
NORTH ELEVATION - 3RD FLOOR

-ORIGINAL WOOD WINDOWS ON THIRD FLOOR. WEATHERING, WOOD ROT, AND PREVIOUS POOR QUALITY REPAIRS HAVE MADE IT INFEASIBLE TO REPAIR WINDOWS.

-THE SCOPE OF WORK FOR THIS PROPOSES TO REPLACE THE WINDOWS IN KIND WITH NEW WOOD WINDOWS MATCHING THE ORIGINAL CONFIGURATION AND PROFILE WITH NEW LAMINATED SAFETY GLASS

3 NEW WOOD WINDOWS REBUILT TO MATCH ORIGINALS. NEW GLAZING TO BE LAMINATED SAFETY GLASS

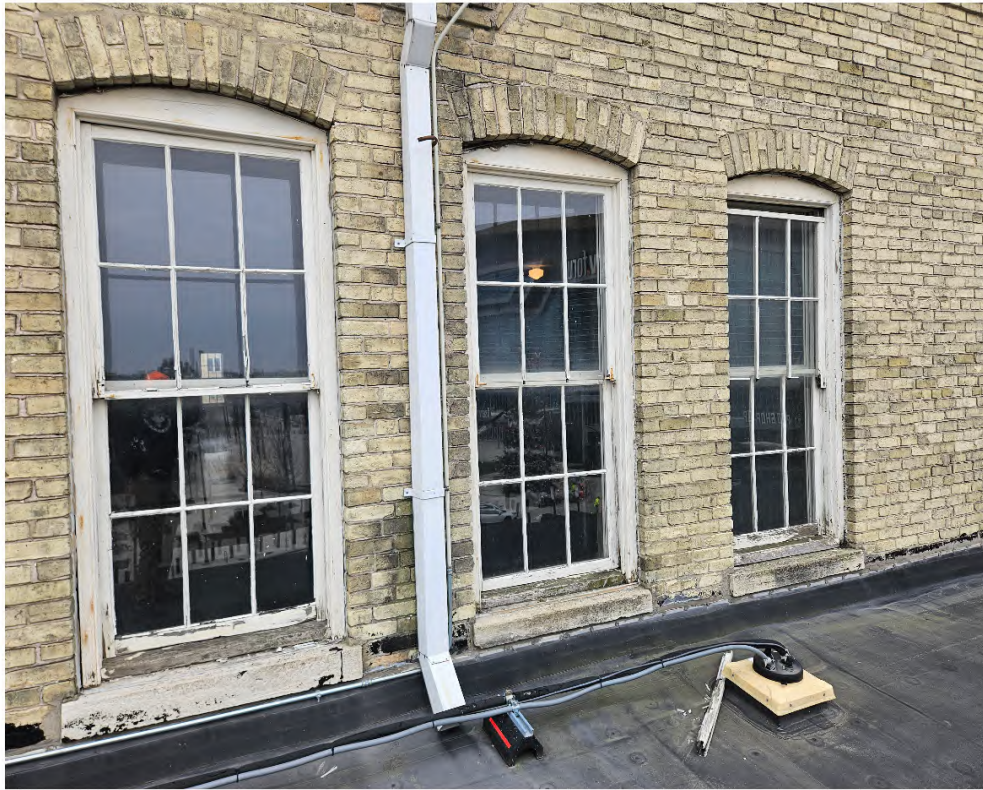
NORTH ELEVATION - 3RD FLOOR

-ORIGINAL WOOD WINDOWS ON THIRD FLOOR. WEATHERING, WOOD ROT, AND PREVIOUS POOR QUALITY REPAIRS HAVE MADE IT INFEASIBLE TO REPAIR WINDOWS.

-THE SCOPE OF WORK FOR THIS PROPOSES TO REPLACE THE WINDOWS IN KIND WITH NEW WOOD WINDOWS MATCHING THE ORIGINAL CONFIGURATION AND PROFILE WITH NEW LAMINATED SAFETY GLASS

3 NEW WOOD WINDOWS REBUILT TO MATCH ORIGINALS. NEW GLAZING TO BE LAMINATED SAFETY GLASS

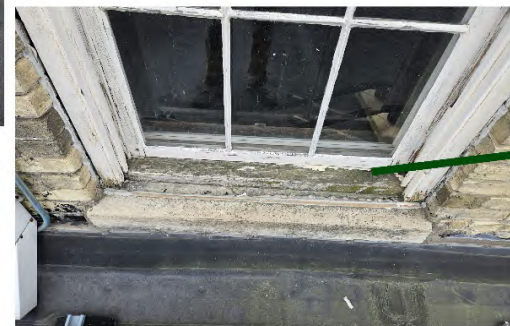
WOOD ROT

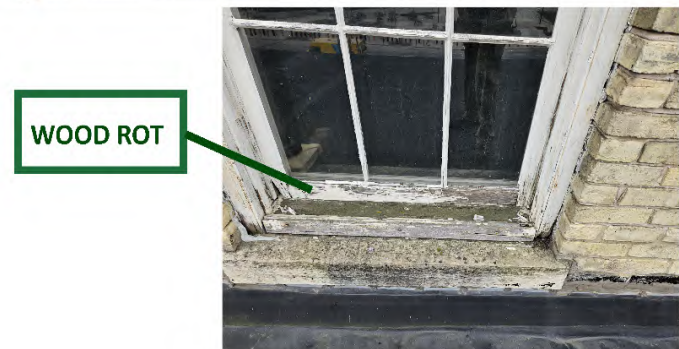
WOOD ROT
