Certificate of Appropriateness

953 N. 33RD ST. Concordia Historic District

Date issued
10-09-2019

AMENDED 10/29/19

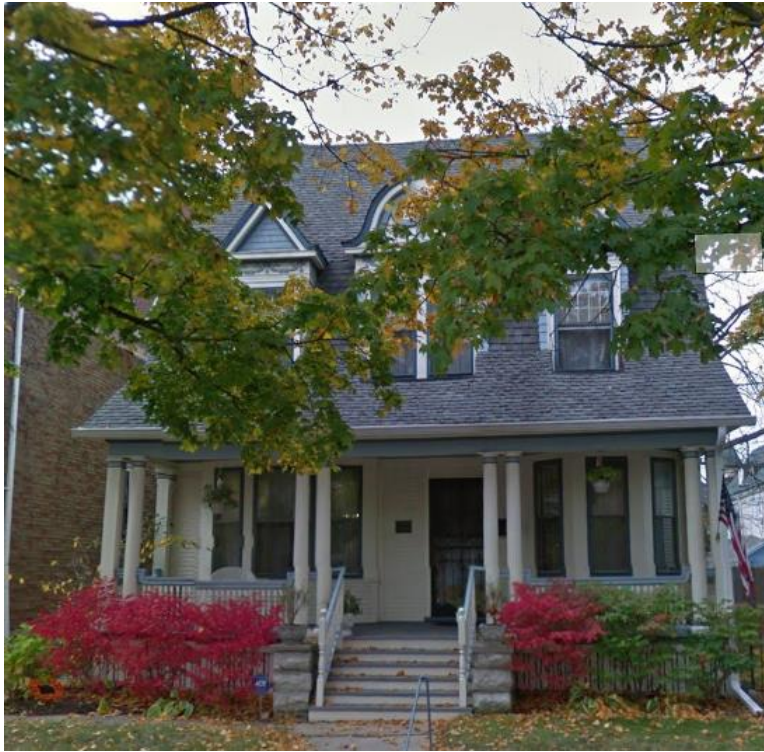
Porch roof will remain since it is integrated into the roof of the house.

All sections of the porch below the roof are to be removed including columns, balusters, steps, handrails and skirting.

This photo shows work underway.

New footings will be poured and the porch deck and skirting are to be rebuilt.

Approval for the railings, balusters, columns and handrails is addressed in this amended COA – see photos attached below.

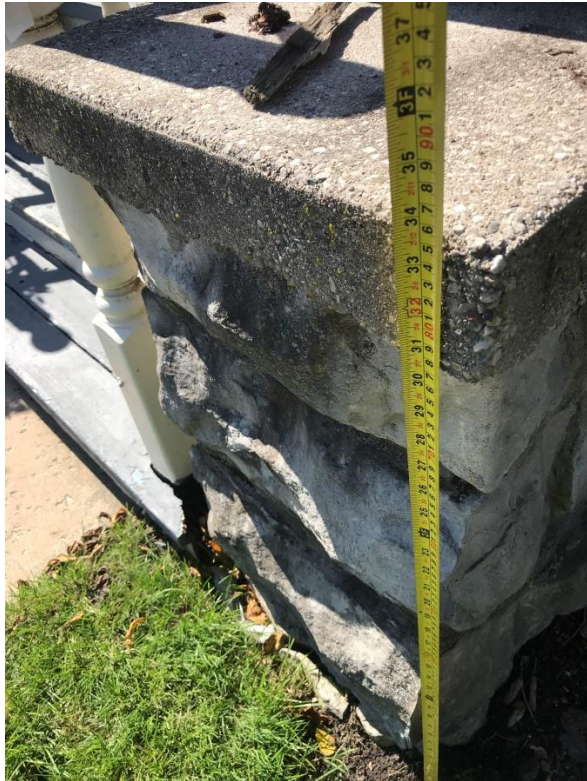
Wing walls measure 32 inches tall by 22 inches wide by 52 inches deep (front to back)
They will remain.

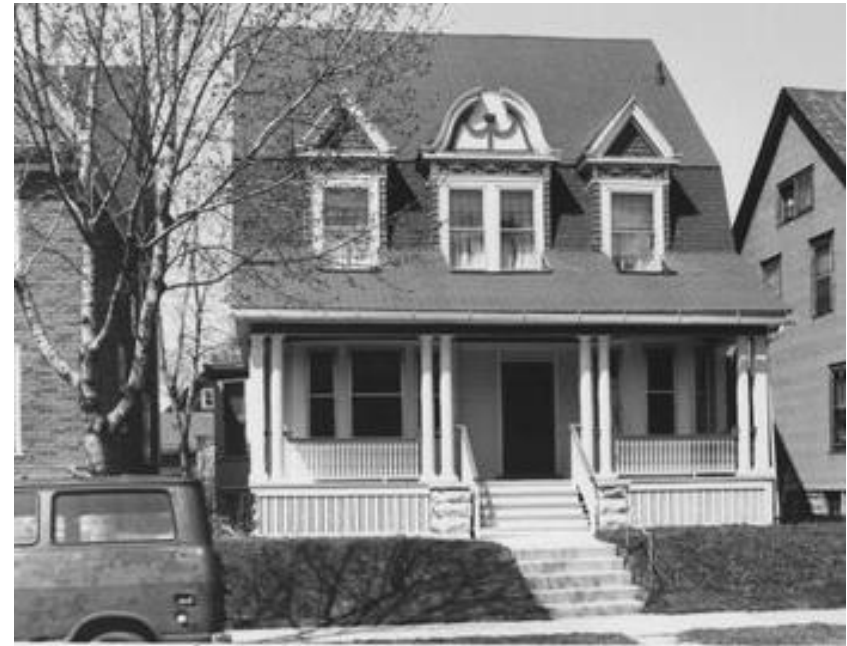
Porch measures 31 feet wide by 7 feet deep.
Railing is 29 inches high.
Skirting boards are 1" by 8" frame and 1" by 6" verticals.

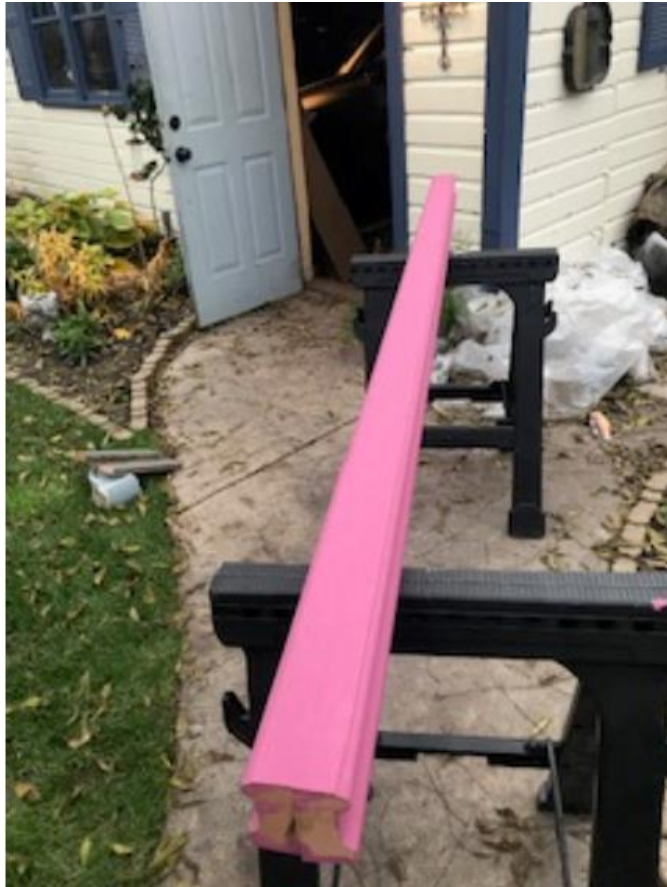
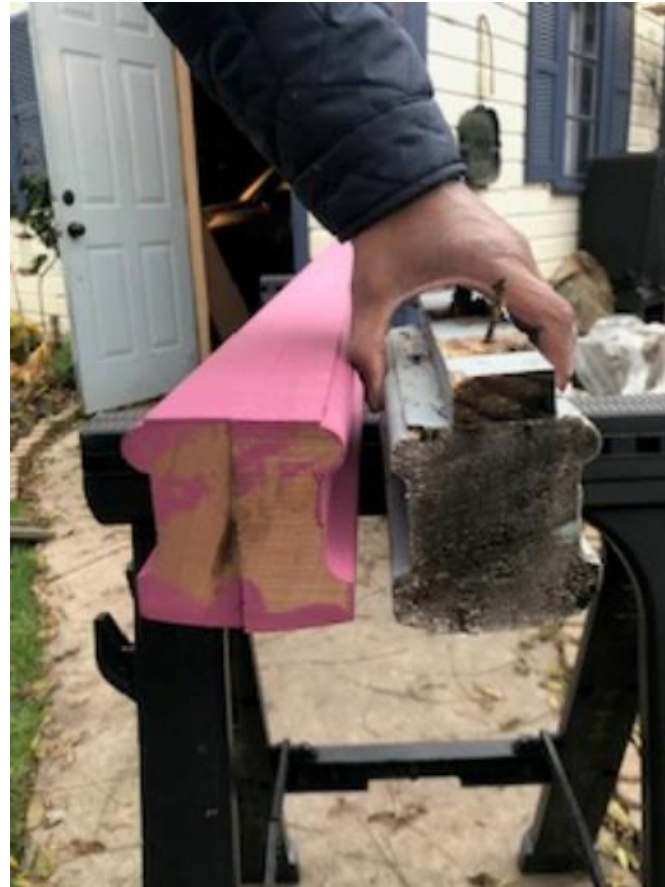
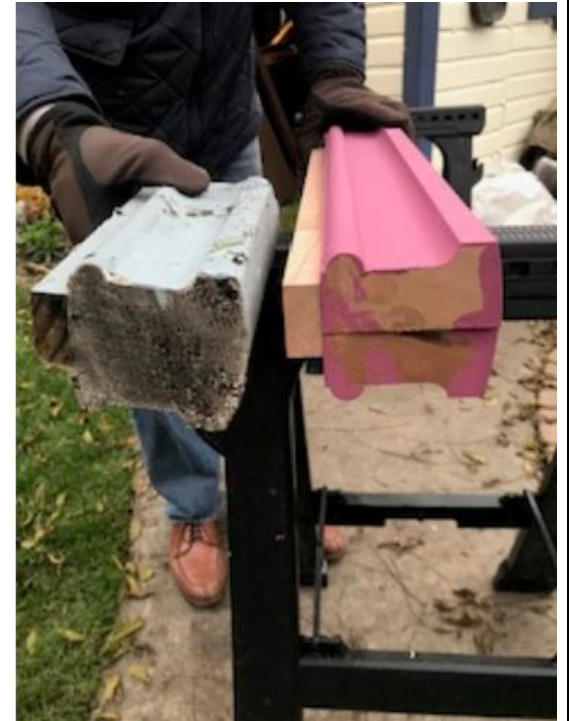
Photographs of the approved handrails to be installed (handrails were already painted and ready for installation at the time of photograph)

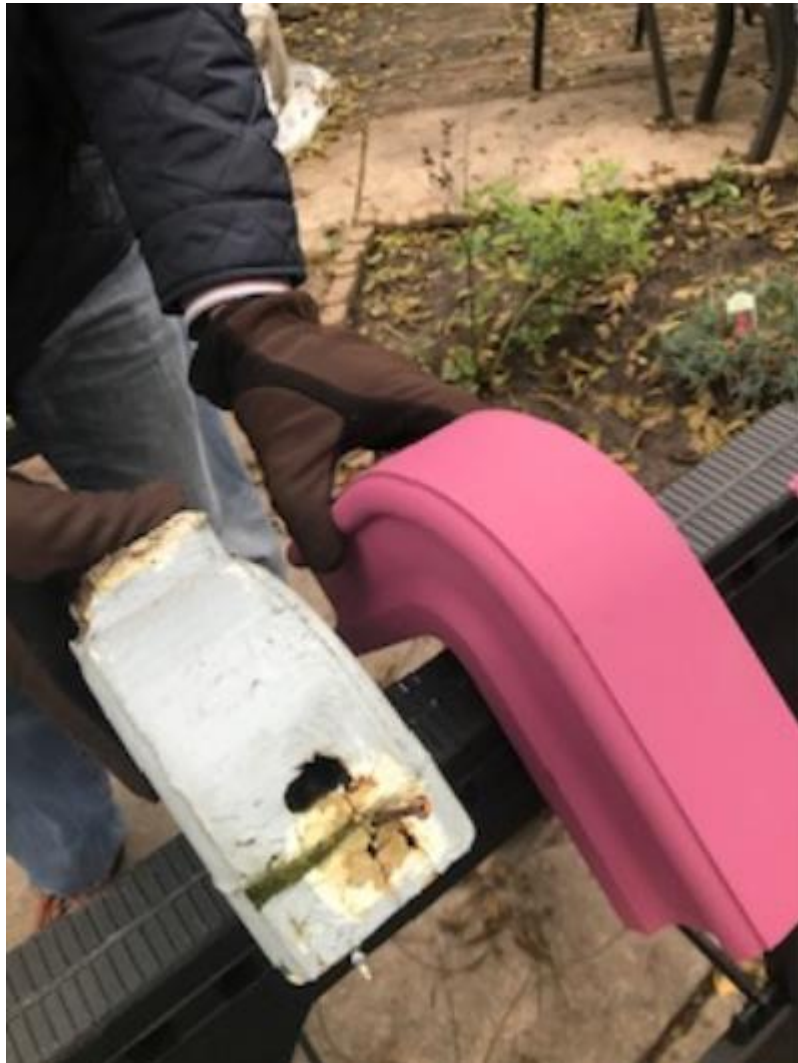
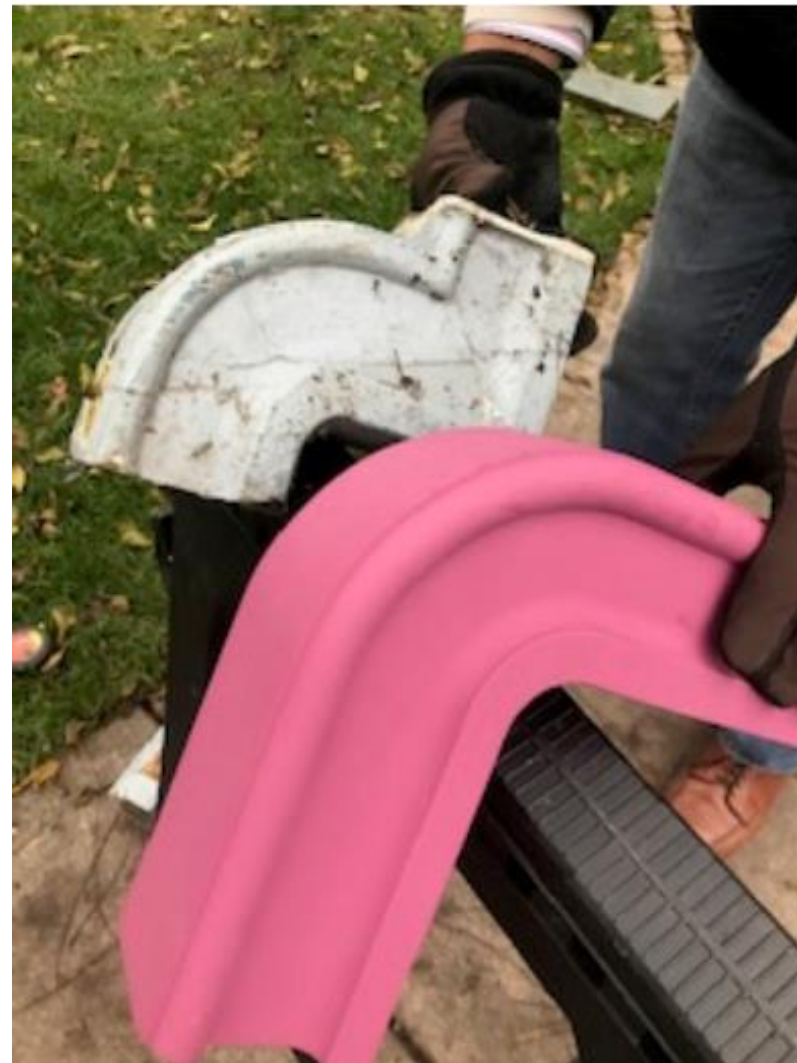
Photographs of the approved handrails to be installed (handrails were already painted and ready for installation at the time of photograph)

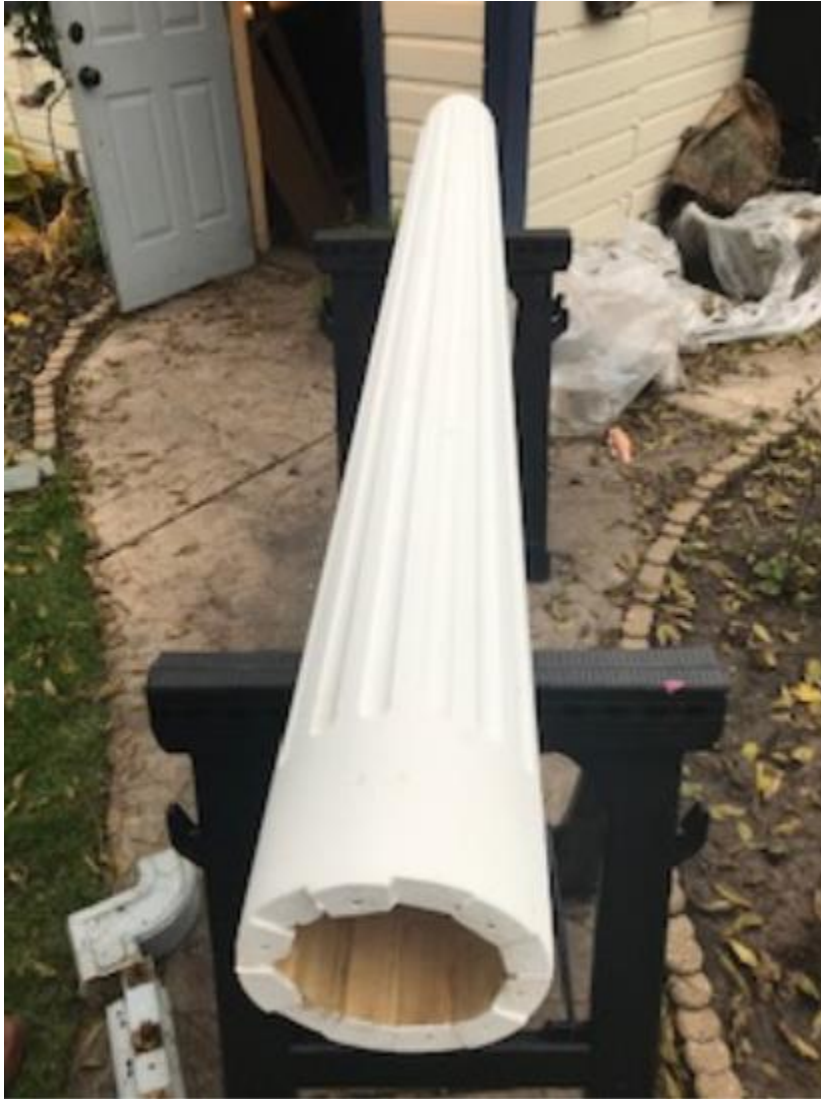
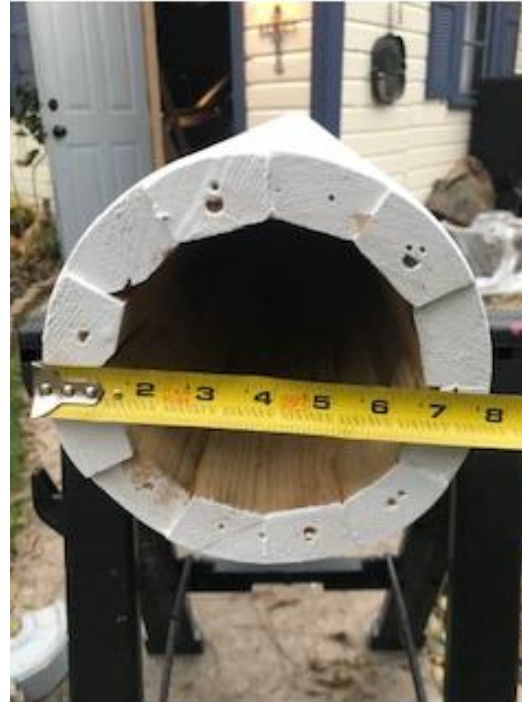
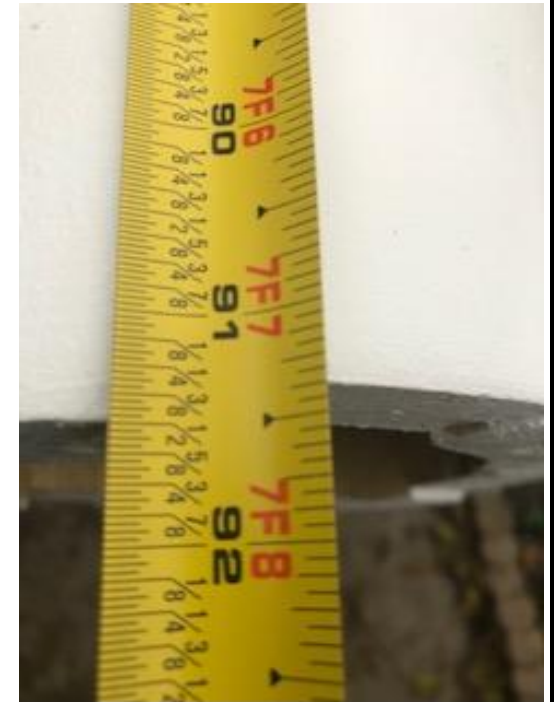
Photographs of the approved fluted cedar columns (columns were already painted and ready for installation at the time of photograph)

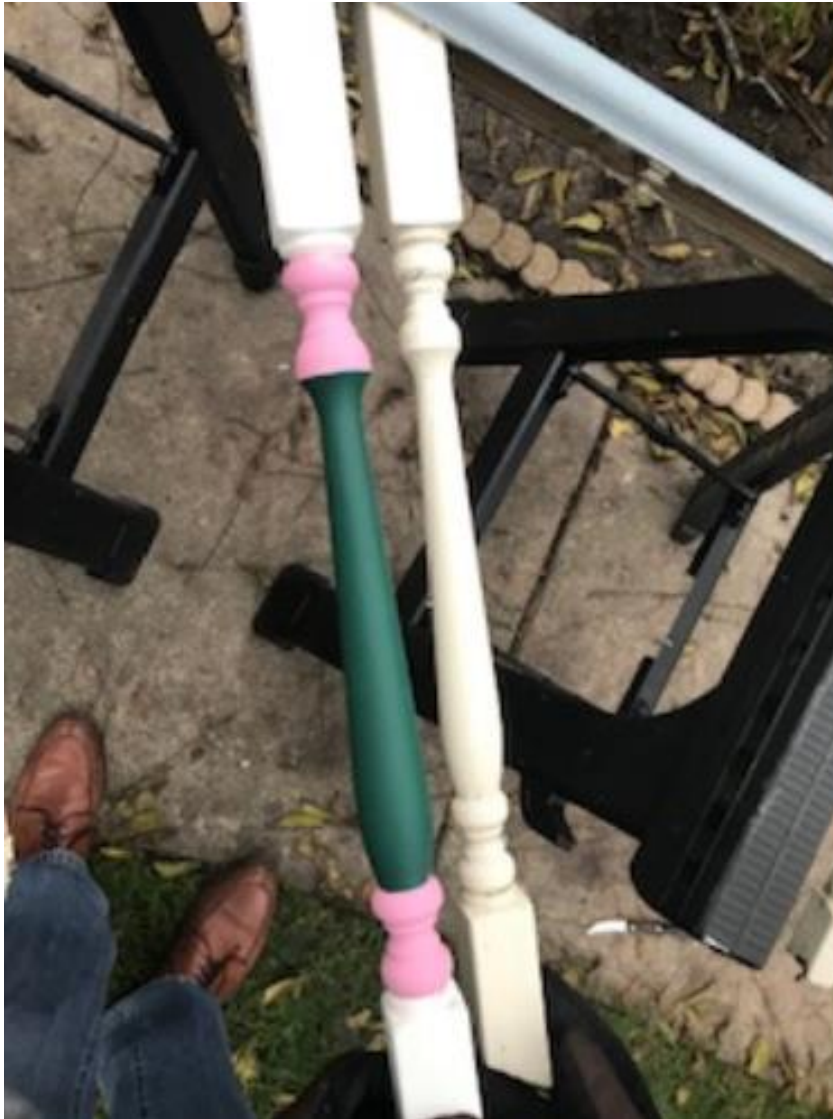
(Left) Photographs of the approved balusters (balusters were already painted and ready for installation at the time of photograph)

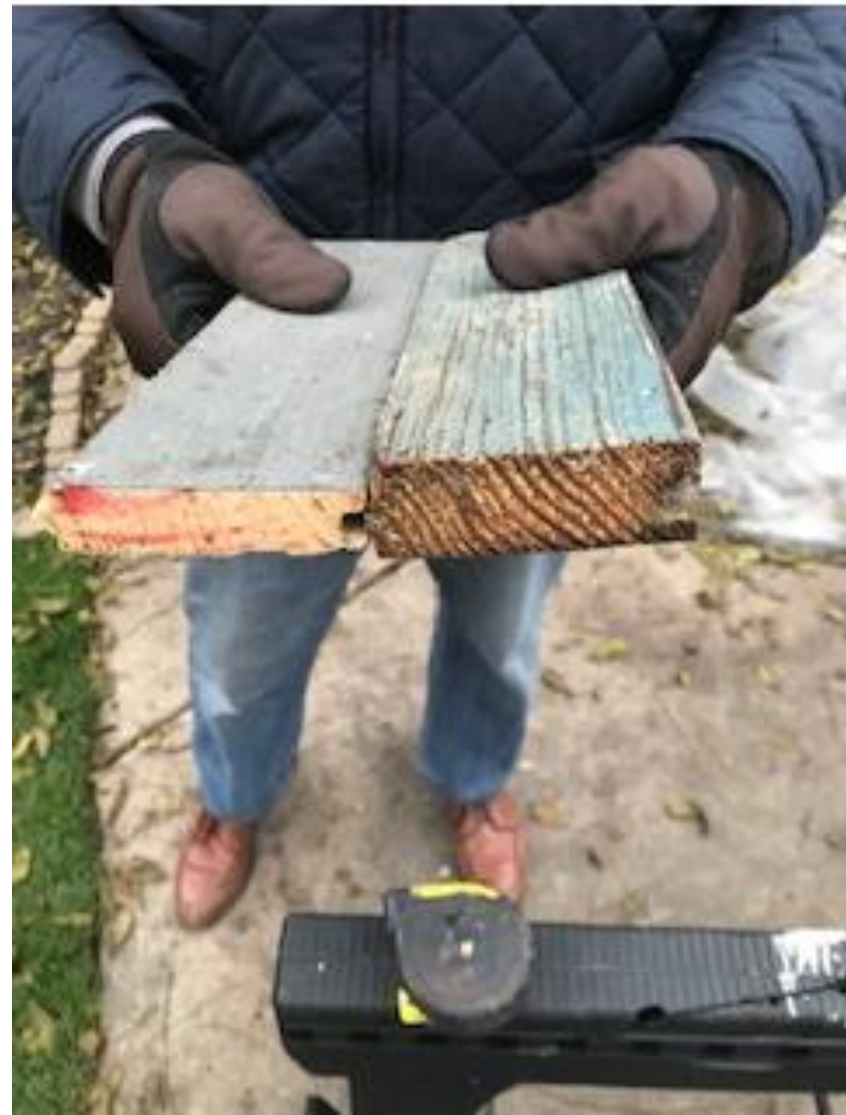
(Right) Also in the process of removing the porch, applicant discovered that the decking was made of 3/4" pine. Applicant discovered pieces of the original decking which were 5/4". Photograph above of the two materials. Applicant will replace the decking with 5/4" birch and NOT 3/4" pine.
