Certificate of Appropriateness

Re-issue/Amended

Property 1851 N. 2ND ST. **Brewers Hill Historic District**
Description of work Re-build front porch deck and roof. Retain historic carved column capitals for re-use on re-built porch. Re-build porch to match original using clear, knot-free finish lumber. Where column capital portions are missing, new pieces will be re-cast in a synthetic material. Spot replace wooden clapboard where missing or damaged with new, matching genuine wood clapboards that are smooth and knot-free.

Date issued 10/3/2014 **PTS ID** 84876 **COA, front porch re-build--reissue/amended**

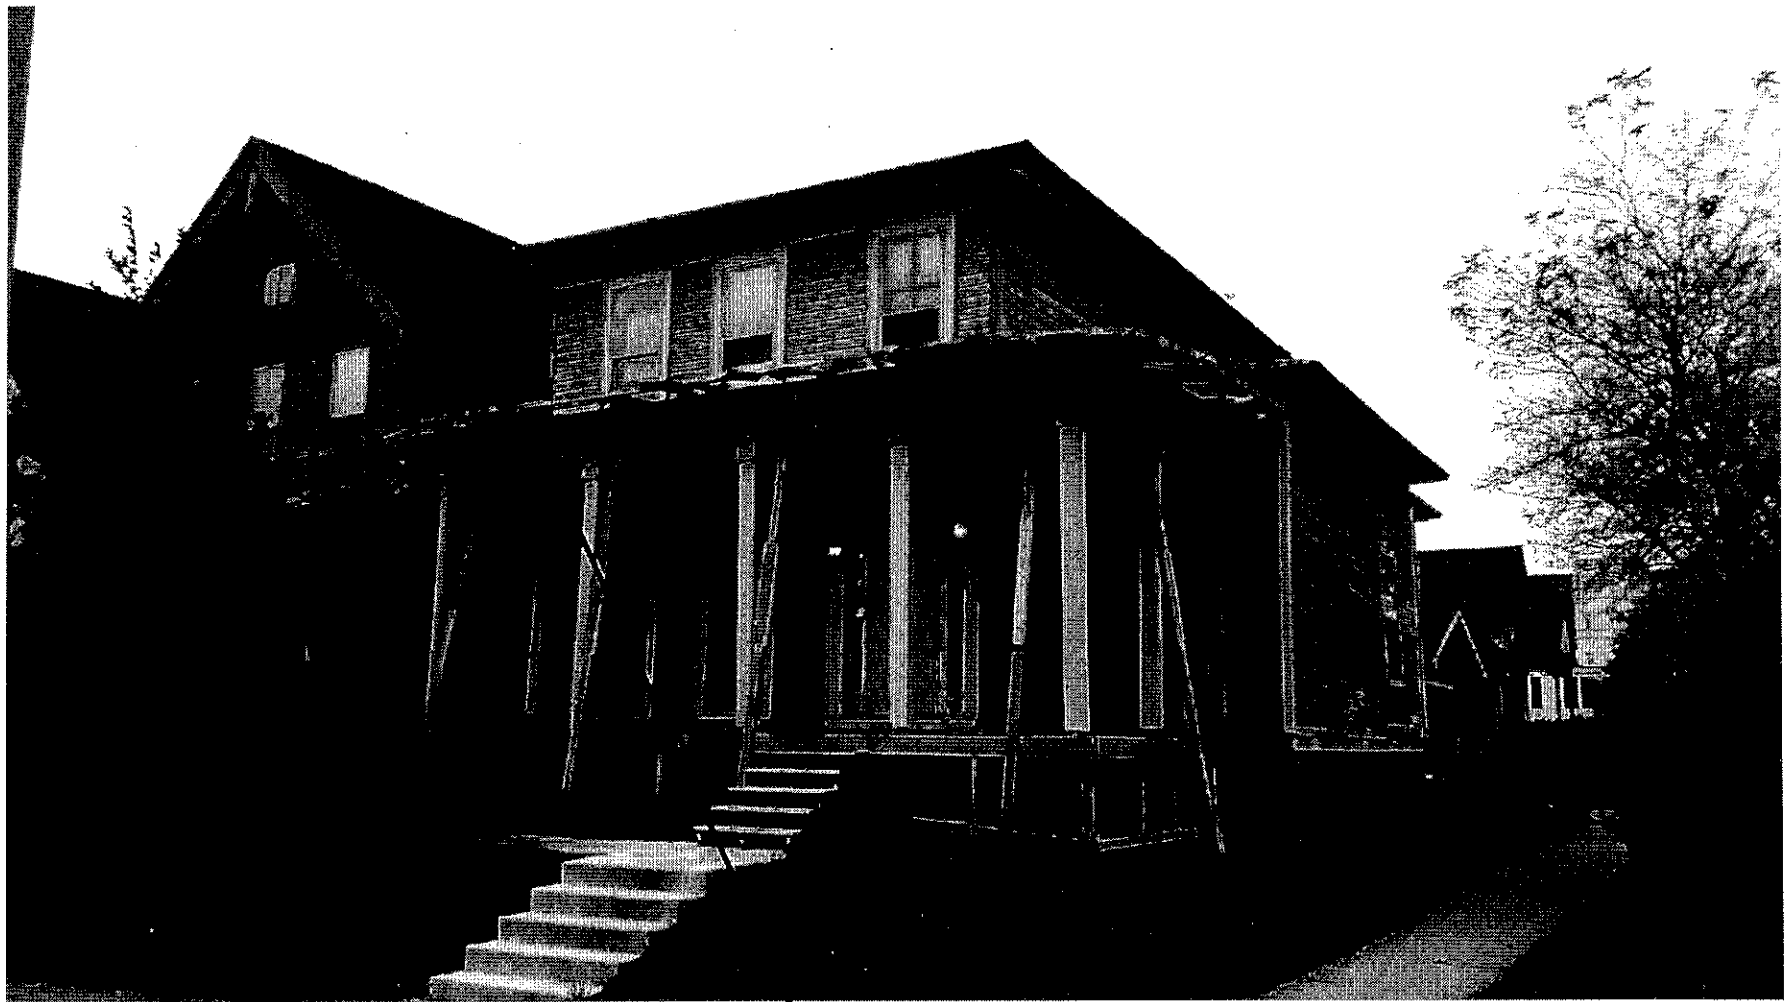
Current photo (10/3/14) of house showing partially rebuilt porch with extensive deterioration to fascia, soffit, ceiling and roof decking. Previous attempt to rebuild porch utilized common pine boards with knots. This must be replaced with clear, knot free material. The finish material on the building now exhibits extensive mold coverage.

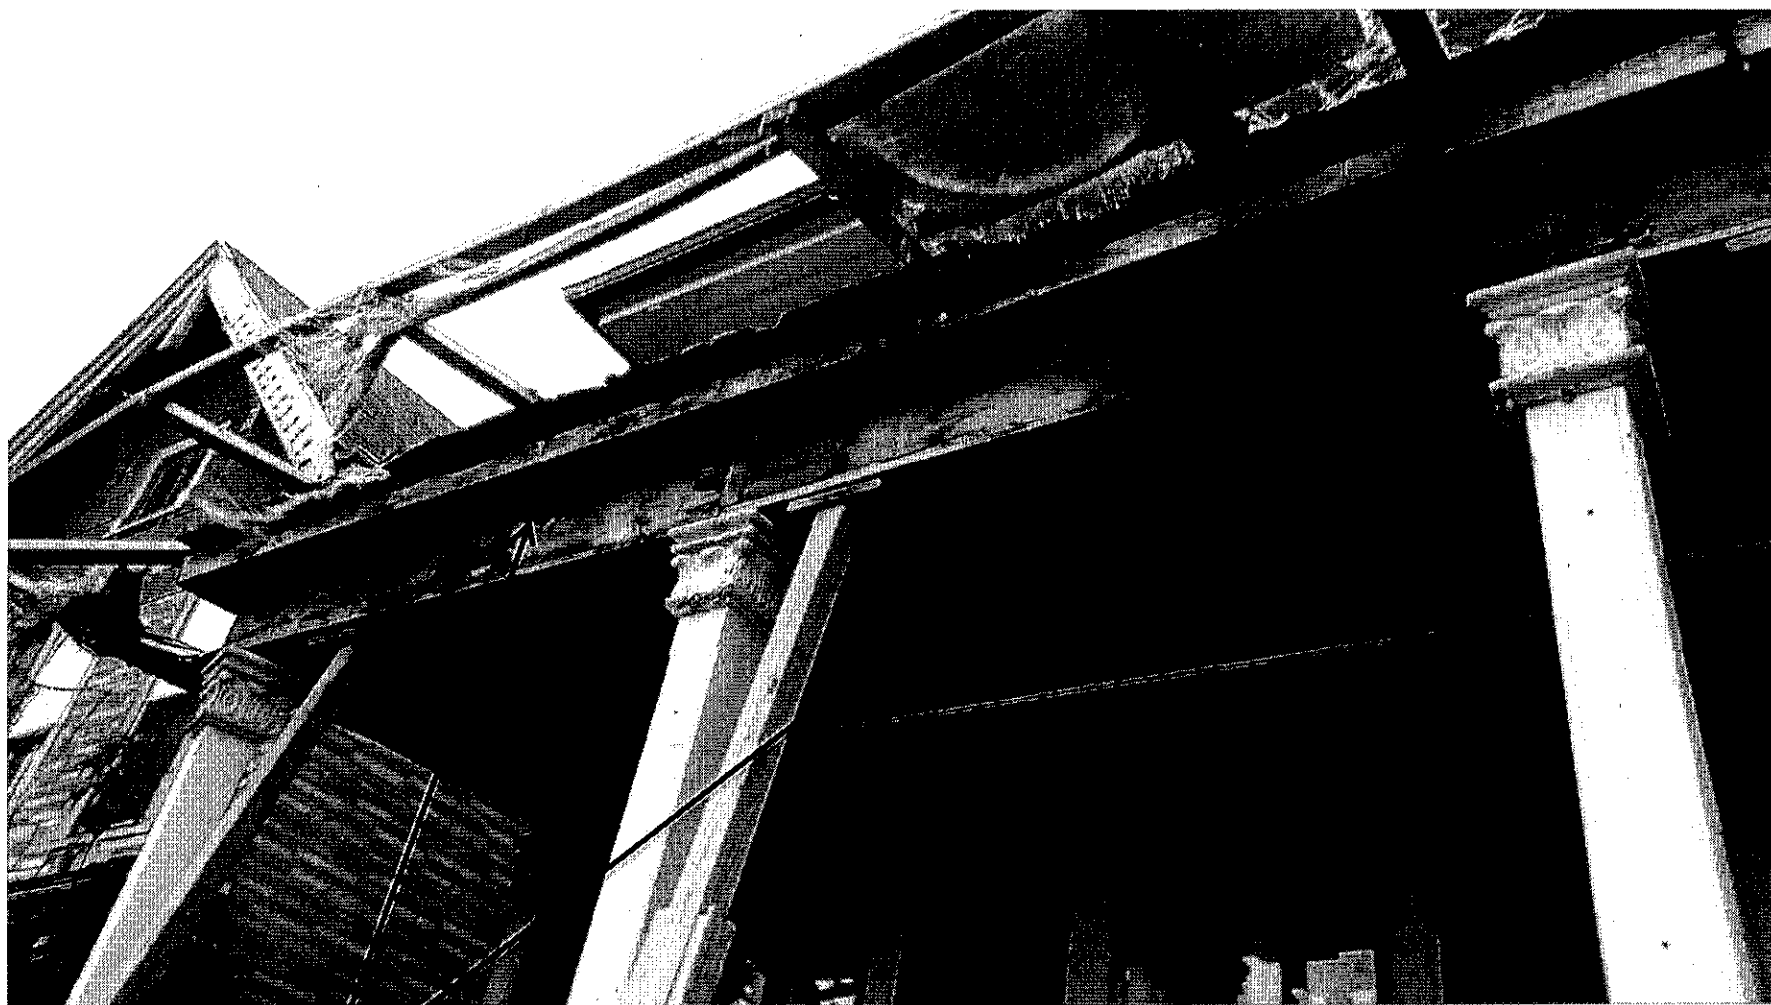
All finish material that is unpainted on roof structure must be removed and replaced with clear, knot-free material. Much of the unfinished material in this current photo exhibits a bloom of mold. Column capitals are original and must be saved. Roof sheathing appears to be deteriorated and must be replaced with new material.

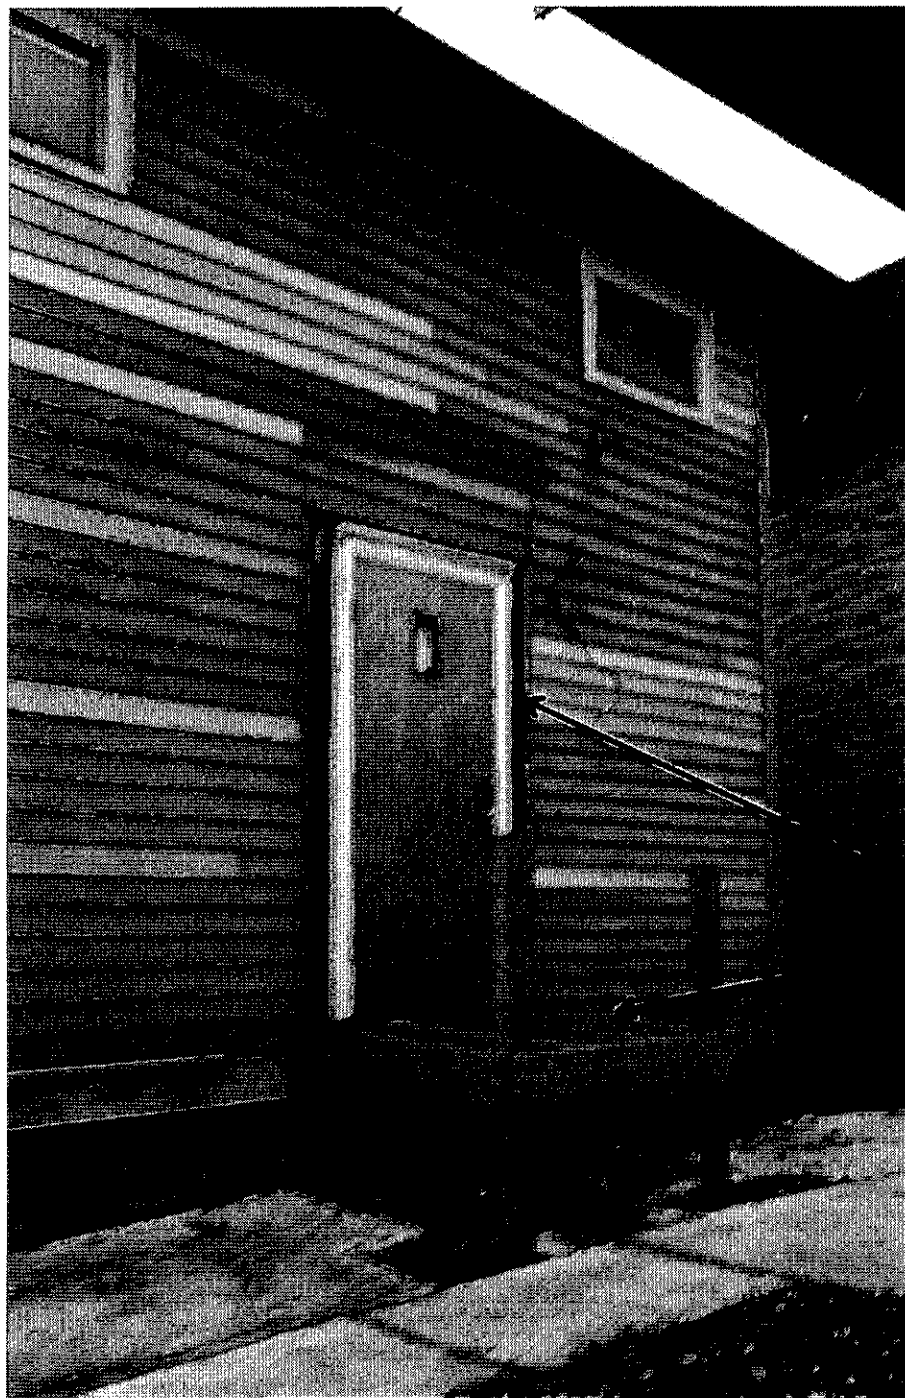
Existing condition of rear stoop. Newels, skirting and balustrade must be installed according to the attached drawings. Flat board trim, 5/4" thick and clear (no knots) must be installed around door.
