Certificate of Appropriateness

Property 2623 N. WAHL AV. North Point North Historic District CCF #170588
Description of work Reinstall original lamppost on front porch. Repair roof structure and underside of roof of front sleeping porch per attached applicant narrative. Replace roof of turret with copper, repair windows, sills, various trimwork, and decorative railing per attached applicant narrative.
Date issued 7/20/2017 PTS ID 114320 COA: turret, porch, and lamppost

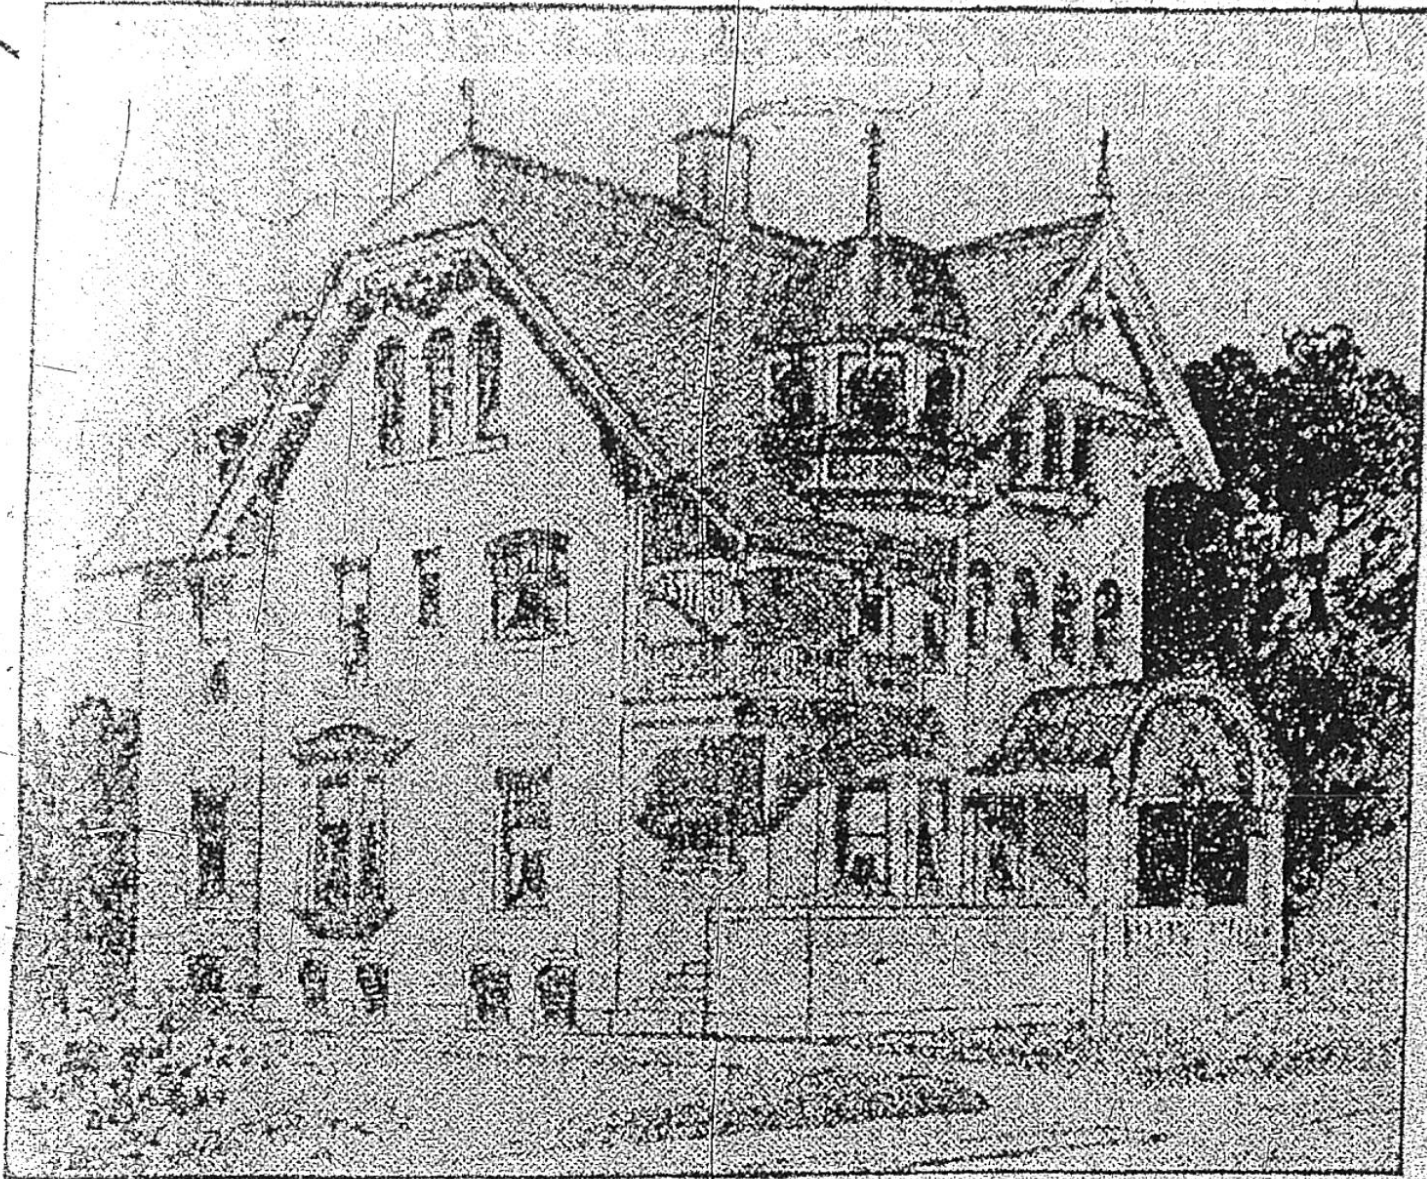
1902 *Evening Wisconsin* image showing original condition of turret and presence of porch lamppost

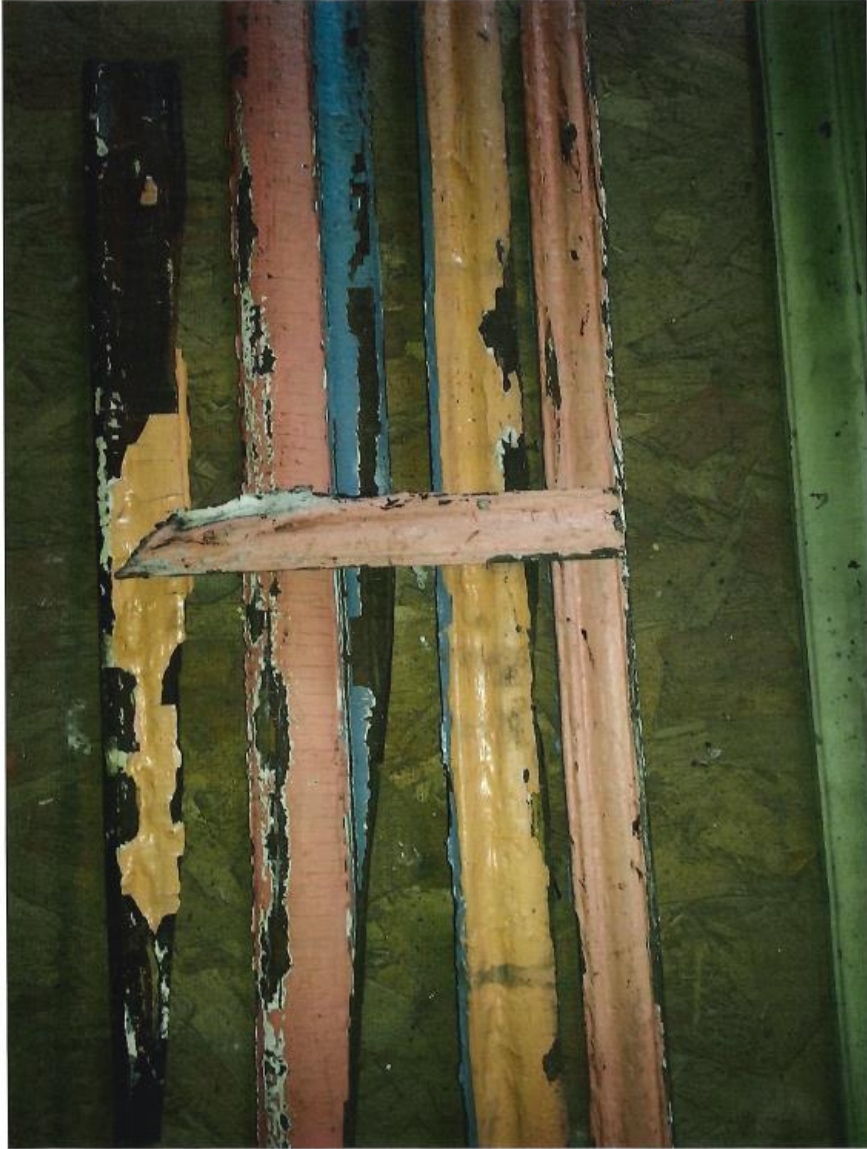
b4
turret trim

Condition of trim work on turret

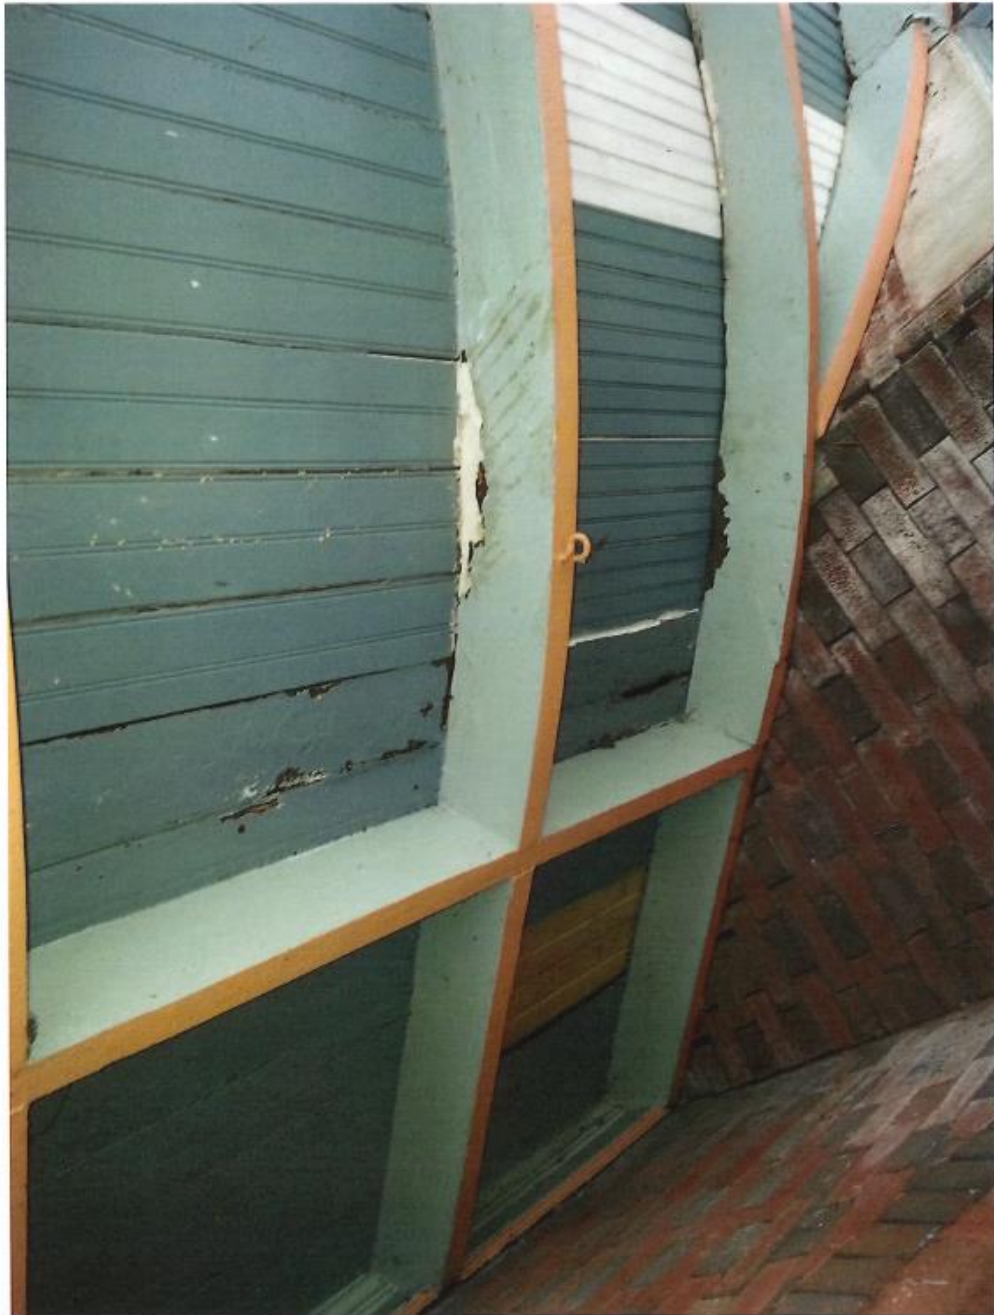
10/13/2017

Underside of sleeping porch roof
requiring repair

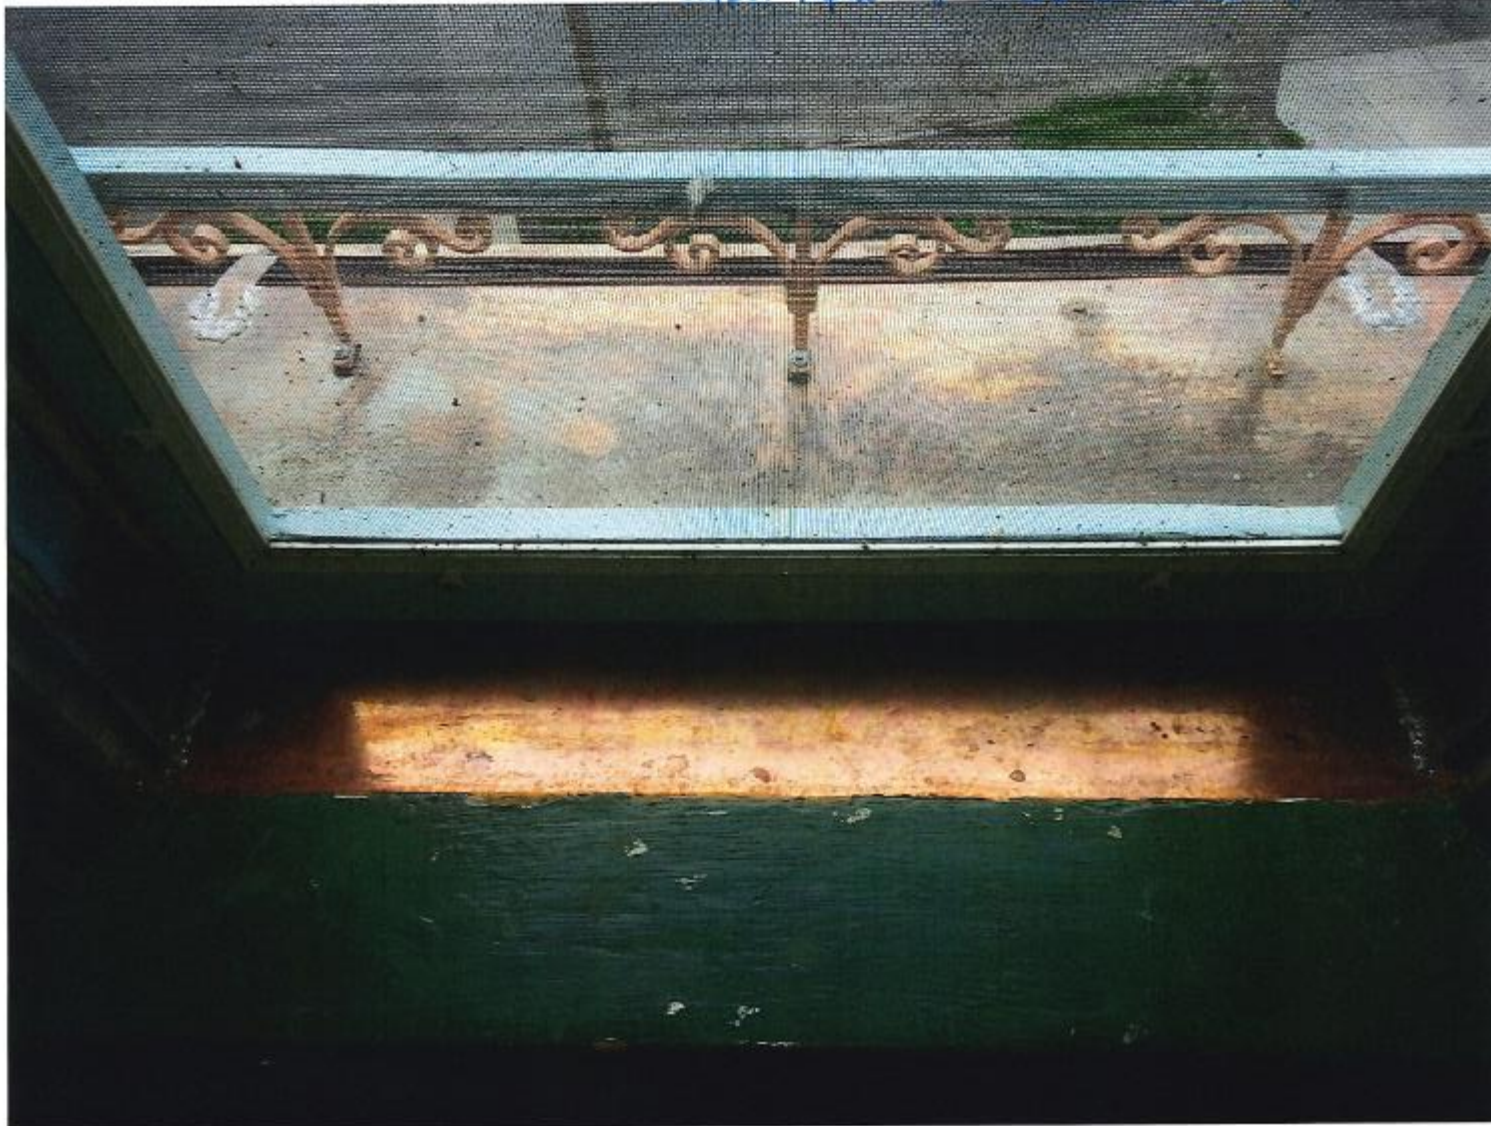
East Side C1
Consumption Perch
Roofing

New ledge beneath turret window sills d2
copper replacing tin and restored railing

New ledges on turret and railing before removal and repair
