Certificate of Appropriateness

Milwaukee Historic Preservation Commission/200 E. Wells Street/Milwaukee, WI 53202/phone 414-286-5712/fax 414-286-3004

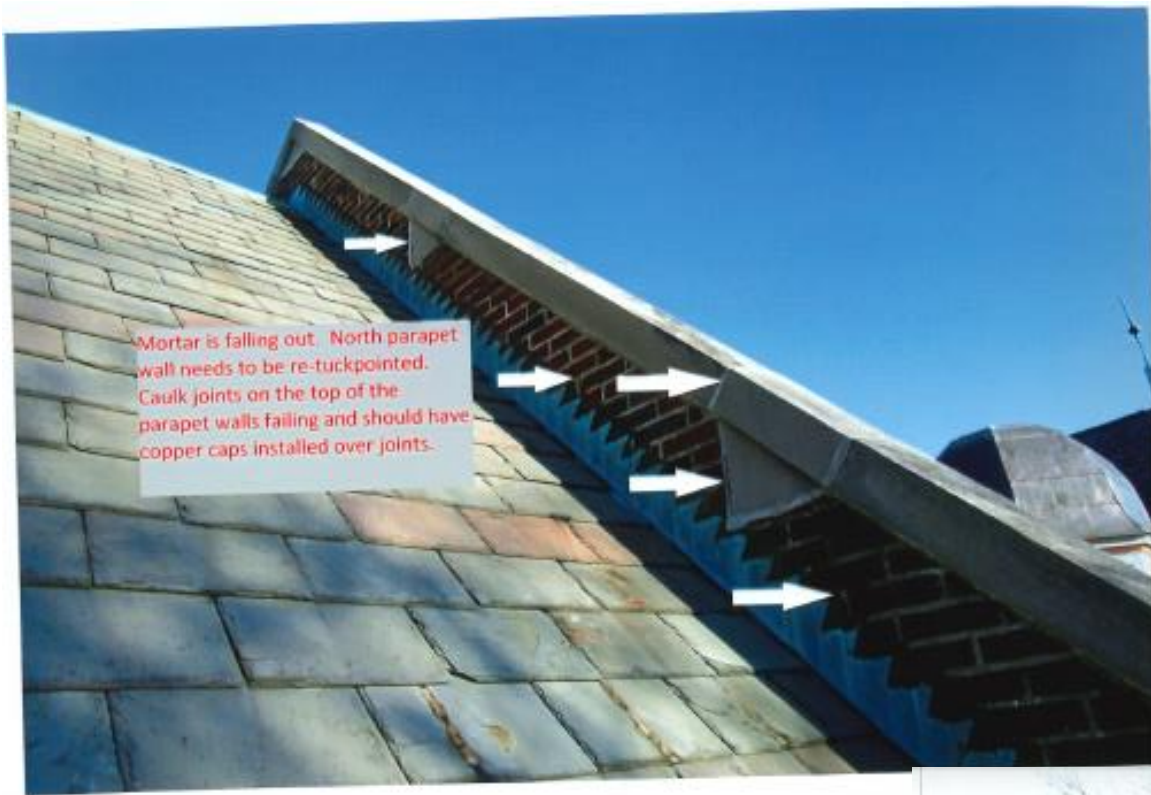
Present condition of the north parapet wall

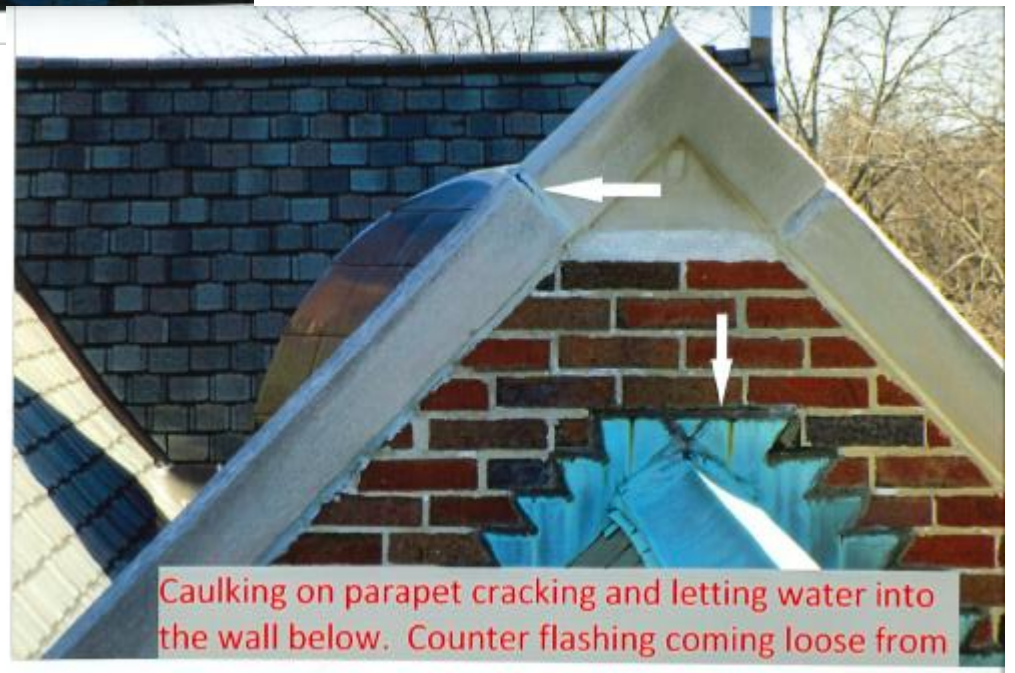
Caulk and mortar joints failing and flashing coming loose

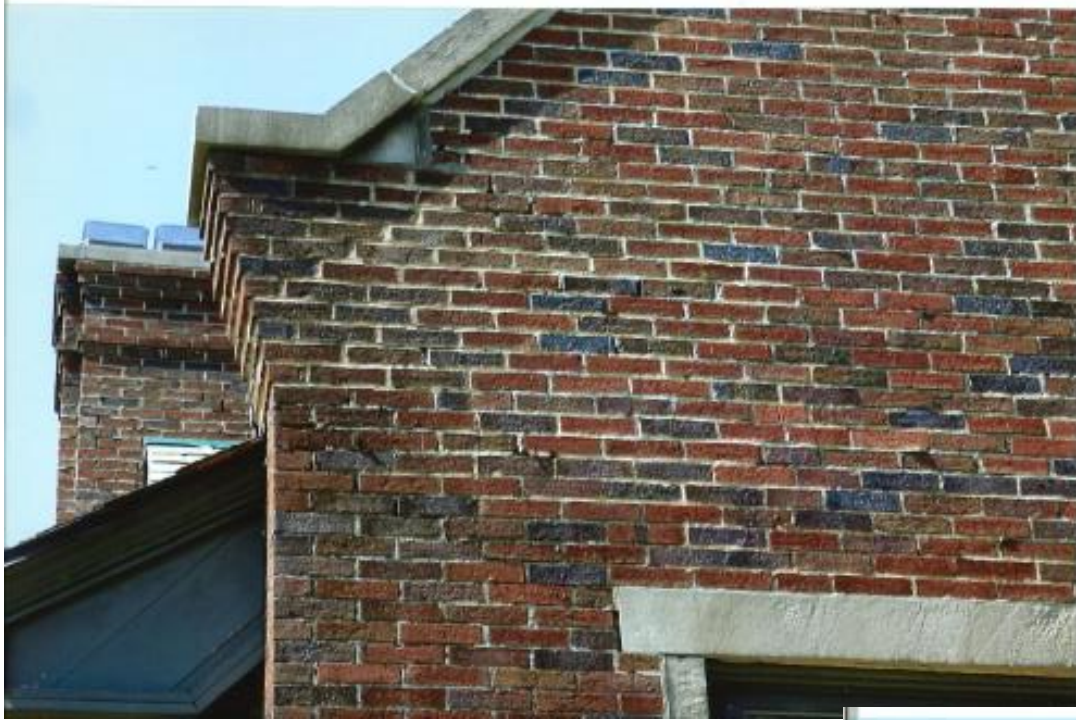
Images of north parapet wall and eave, north facing side. Mortar joints failing, bricks will be checked for integrity, mortar joints between the masonry and along the limestone cap will be tuck pointed.

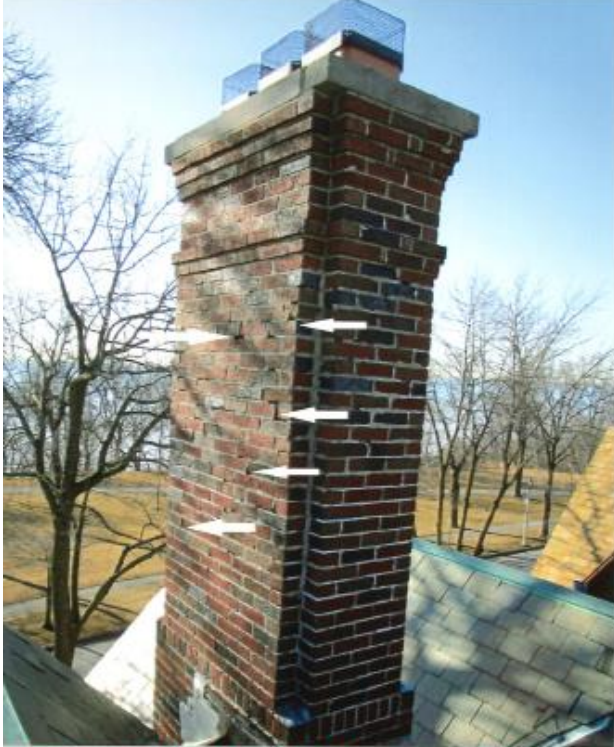
Chimney on the front of the home has large gaps in the mortar. In need of tuck pointing

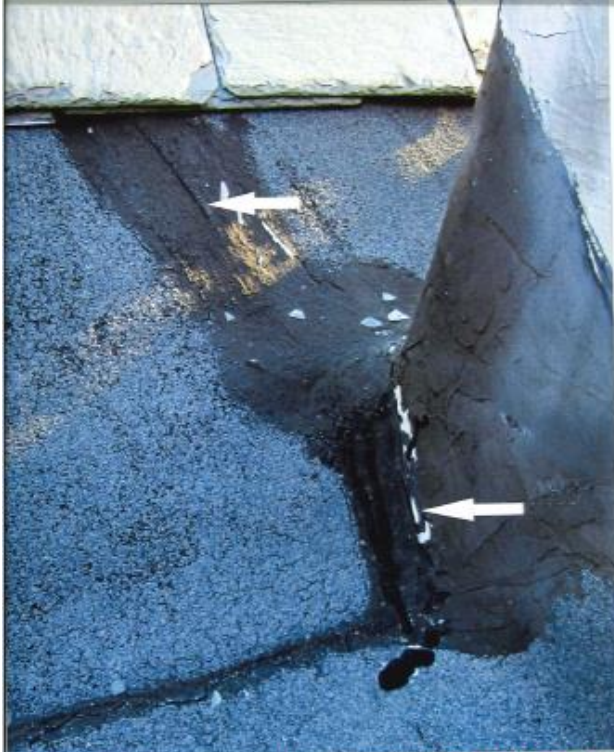
At front chimney saddle corners of flat roof beginning to open. Possible water

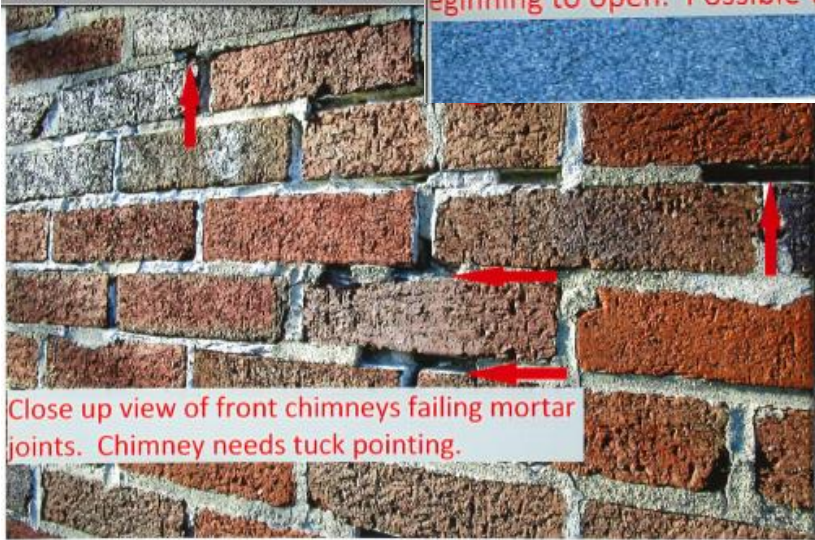
Close up view of front chimneys failing mortar joints. Chimney needs tuck pointing.

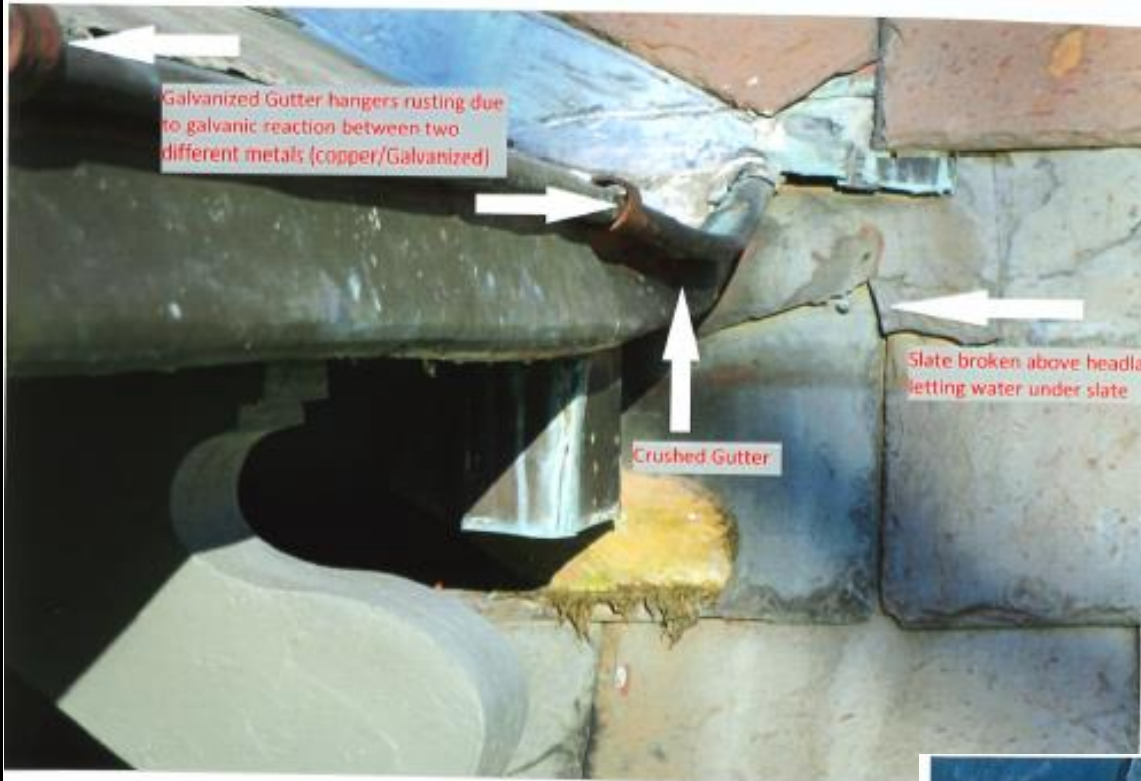
(Above) Gutters will be replaced, match existing profile and material

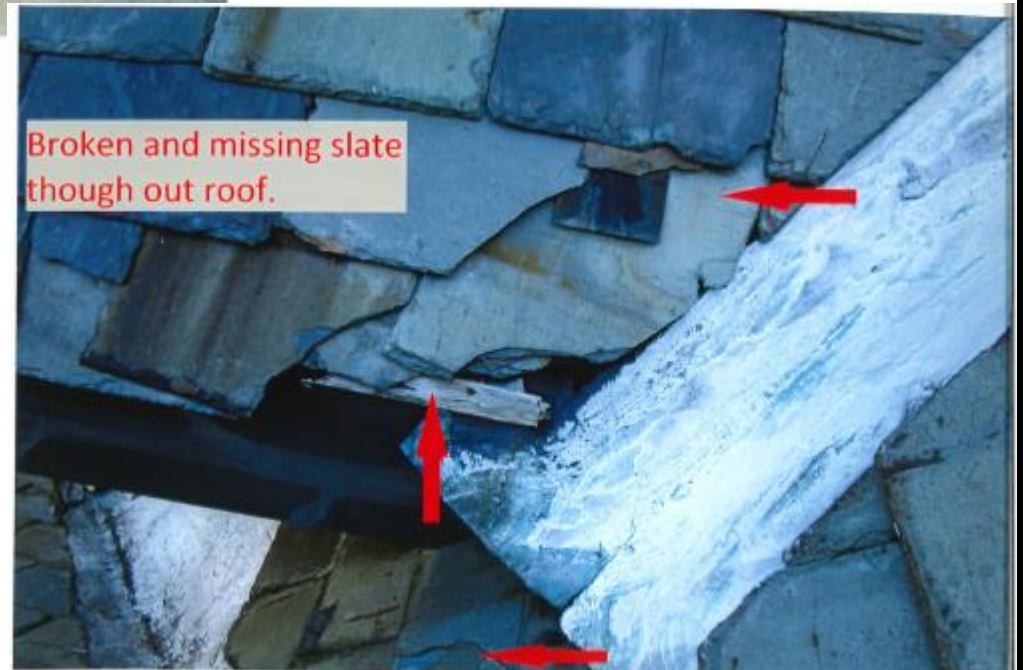
Approved description of work from the Wisconsin State
Historical Society
WHS project no.18 0259

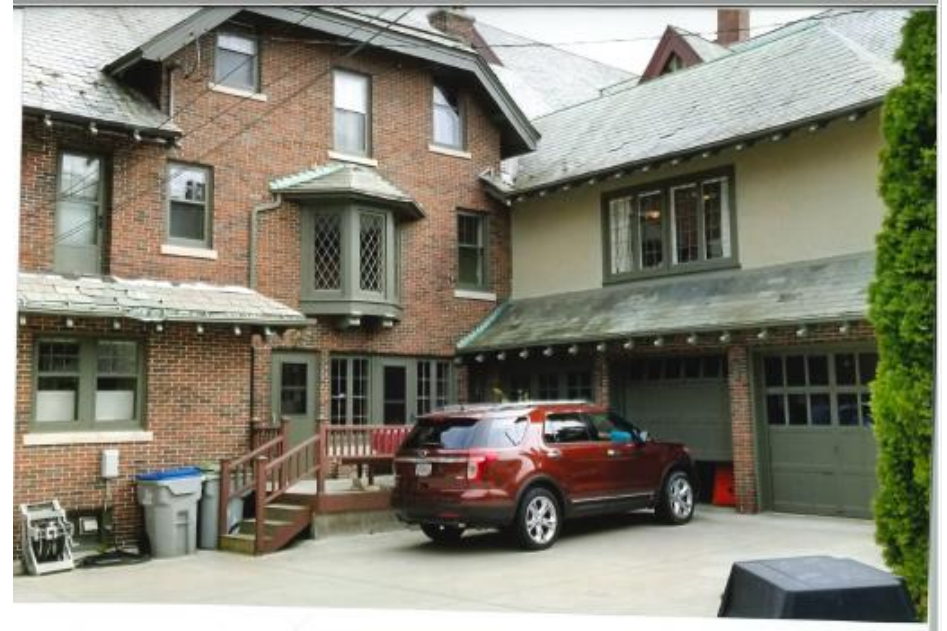
Back porch is at center left of above photo. No railing will be constructed at this time.
