Certificate of Appropriateness

1879 N. Cambridge Ave. George Knowles Jr. House

Description of work Repair and reconstruct elements of the front porch. Repaint existing and new wood elements to match existing. If able, reconstruct missing decorative arch to match historic photographs and

PTS ID 114831 COA: porch

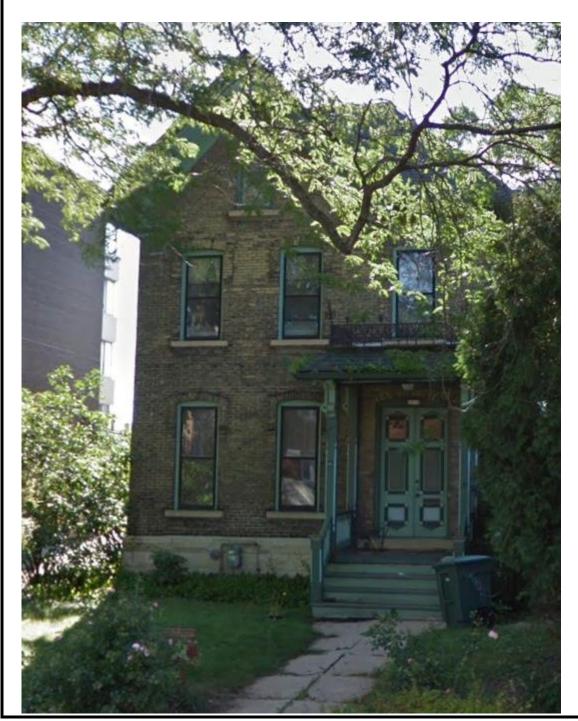
Current condition

Damaged skirting, rails, newels, and posts will be repaired and replaced as needed. New and repaired wood elements will be repainted to match existing.

Entire upper porch will be removed and reconstructed to match existing. Metal rail will be retained.

Columns will be removed, repaired offsite, and reinstalled. Matching porches, decorative arch now missing from 1879 N. Cambridge

From bottom section of porch (floor down) remove several damaged skirting boards Perform epoxy repairs to any remaining boards on skirting or stairs. Remove existing columns; remove to our shop for repairs

Remove entire upper porch (ceiling, soffit, fascia, roof, rail) and dispose. Set aside metal rail for customer in the event that she wants it to be restored by others)

Reframe upper porch following current details and dimensions. All exposed wood to either clear vertical grain cedar or clear douglas fir. All moldings to be custom cut to match existing. All exposed wood to be primed on all sides prior to installation.

Existing rails to be repaired with epoxy where possible, though some new pieces may be required for the stairs. The existing posts to be repaired with epoxy. All rails and columns to be stripped to bare wood and be primed an fully painted with two coats premium latex paint.

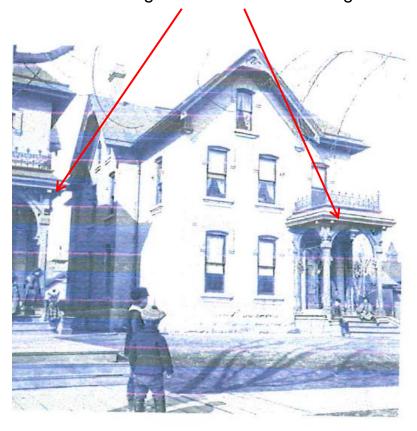
Historic photographs indicating that this house at 1879 N. Cambridge Ave. was built as a twin to the house immediate adjacent to the north.

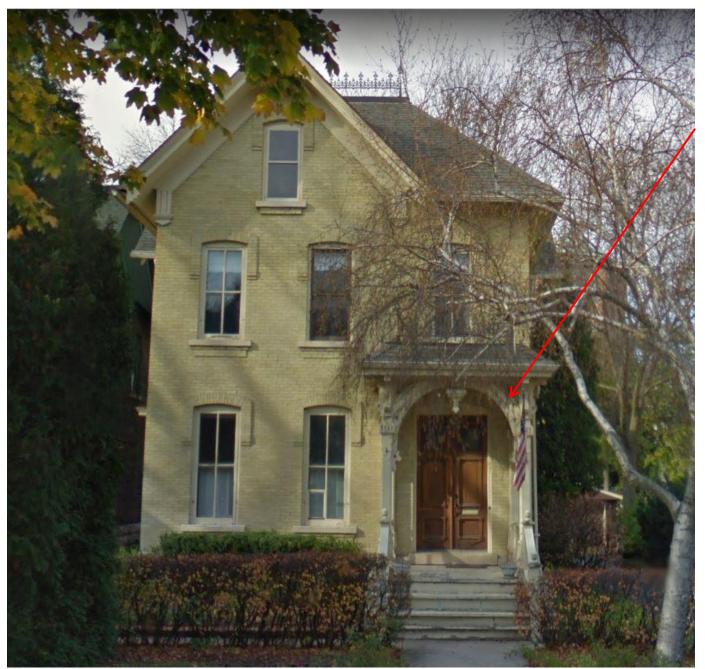
Current condition of the twin home immediately adjacent to the north.

Possible reconstruction of the porch arches indicated in the photograph.

For an additional added to price, below we will custom mill new decorative arches matching the house directly to the north. These will be cut from clear cedar, fir, or mahogany and be fully primed and painted prior to installation.
