May 6, 2021

Attn: Pam Weisser – Program Director
Re: Masonry Repairs / Restoration
Grand Avenue Club
Insurance Exchange Building
210 E. Michigan St
Milwaukee, WI 53202

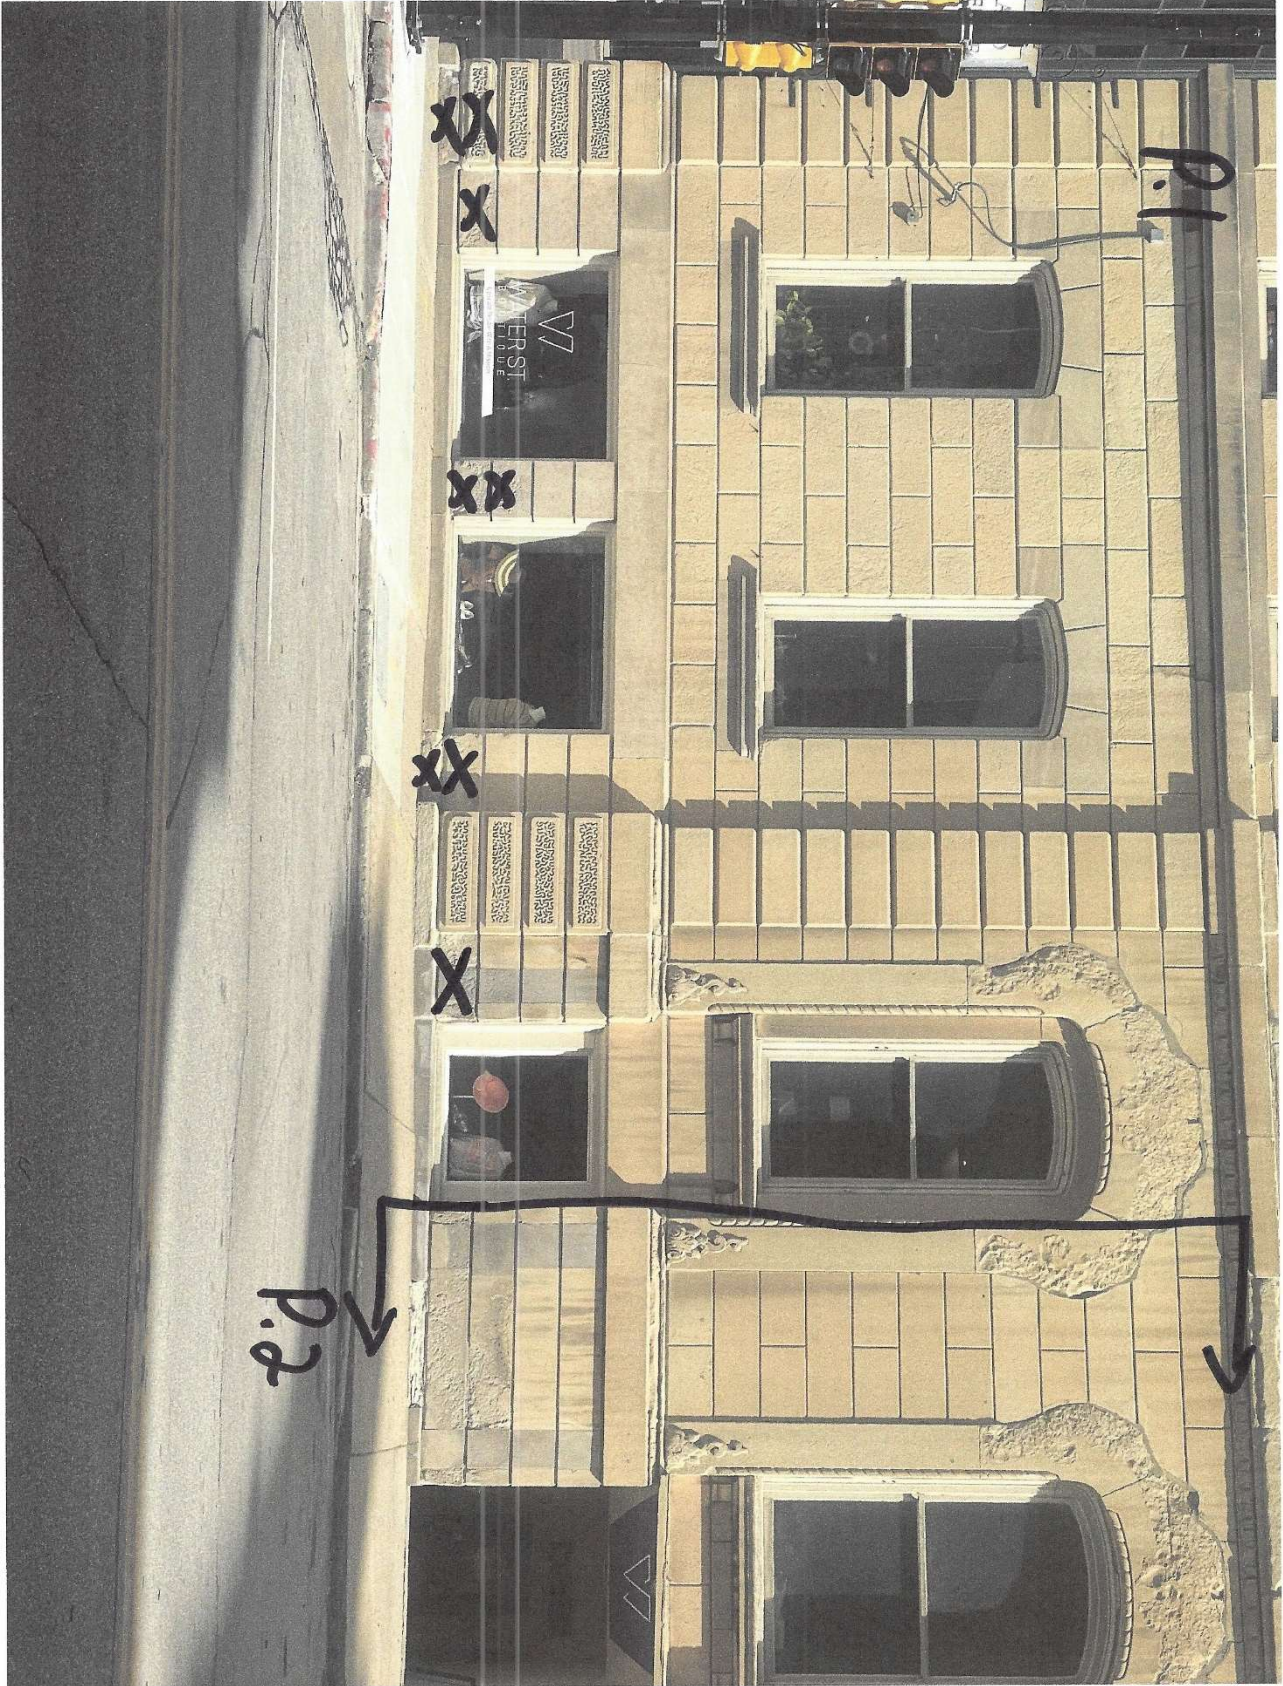
- 2.) Restoration of Main Entrance on South Elevation: The stones at the front entrance of this building on the south elevation are in poor condition, this is mostly due to salt attack of the stone masonry. We are proposing to remove and replace the deteriorated stones at this location with stones that mimic the original stones, as best possible.

Accordingly, we will remove the stones at the base of the columns to either side of the door – see attached marked photo. When completing this, care will be taken to preserve the two panels that

were recently replaced. These stones, along with any historic photos that can be located, will be shipped to a stone fabricator so that replica stones can be created. The remaining structure will be stabilized and shored to ensure that the remaining stones will not shift.

Once the replica stones are back from the stone fabricator, they will be mocked up in place to ensure they fit the opening appropriately. With it confirmed that they fit as they are supposed to, they will again be removed. The stones will then be set in place in a full bed of mortar and anchored to the backup wall using stainless steel anchors.

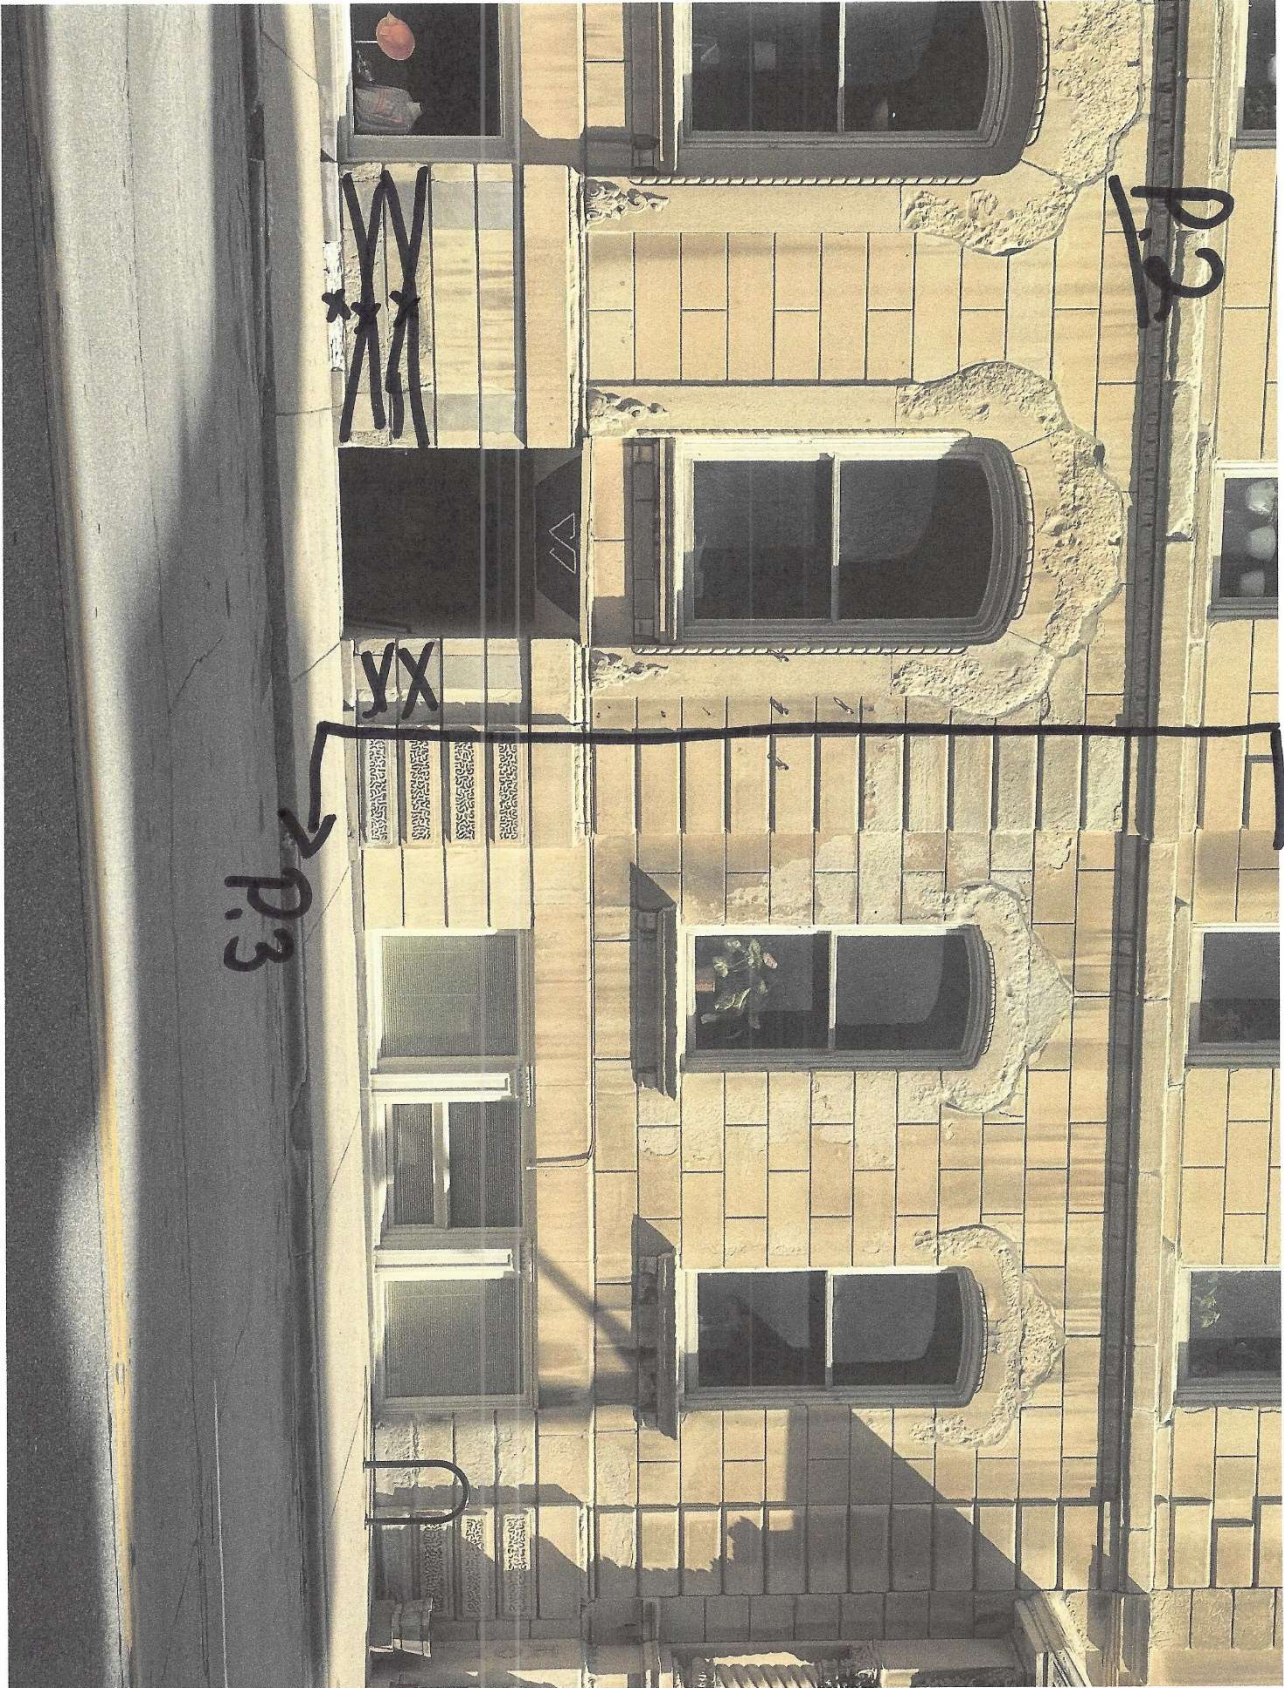
- 3.) Restoration of South Elevation BELOW 1st Floor Window Sills to Grade: The work associated with this item starts just below the first floor window sills (not including the window sills). Deteriorated stones will be replaced with similar cut and shaped stones. In total, we have included replacing 33 stones and resurfacing three.

We have also included attempting to re-surface three stones. These are located to the west of the main entrance and are marked with an 'R' on the attached marked photos. These stones will be ground flat then sanded with 60 grit abrasive wheel to give an appearance of a new(ish) stone. This may or may not prove to be fruitful, but in our opinion, it is worth an attempt. If resurfacing proves to be a viable option, then the stones further up the wall whose faces are scaling off may be able to be resurfaced at a fraction of the cost of replacement.

When replacing stones, the existing stone will first be measured and photographed. A replacement stone (Dutchman) will be ordered to match the texture of the original and overall outer dimensions. The replacement stones were assumed to be Dutchman stones that are approximately 8" deep. It was assumed that Mankato Stone would be a suitable replacement material. Further, it was assumed that the stones with the relief carved into the surface (such as what can be seen at the south elevation west end corner stones) is a random pattern and can be mimicked without exactly mimicking the original pattern.

Once the new stones have arrived (likely 8 – 10 weeks out from date of approved shop drawings), the original stones will be removed from the wall to the depth of new stones (approximately 8"). Stainless steel pins will then be epoxied into the parent stones. Corresponding holes will be drilled into the back of the new stones. The new stones will then have the holes partially filled with epoxy, installed onto the stainless steel pins and set in a full bed of mortar.
