Certificate of Appropriateness—Amended

Property	2251 N. Lake Dr. North Point South HD		
Description of work	South chimney will be tuck pointed and deteriorated bricks will be replaced. Chimney will be rebuilt to match existing and retain corbeled profile. Some bricks will be utilized to infill area at lower level of home. At the southwestern corner of the rear of the home, an area of previous brick infill will be removed and refilled with brick and mortar that matches the existing condition of the home.		
	Original Glen Gery brick has been discontinued. The Sioux City brick on the last page is an approved substitute as is the mortar sample.		
Date issued	10/8/2019 Amended & extended to expire one year from 9/9/2020	PTS ID	114596 COA masonry repairs

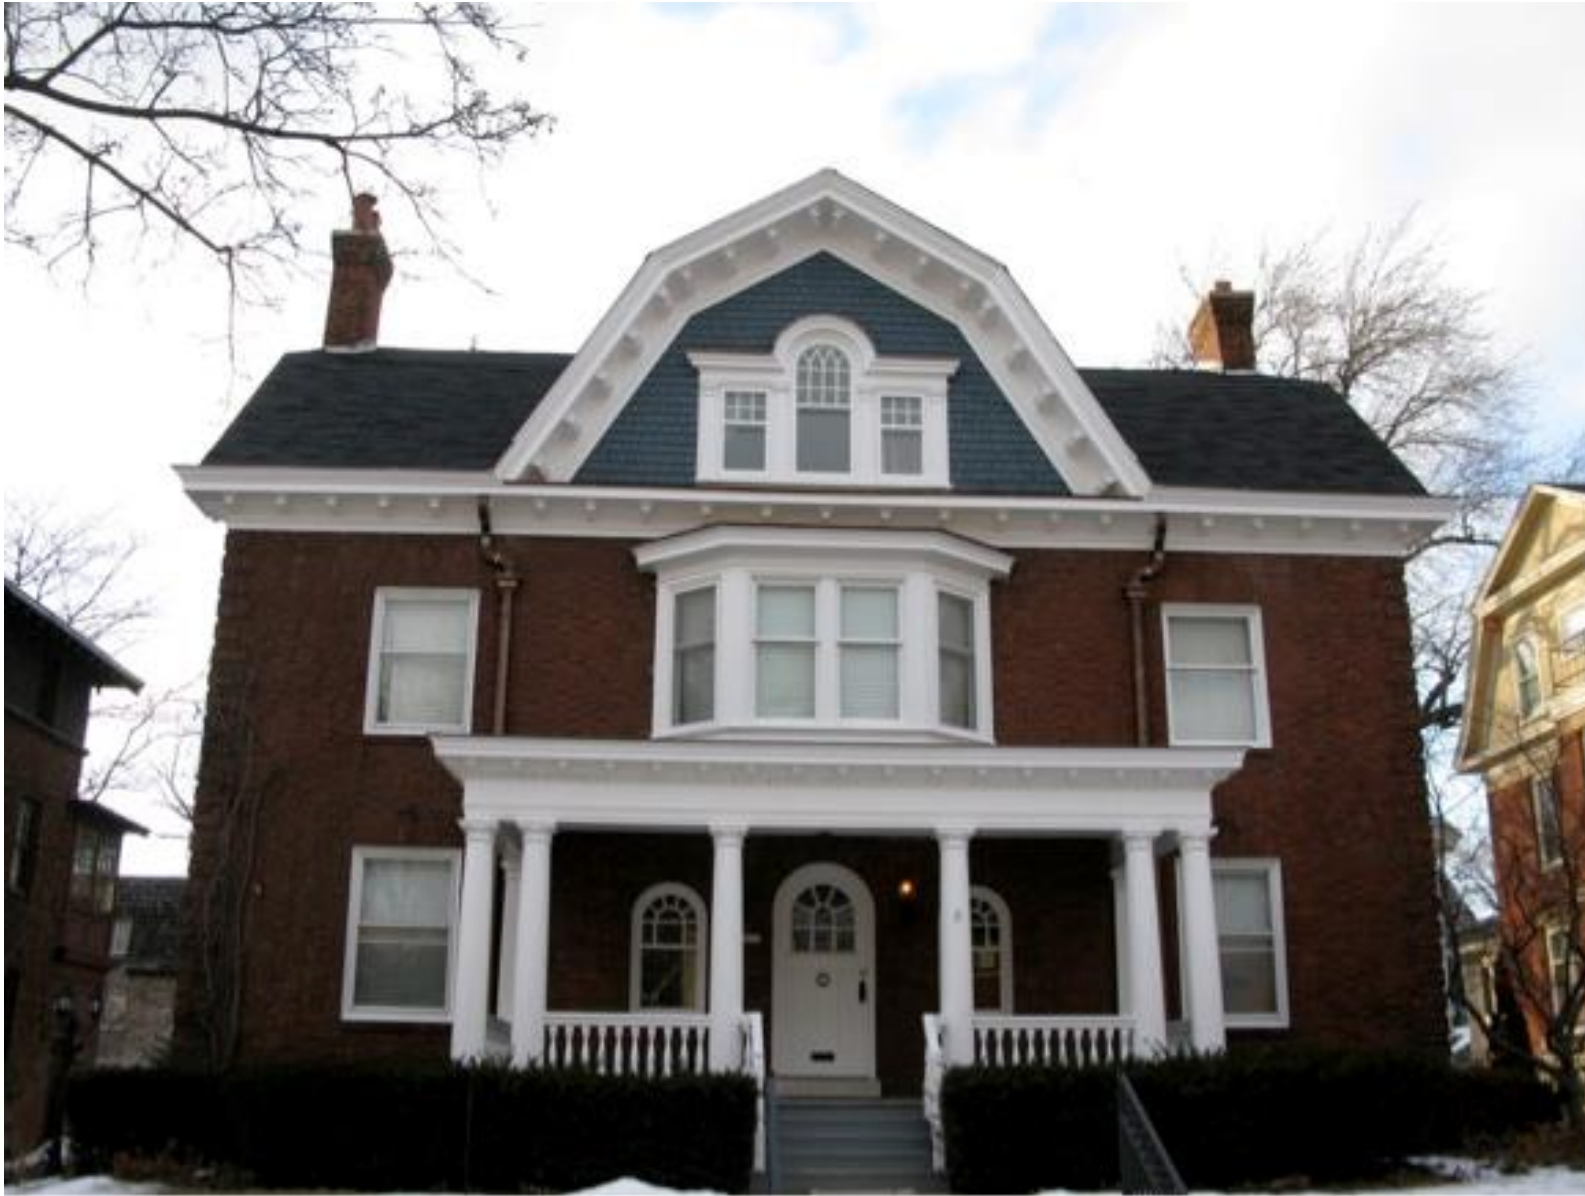
Front (East) elevation of the property

South chimney (Left) will be tuck pointed, damaged brick will be removed, and brick in good condition will be utilized at the rear (southwest) corner of the home for infill. The chimney will be reconstructed with brick and mortar that matches the existing condition. The chimney will retain its profile and corbeling.

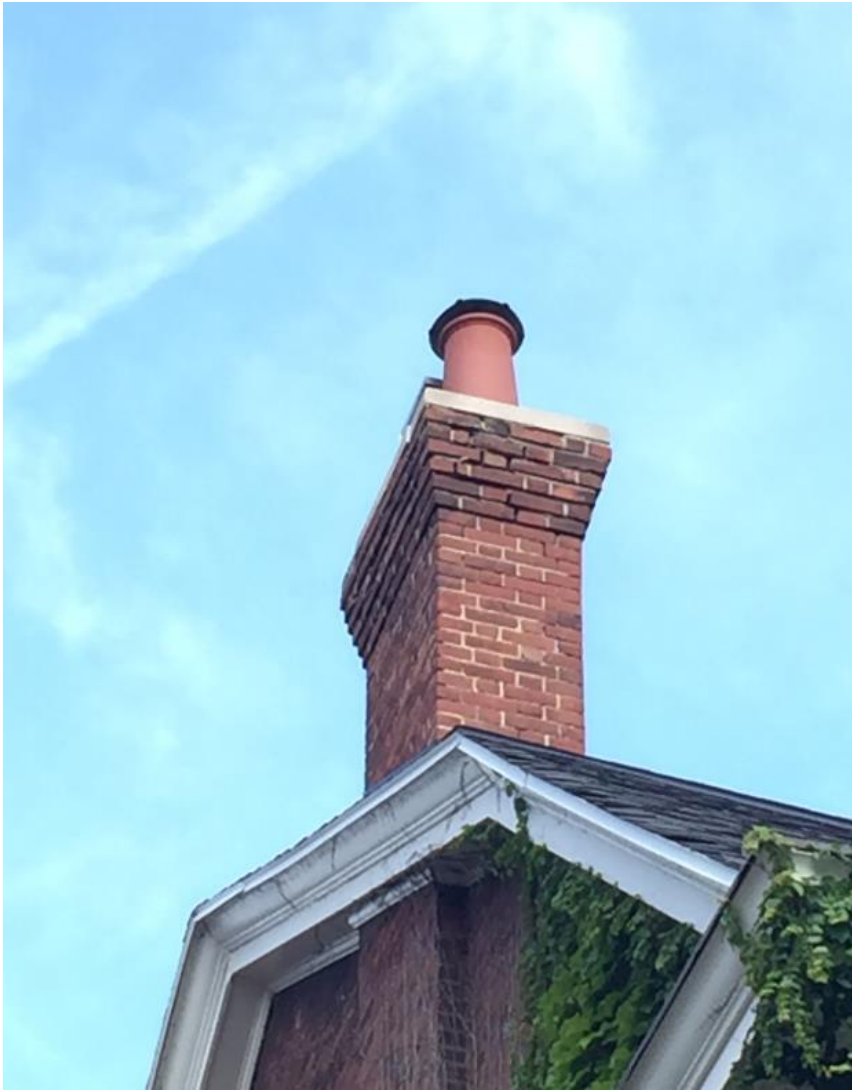
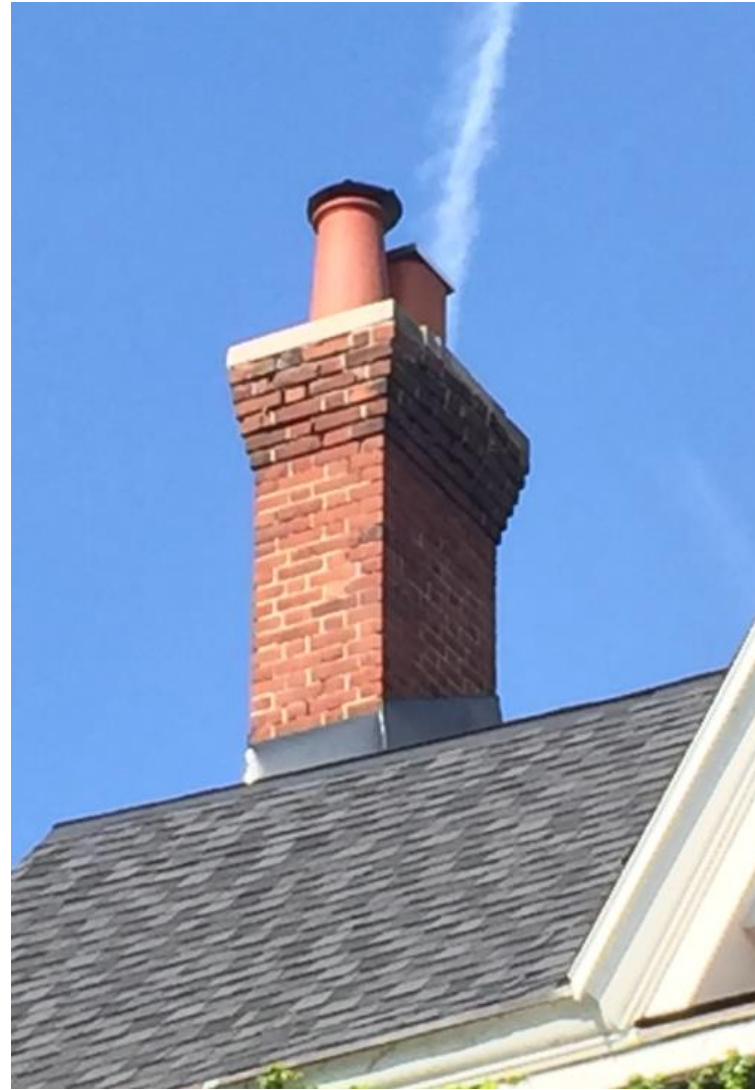
Images of South chimney to be tuck pointed, damaged brick will be removed, and brick in good condition will be utilized at the rear (southwest) corner of the home for infill. The chimney will be reconstructed with brick and mortar that matches the existing condition. The chimney will retain its profile and corbeling.

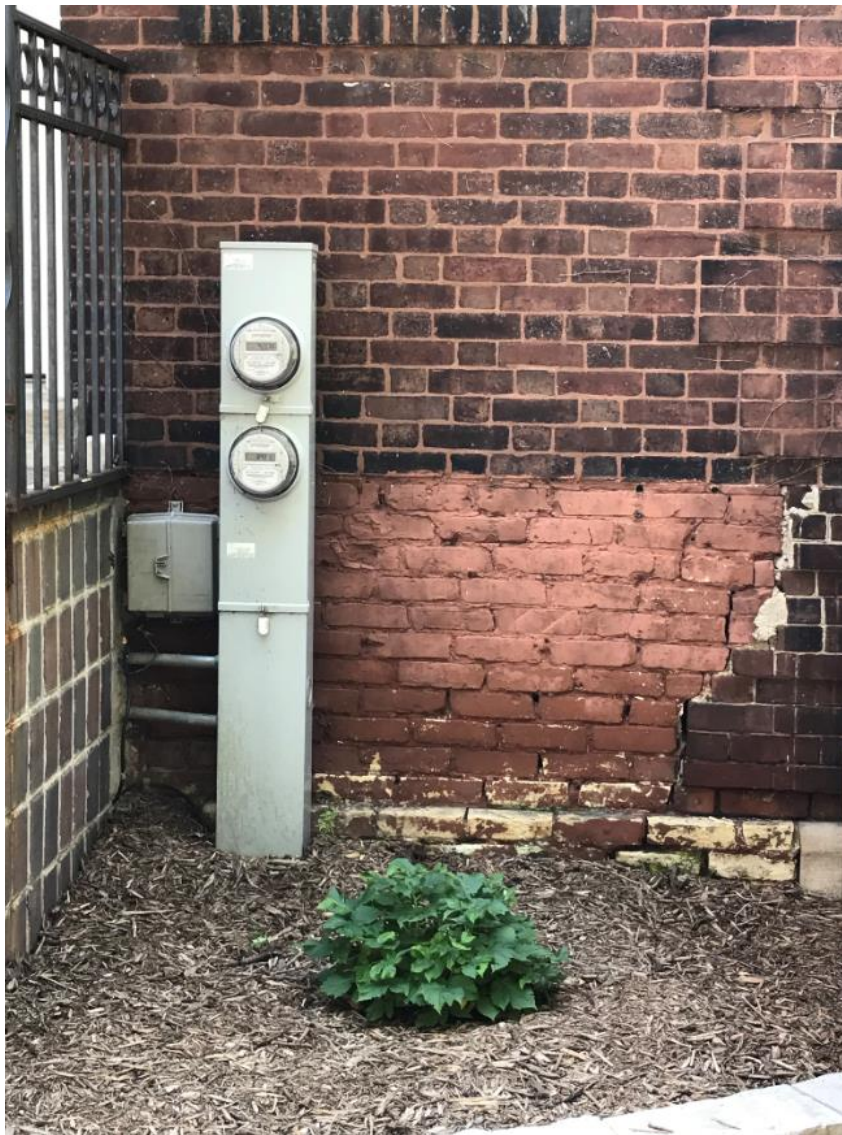
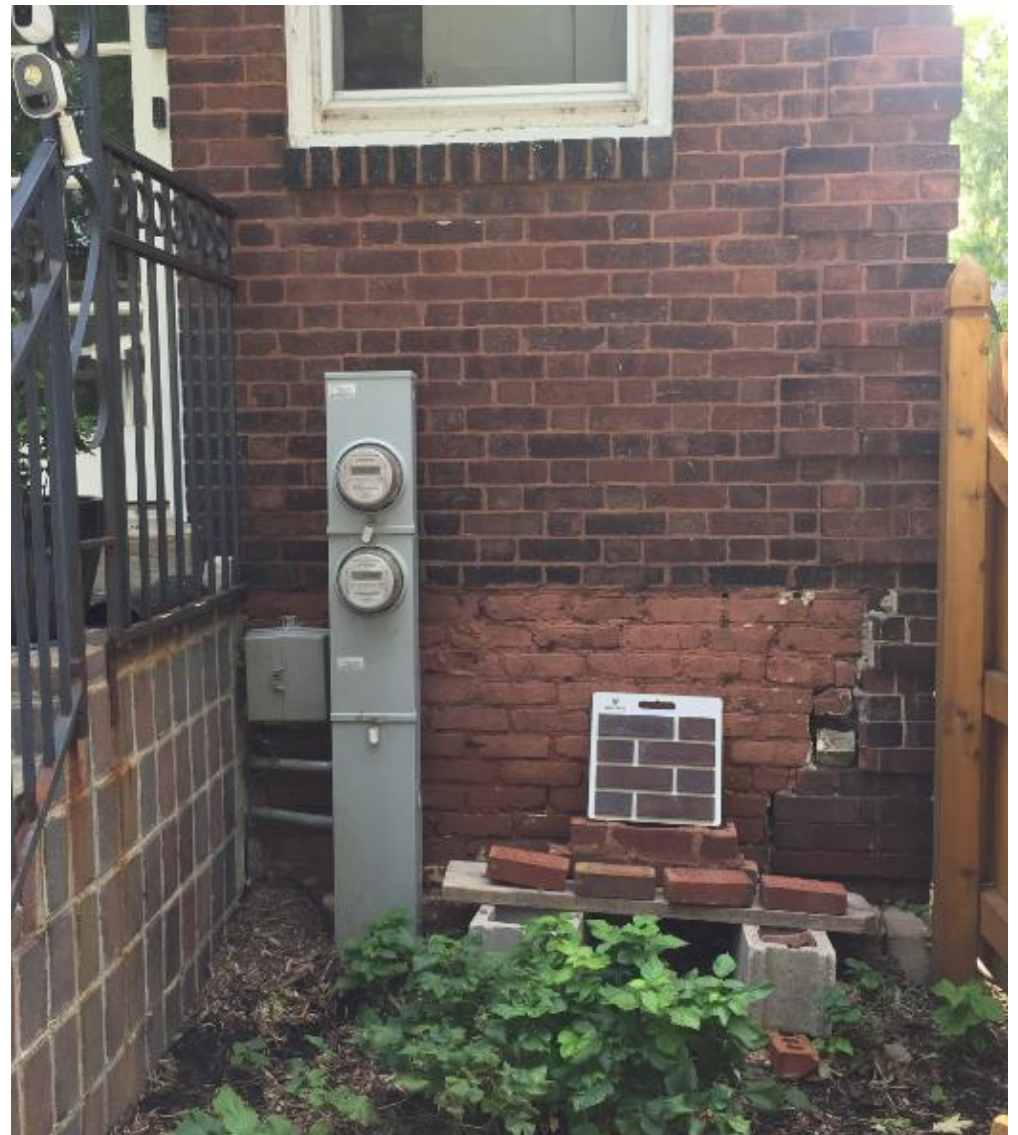
Images of southwest corner of the home. Brick infill will be removed. Right image include samples of brick and mortar to be utilized for new infill. Some bricks removed from the chimney will be mixed throughout the infill at the southwest corner. The new infill will match the existing Flemish bond utilized on the home. Mortar and brick sampled approved on-site 09-24-19.

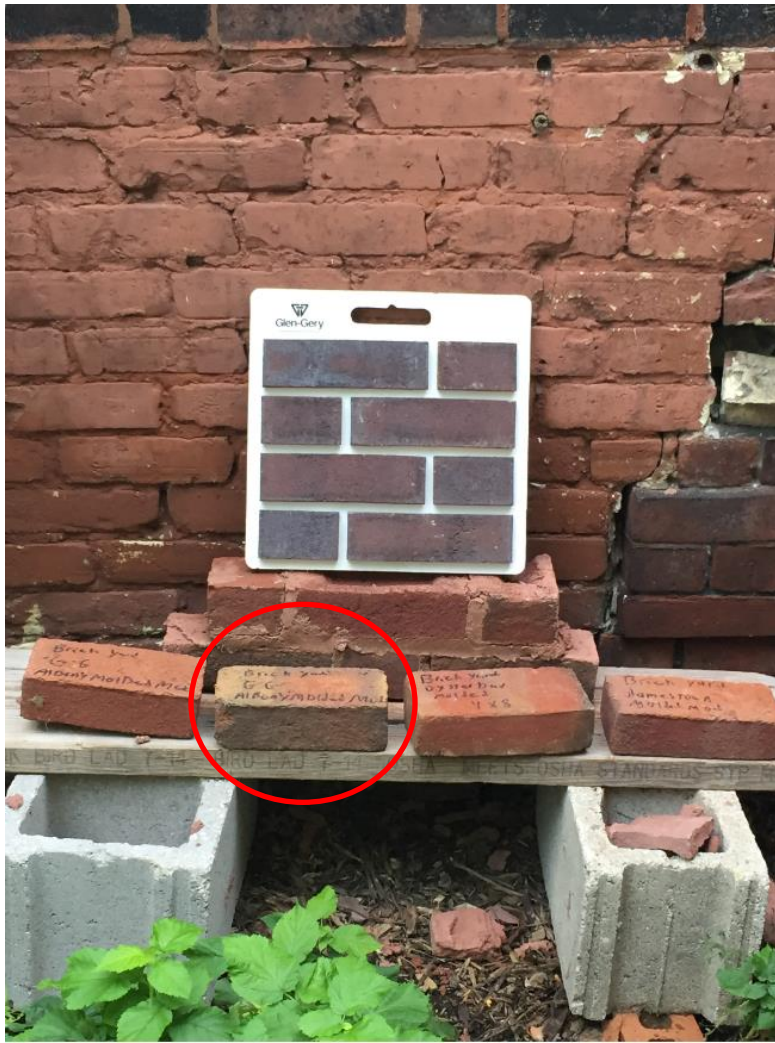
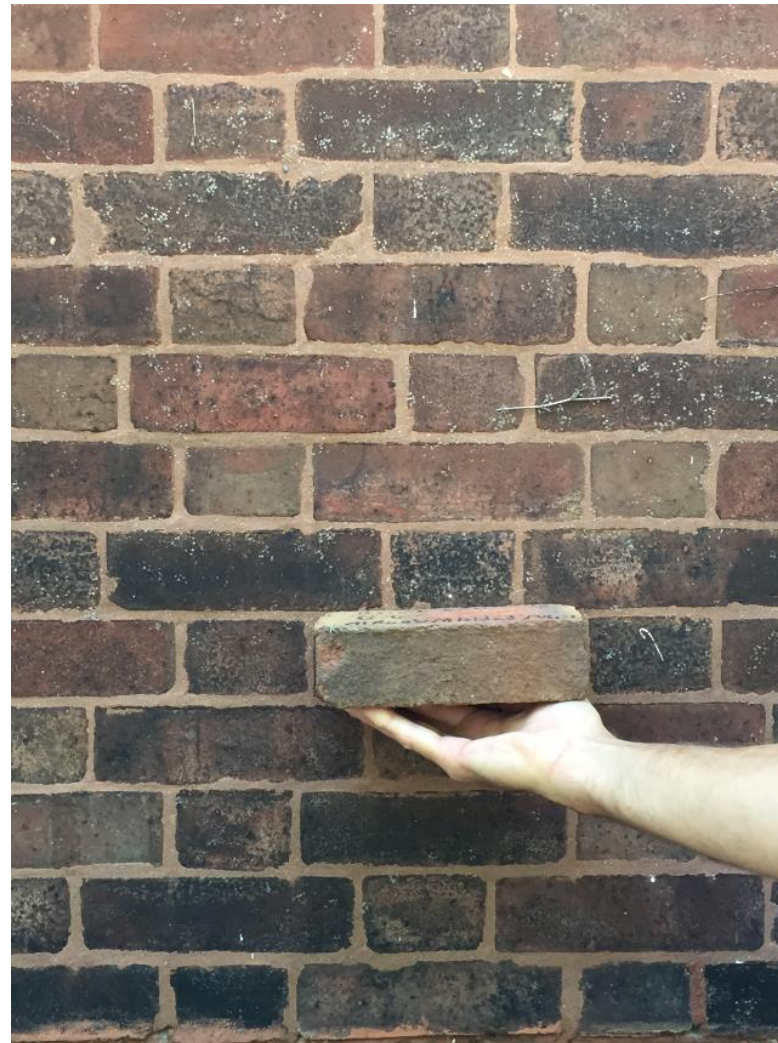
Detail images of (Left) the mortar sample, coursing sample (indicating Flemish bond) and (Right) brick to be utilized for infill at this location and for the reconstruction of the southern chimney

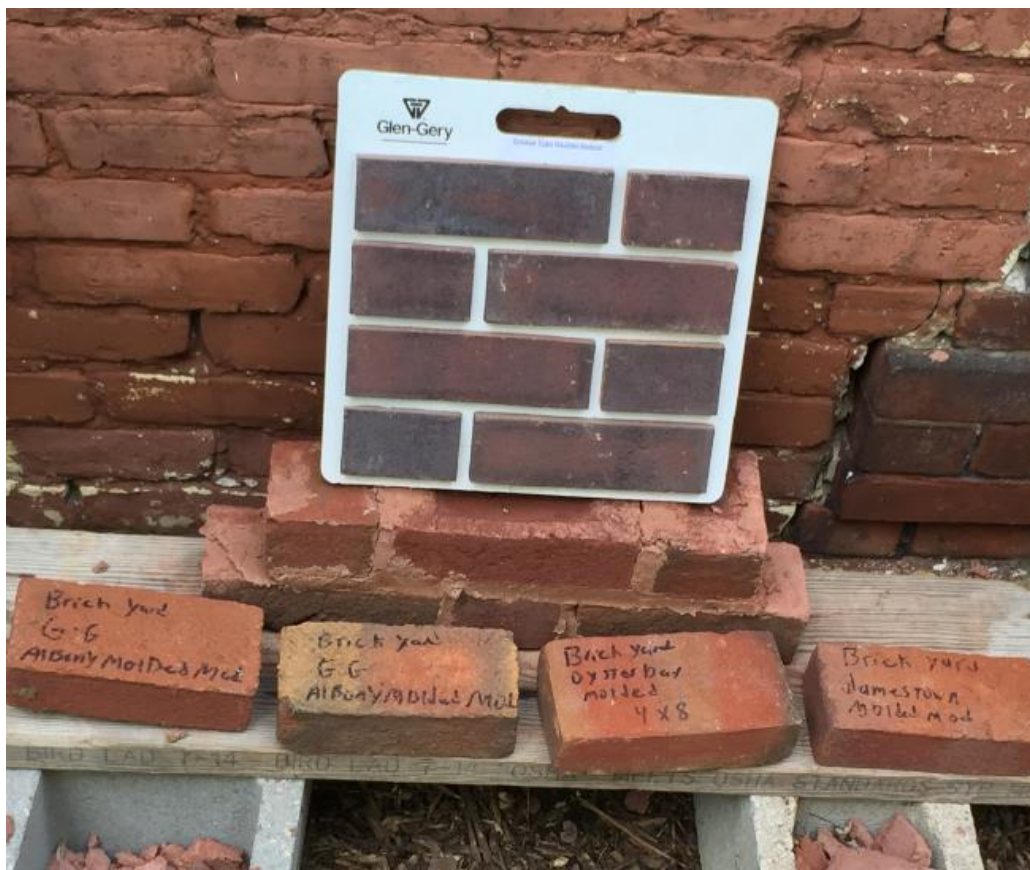
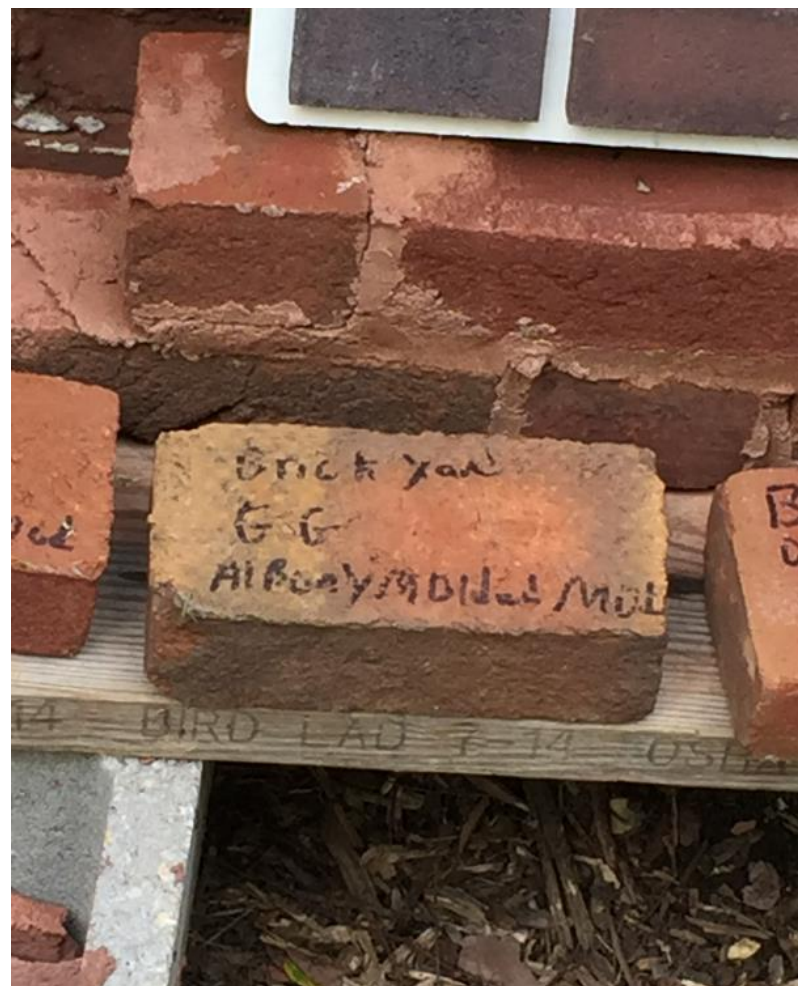
Detail images of coursing sample and brick to be utilized.

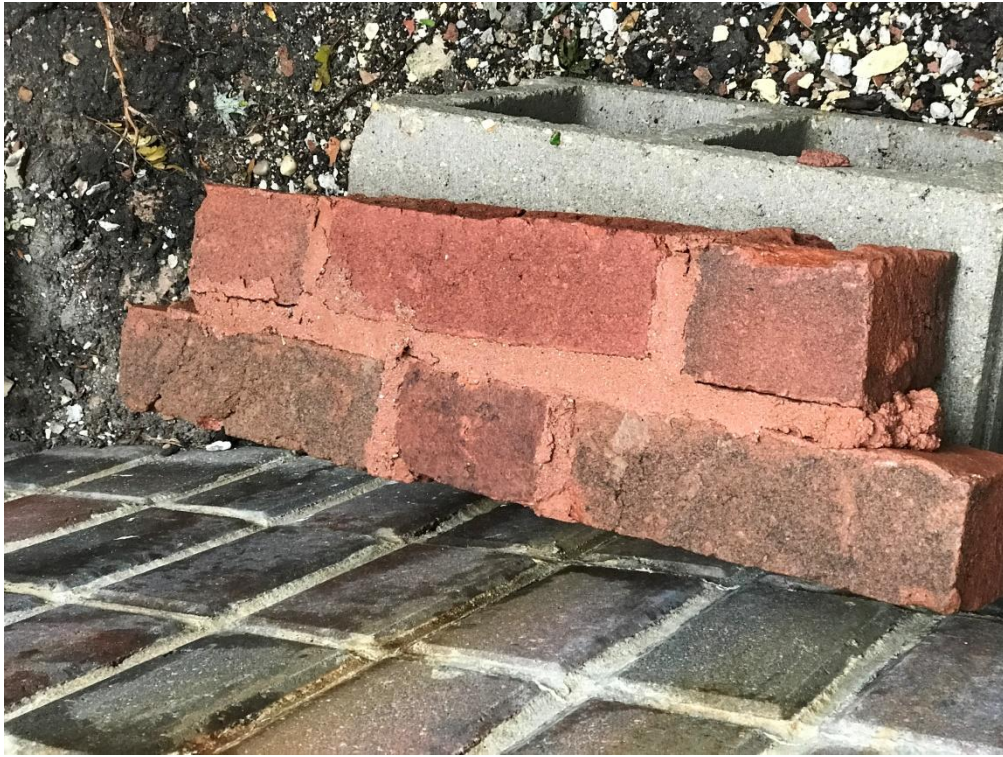
Mortar sample is approved as to color only. Joint profiles and thicknesses will match existing.

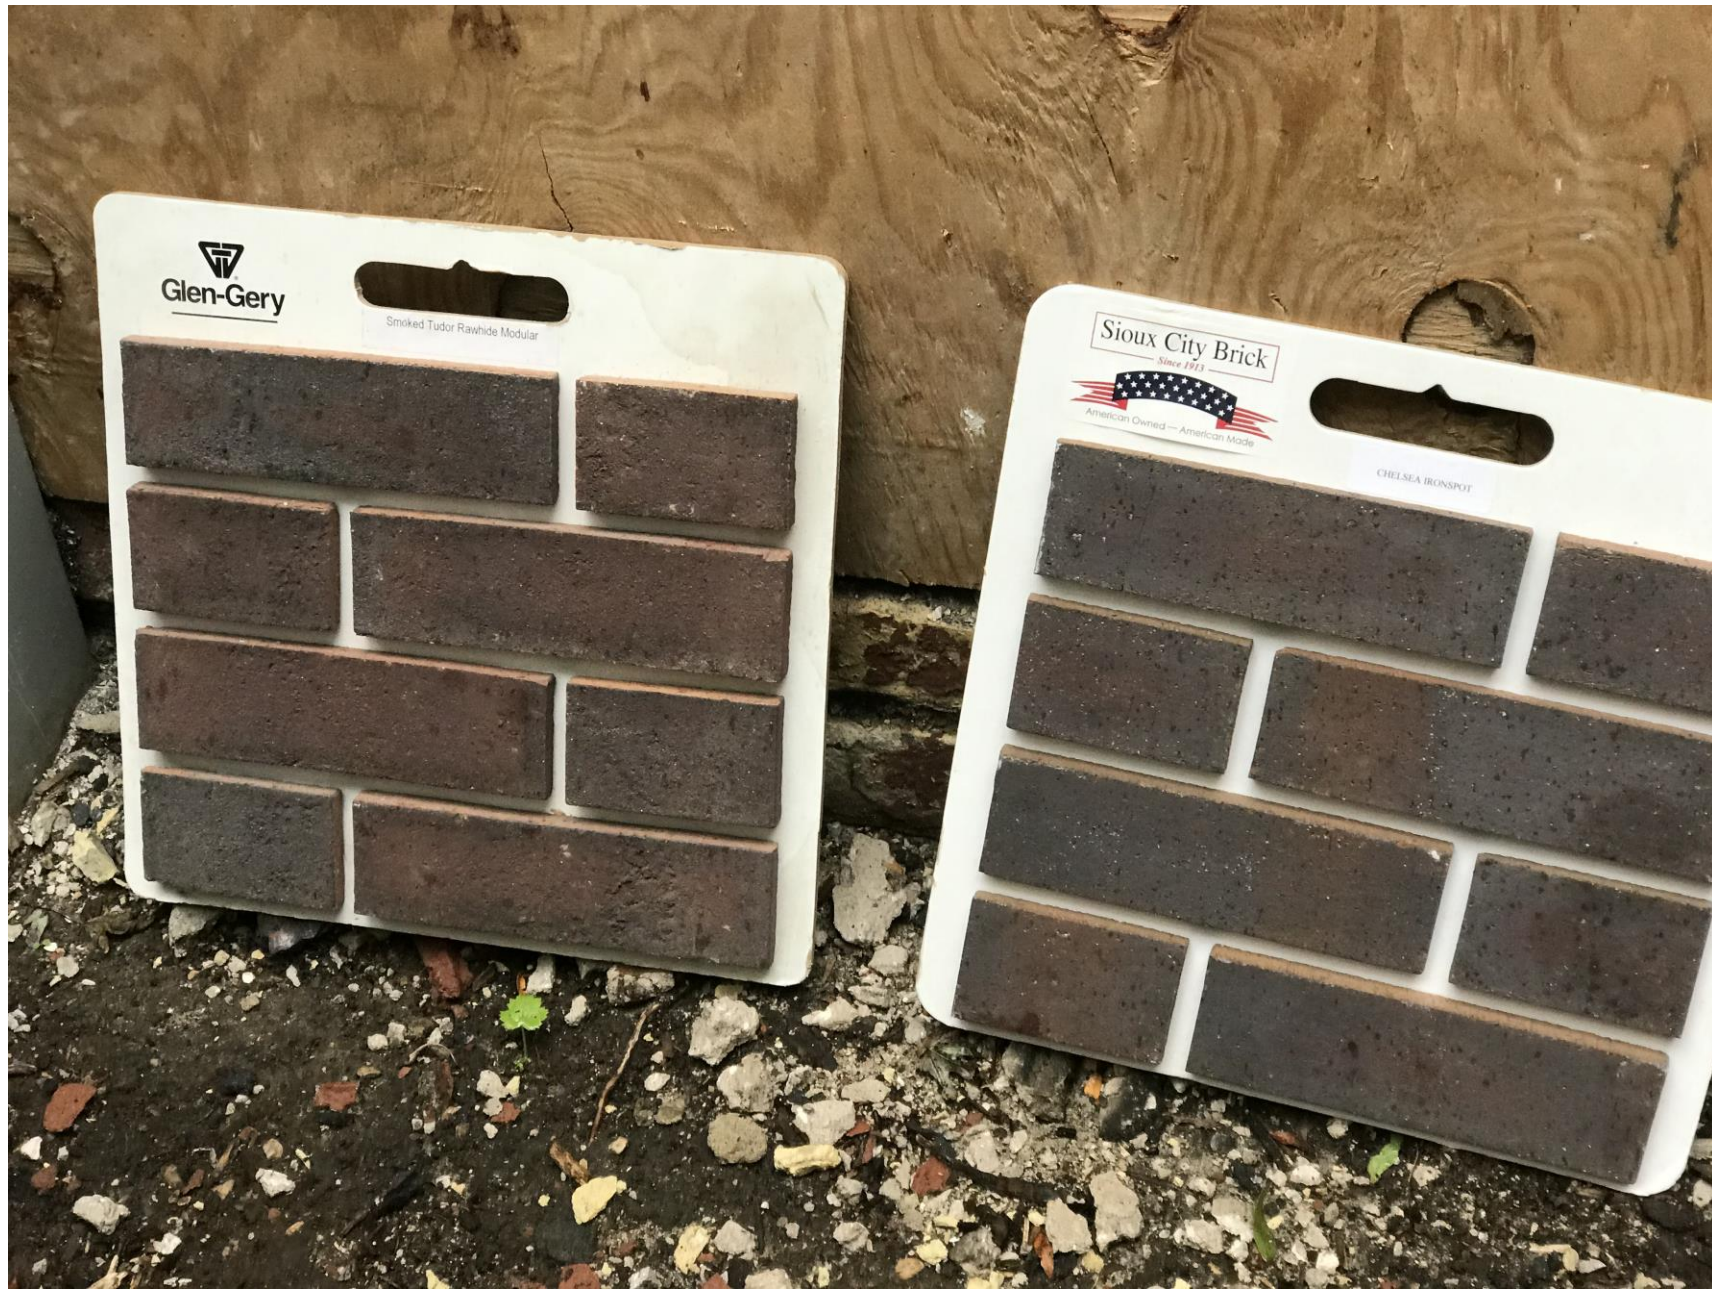
Glen Gery brick was discontinued before project could begin. Sioux City sample at right will substitute.
