Turner Hall
1034 N Vel R Phillips Ave
Milwaukee, WI 53203

FEMA Grant Safety and Security Project
Certificate of Appropriateness Application
Drawing and Photo Exhibits

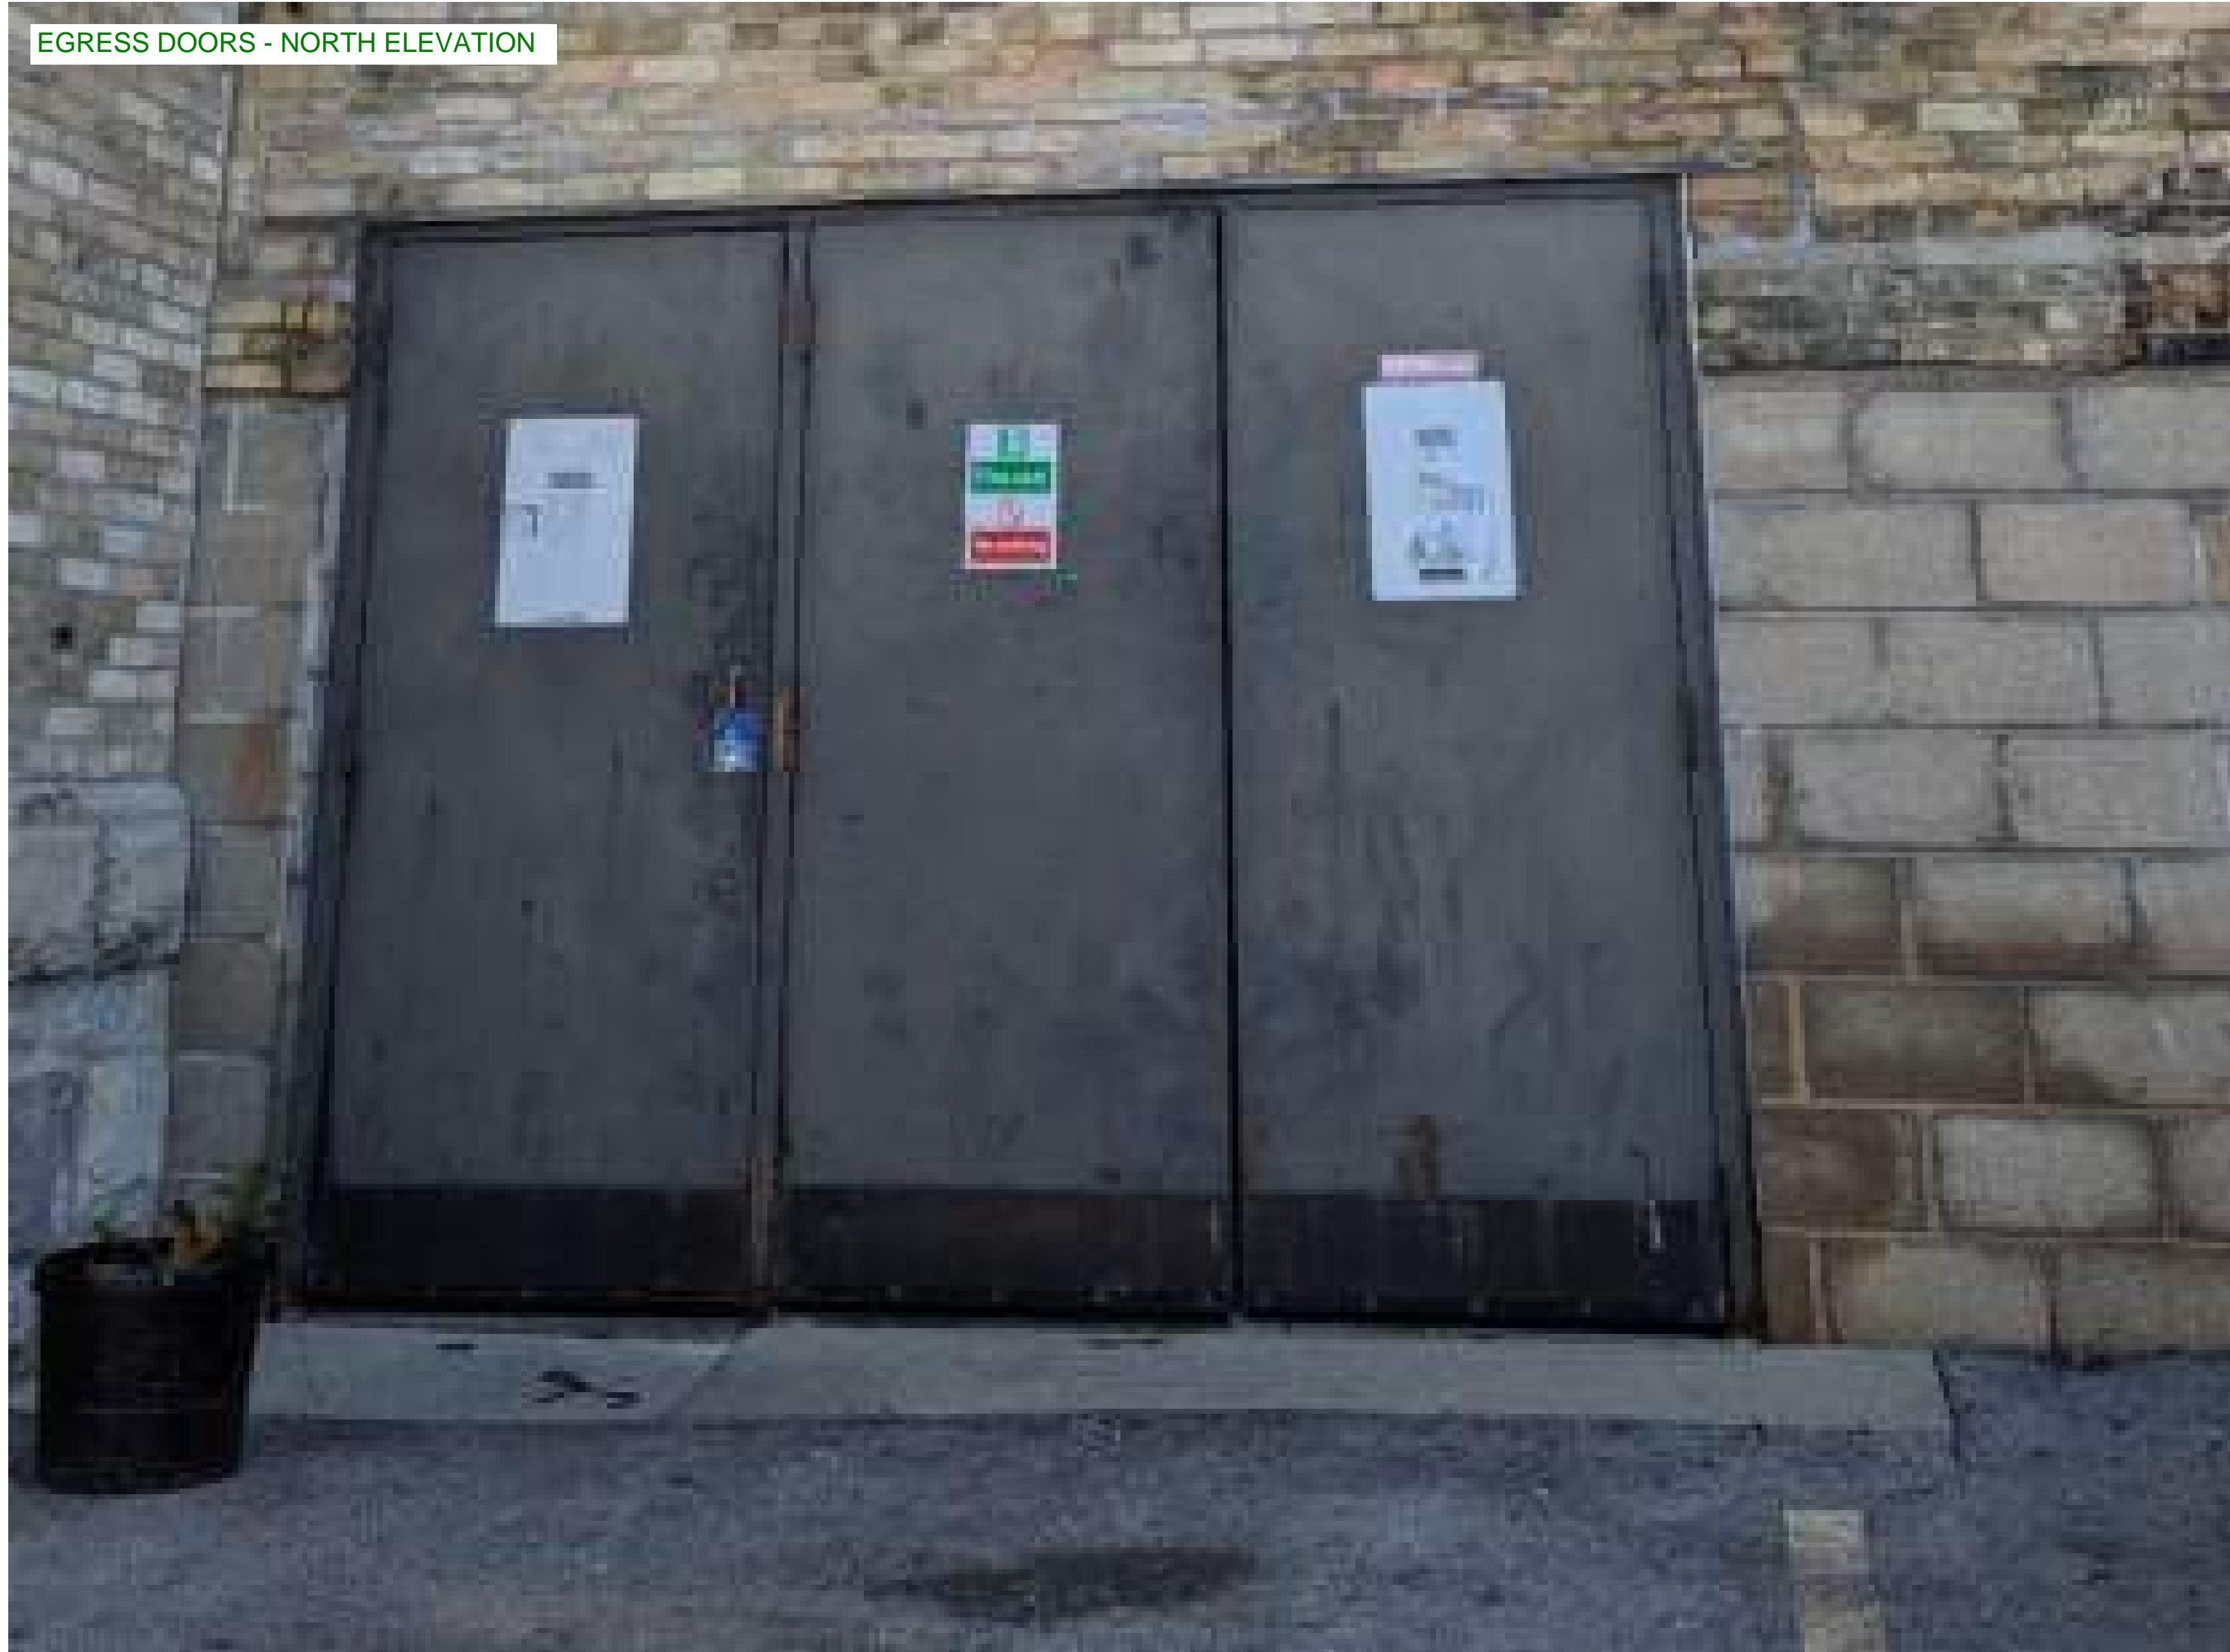
EGRESS DOORS - NORTH ELEVATION

Non-original metal doors, in non-original opening to be replaced with new metal single panel doors. Doors and frames to be painted cream to match adjacent historic brick

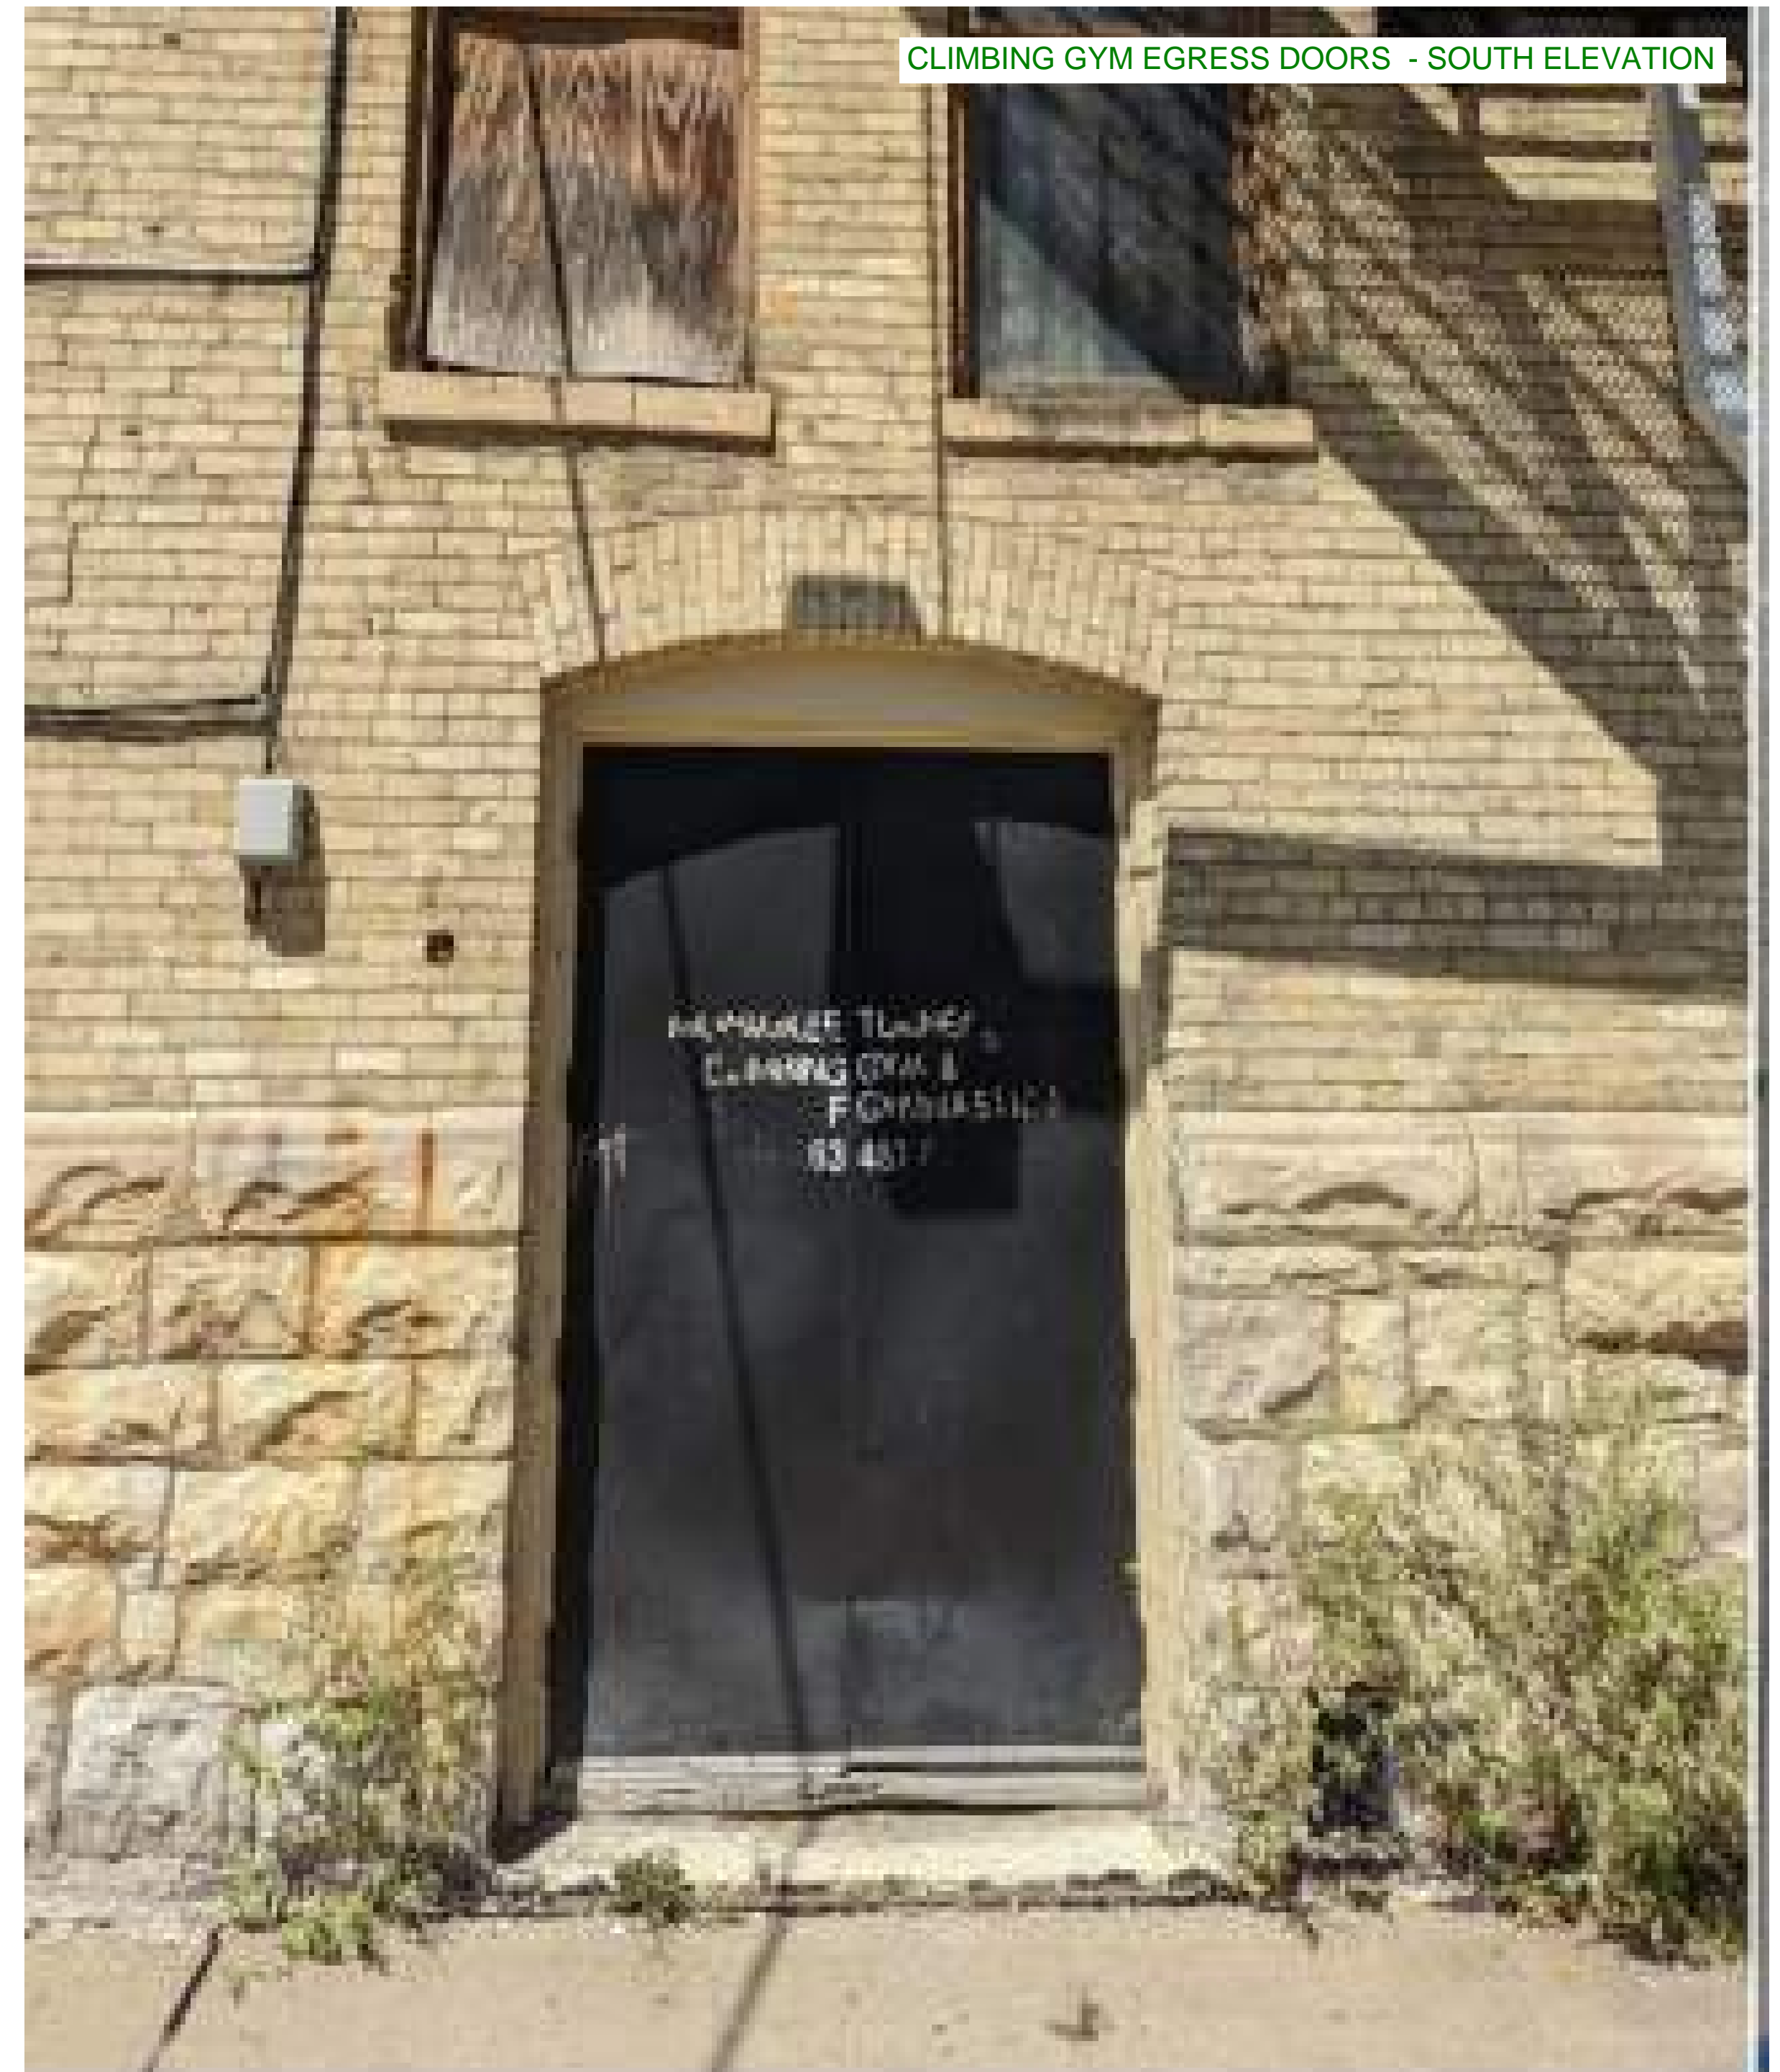
CLIMBING GYM EGRESS DOORS - SOUTH ELEVATION

Non-original metal double doors in historic open. Historic opening to remain intact. New single panel metal double doors to be installed in existing opening. Original door configuration unknown.

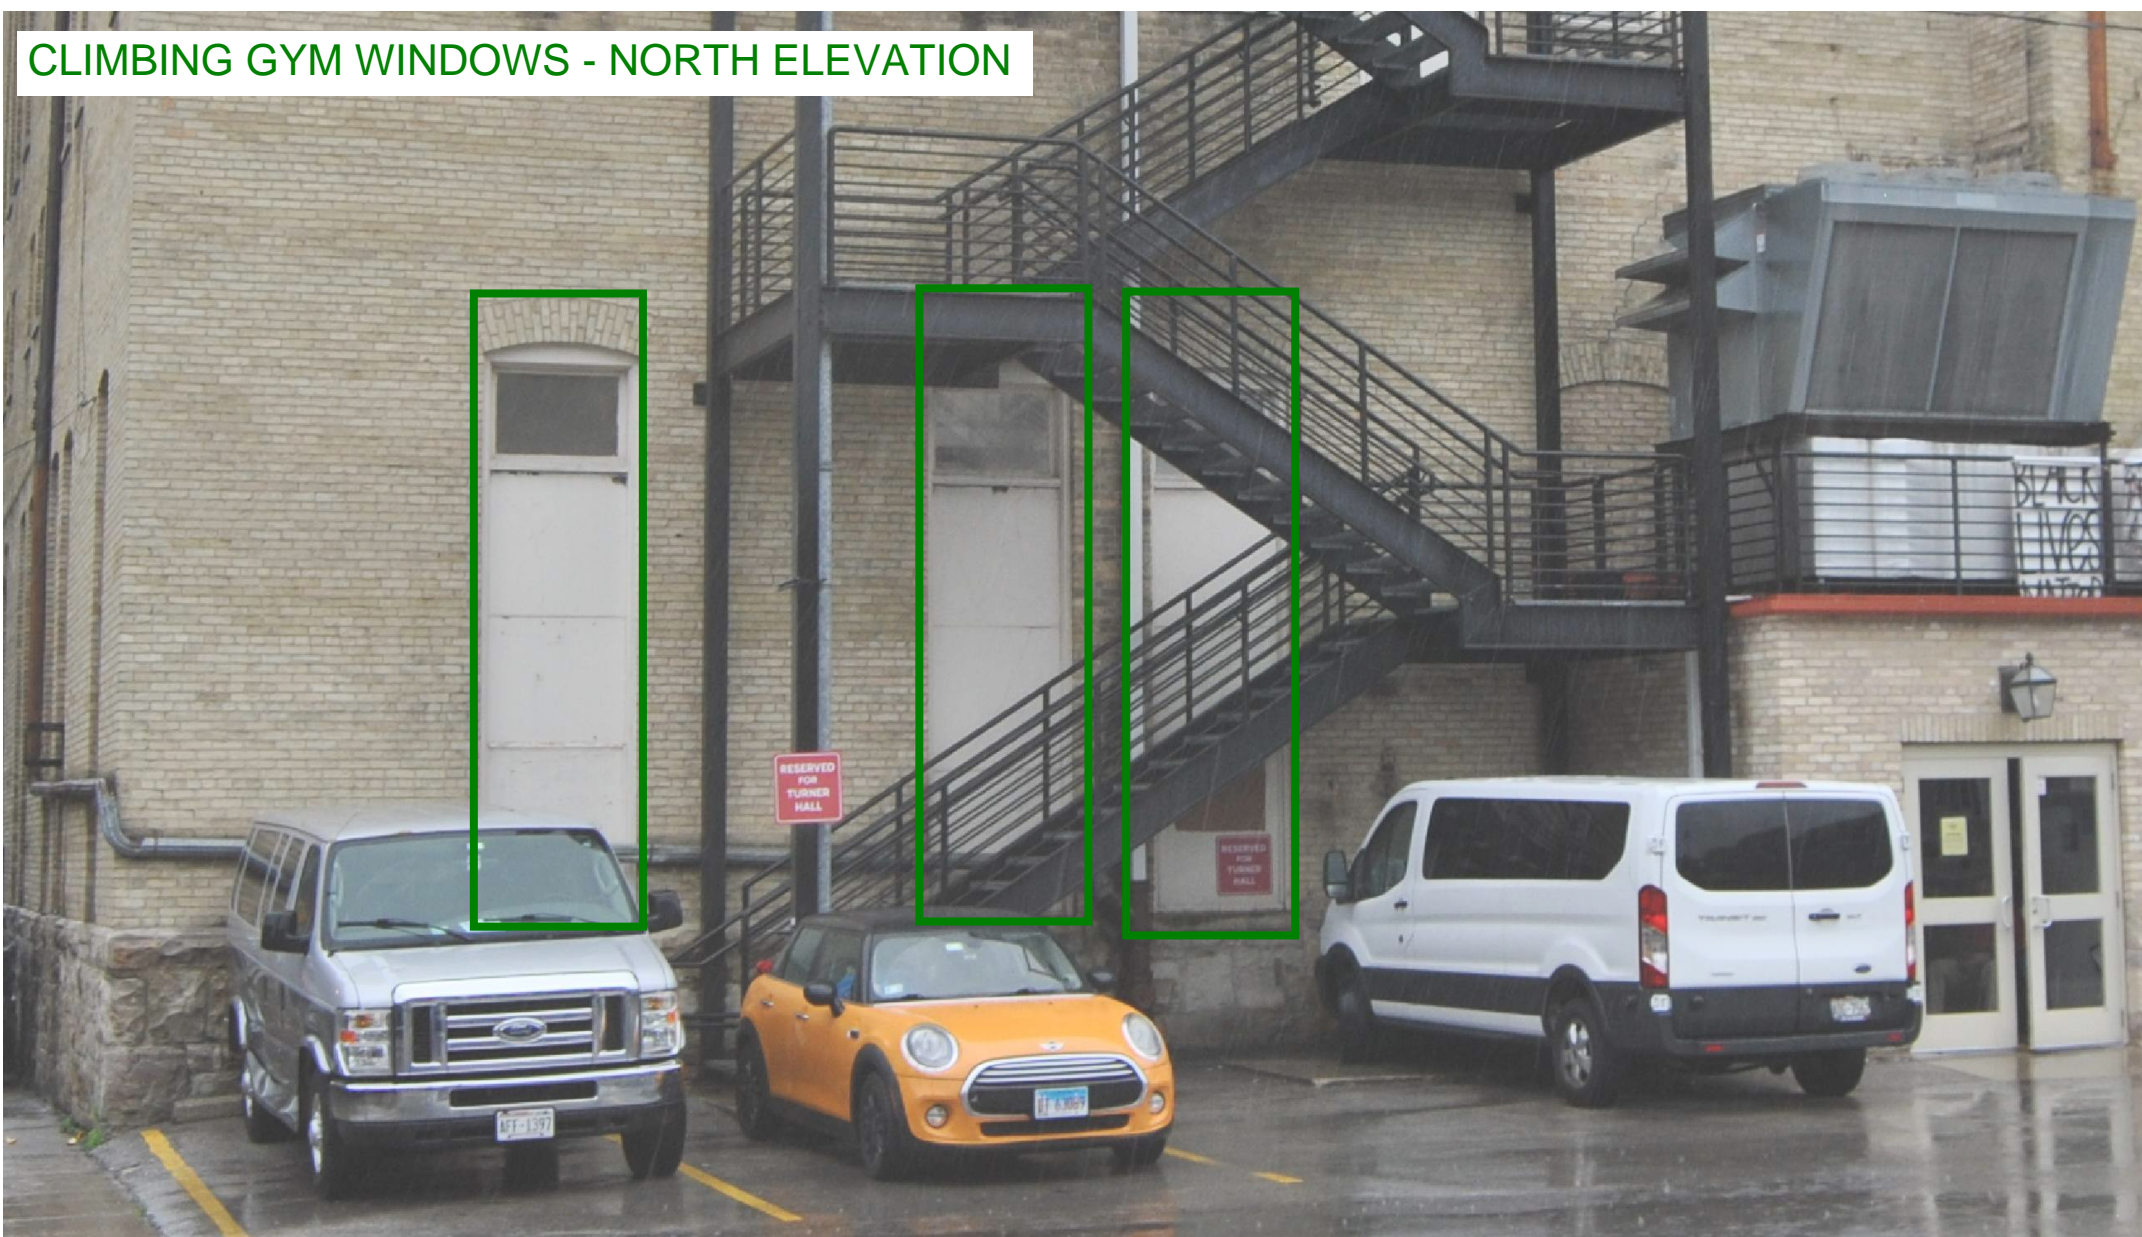
Original wood windows at the Climbing Gym. Rigid insulation protective panels have been applied from the interior. Beneath the protective panels, some of the original wire glass exists, but if it does, it has been painted from the exterior and most of the panes are broken. Several of the panes have also been replaced with wood panels.

The scope of work for each window proposes to restore the original wood frame, remove and repair the existing sashes (when possible), and replace the existing glazing with new safety glazing and film. The new glazing will bring natural light back into the gym space, as was originally intended.

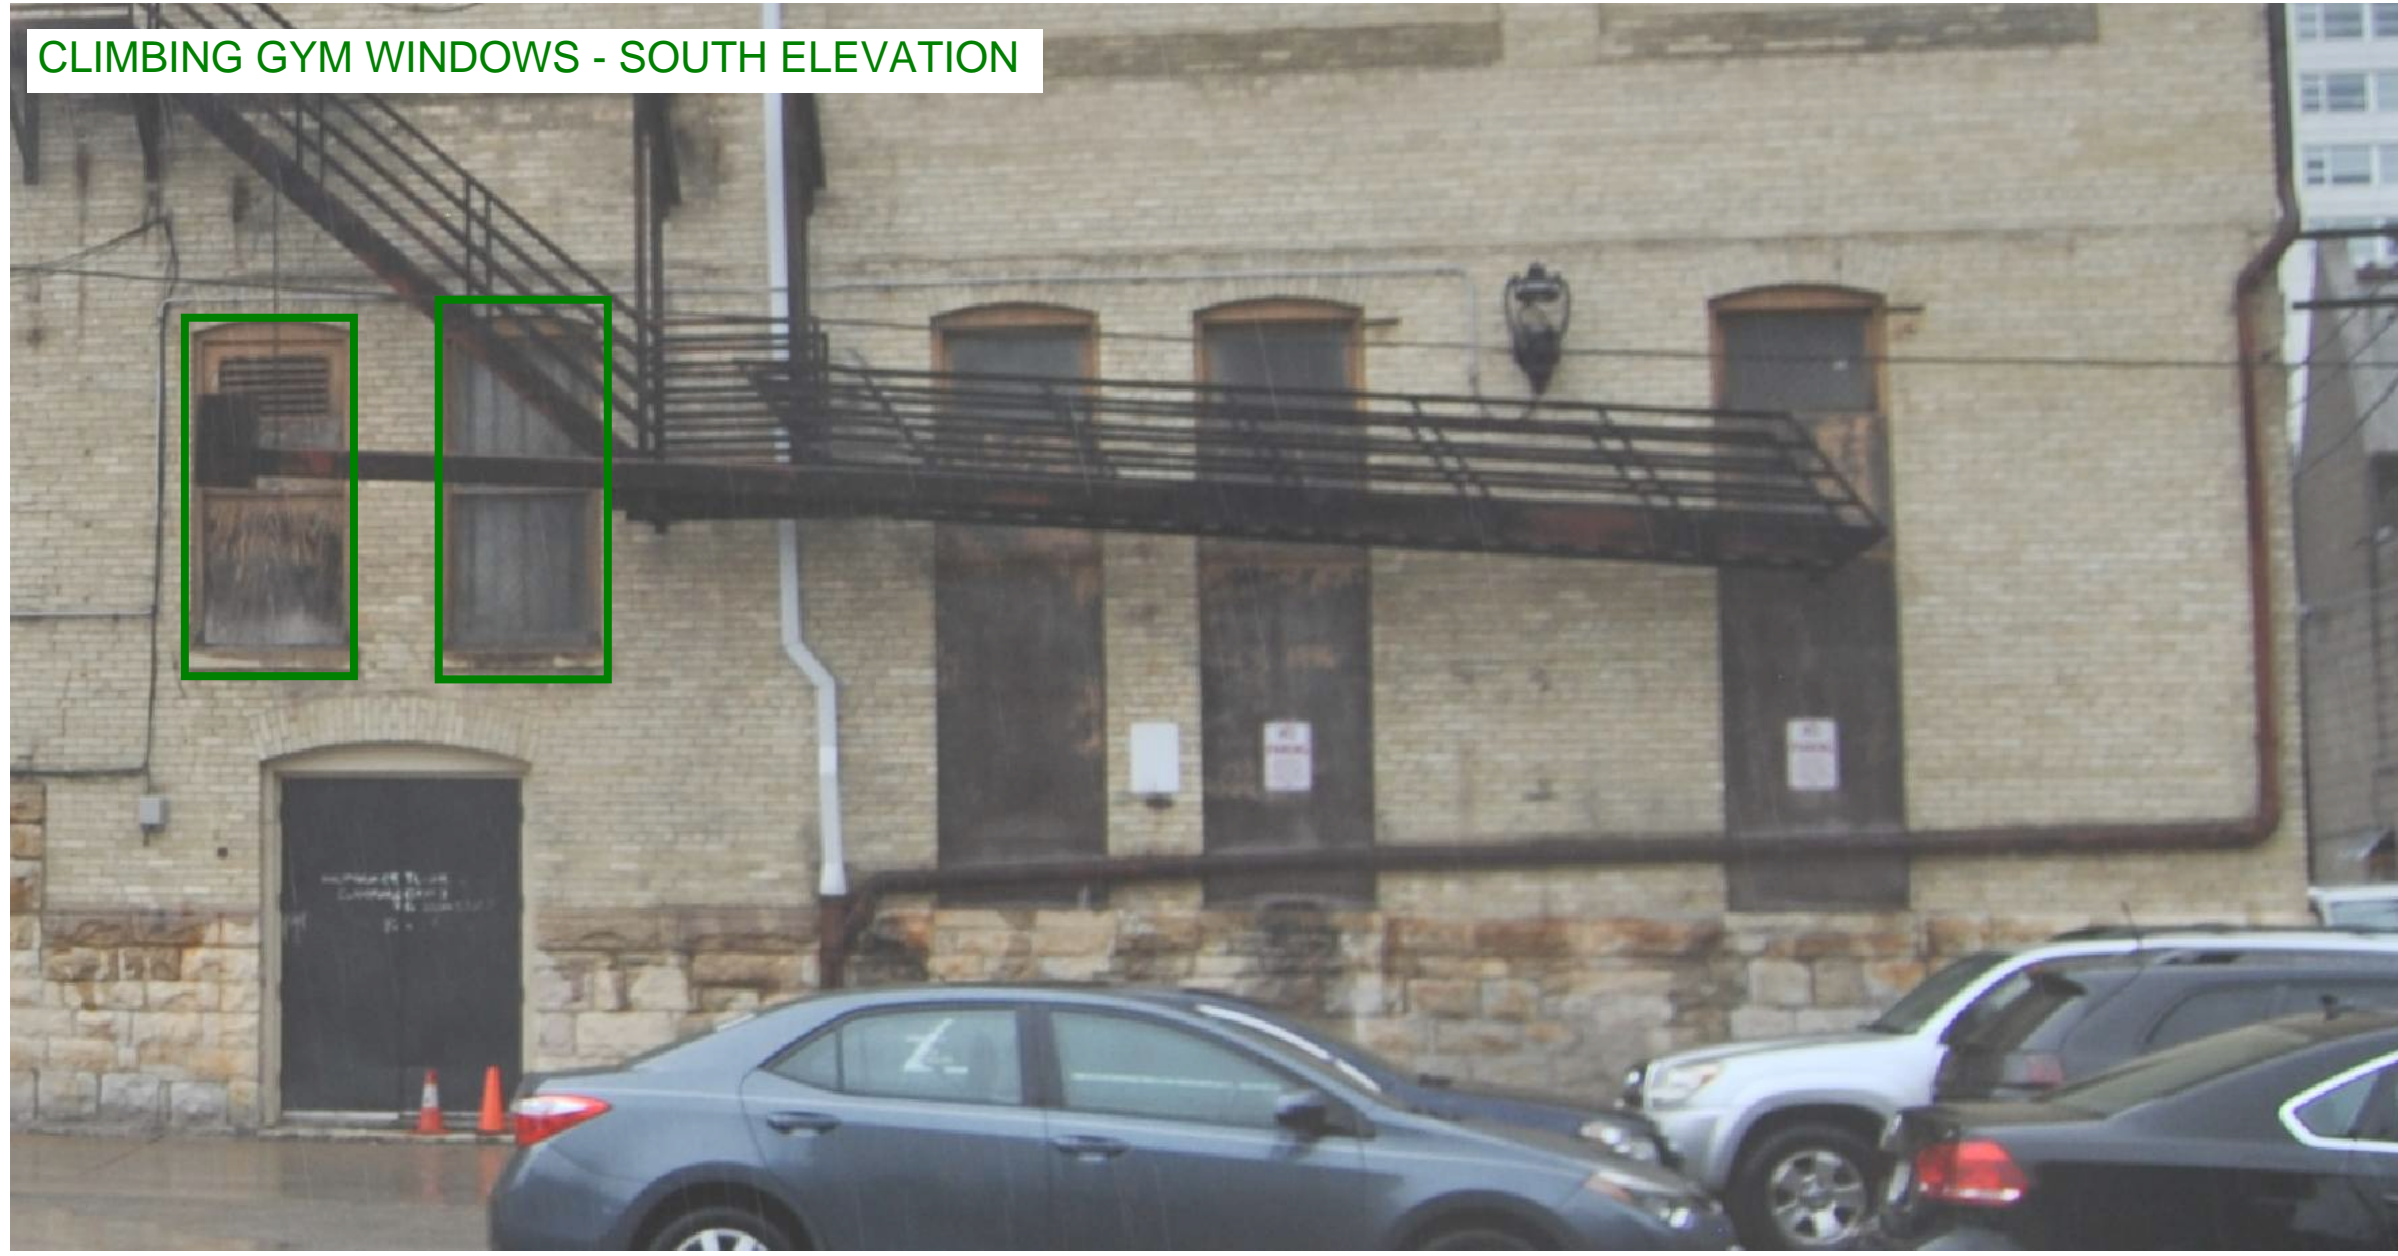
CLIMBING GYM WINDOWS - SOUTH ELEVATION

Original wood windows at the Climbing Gym. Protective panels have been applied from the interior. Beneath the protective panels, some of the original wire glass exist.

The scope of work for each window proposes to restore the original wood frame, remove and repair the existing sashes (when possible), and replace the existing glazing with new safety glazing and film. The new glazing will bring natural light back into the gym space, as was originally intended.

Provide new metal louver and infill panel. Paint to match window frame/sash color.

Repair and restore existing wood frame

Remove and repair existing sash when feasible. If sash is too deteriorated, provide new to match existing.

Replace existing glazing with new safety glass

Install new 8 Mil Safety and Security series Lumar window film.

Remove wood infill panels, where occurs

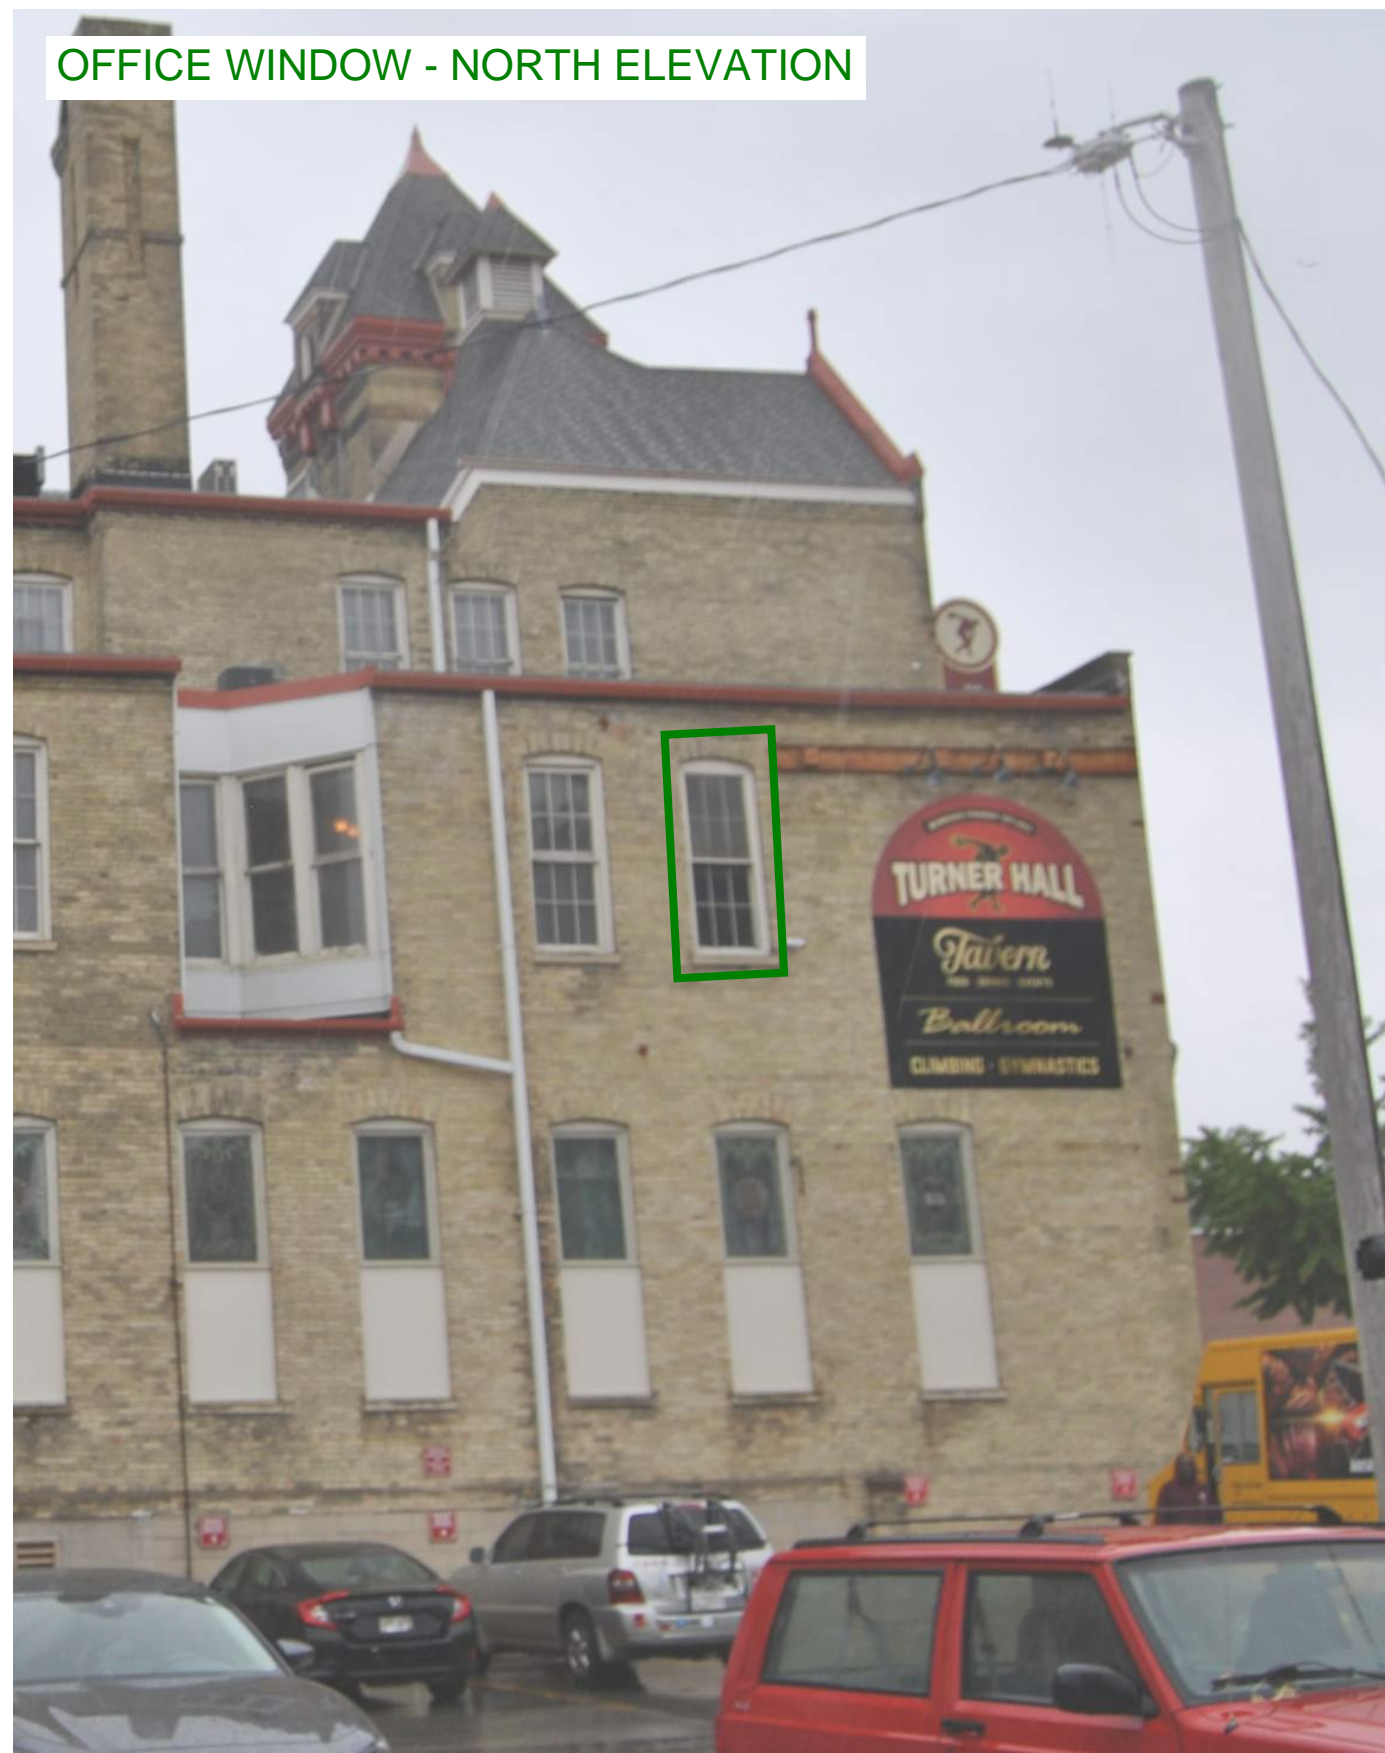
OFFICE WINDOW - NORTH ELEVATION

Original wood window at the Office Storage room. Wood rot and previous poor quality repairs have made it infeasible to repair this window. The previous repairs have made the window sash too small to fit in the current frame.

The scope of work for this window proposes to replace this window in kind, with a new wood window of the same configuration and profile. After the new window is installed, 8 Mil Safety and Security series Lumar window film will be installed over the new glazing.

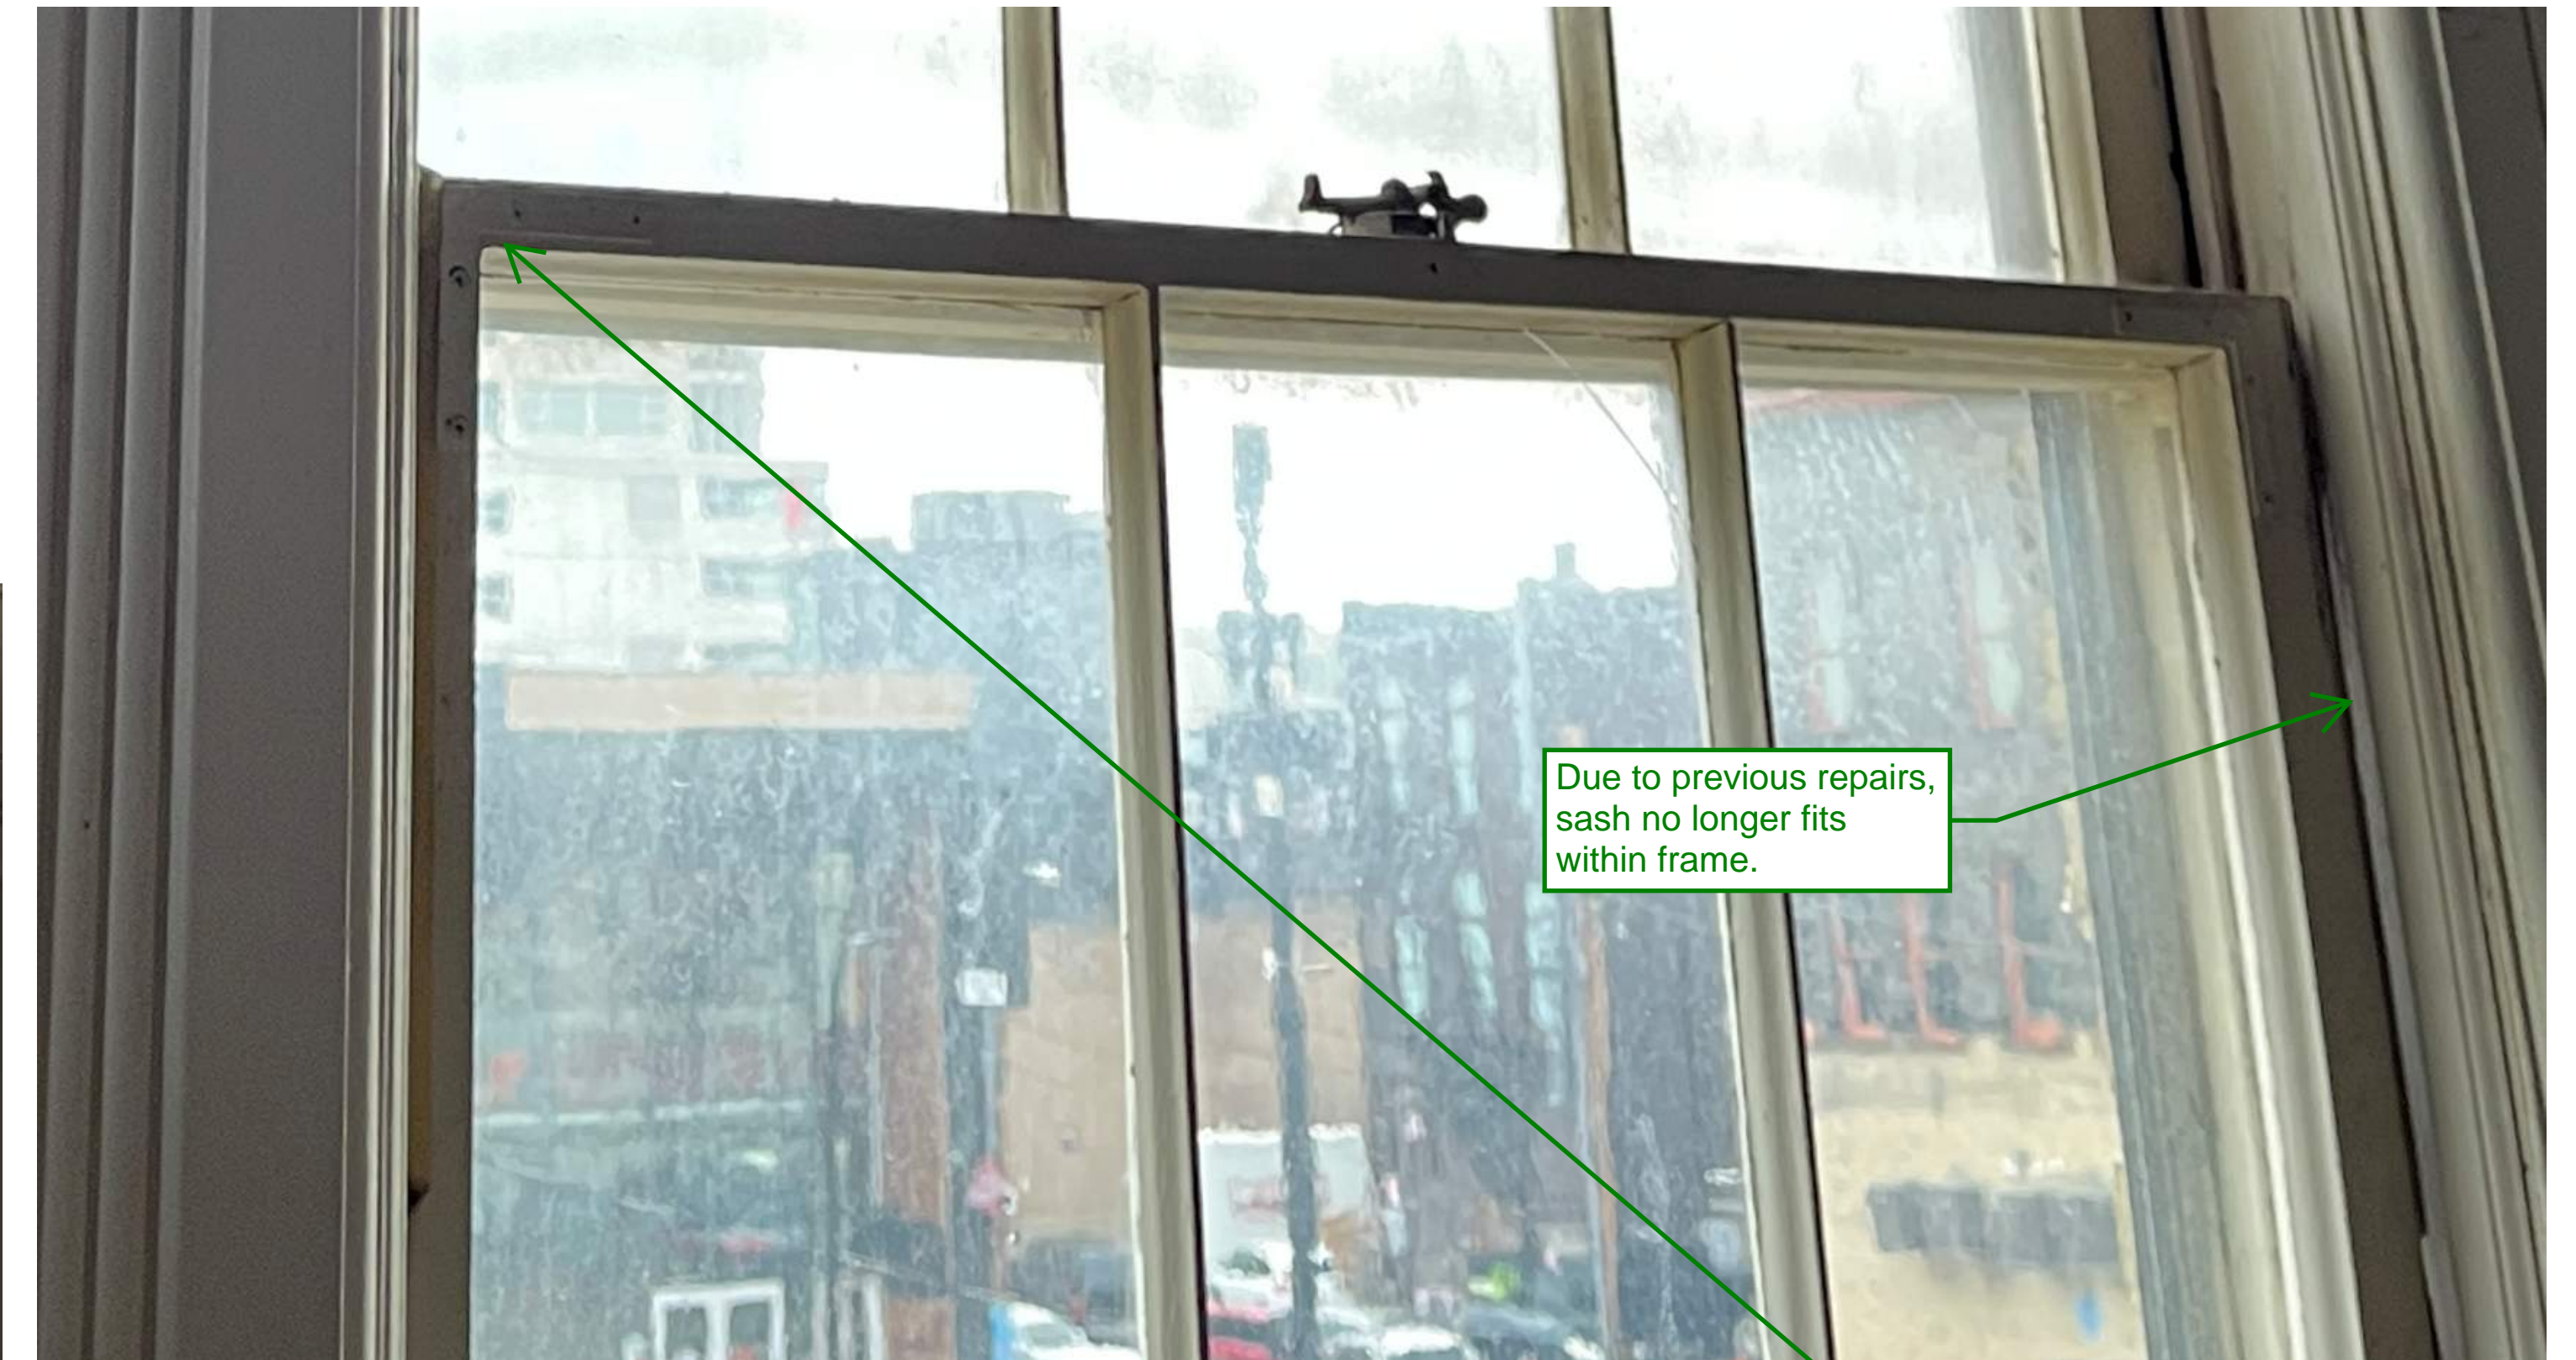
Due to previous repairs, sash no longer fits within frame.
