Turner Hall
1034 N Vel R Phillips Ave
Milwaukee, WI 53203

FEMA Grant Safety and Security Project
Certificate of Appropriateness Application
Drawing and Photo Exhibits

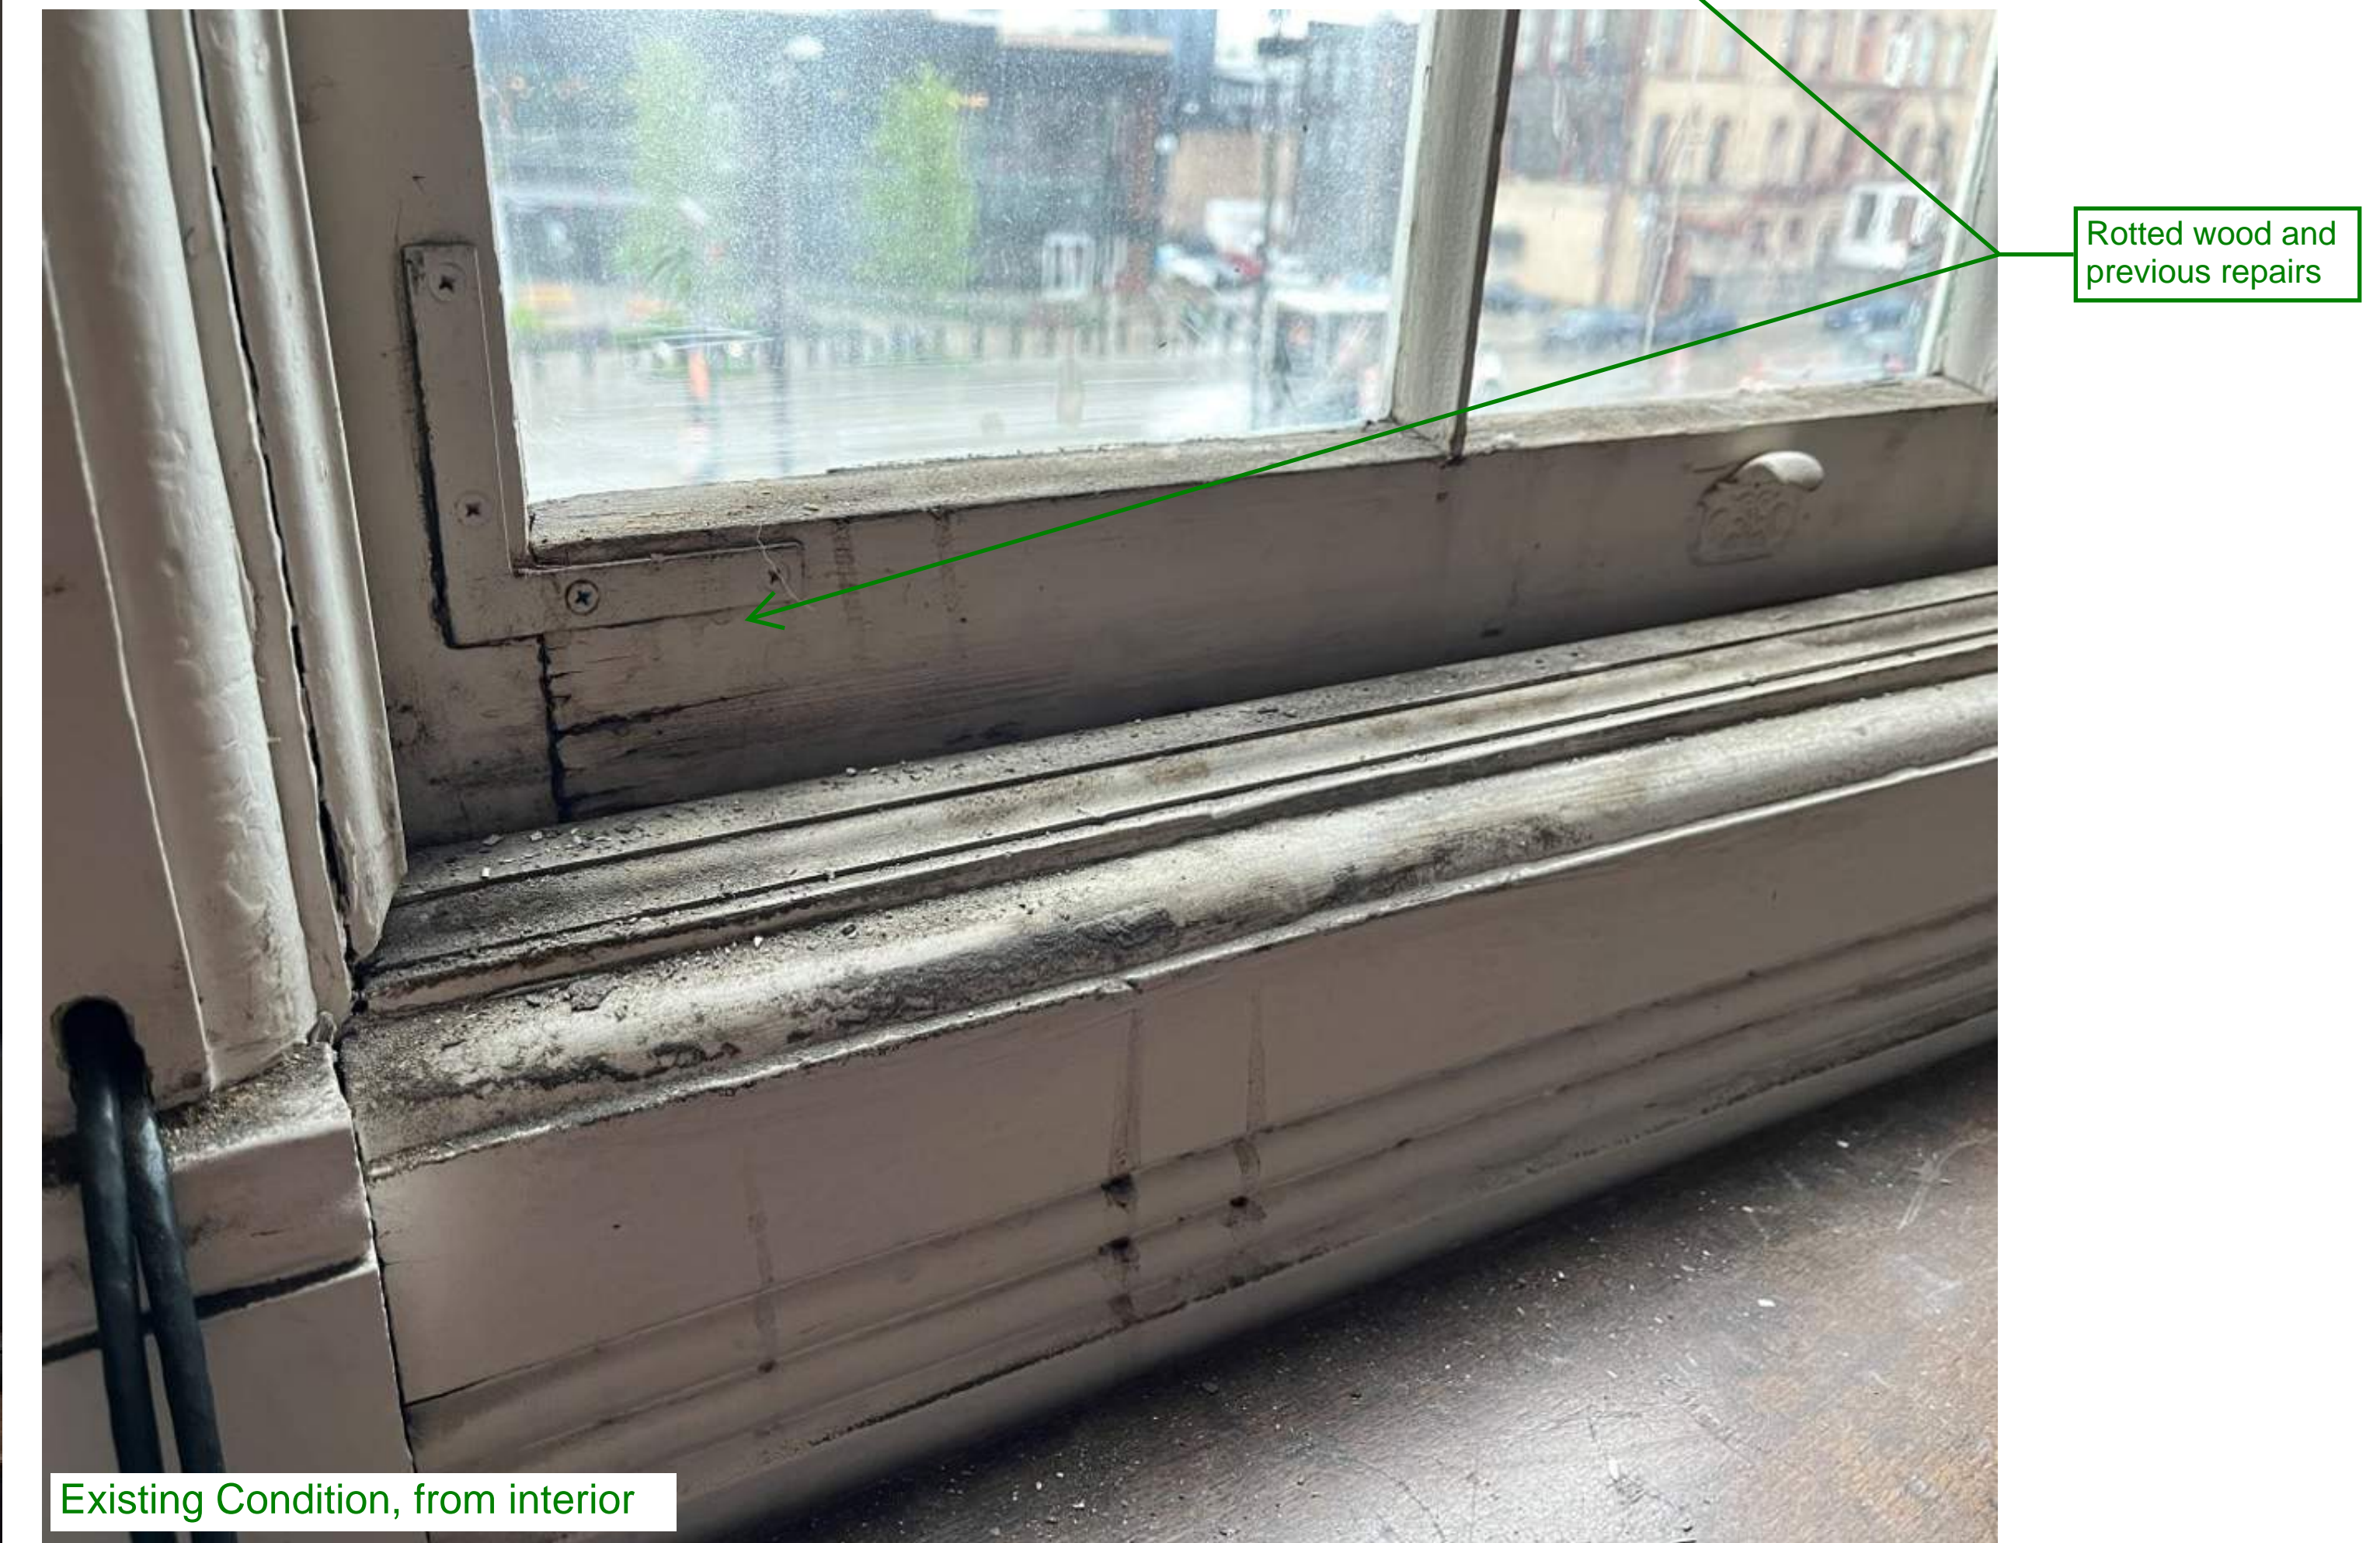
Rotted wood and previous repairs

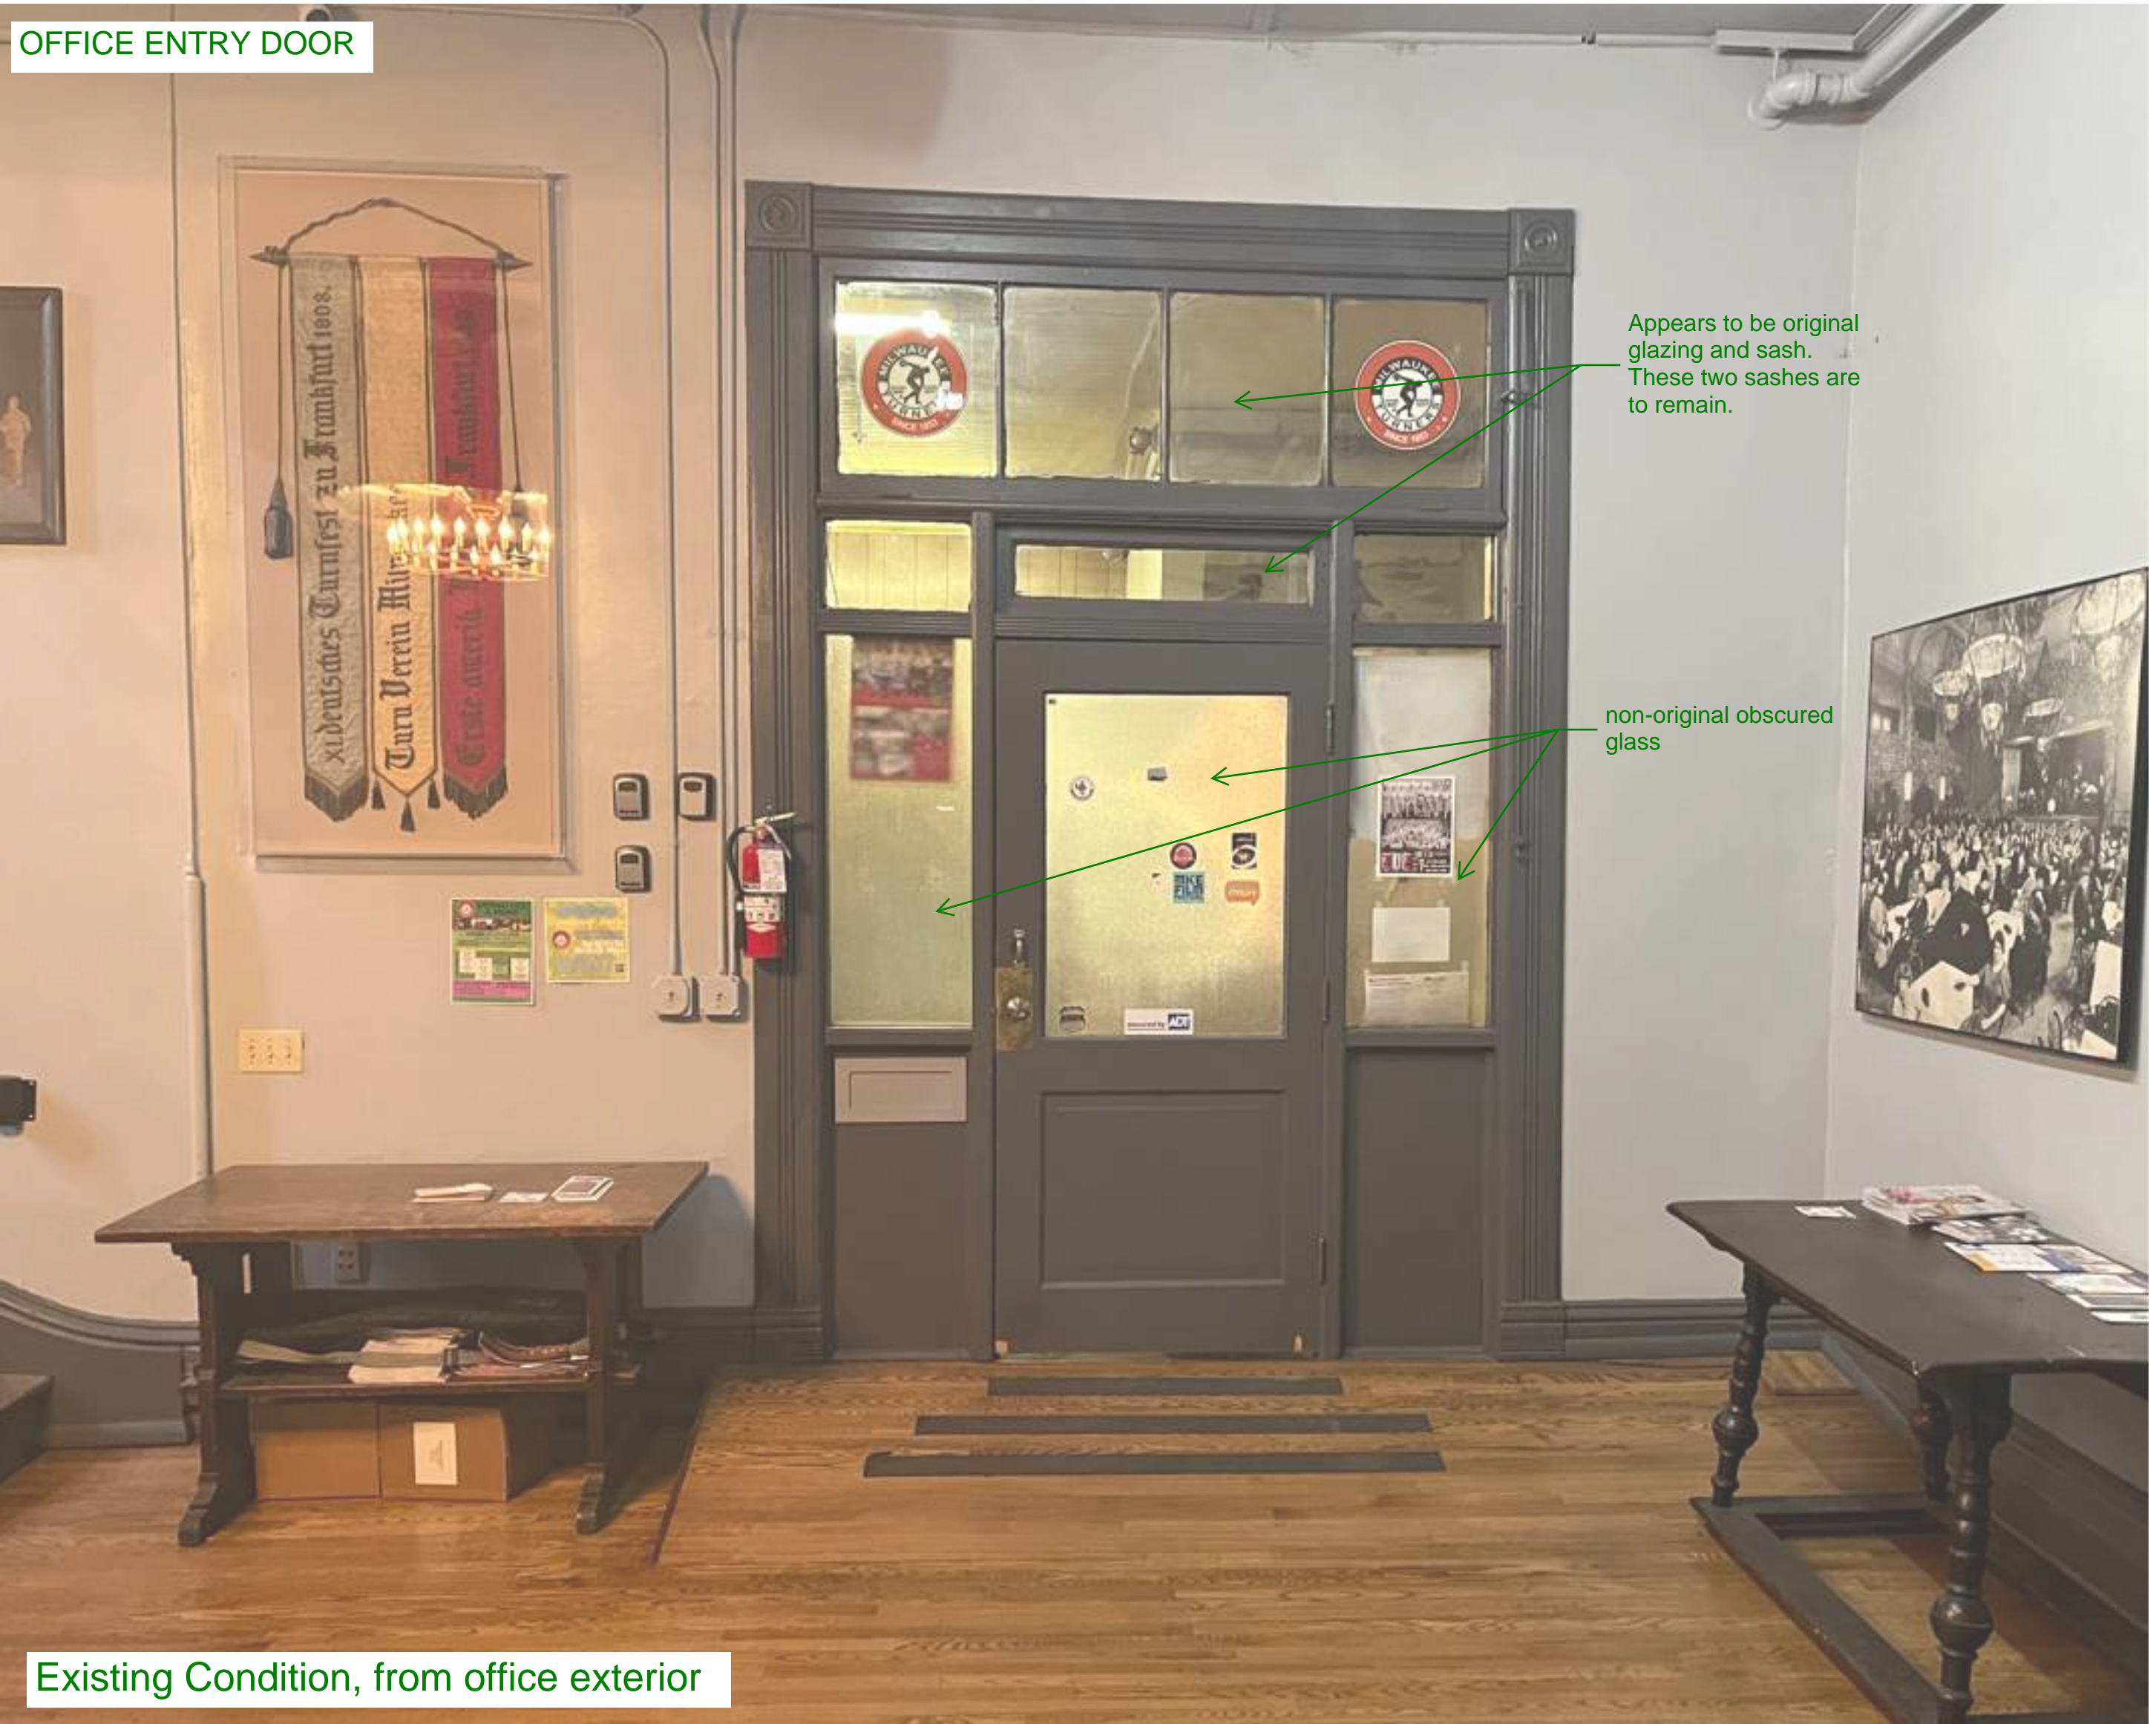
Existing Condition, from office exterior

The existing Office Entry door has been significantly altered over the years. Most of the lower divisions appear to have been replaced over time, and the door is believed to be salvaged from a different location within the building.

Appears to be original glazing and sash. These two sashes are to remain.

non-original obscured glass

The proposed scope of work includes replacing the door and sidelight glazing. The new glazed panels will consist of a safety glass of a similar thickness to the original glass (in the transom) and the door will match the existing configuration.
