CERTIFICATE OF APPROPRIATENESS APPLICATION FORM

East Side Commercial Historic District

611 N. Broadway

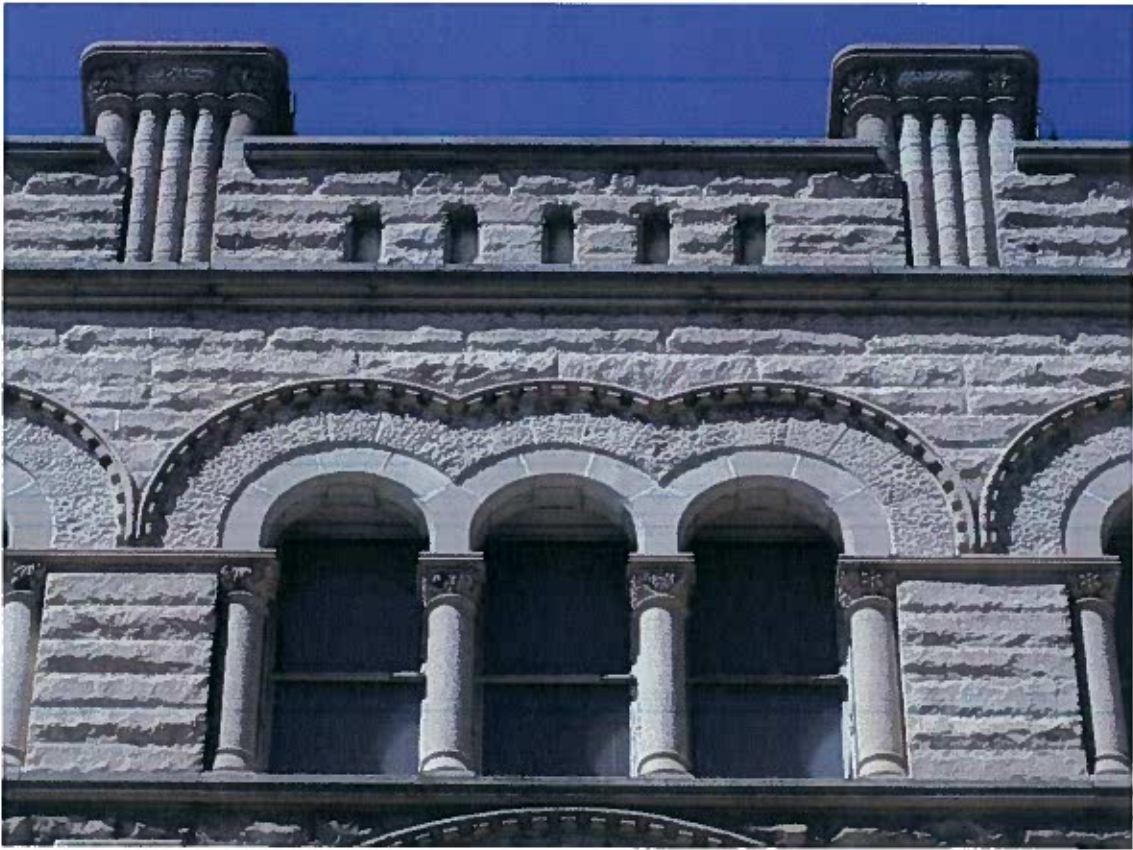
Photo 13: Parapet detail

The granite façade was painted in the 1960's and remains so today. An area around the main entrance was stripped and cleaned a couple of years ago as a test patch to reveal the natural stone. The underlying stone appears to be in very good condition. Mortar joints are in generally good condition, with minor repointing and other miscellaneous masonry repair required. The façade inspection report prepared in 2010 per City Ordinance notes some parapet shifting in the center of the east façade.

Granite joints will be repointed where existing mortar is loose, damaged, missing or has been replaced inappropriately with sealant. Mortar composition will be analyzed so that pointing mortar can match the original as closely as practical in mix design, hardness and color. Joint profiles will match the original. Selective demotion will be performed on the east parapet to determine the amount of reconstruction required. The parapet will be reconstructed as necessary to be structurally sound and match the original appearance. Skyward-facing joints at granite (parapet caps, window sills, etc.) will be cut out and replaced with sealant.

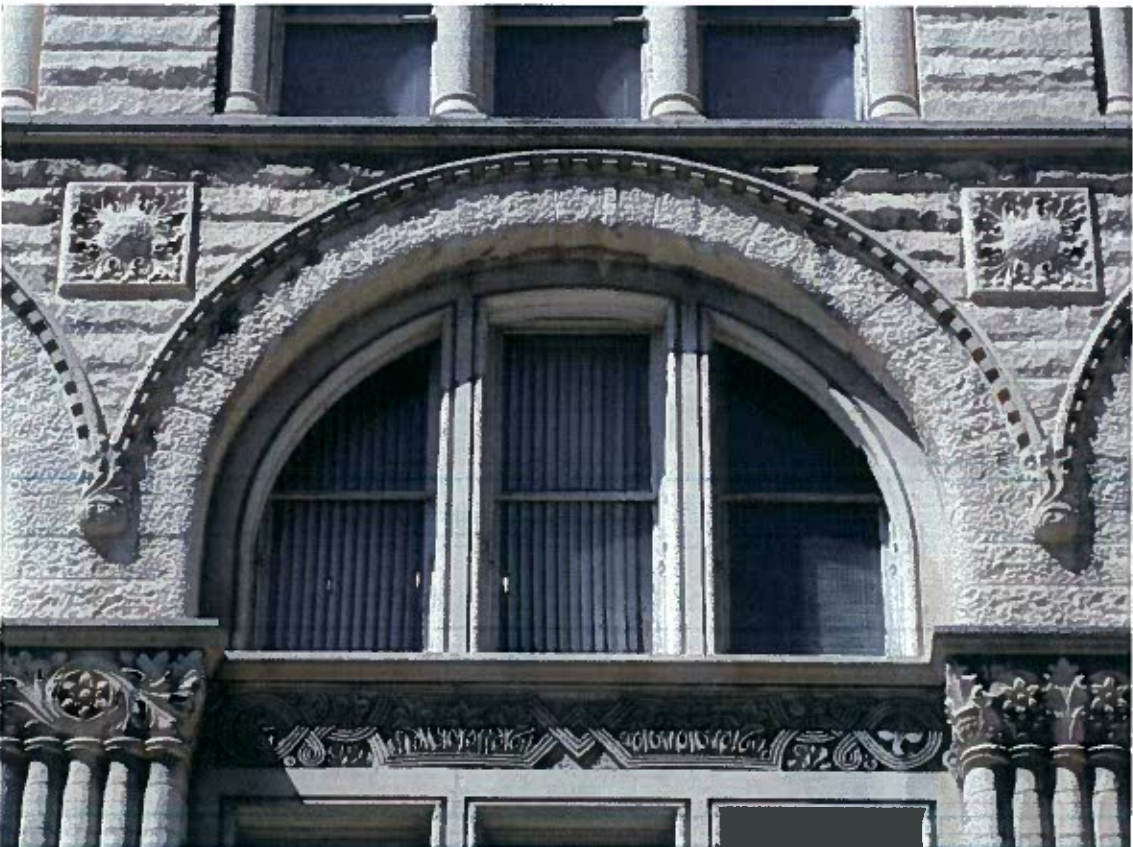
Photo 14: Fourth Floor window detail

Windows are in fair condition (Photos 13-16). Most of the windows in the building appear to be original wood sash with single-pane glazing. Storm sashes are not present. The windows have not been painted recently, so show significant areas of bare wood. Sills throughout the building exhibit severe checking (Photo 20). Some windows show deterioration of the bottom rail. Transom lites at the first floor of the Broadway façade have been infilled with an opaque material. A few windows have been replaced, particularly at the ground level of the Broadway façade, in the area well (Photo 17).

Windows will be scraped and sanded in preparation for painting. Sills will be repaired with Abatron LiquidWood and WoodEpoxy or equal by West System. Deteriorated sash members will be repaired with wood epoxy if possible, or replaced in kind. Windows will be fixed shut and repainted with exterior latex paint. Interior storm windows will be added for energy efficiency.

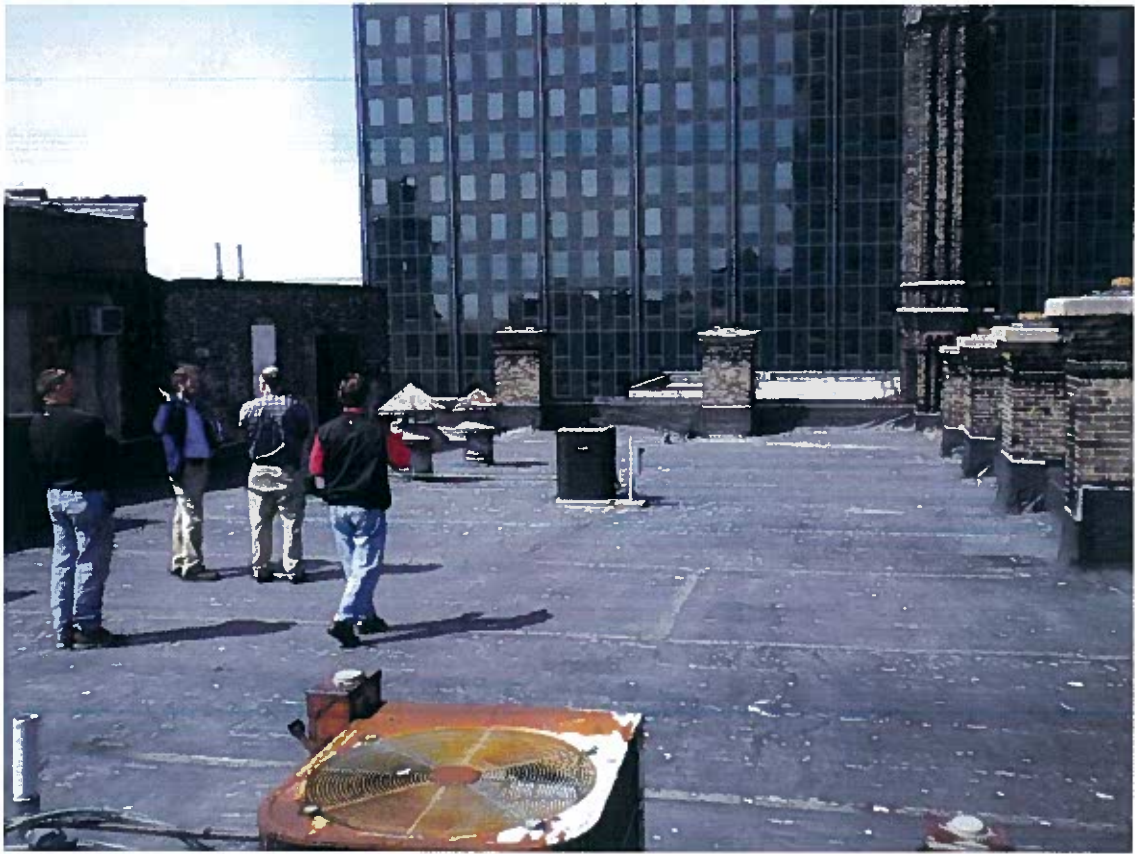
Photo 19: Roof, looking West

The existing roof has a low-slope EPDM roofing system. The roof membrane is in satisfactory condition. The roof slopes from the high side on the east down to the west. Ice damming on the roof behind the west parapet has been an ongoing problem, resulting in some masonry deterioration and leakage around the drainage scuppers.

The existing roofing will remain and be patched as necessary. Two cooling towers will be added above the northwest portion of the roof (Photo 19). The total height of the cooling towers, including support structure, will be approximately 13' above the roof surface. The northwest corner location was selected because it is furthest from the street facades and is at a relative low point of the roof. In addition, this location allows the cooling towers to be hidden from southeastern vantage points by the skylight dome and elevator penthouse. This location is pending confirmation of adequate structural support. The existing skylight will remain, any minor leaks will be repaired, and the metal structure will be repainted. A skylight will be added at the second floor roof to create a lightwell at the north end of the building. Historic photographs show a skylight in this location originally.

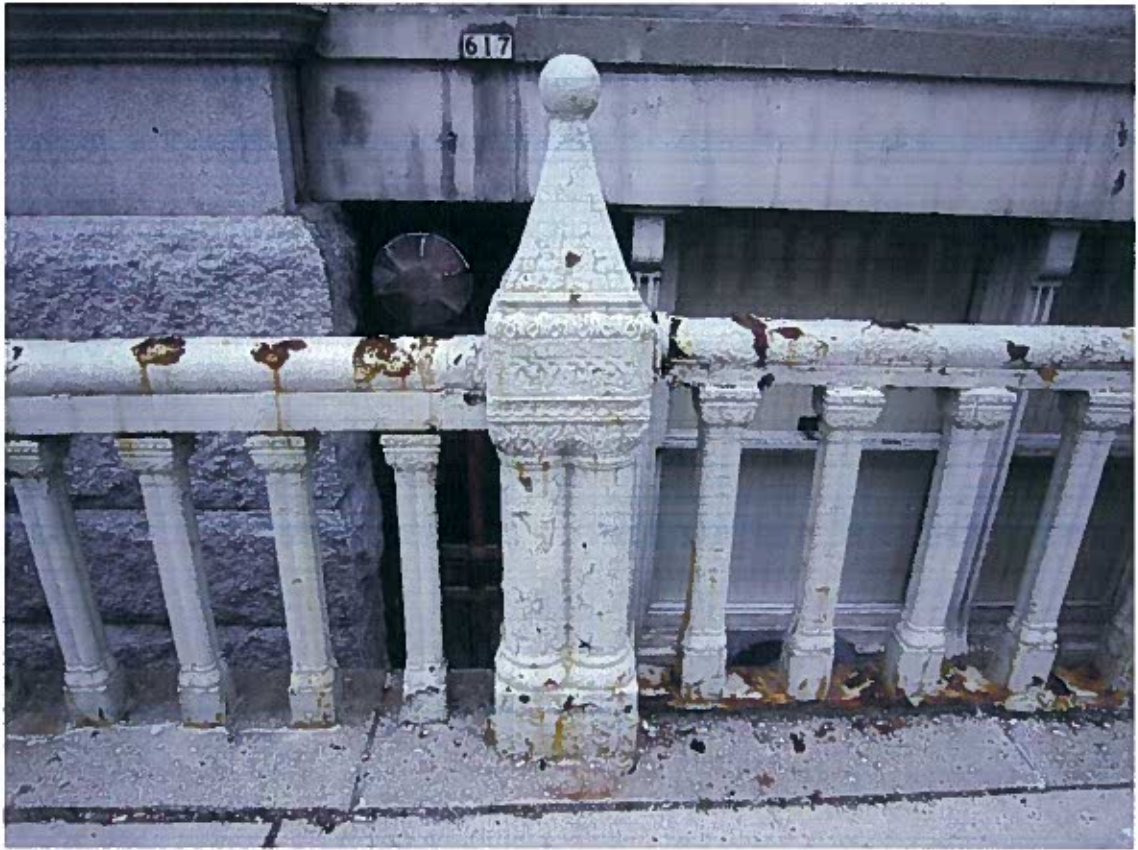
Photo 21: Sidewalk railing

There is a prominent cast iron railing along the Broadway sidewalk (Photo 21). The newel posts and balusters are in fair condition, showing some surface rust. The steel top rail is not original and exhibits severe rust. The entire railing is set on a concrete base which is deteriorating.

The cast iron railing will be disassembled and refinished. The existing paint will be removed and the members will be repainted. A new metal top rail will be fabricated. A new concrete base will be poured. The railing will be reassembled in its original location.
