# Certificate of Appropriateness

2555 N. LAKE DR. North Point North Historic District

PTS ID 111411 COA Reclad Exterior

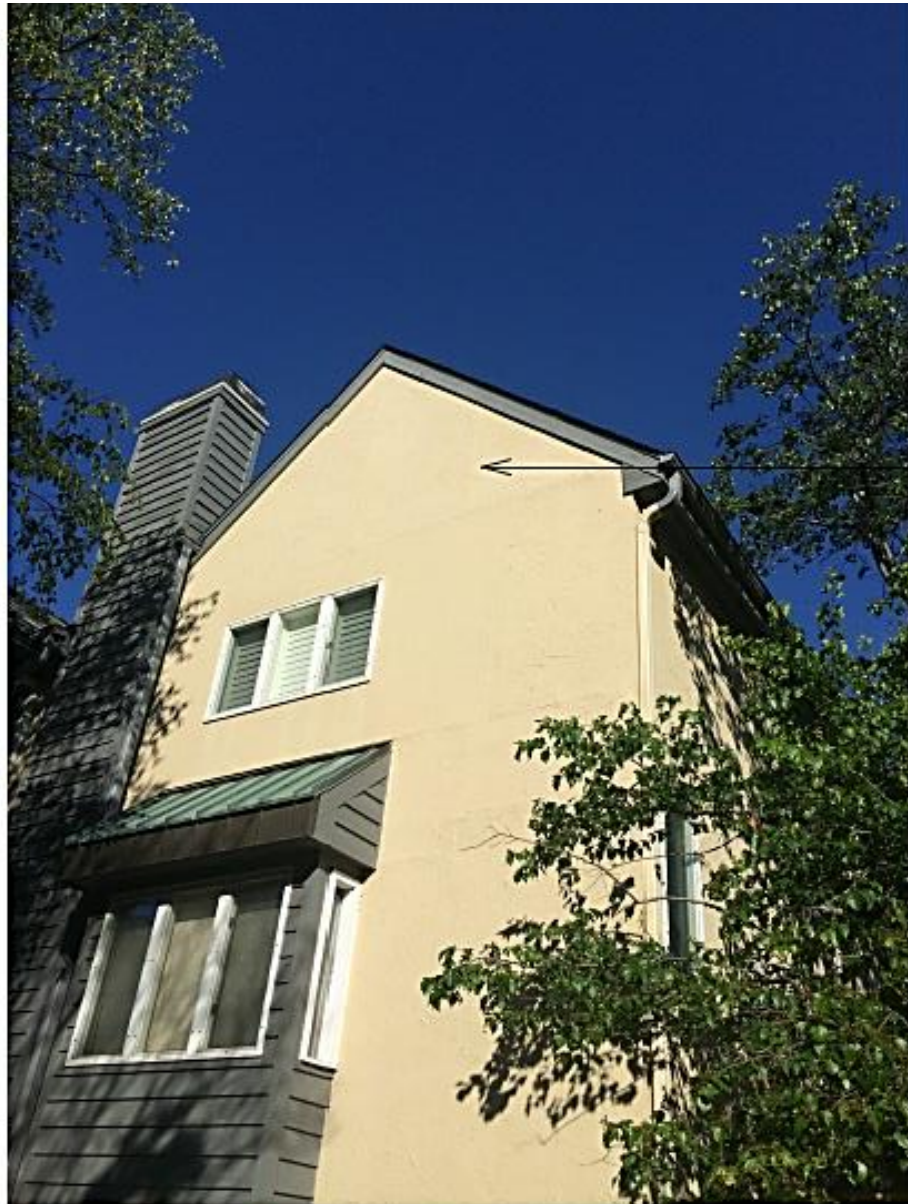
Typical seam "telegraphing" @ facade. Telegraphing is symptom of failed moisture barrier and exposure of substrate sheathing to moisture. Repair will require replacement of damaged substrate and new drained EIFS system

Exterior Facade - showing typical "telegraphing" of sheathing through EIFS finish

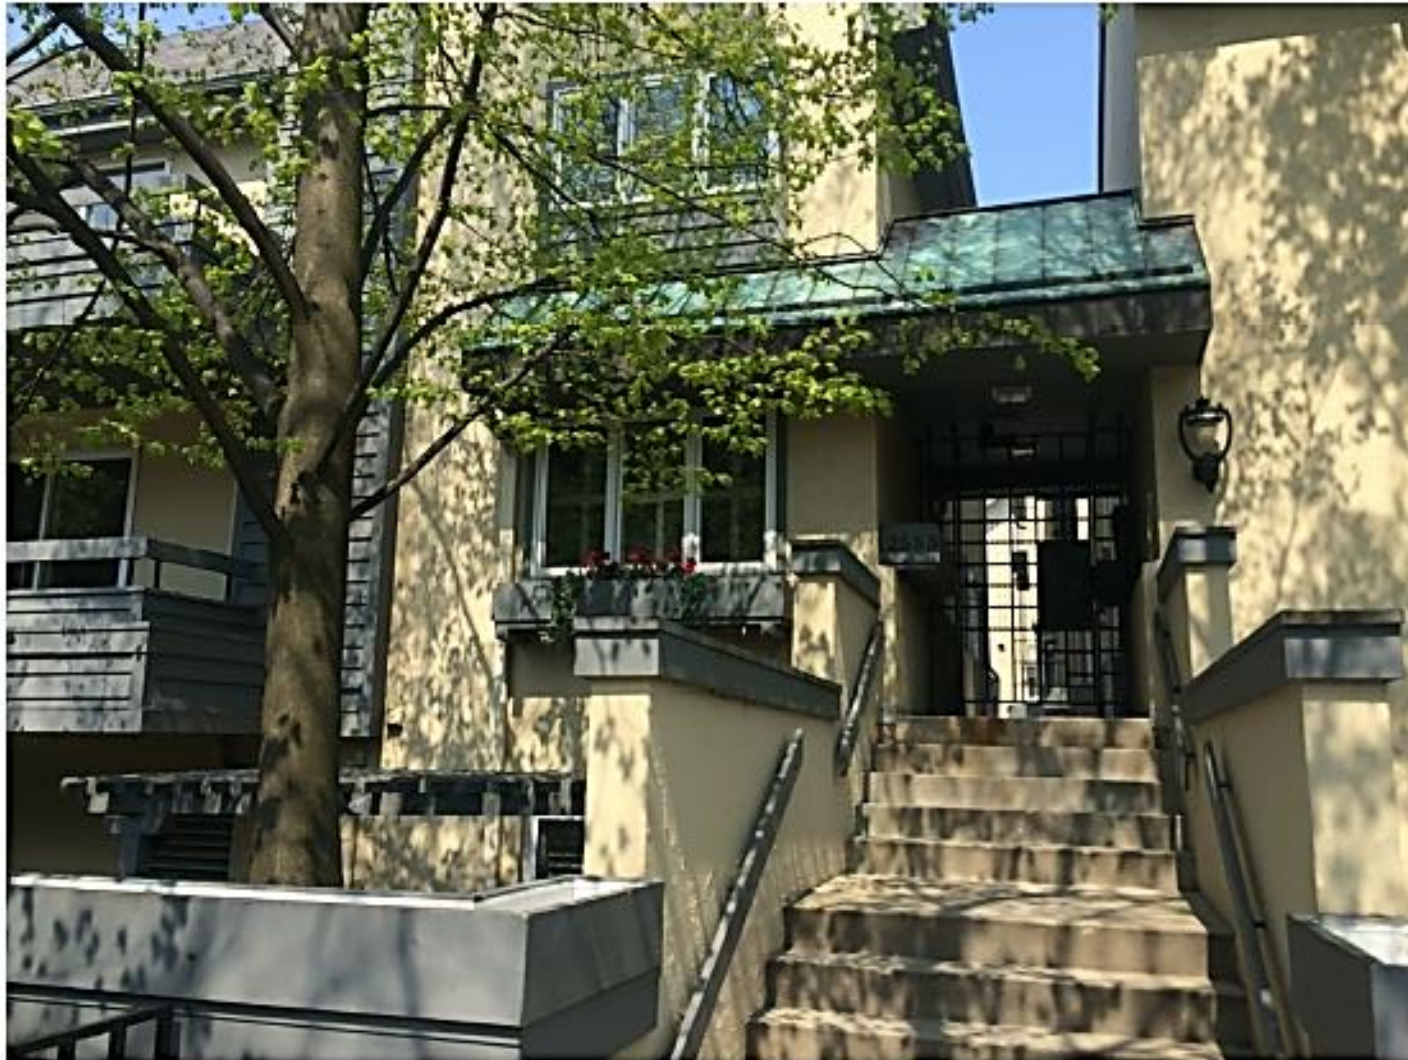
Existing entry gate area to be renovated

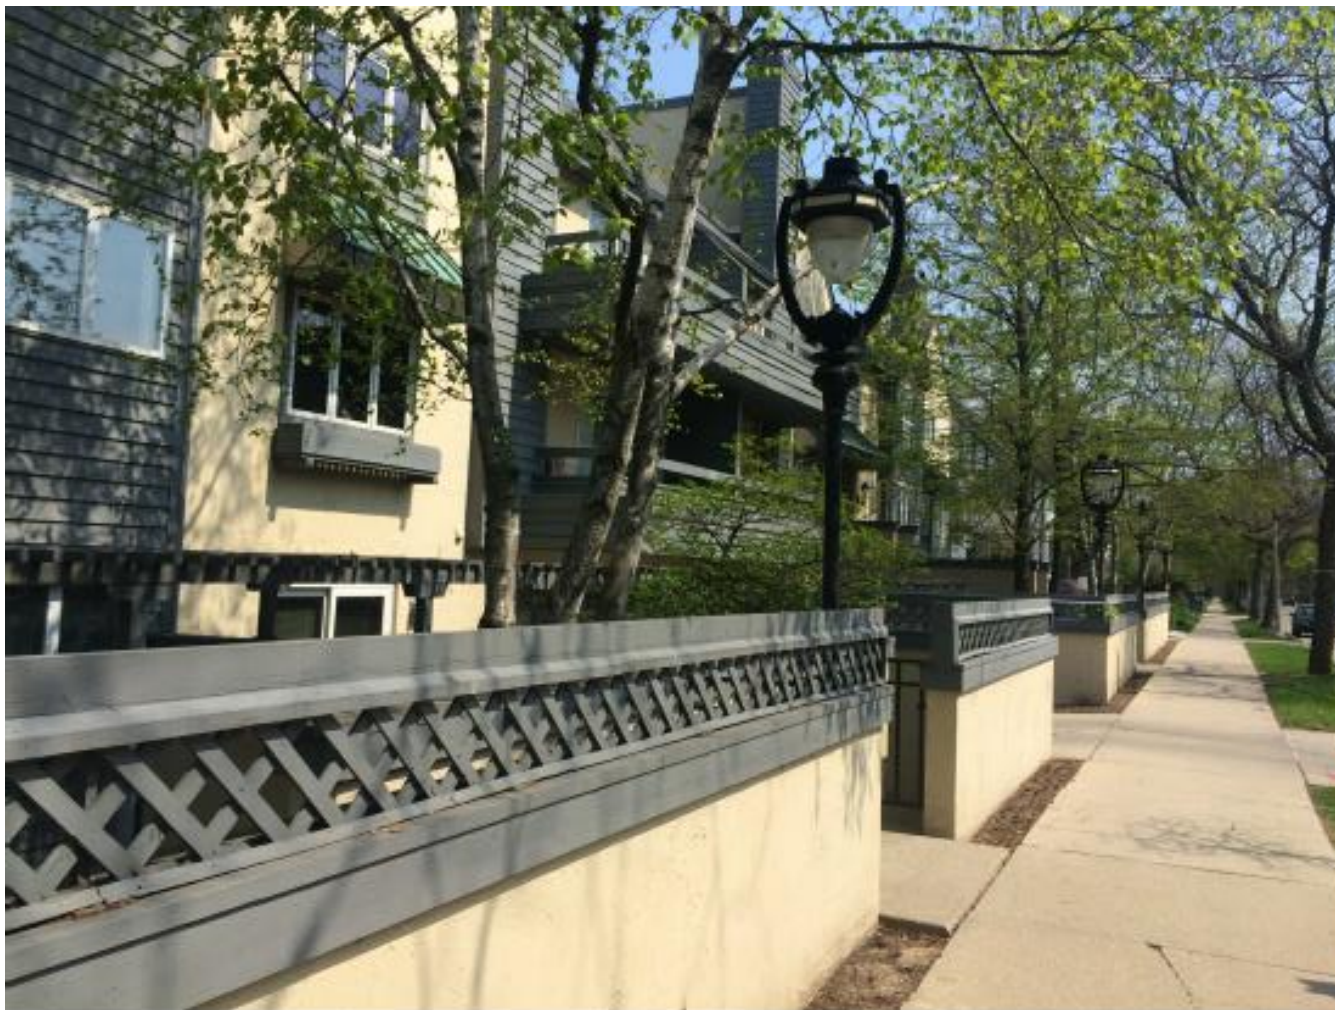
Pedestrian View traveling north - showing half wall to be renovated

EFS to be replaced (typ)

cedar trim to be repaired (typ)

new patio doors + windows to match existing (typ.)

front entry gate to be renovated

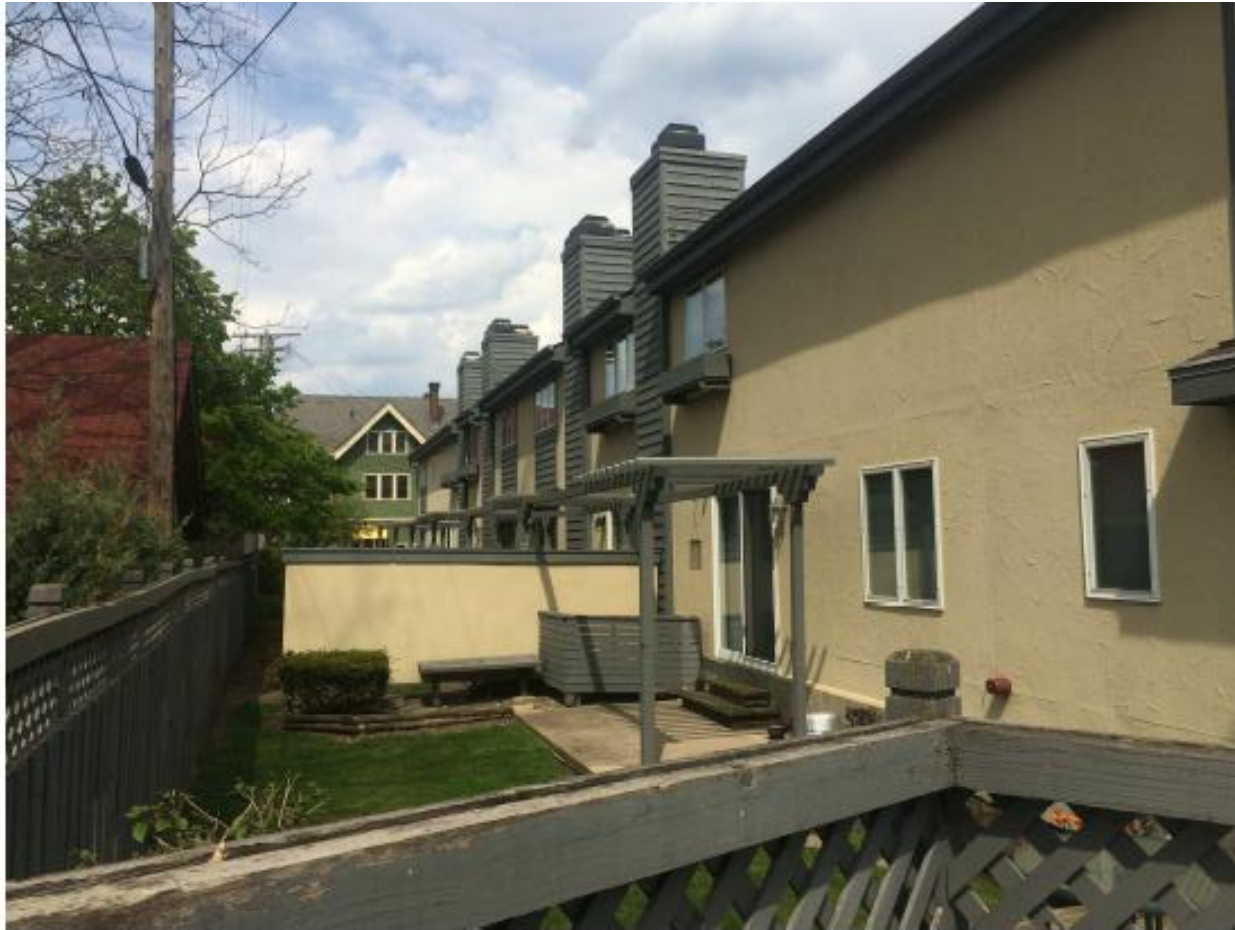
Western property face looking north from southern edge

Note windows and sliding patio doors are non-historic. They lack sills, traditional framing and muntins and appear to sit on the wall rather than in the wall. They are original to the building. They are being replaced in kind.
