LIVING WITH HISTORY

Certificate of Appropriateness

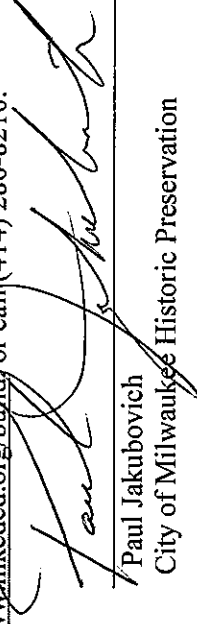
Paul Jakubovich
City of Milwaukee Historic Preservation

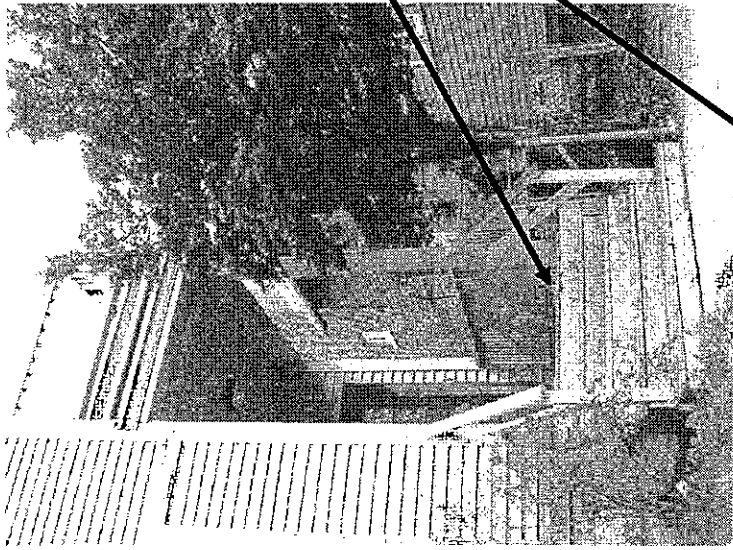
Front porch deck and railings to be replaced.

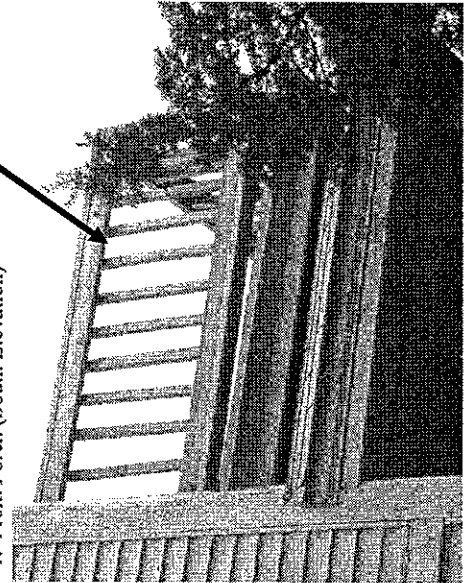
2. Upper deck railing above front porch

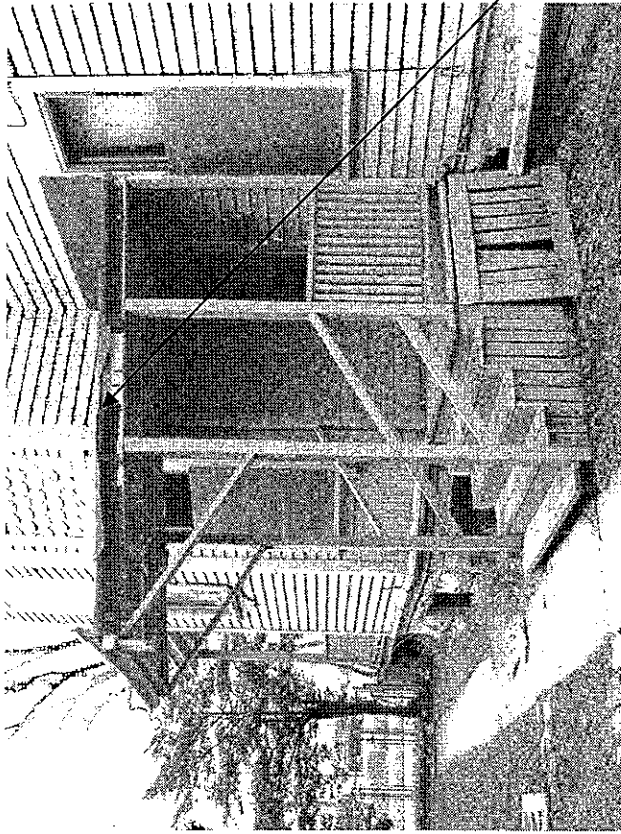
9. Side porch (North-East Elevation) with loss skirt and deteriorated roof

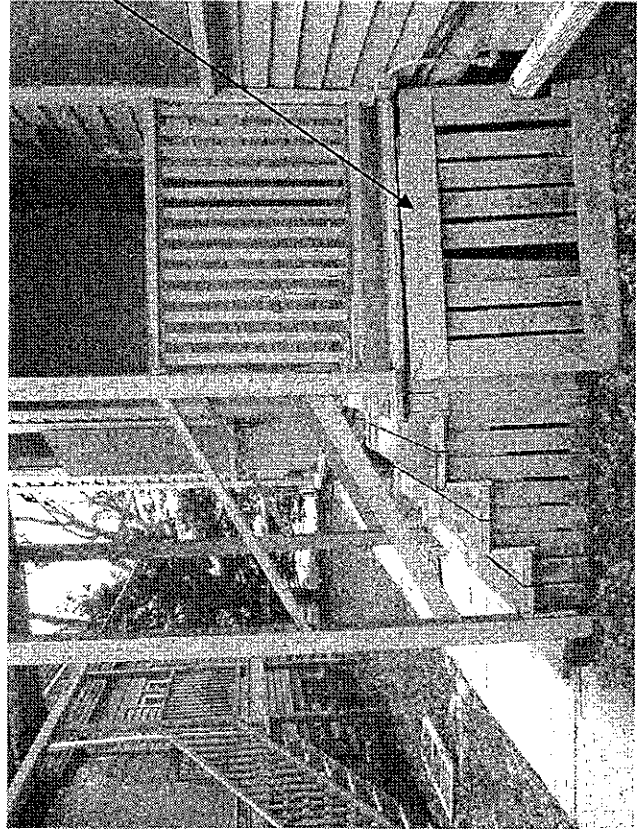
10. Side porch (North Elevation)

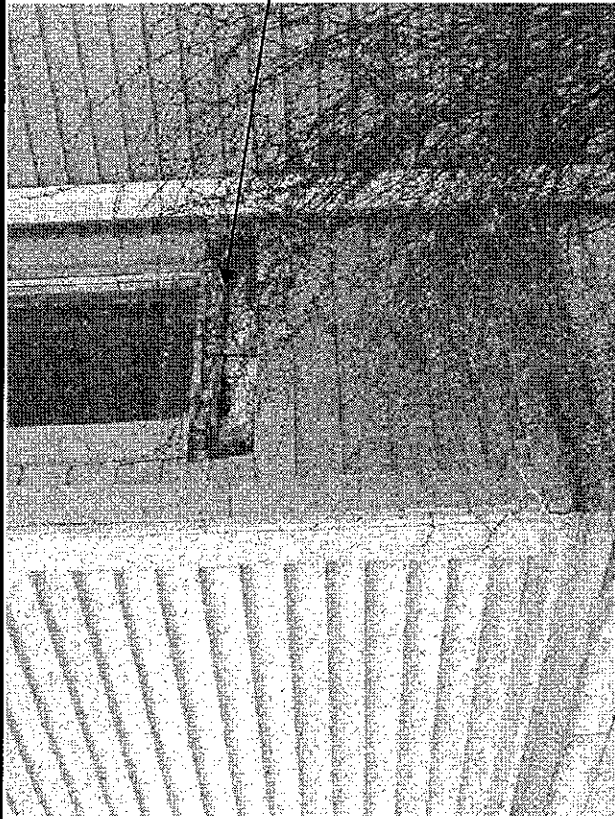
Replace missing trim to match original. Thickness and profile of new wood must match the original.

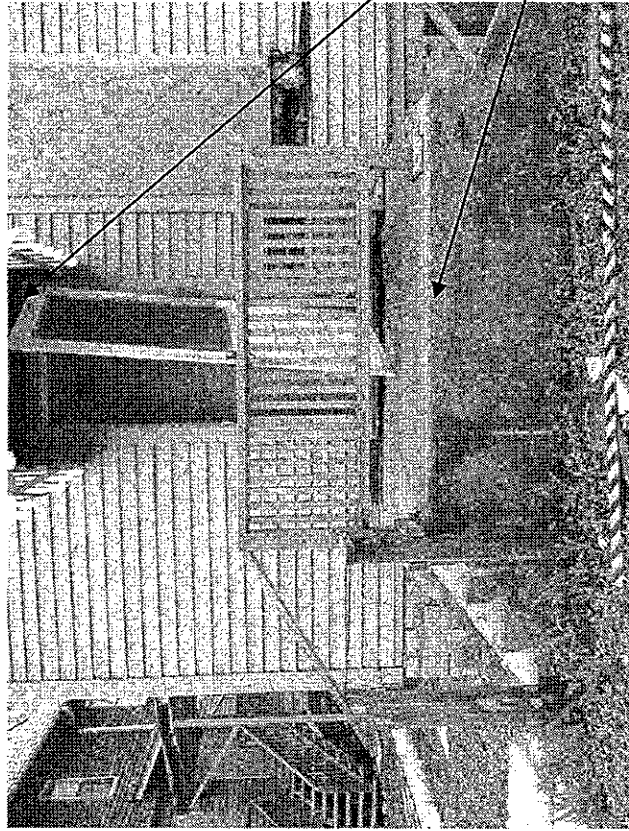
Rear porch and canopy to be removed and replaced with new, shed-roofed porch.

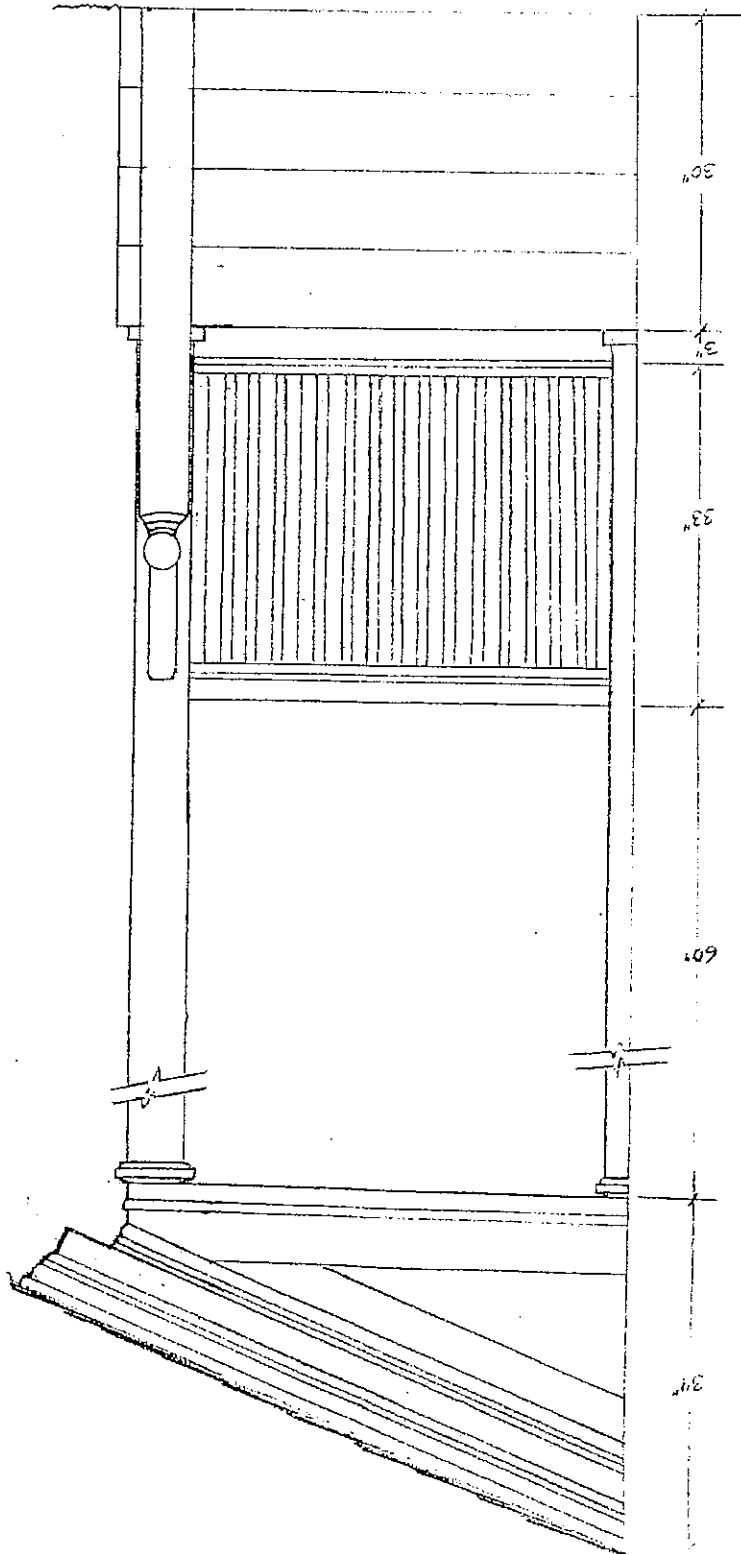
Elevation of new rear porch

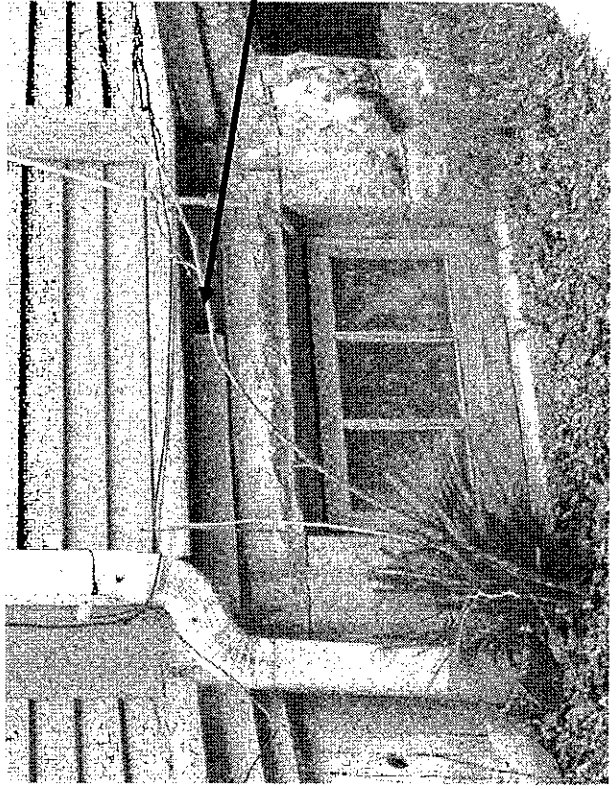
Replace missing and damaged water table boards to match originals

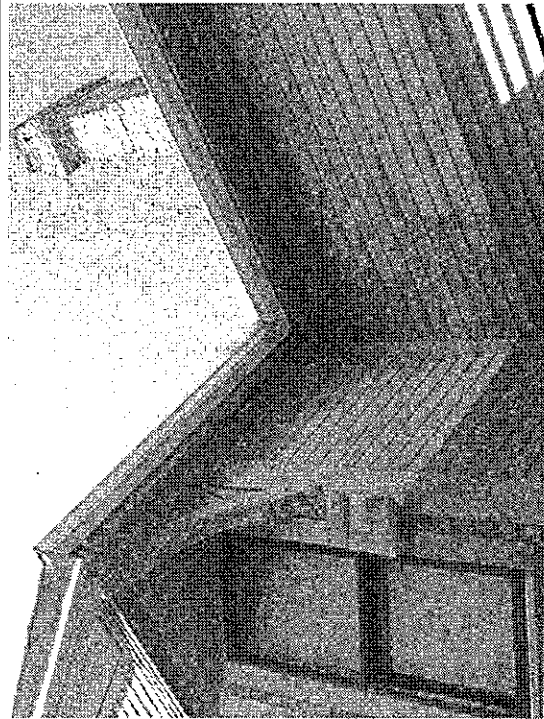
7. Second floor (North-East Elevation) above side porch

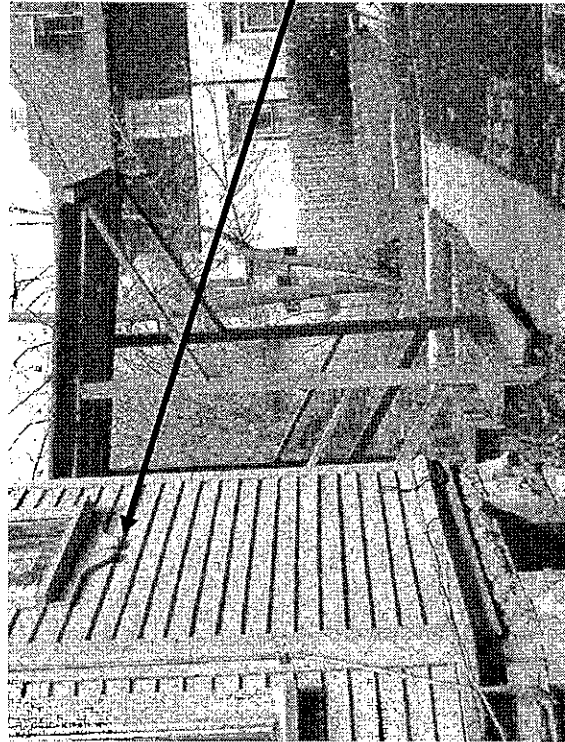
Missing trim under windows to be replaced according to this original design
