# Certificate of Appropriateness

2742 W. STATE ST., **Concordia Historic District, City Of Milwaukee, owner**

6/24/2011

PTS ID 73475 COA, exterior repairs

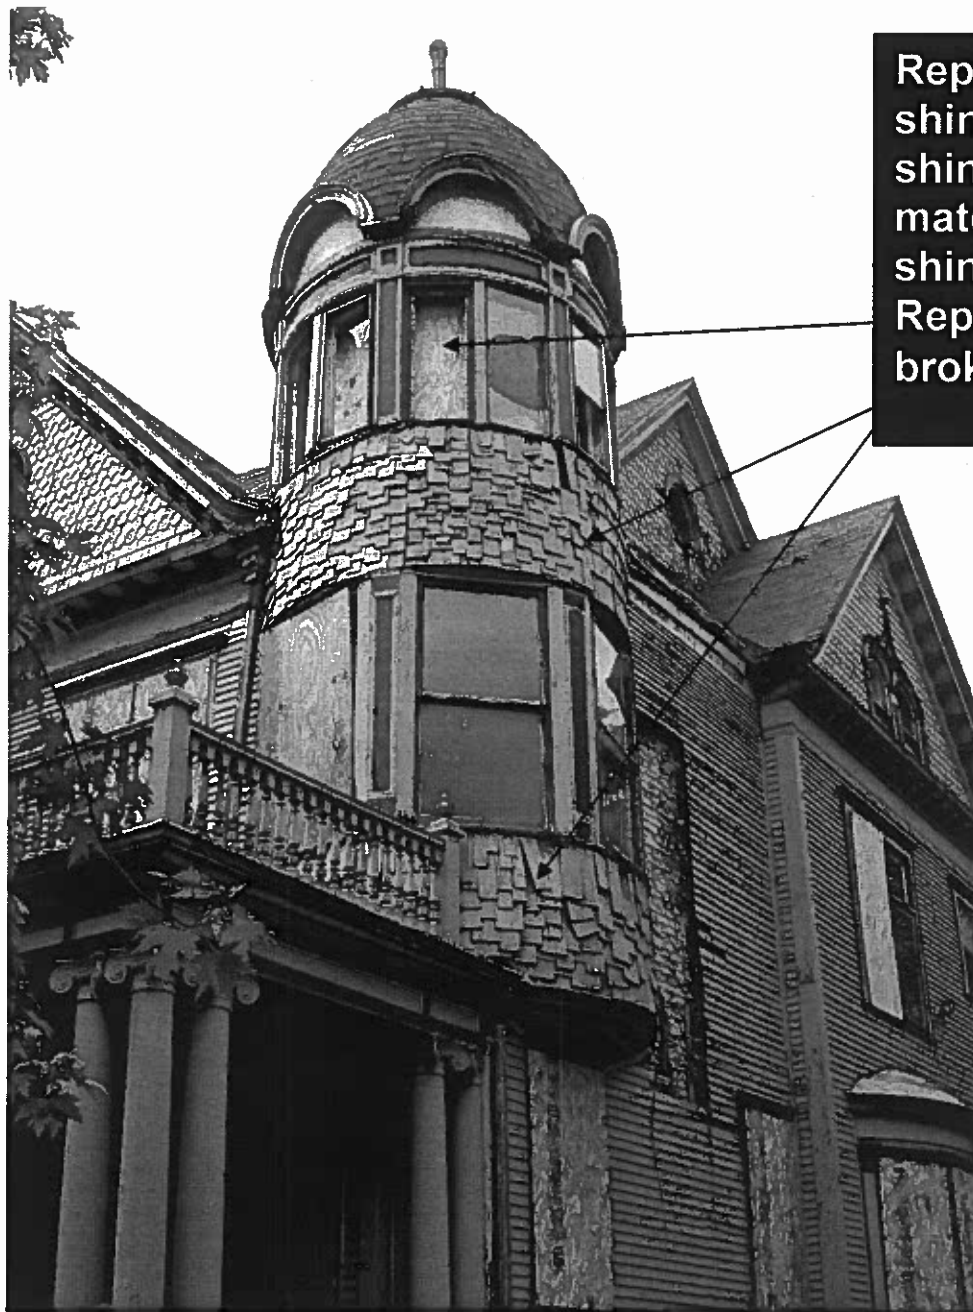
Replace existing, non-original shingles on tower with new, clear shingles laid in even courses to match the exposure of the shingles in the side gables. Repair/replace missing and broken tower windows.

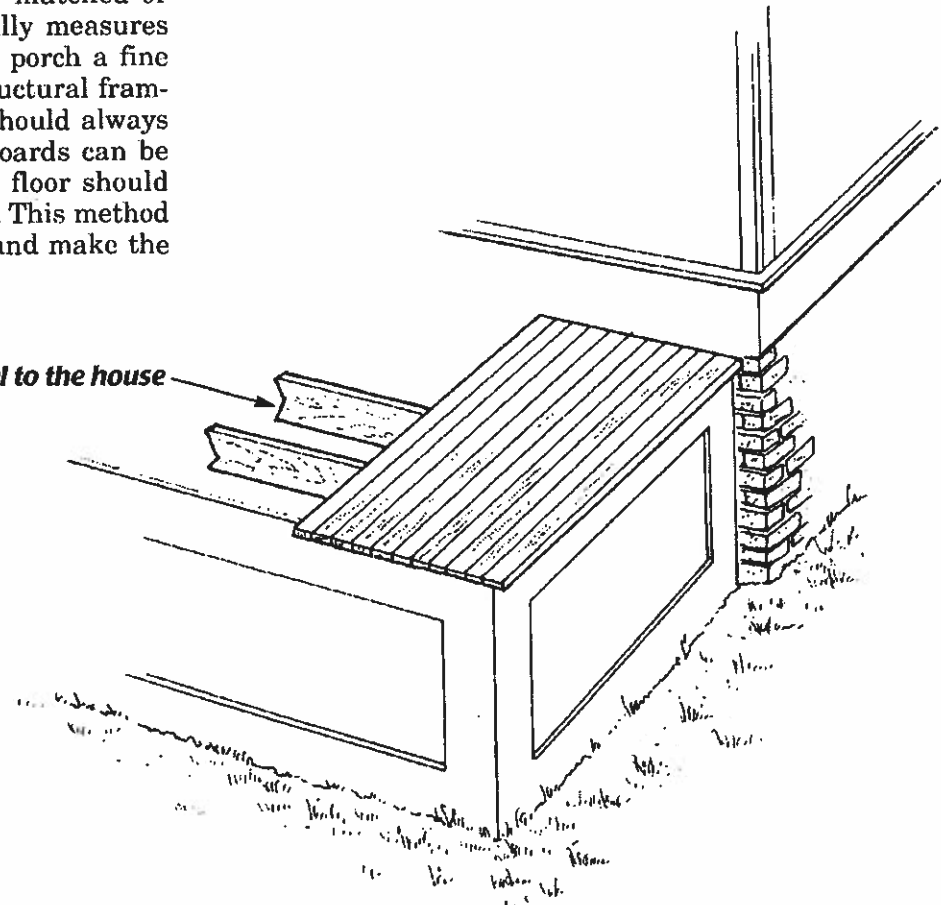
Tongue and groove, also called center-match flooring to be installed on front porch deck. Note direction of floorboards.

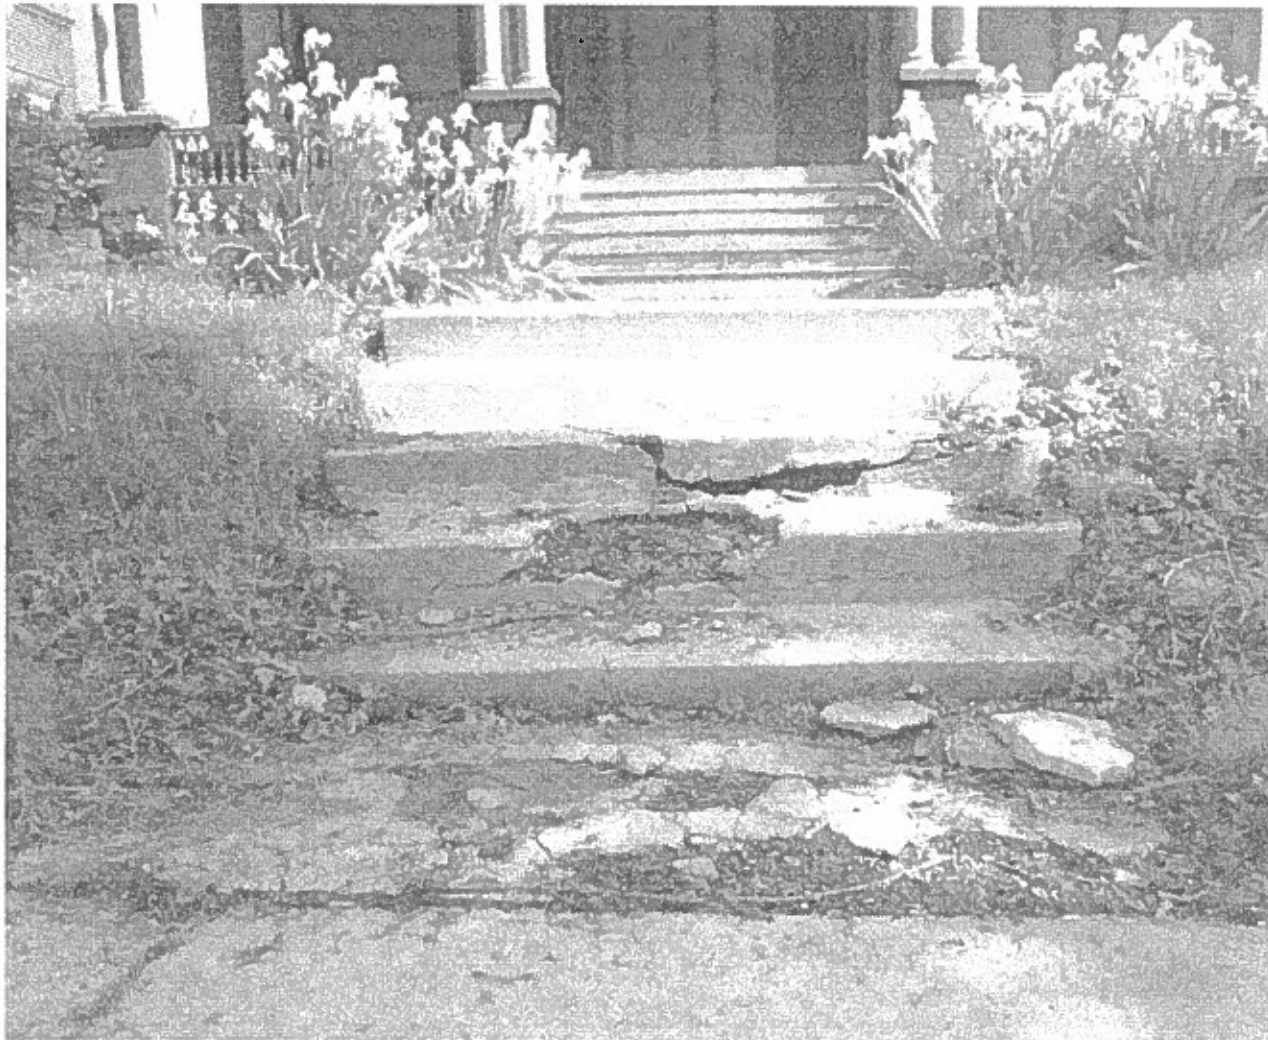
**Front concrete steps and service walk to be replaced with new concrete in same footprint.**

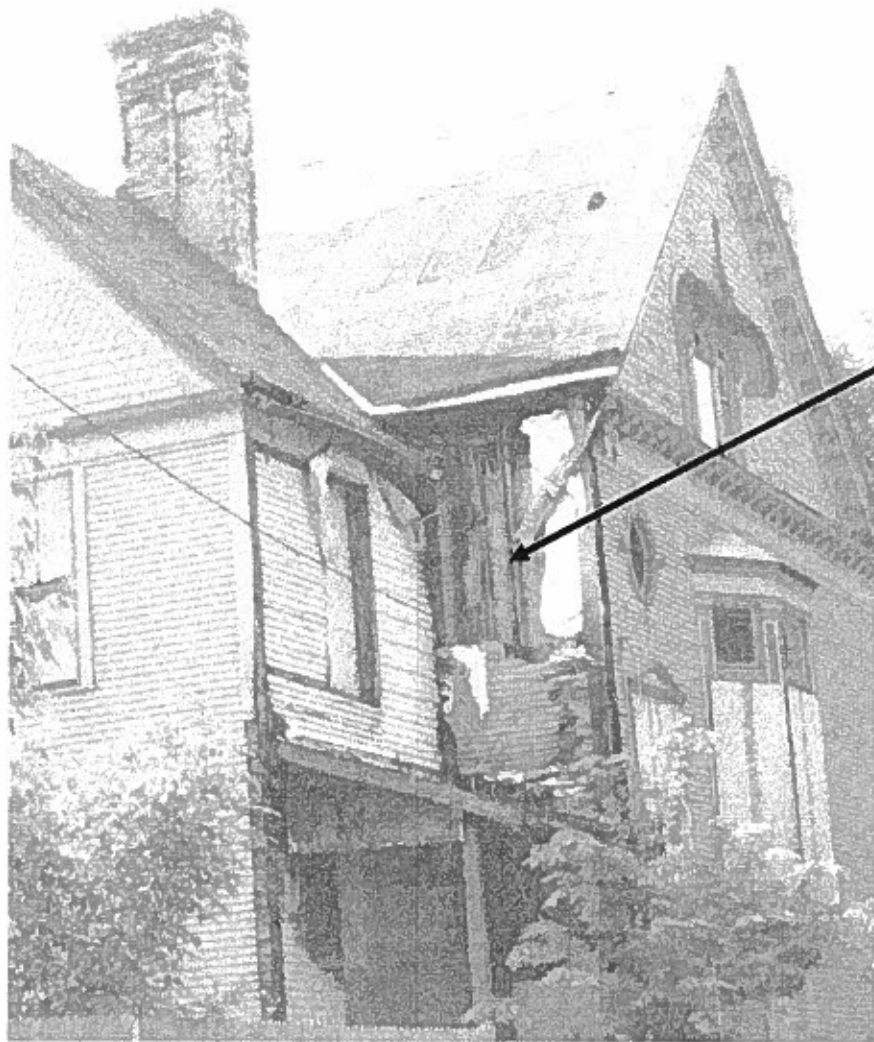
Fire damage on north elevation  
to be repaired with new,  
radially-sawn pine clapboards

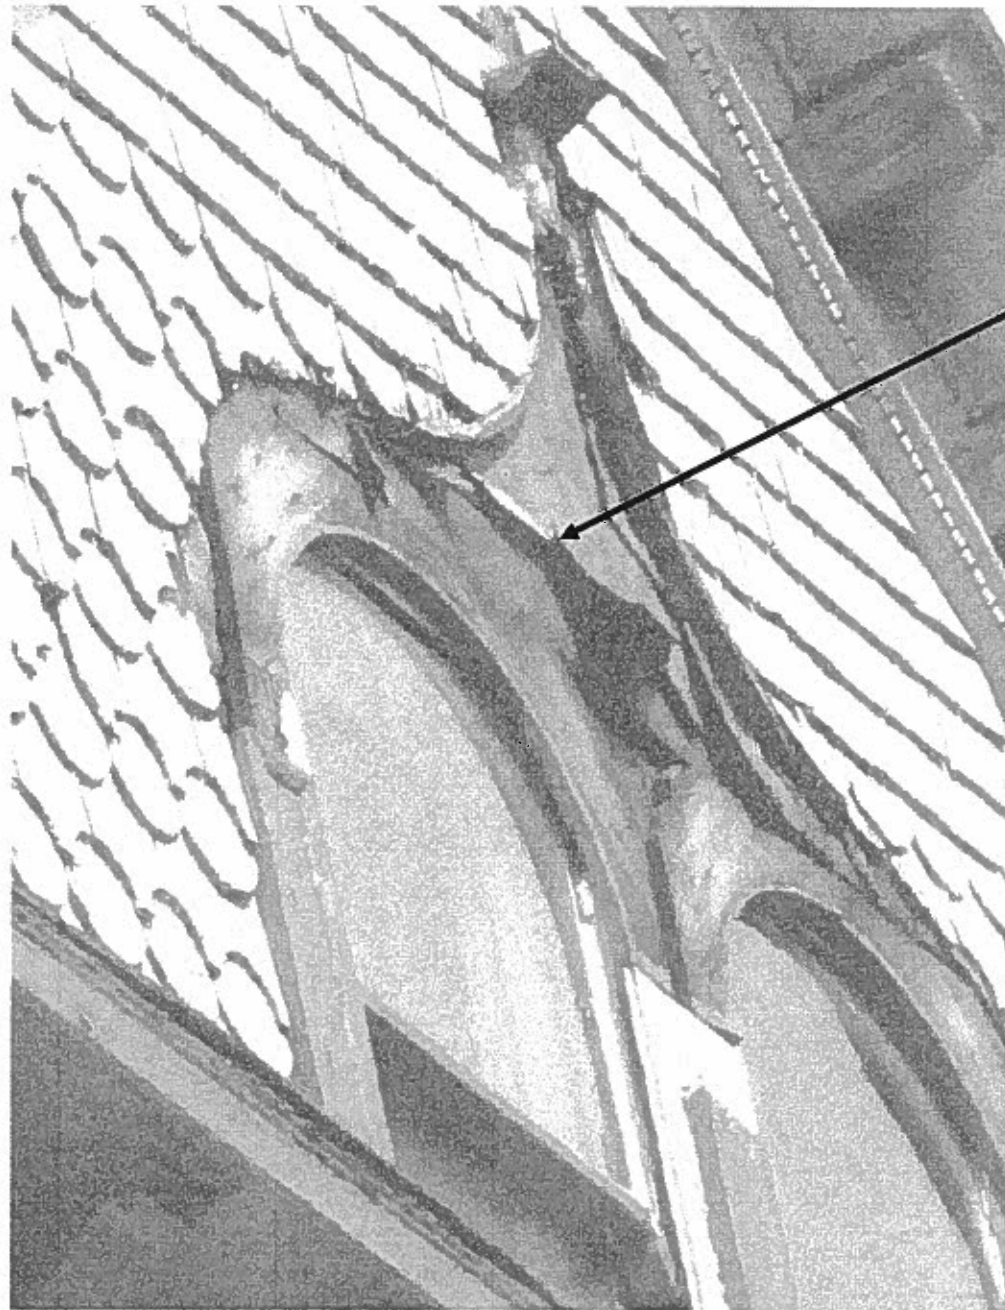
Missing window top to be replaced to match the similar existing window tops of the same design on the house

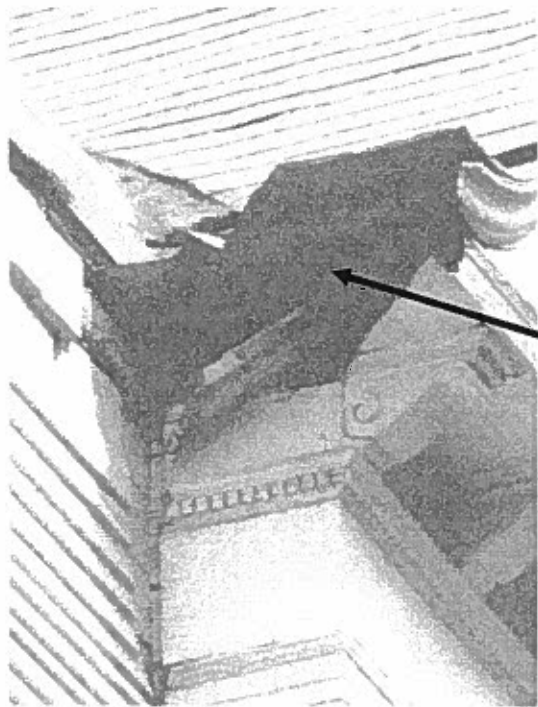
15. Missing soffit and fascia on southeast corner of east side gable.

Rebuild damaged and missing soffit, fascia and trim where needed. Rebuild built-in rain gutters as needed. All molding profiles and original designs must be duplicated exactly.

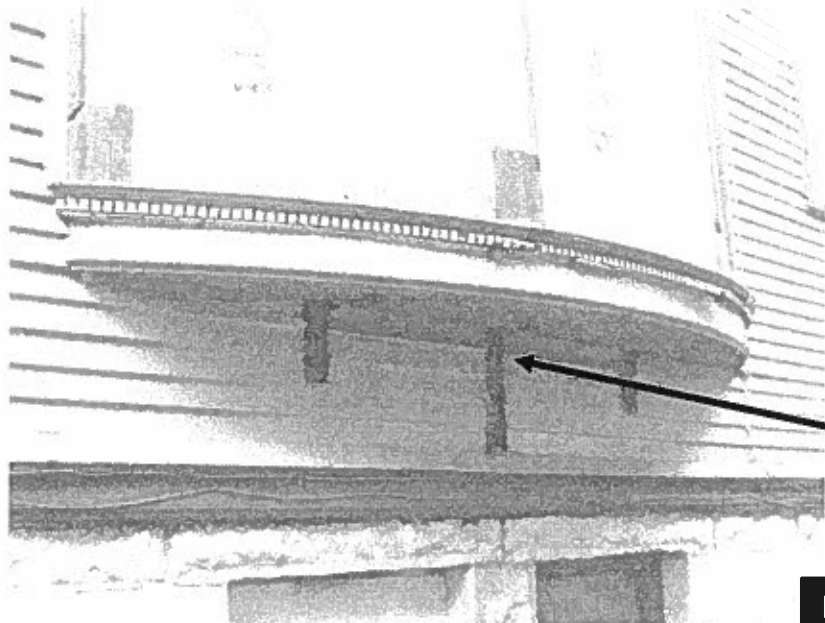
Replace missing brackets under bay window on east elevation

Note: Bracket design has not been supplied. Bracket design must be reviewed and approved by HPC prior to installation

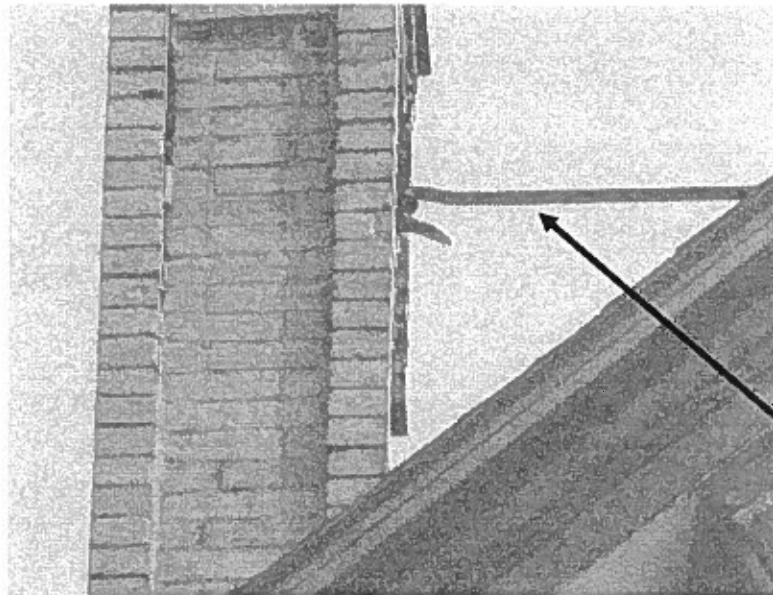
4. Front chimney connection with tie bar and hook

Hook must be preserved in its original location

Remove existing cap  
and replace with stone

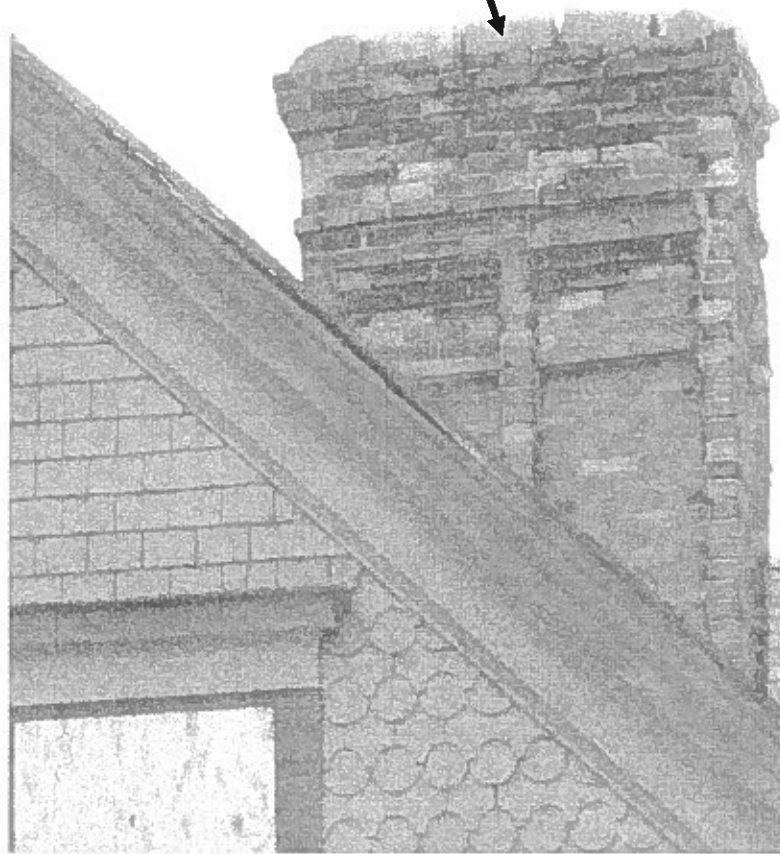
8. Rear chimney (close up) showing need for cleaning and possible repair

Rear chimney must be preserved in its original design. It can be tuckpointed and cleaned using a chemical cleaner and a hot water wash (no baking soda, walnut shells or other abrasives are permitted). The top of the chimney should be fitted with a stone cap, 3-1/2" in thickness that overhangs the brick course beneath it by one inch.

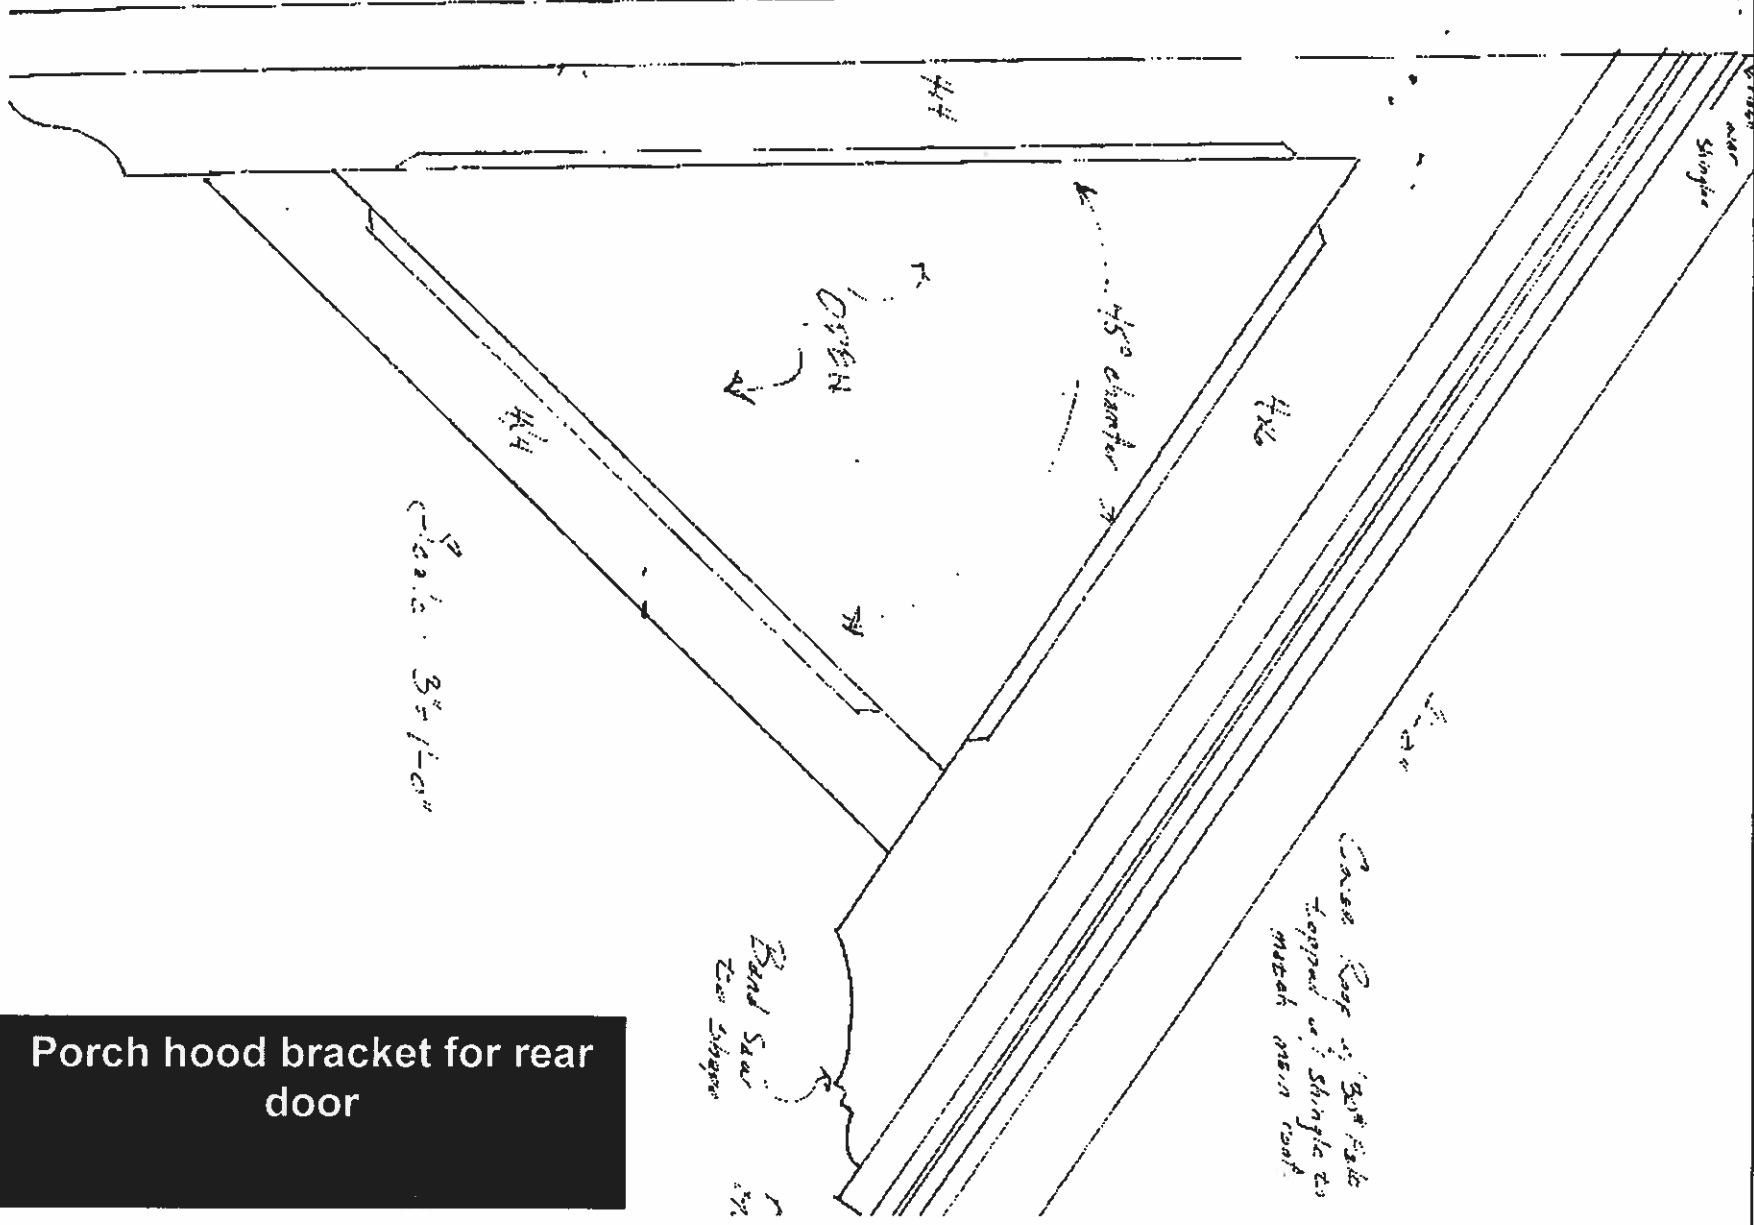
Porch hood bracket for rear door
