CERTIFICATE OF APPROPRIATENESS APPLICATION FORM
Incomplete applications will not be processed for Commission review.
Please print legibly.

3014 West McKinley Blvd., Milwaukee, WI 53208

Enclosed please find a proposal for the restoration of front entrance and doors, repair of side entrance doors, and the manufacture of 4 storm doors for your residence at the above address. This document is submitted for your consideration and comments. The subject areas are as follows.

Project I: Front Entrance

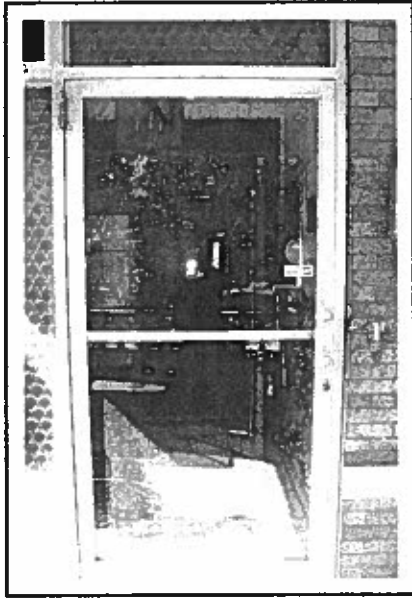
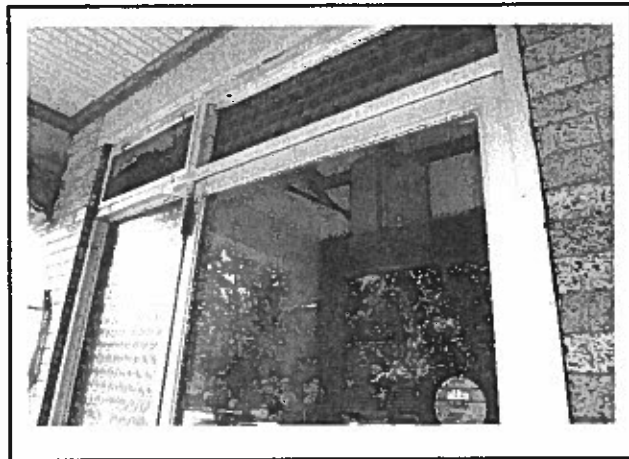
This project involves the restoration of the prime doors serving as the front entrance to the house at 3014 W. McKinley Av, located in the historic district of Coldwater Springs in Milwaukee, WI. The door, now in service as the front door, was installed in the 1970s to conform with the requirements of the American Disabilities Act. It included a 40 inch wide metal door with two fixed panels which closed the original opening of 74 inches by 96 inches down to 40 inches by 72 inches (Fig. 1, 2).

Figs. 1, 2 Doors installed in 1970. Doors to be replaced in the restoration project.

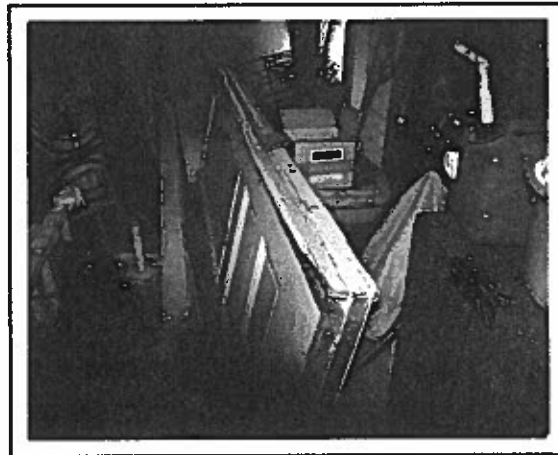
No photographs survive to guide answering the above questions. Fortunately, there is material evidence that can provide some direction. What are presumed to have been the original doors survived, although damaged, on site in a shed at the rear of the property (Fig. 3). Thus it can be said that the original entrance consisted of a double door, Northern White Pine core with 1/4 inch quarter-sawn White Oak veneer, two raised panels each, and 22 x 52 inch glass panels each (Fig. 3). Once the metal door frame was removed, two more important question were answered. First, it was determined, that the rough opening on the interior side is 70 inches, and not the 72 inches that is measured from brick face to brick face on the outside of the opening. Second, and based on residual caulk showing where the original doors were set (Fig. 4), the doors were in-swinging. Further, the cutouts into each door leaf indicate that the doors closed into each other with a doubled astragal feature closing the gap between them and anchor bolts, top and bottom, holding the right hand door (as you face the doors from the outside) secure.

Fig. 3. Doors Found on Site in Back Shed

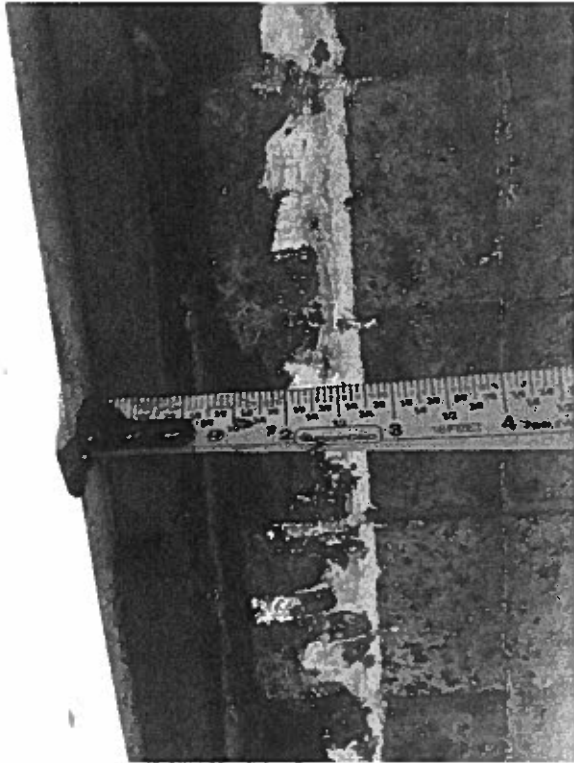
Fig. 4 Caulk Lines Indicating Original Set Back

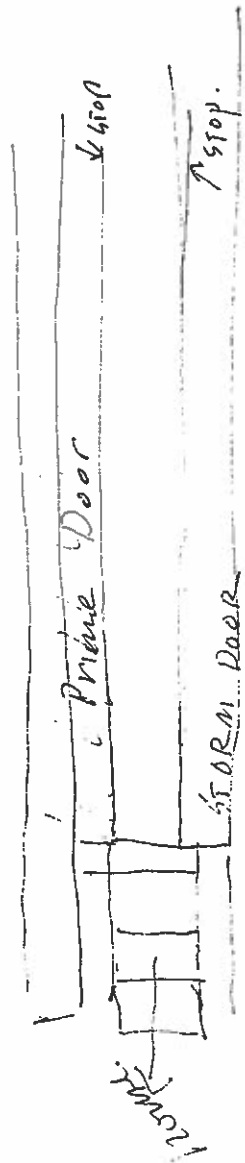
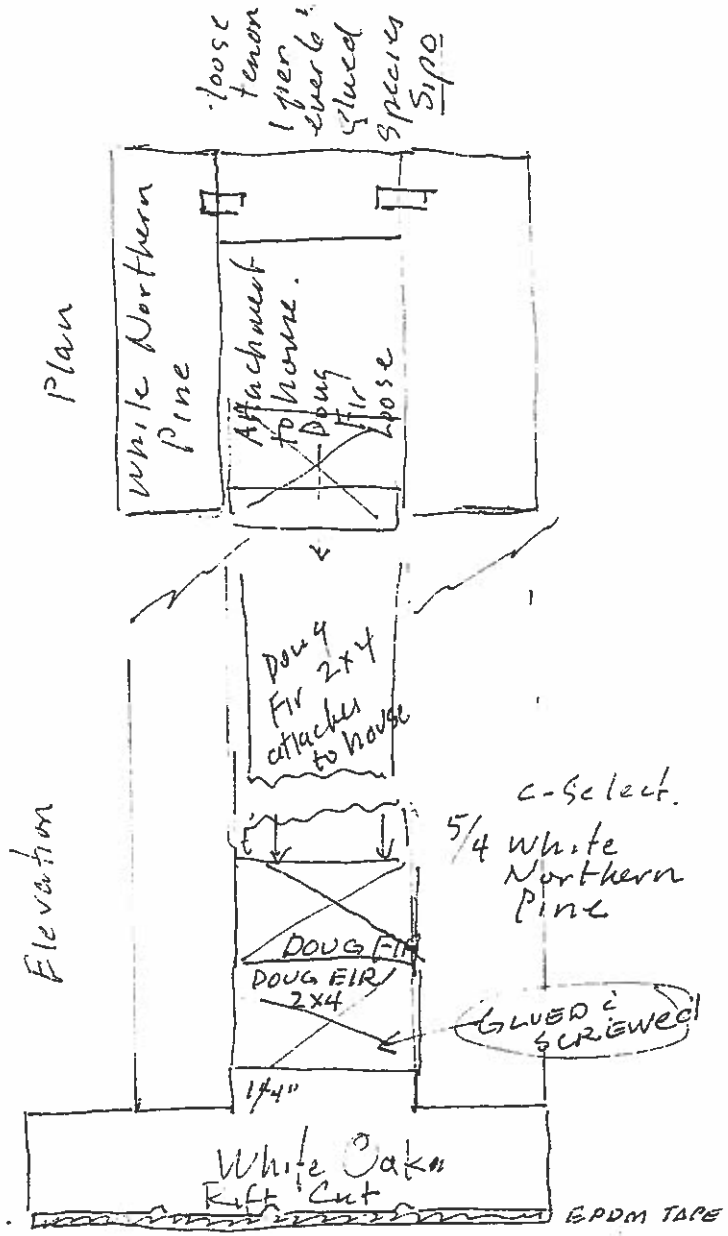
STORM DOORS - Front Entrance

proportion
panels:
applied
moldings
match
100%
prime
door.

FULL MORTICE: TENON
JOINERY

Storm Doors. The storm doors are manufacturer using 5/4 clear White Northern Pine. The configuration matches the layout of the rails and stiles outline in the prime doors. Deltana 3 ½ inch squared blackened solid bronze hinges, and Emtek latch and lock set provide finishing details. They are to be fitted with laminated glass (Fig. 7).

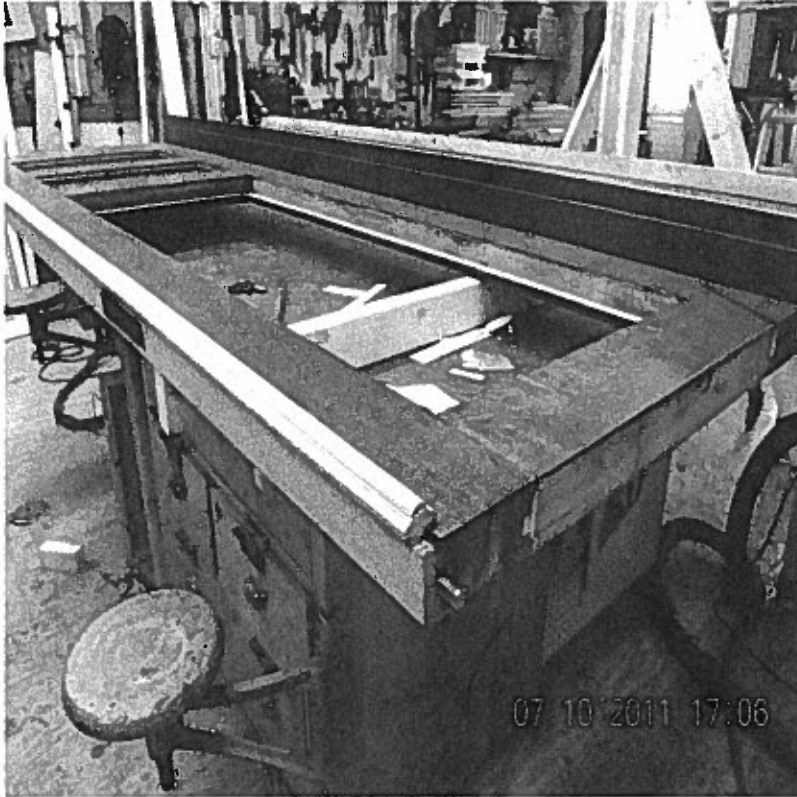
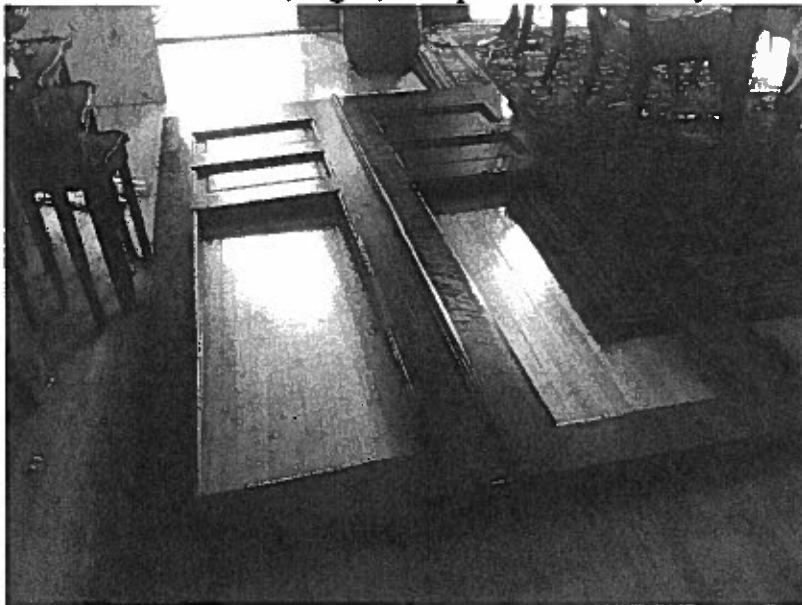
Once several layers of paint had been removed the scope of the restoration project became clear. The doors had been in a fire which damaged the top rail and one stile in one leaf. This surface damage, plus water damage that had deteriorated the laminations in the core, plus physical damage that had resulted from an inartistic lock extraction, plus the extreme difficulty in locating quartered White Oak that would match the existing flake pattern, led to the following decisions. First, two new stiles, and 1 new rail would be fabricated. And second, the damaged rails and stile became a source for veneers that were used to patch the numerous holes (such as mail slots, peep holes, abandoned lock holes, etc) that had been crudely patched.

Fig. 8, Restoration in Process; Fig. 9, Completed Doors Ready for Installation

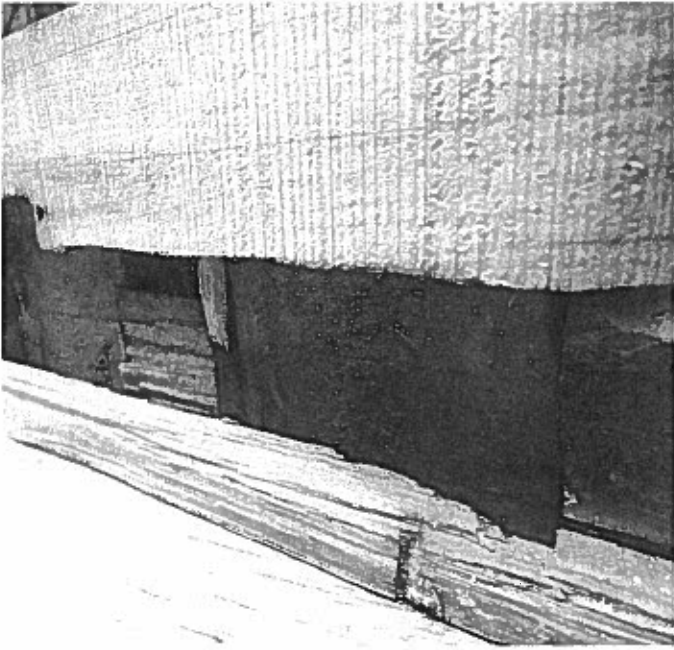
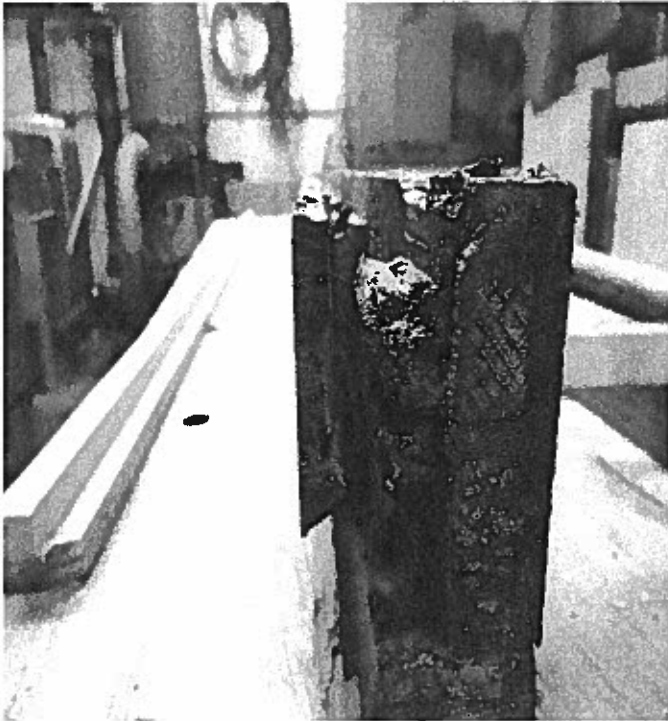
Fig. 10, Stile showing internal damage; Fig. 11, Stile showing end grain damage

New Stile and Rail Fabrication. A new stile and rail were manufactured conforming to the construction of the existing parts of the door. The core, made up of Northern White Pine, was laid up with grain running in opposing directions and glued with *Eptron*® structural epoxy adhesive.¹ The face veneer cut for one side from the abandoned stiles, and from new wood for the reverse side, was selected based on matching flake patterns. It consists of 1/4 inch quartered sawn White Oak, and 1" edge bands on the two long sides (Fig. 12, 13).

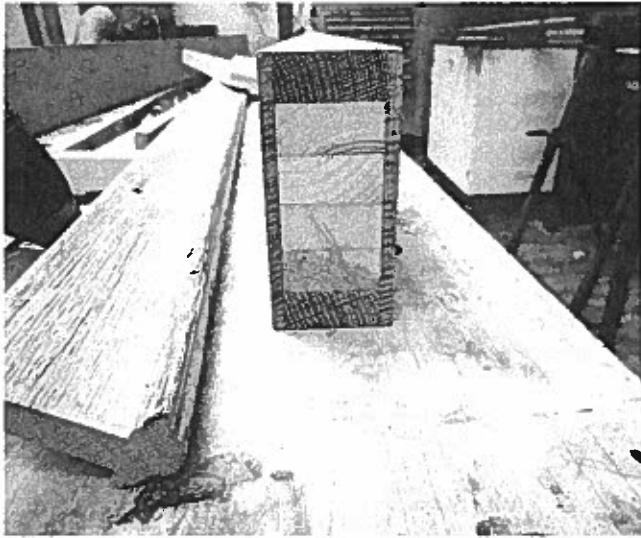
Fig. 12 Replacement Stile

Fig. 12 Replacement Stile, Sill, Astragal, showing placement in Sill.

Framing. No parts from the original framing remained. Thus, the new sills, jambs, and box frames were fabricated. The jambs and sill, cut from rift White Oak, have integral stops and accommodate both the prime doors and storm doors (Fig. 5, 6, 12, 13). The box frame members were fabricated from White Northern Pine, glued and joined with *Dominos*®.² The box frame was based on a tradition of framing windows and doors in solid masonry and brick veneer buildings, and from publications.³ This box frame forms a ground casing for decorative White Northern Pine moulding on the exterior and for the White Oak trim on the interior.

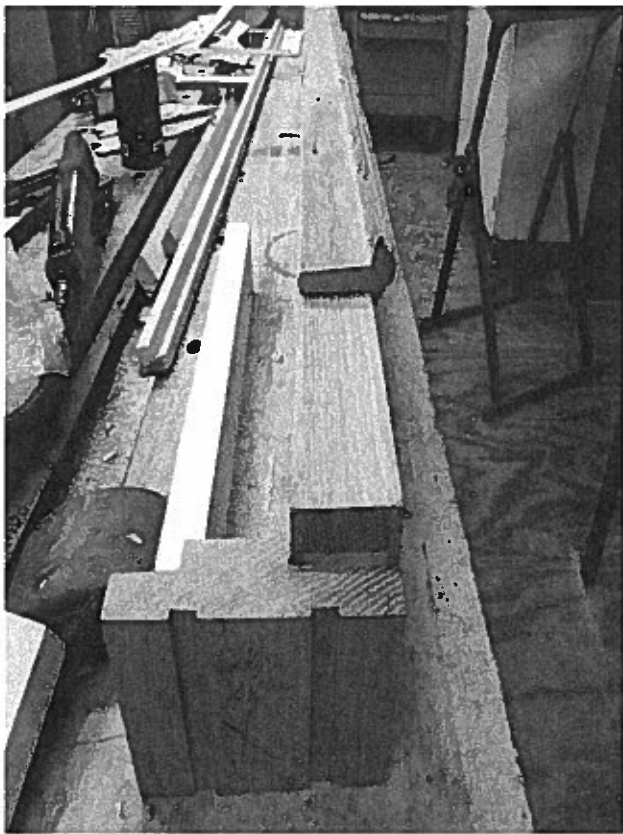
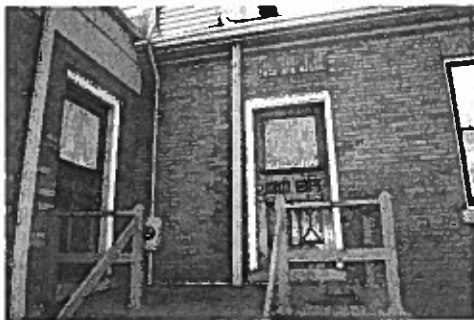
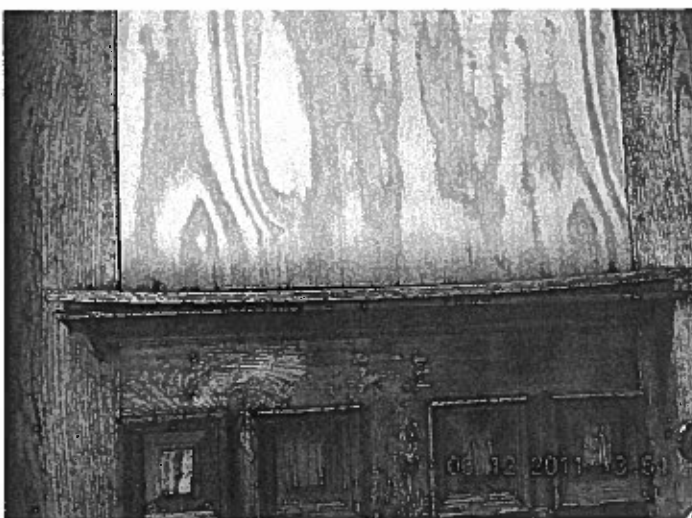
About five years ago, two side entrance doors replaced the metal doors that had been installed at the same time the front entrance had been reconfigured. These doors were part of the original historic restoration plan. Over the past 5 years, they have weathered poorly and now require extensive repair. Their advancing deterioration has been caused by a poor choice of materials, finishes, and construction design. They were constructed from Red Oak (which does not survive exposure to the elements); an interior grade plywood (which is now delaminating) was used for the panels which are not captured into the framing; trim is set into the re-entrant angle between frame and panel to hold the panels in place. Because the panels are not captured, and because the moulding is not “wrapped around” the framing edge, the assembly has deformed beyond repair. The moulding has warped and the plywood has delaminated. In short, the design and material have not survived the elements (Figs. 14, 15, 16).

Figs. 14-16 Side Doors, Details showing damage from weather exposure.

The repair strategy is to remove all the trim, remove the plywood panels, attempt to reattach the delaminating veneers on the bottom rail, replace the plywood panels with solid wood raised panels, replace the trim with a bolection moulding, sand the surface, and apply an exterior grade paint. Most important, each door will be fitted with a storm door that is designed to protect the prime door from the elements.

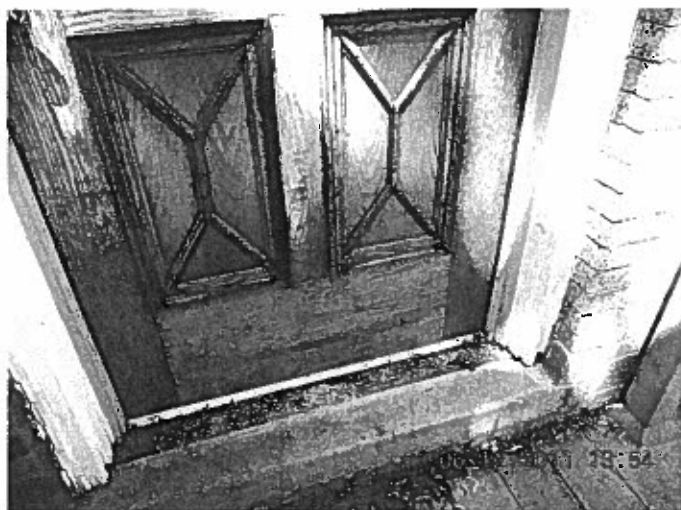
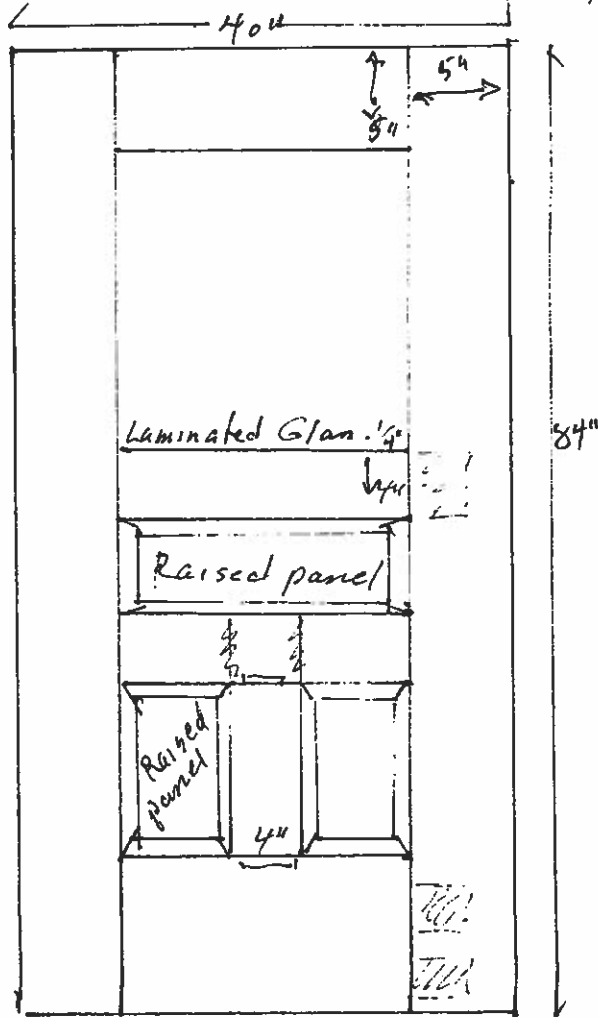
Fig. 17. Storm Door for Side Entrance (2)

Species: White Northern Pine (Grade) 1/4"
& select and Better.
Full mortice & tenon joinery.

The design of the storm doors follows the basic outlines of the prime door. They are constructed from clear White Northern Pine, dried to 8%, and constructed with full mortice and tenon joinery. The raised panels are captured in ½ inch grooves and so will not depend upon a moulding to keep the panels in place (Fig. 17).

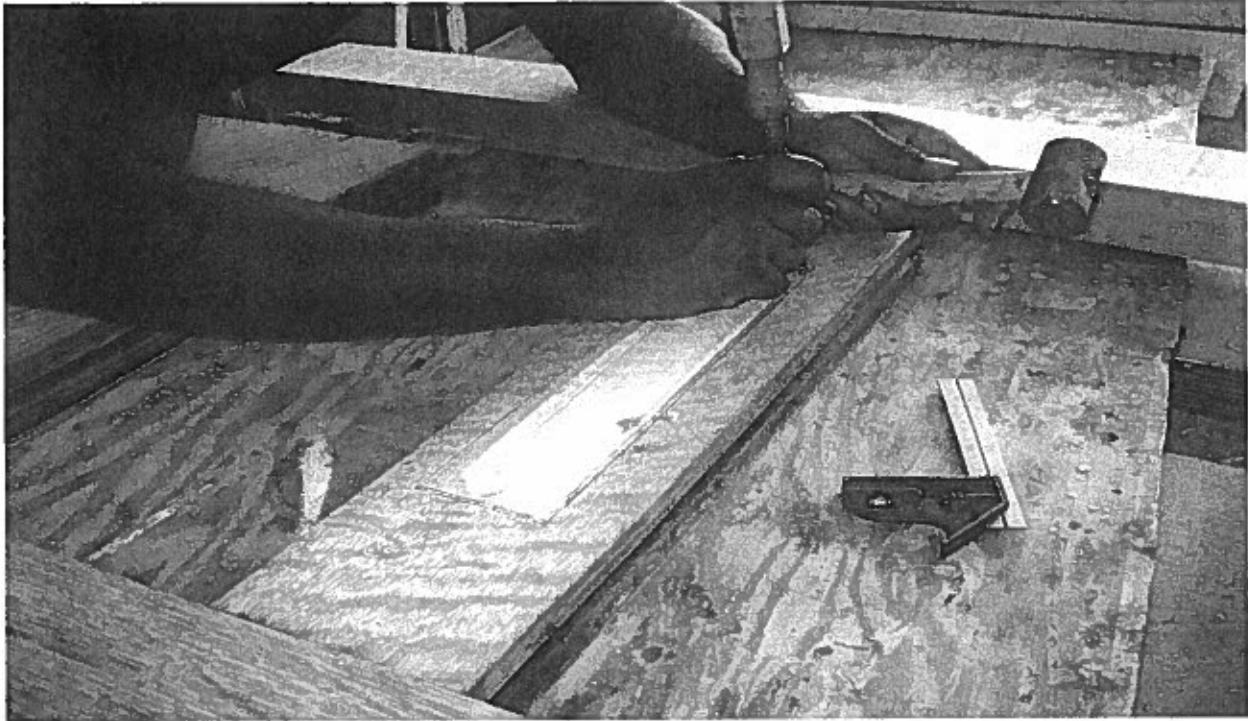
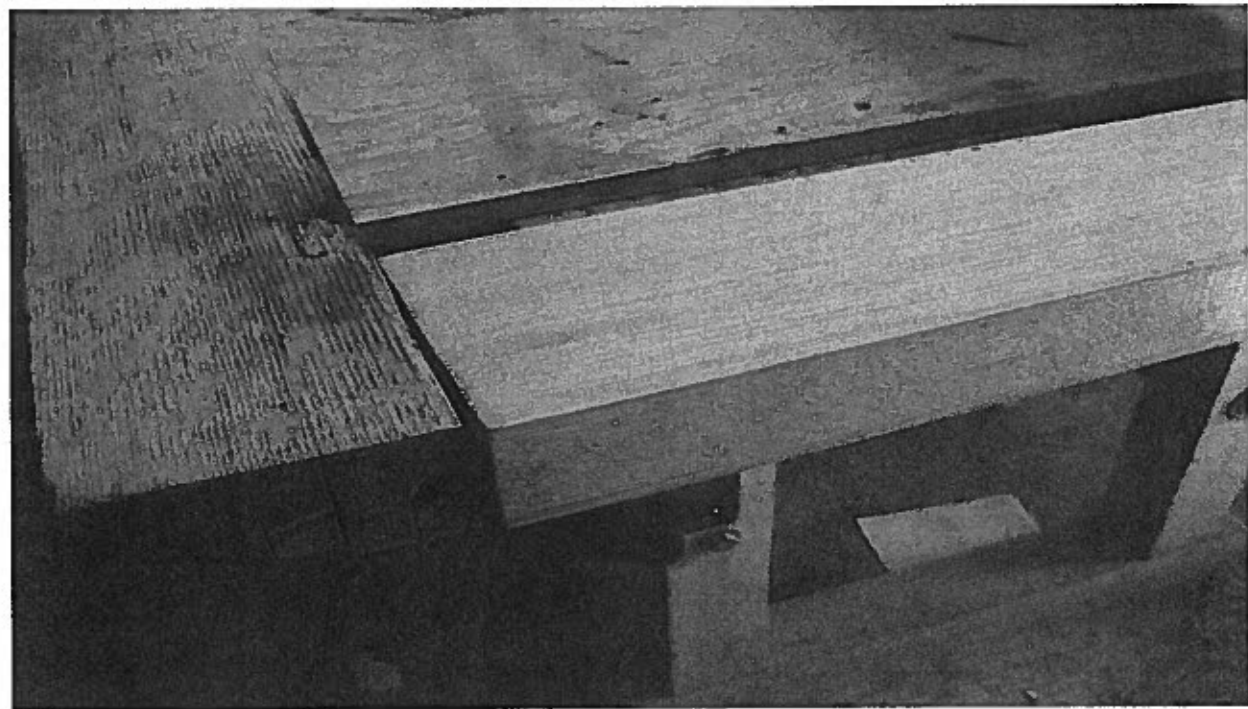
Figs. 5 and 6. Repairs in progress.
