## CERTIFICATE OF APPROPRIATENESS APPLICATION FORM

Laura and George Pechkam Miller House

1060 E. Juneau St., Milwaukee, WI

Attn: Corey Didier  
Re: Maintenance to Exterior Masonry  
1060 E. Juneau St.  
Milwaukee, WI

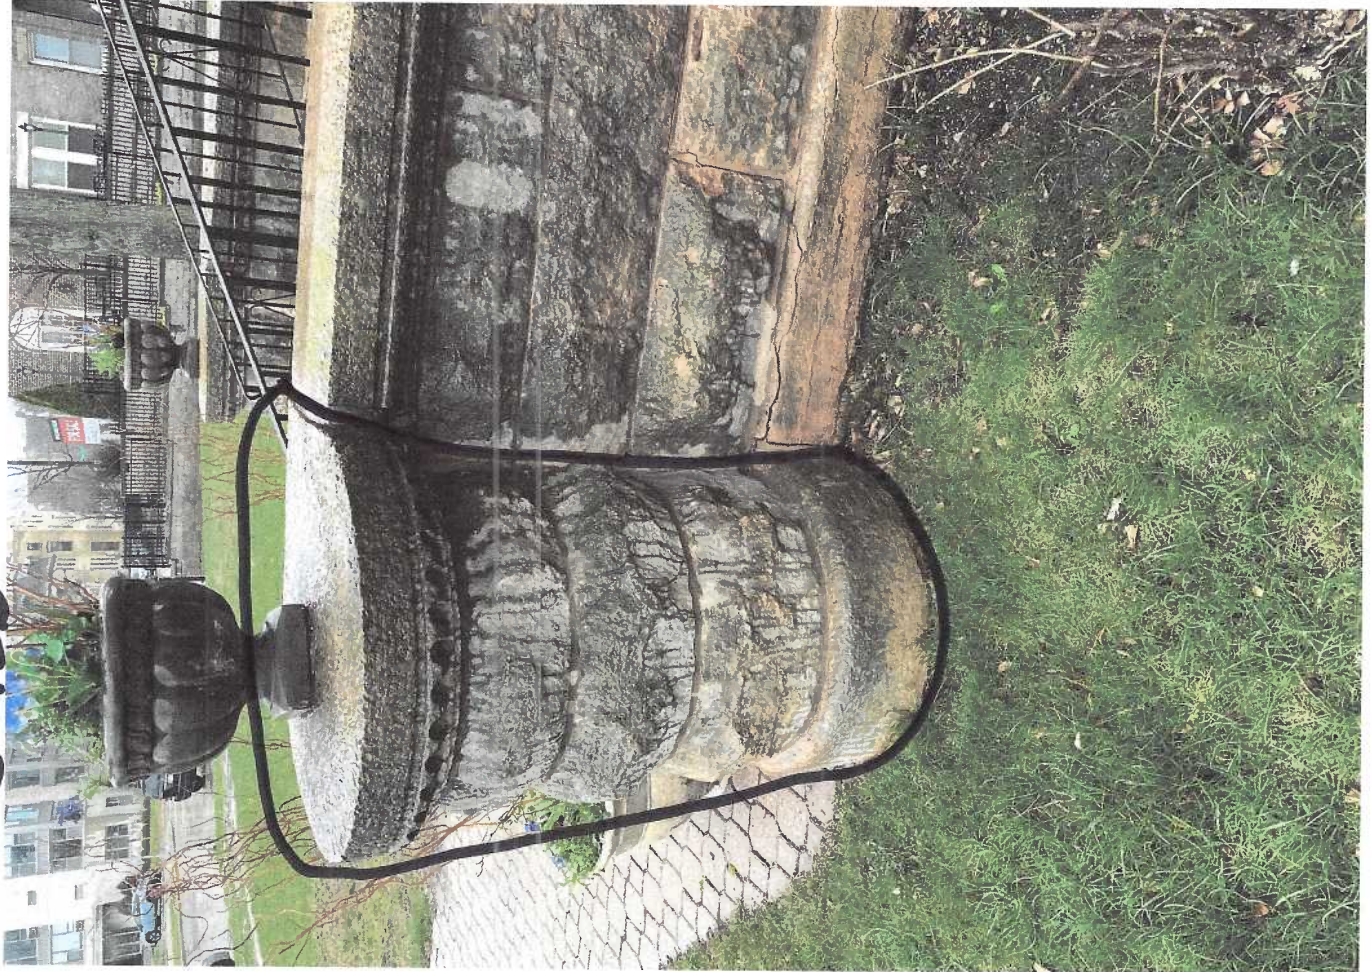
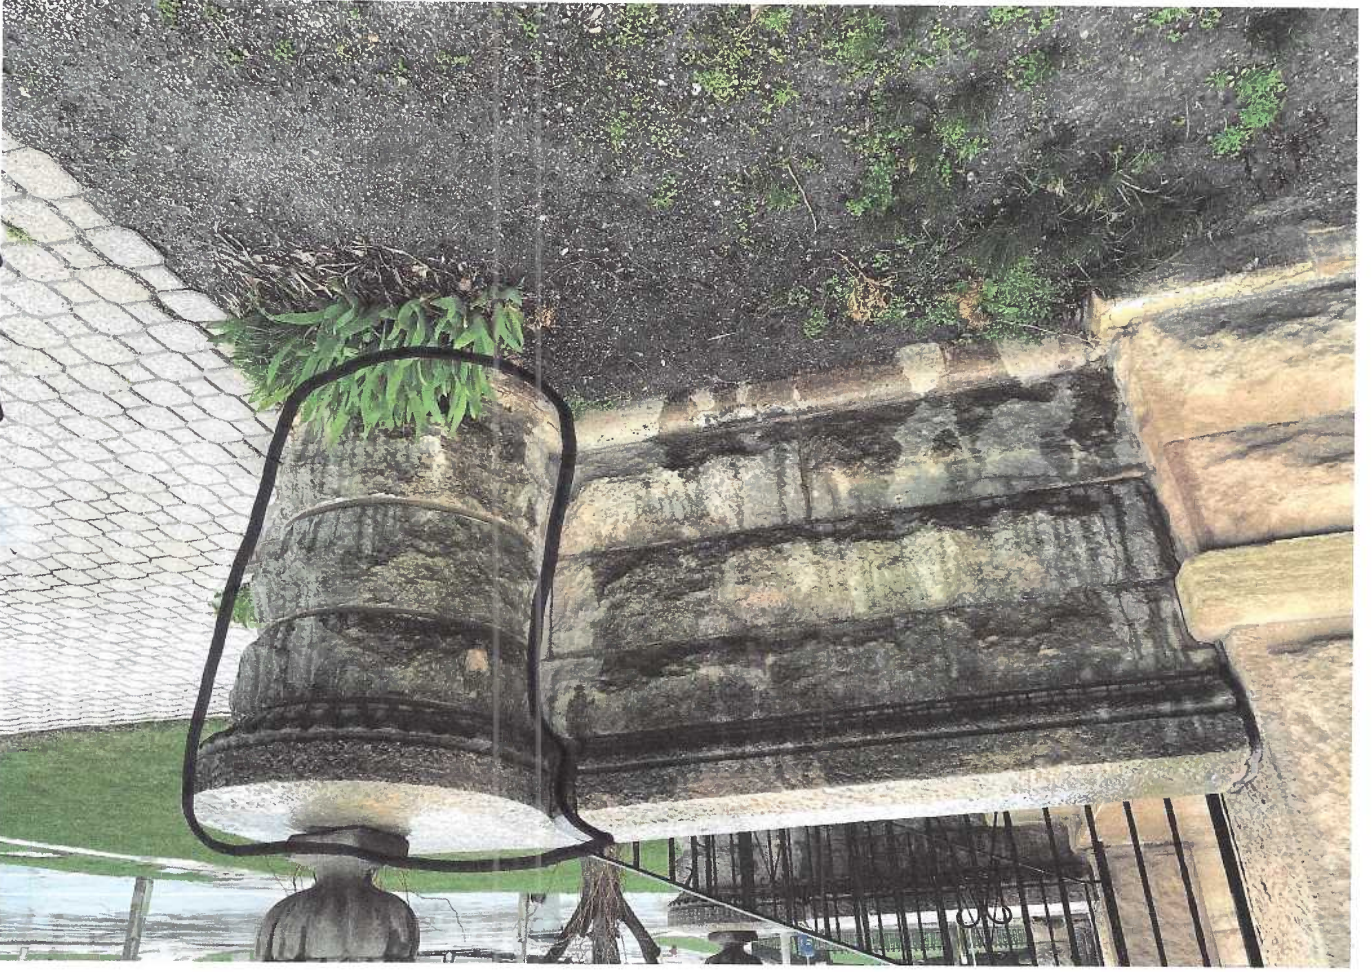
Accordingly, we have broken this proposal down into two phases. The first phase requires the most pressing repair and that entails rebuilding the two front columns at the base of the south stair. It appears that these two columns have been falling away southward from the wingwalls for some time. This is evident due to some mis-matched mortar and sealant installed into the joints between these columns and the wing walls. It is believed that the foundation for these columns are insufficient and are settling.

REBUILD  
COLUMNS

REMOVE  
MORTAR  
"CHUNK"

**EXTENT OF REBUILD**

To repair this issue, these two columns will be carefully taken apart, set on plywood that is adjacent to these columns and the residual mortar will be cleaned from the stones. The bottom stone on the west column will likely need to be replaced with a similar stone. Because of this, a suitable replacement stone quarry will need to be located prior to the commencement of this work. It is believed that the stone originally used to construct this building came from the Baraboo River area (Abelman quartzite<sup>4</sup>). Because quarries in that area no longer produce stone for architectural features, a similar stone will need to be located. It is believed that a Kasota stone from a quarry in southern Minnesota could be located that would match sufficiently.

With the columns removed, the existing foundation for these columns will be inspected and it is believed they will need to be removed. A new foundation will then be constructed consisting of a 12" thick reinforced concrete footing and a concrete pier that extends upward to slightly above grade that is the size of the original foundation (assumed to be circular and approximately 8" less in diameter than the bottom stone). With the new concrete foundation in place these columns can then be rebuilt.

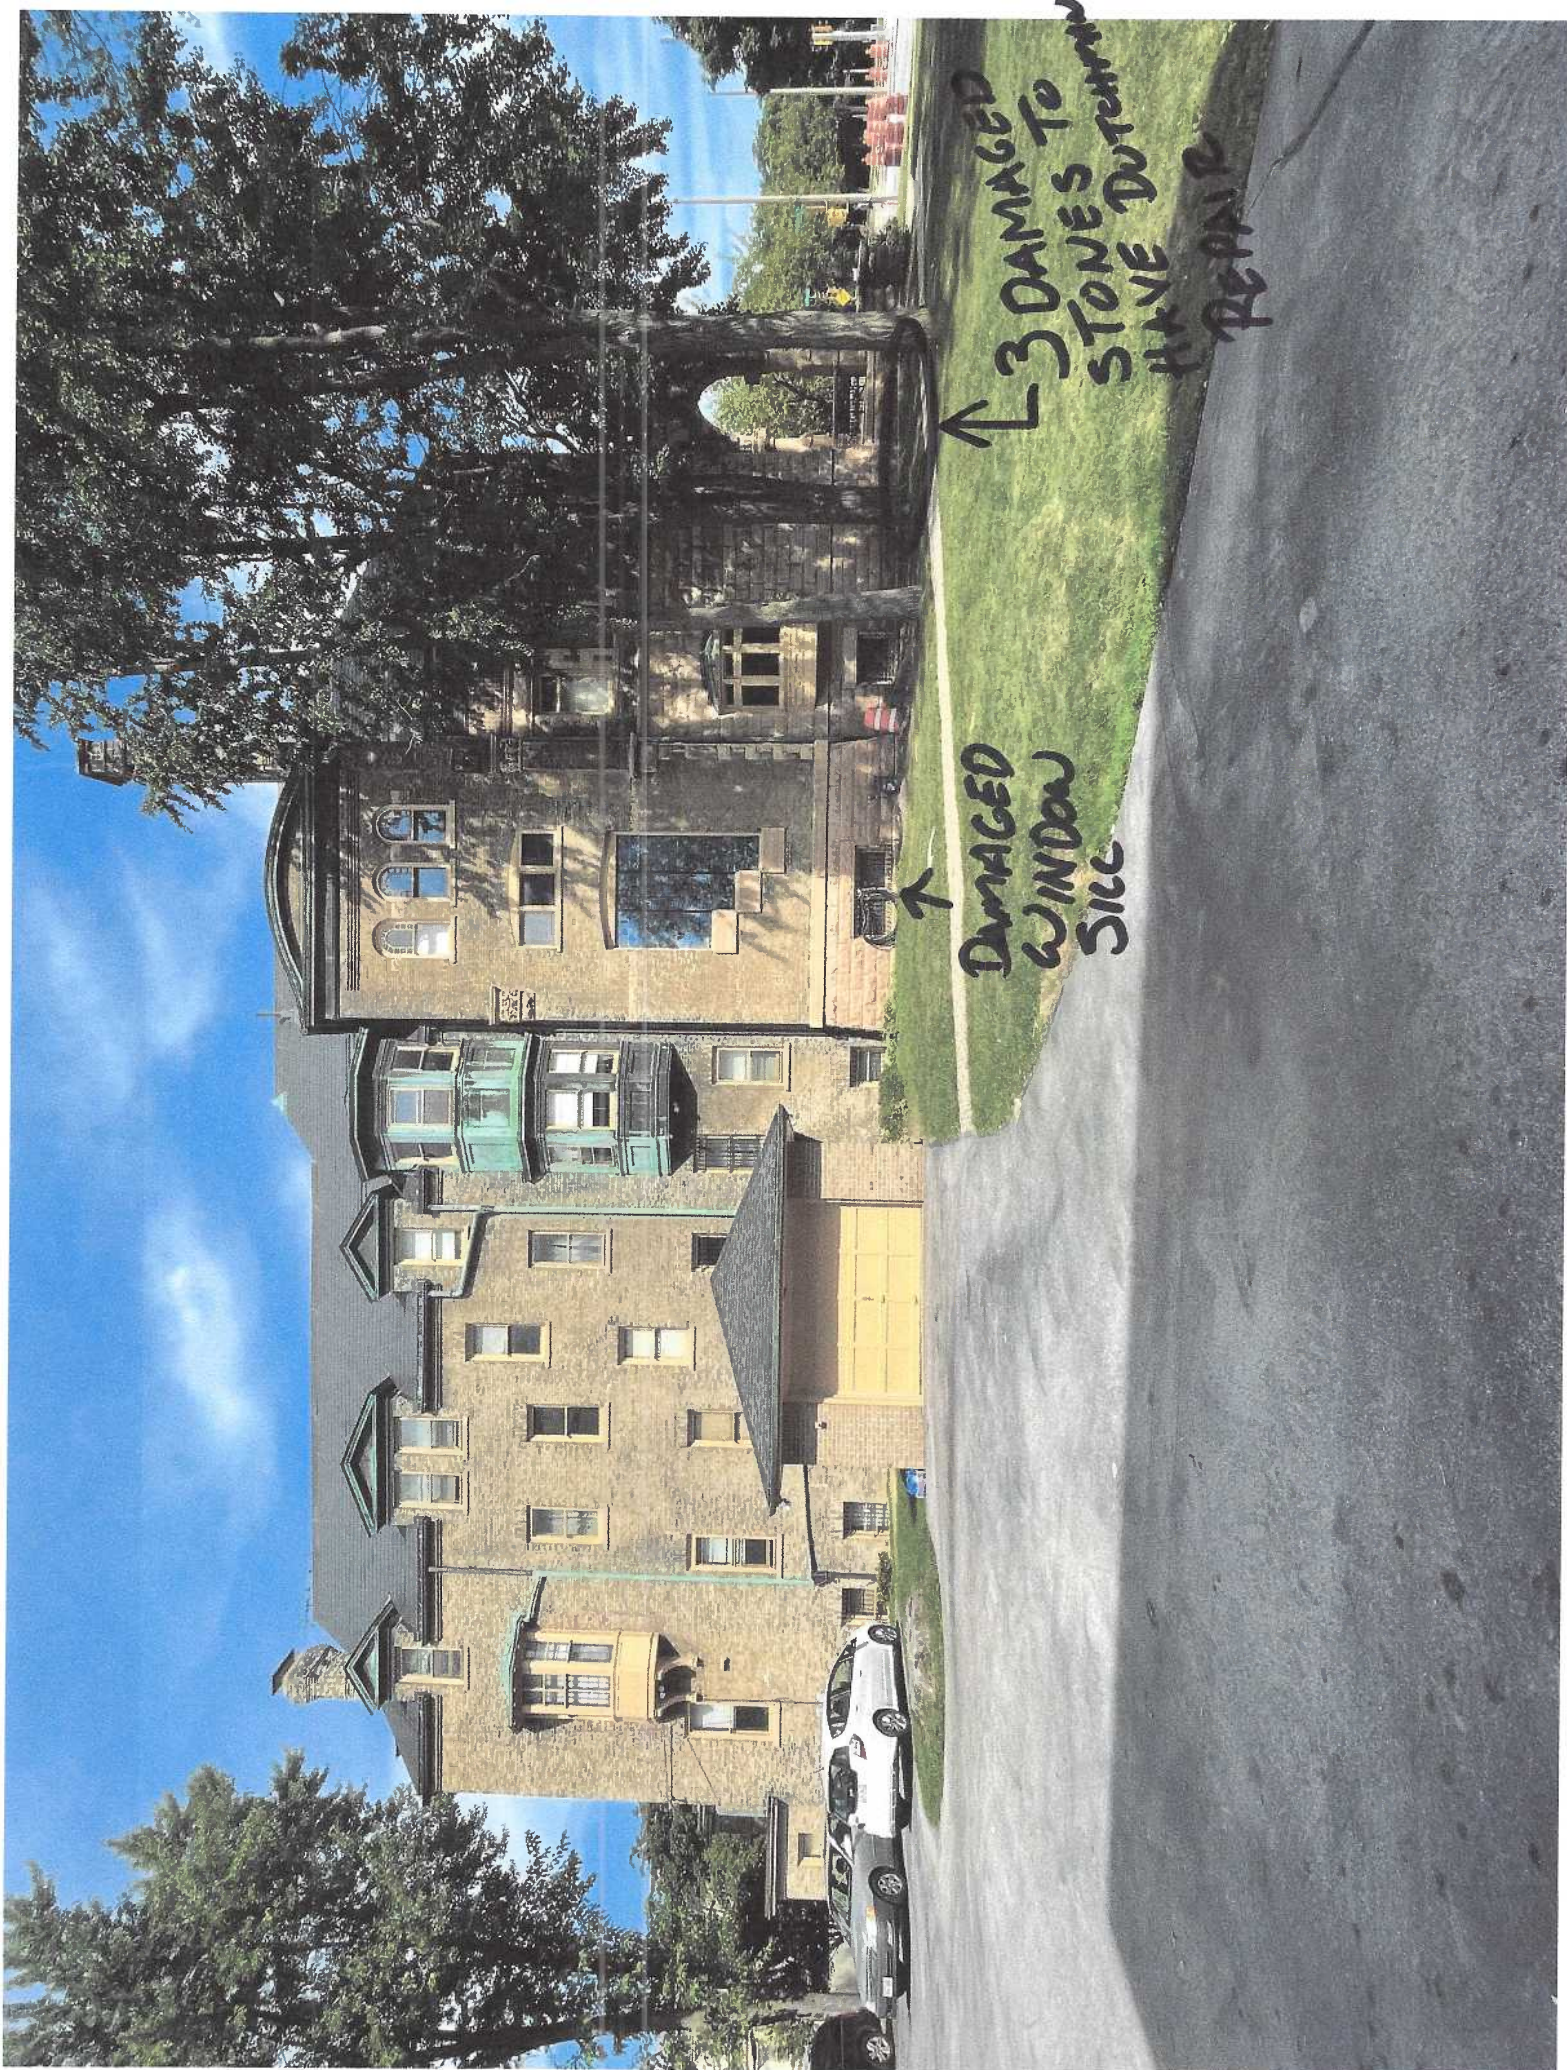
The second phase of this project will be to complete basic maintenance to the stone masonry. To begin with, there is a block of mortar that, it appears, someone in recent times placed below the south east column of the front porch. This will be removed and the “cream city” brick behind will be inspected and repaired as necessary. It was assumed that there would need to be approximately 5 brick replacements completed and that they could be replaced without the need to remove any stone.

There is also one stone from a second floor window on the east elevation that has broken off. This stone will be reset into place. Specifically, stainless steel pins will be installed, as described earlier, to hold the fractured stone to the parent stone. The surrounding mortar joints will then be tuckpointed and struck to match the surrounding joints, as best possible.

RESET  
DAMAGED  
STONE

REMOVE MORTAR  
CHUNK

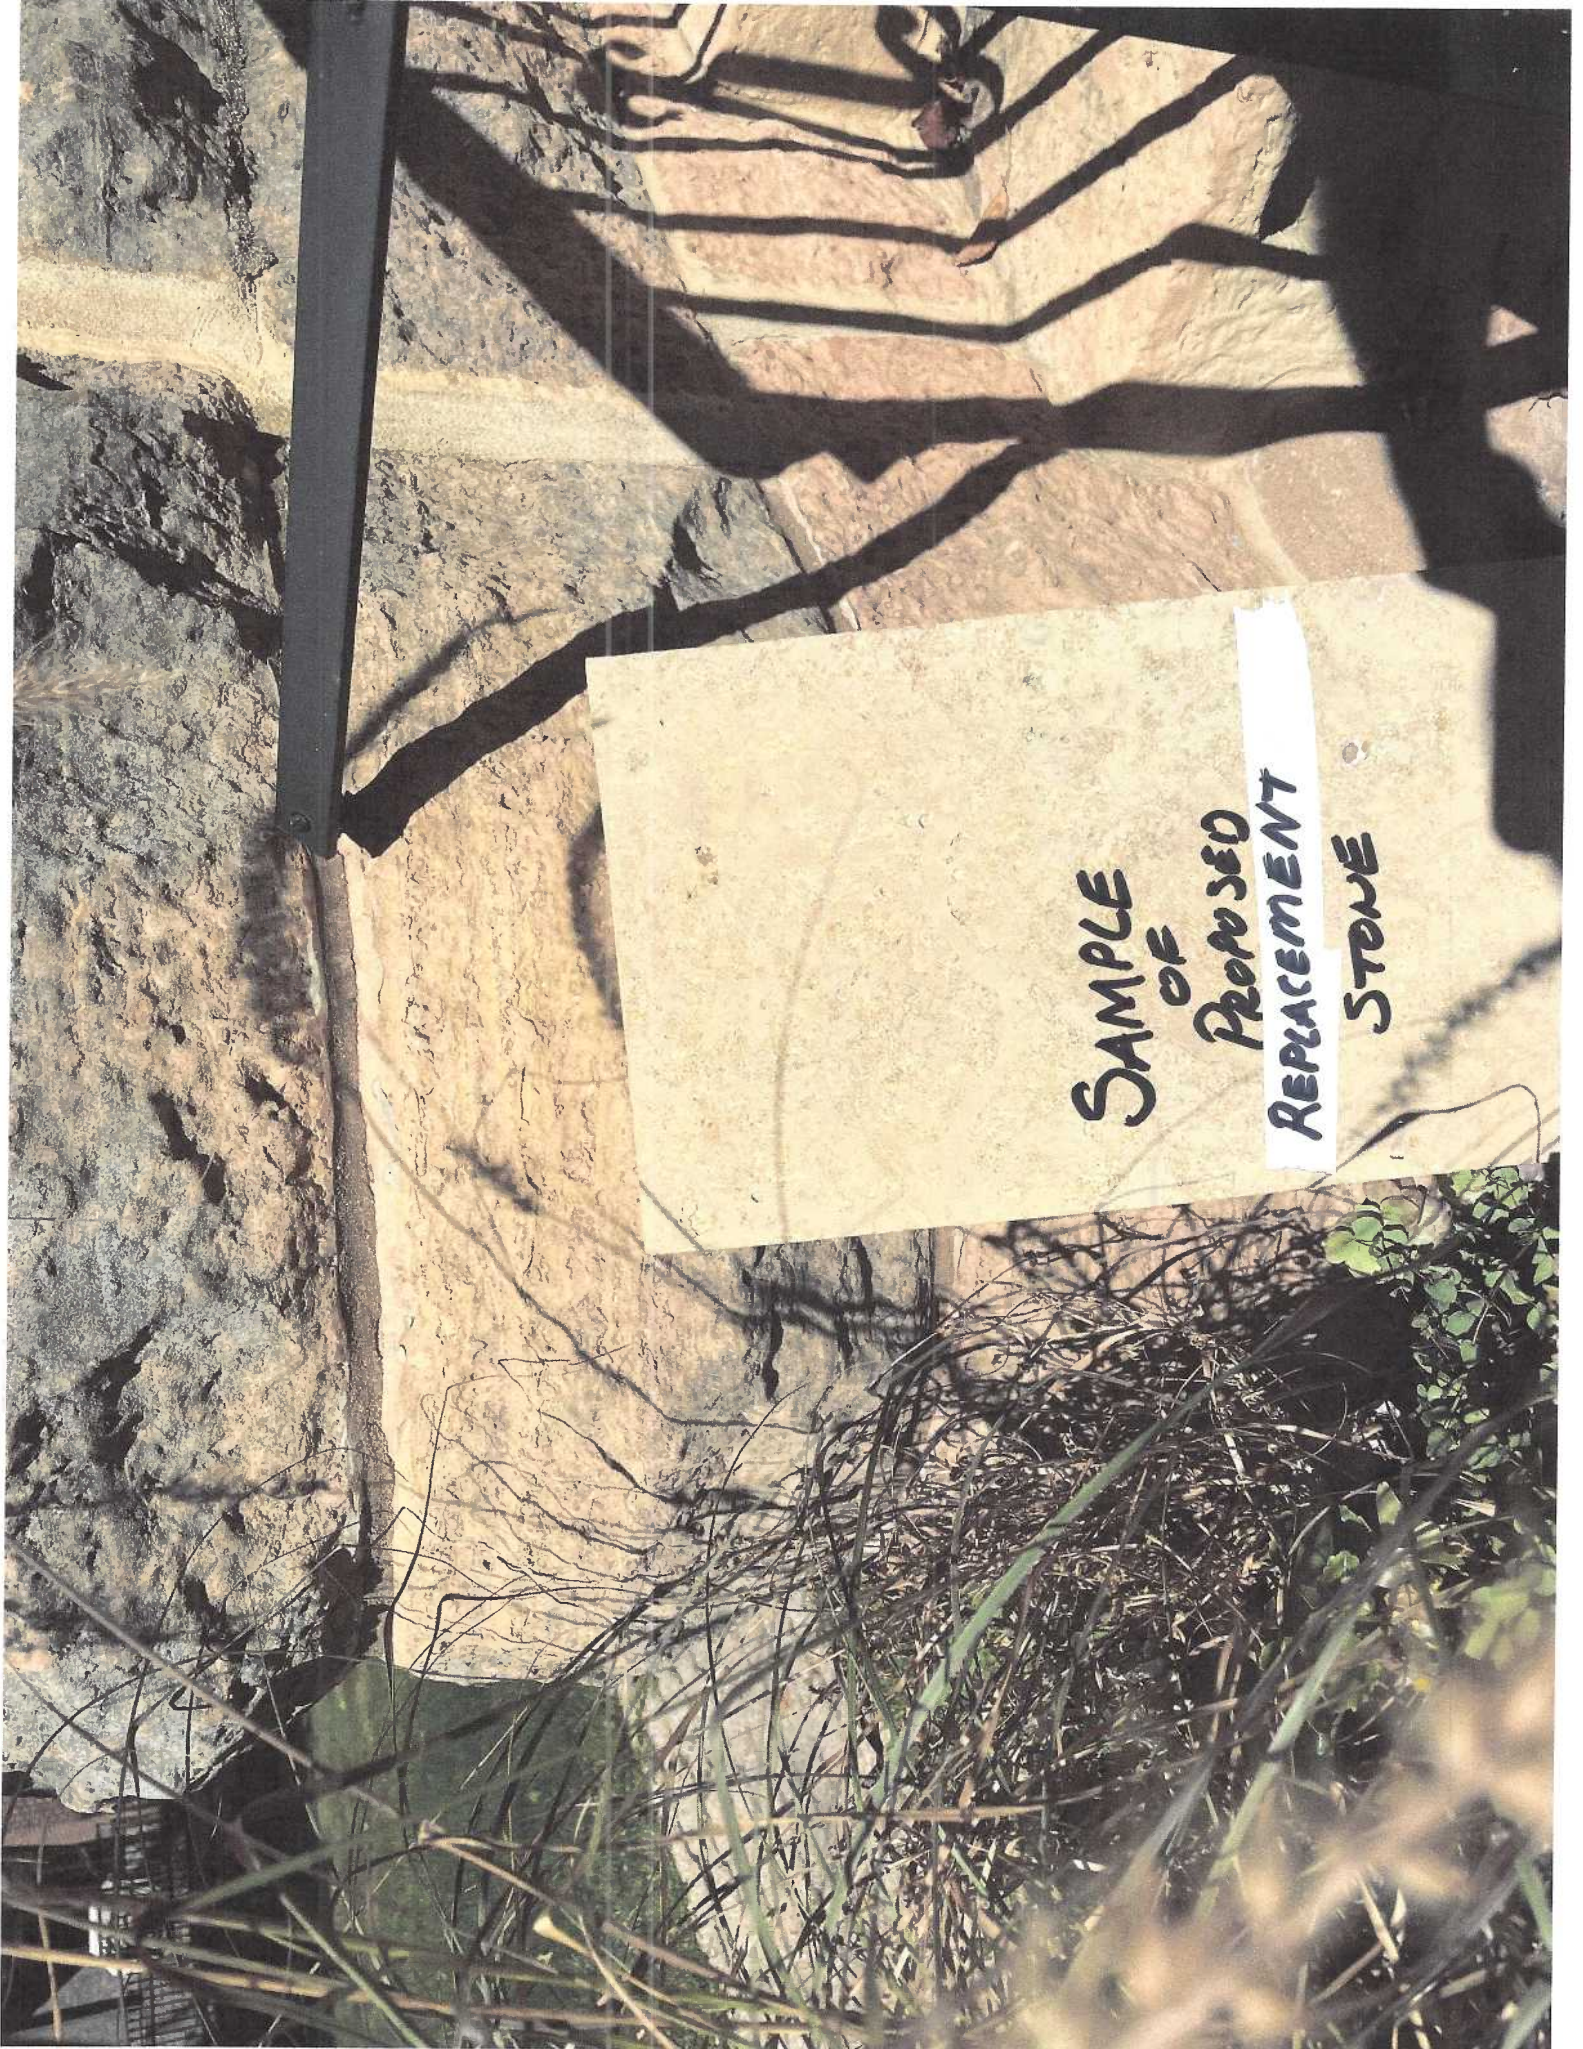
There is a basement window sill on the west elevation that is badly cracked. This will be completely replaced with the type of stone that was found to be a match for the front porch columns. Further, there are three (3) stones at the base of the building on the west elevation that are delaminating. As these stones are likely the full thickness of the wall, a dutchman type repair will be completed (confirmation of stone depth prior to ordering of new stone elements).

DAMAGED WINDOW SILL

3 DAMAGED STONES TO HAVE DUTCHMAN REPAIR

SAMPLE  
OF  
PROPOSED  
REPLACEMENT  
STONE

The existing failed stones will be chipped back approximately 4” from the predominate plane of the building and stainless steel pins will be epoxied into the parent stone at 12” on center or a minimum of two pins. Corresponding holes will be drilled into the dutchman stone. These holes will then be cleaned of dust by brushing and blowing out the dust and a gel epoxy placed into the holes. The stone will then be set in place in a full bed of mortar with the stainless steel pins firmly set into the wet epoxy in the corresponding holes of the new stone.
