## **TURNER HALL**

## **FEMA Grant Safety and Security Project**

Certificate of Appropriateness Application  
Drawings and Photo Exhibits

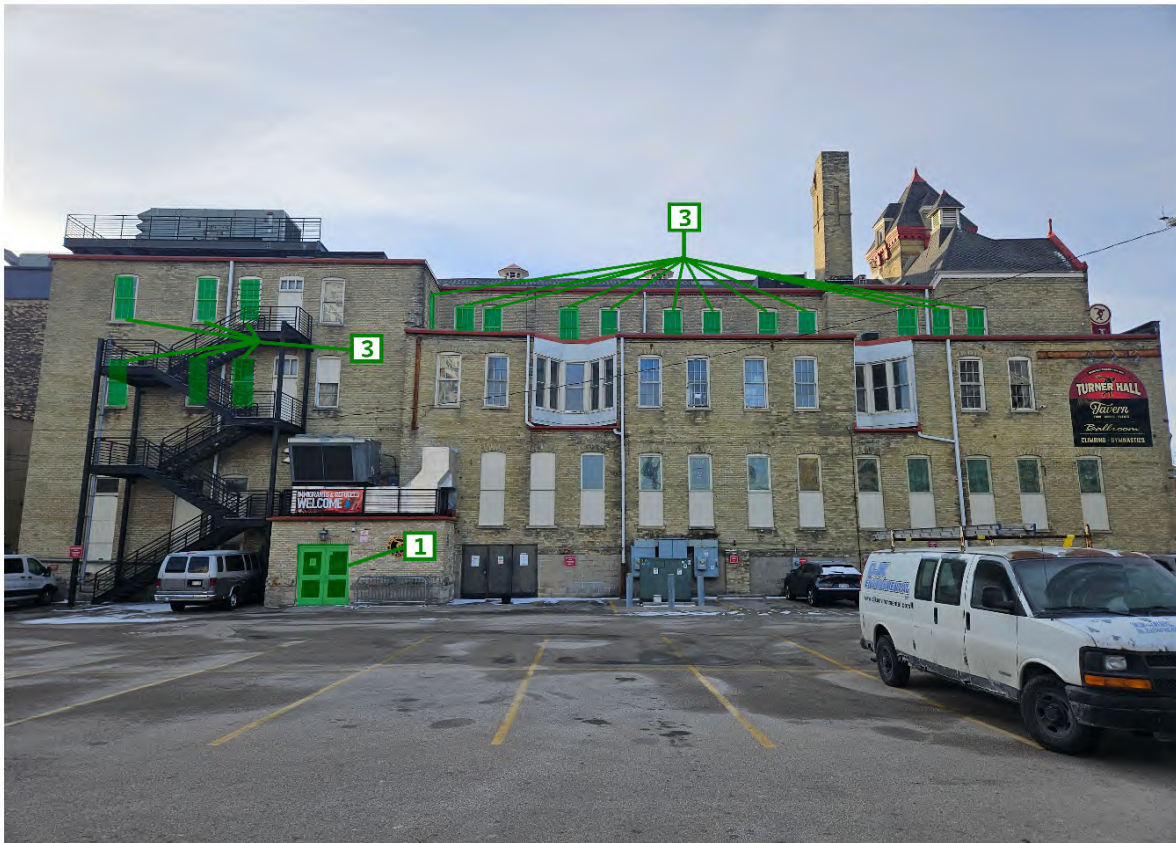
### NORTH ELEVATION - EXISTING CONDITION

- 18 WINDOWS FOR REPLACEMENT ON NORTH ELEVATION
- REPLACE NON-ORIGINAL DOORS TO ELEVATOR ENTRY

- 1** REPLACE EXISTING NON-ORIGINAL DOORS WITH NEW METAL DOORS. PAINT DOORS CREAM COLOR TO MATCH ADJACENT BRICK.
- 3** NEW WINDOWS REBUILT TO MATCH ORIGINALS. NEW GLAZING TO BE LAMINATED SAFETY GLASS.

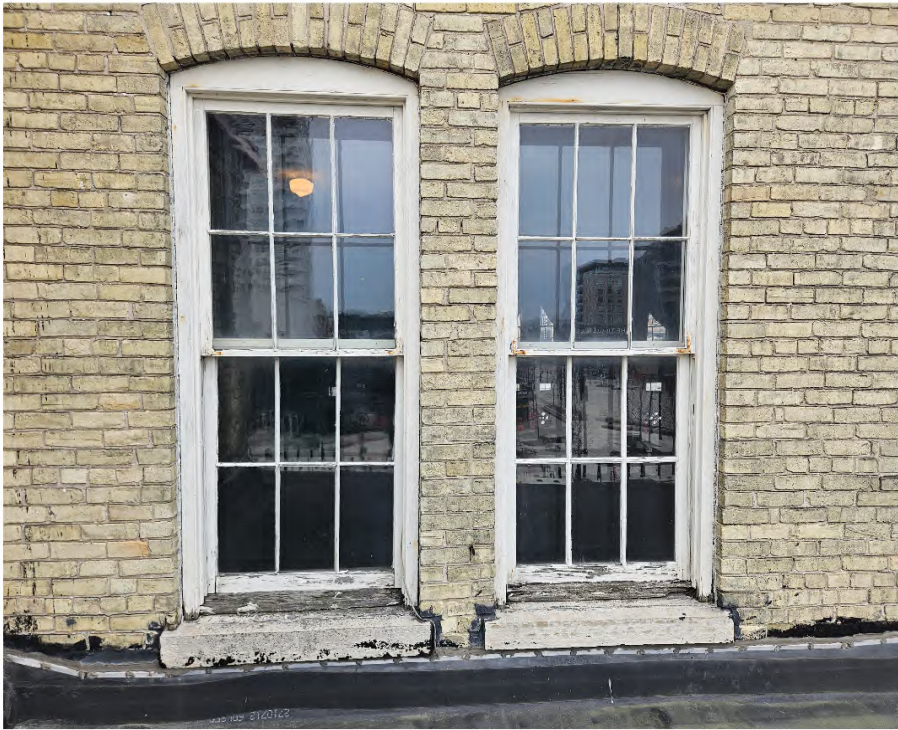
### NORTH ELEVATION - 3RD FLOOR

-ORIGINAL WOOD WINDOWS ON THIRD FLOOR. WEATHERING, WOOD ROT, AND PREVIOUS POOR QUALITY REPAIRS HAVE MADE IT INFEASIBLE TO REPAIR WINDOWS.

-THE SCOPE OF WORK FOR THIS PROPOSES TO REPLACE THE WINDOWS IN KIND WITH NEW WOOD WINDOWS MATCHING THE ORIGINAL CONFIGURATION AND PROFILE WITH NEW LAMINATED SAFETY GLASS

**3** NEW WOOD WINDOWS REBUILT TO MATCH ORIGINALS. NEW GLAZING TO BE LAMINATED SAFETY GLASS

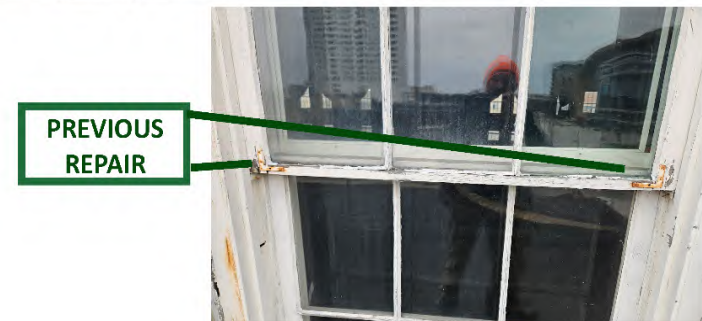
PREVIOUS  
REPAIR

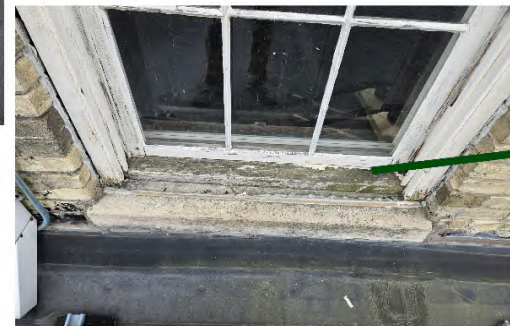
WOOD ROT

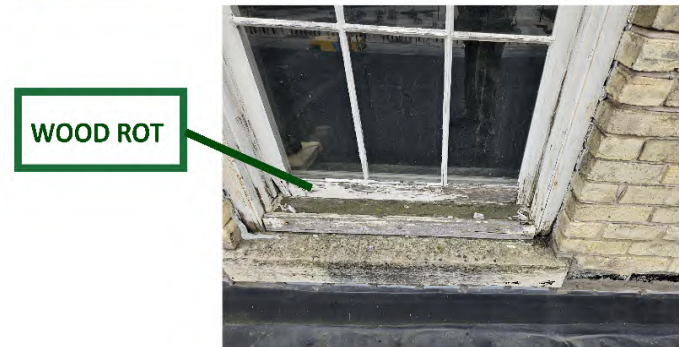
WOOD ROT
