Milwaukee Historic Preservation Commission Staff Report

HPC meeting date: 01/19/2009
Ald. Milele Coggs District: 6
Staff reviewer: Paul Jakubovich
PTS #55417

Property 135 W. RESERVOIR AV. (Brewers Hill Historic District)

Proposal Front door was replaced with new door made of composite material and original sidelites were removed to accommodate a new stock sized door. A metal storm door was also installed. The work was done without a Certificate of Appropriateness.

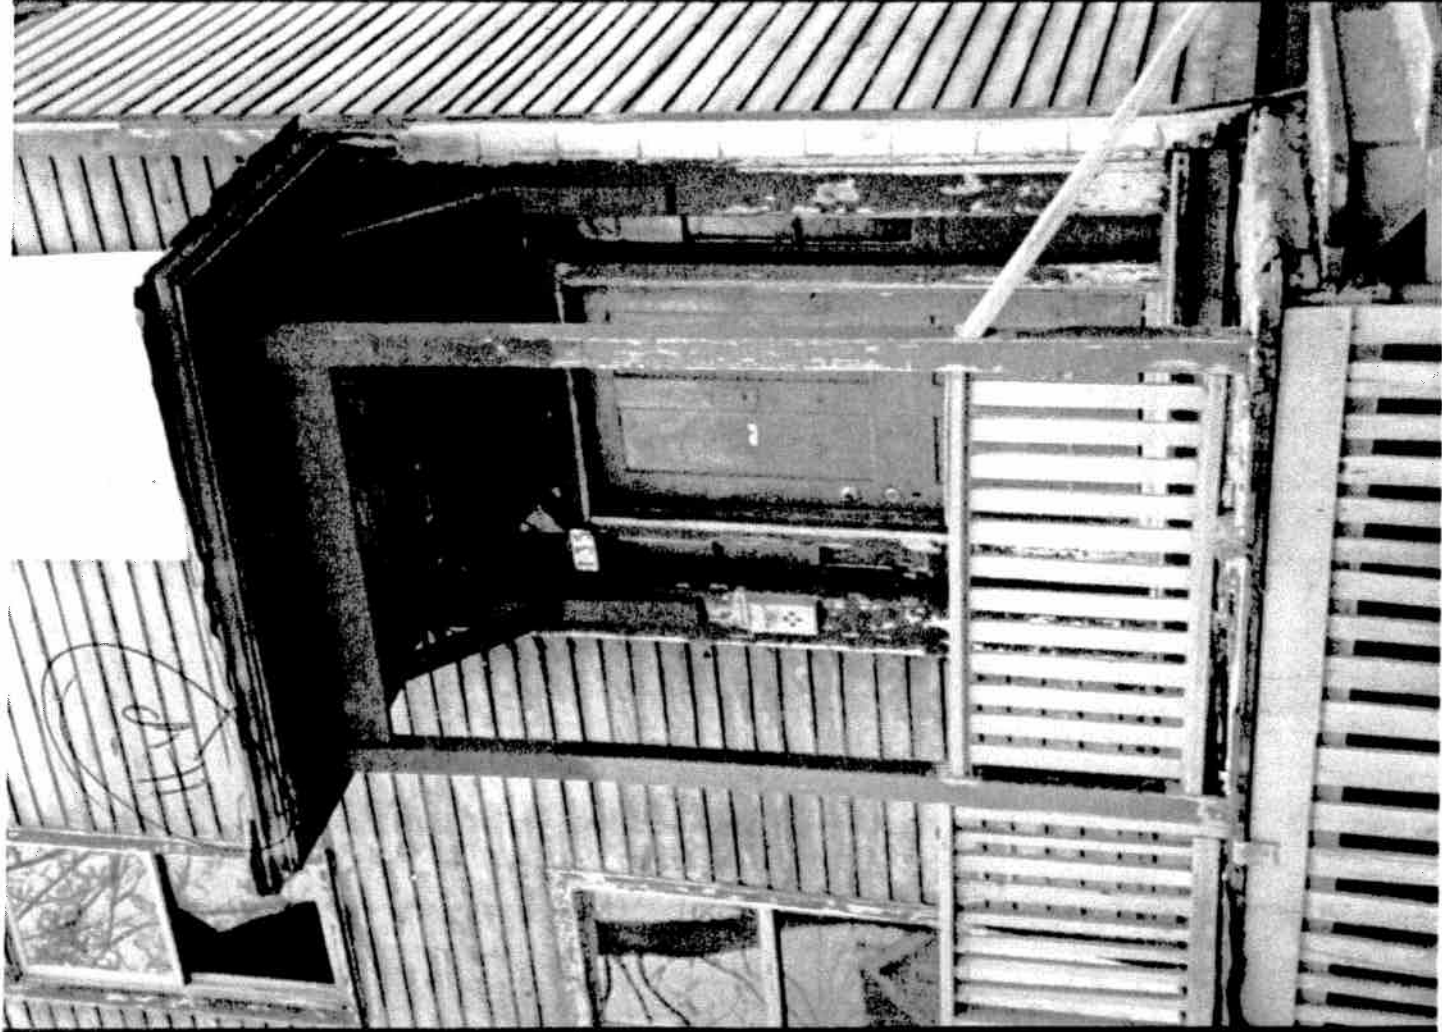
- The door, transom and sidelites in 1998 when a COA expressly required preservation of these features.

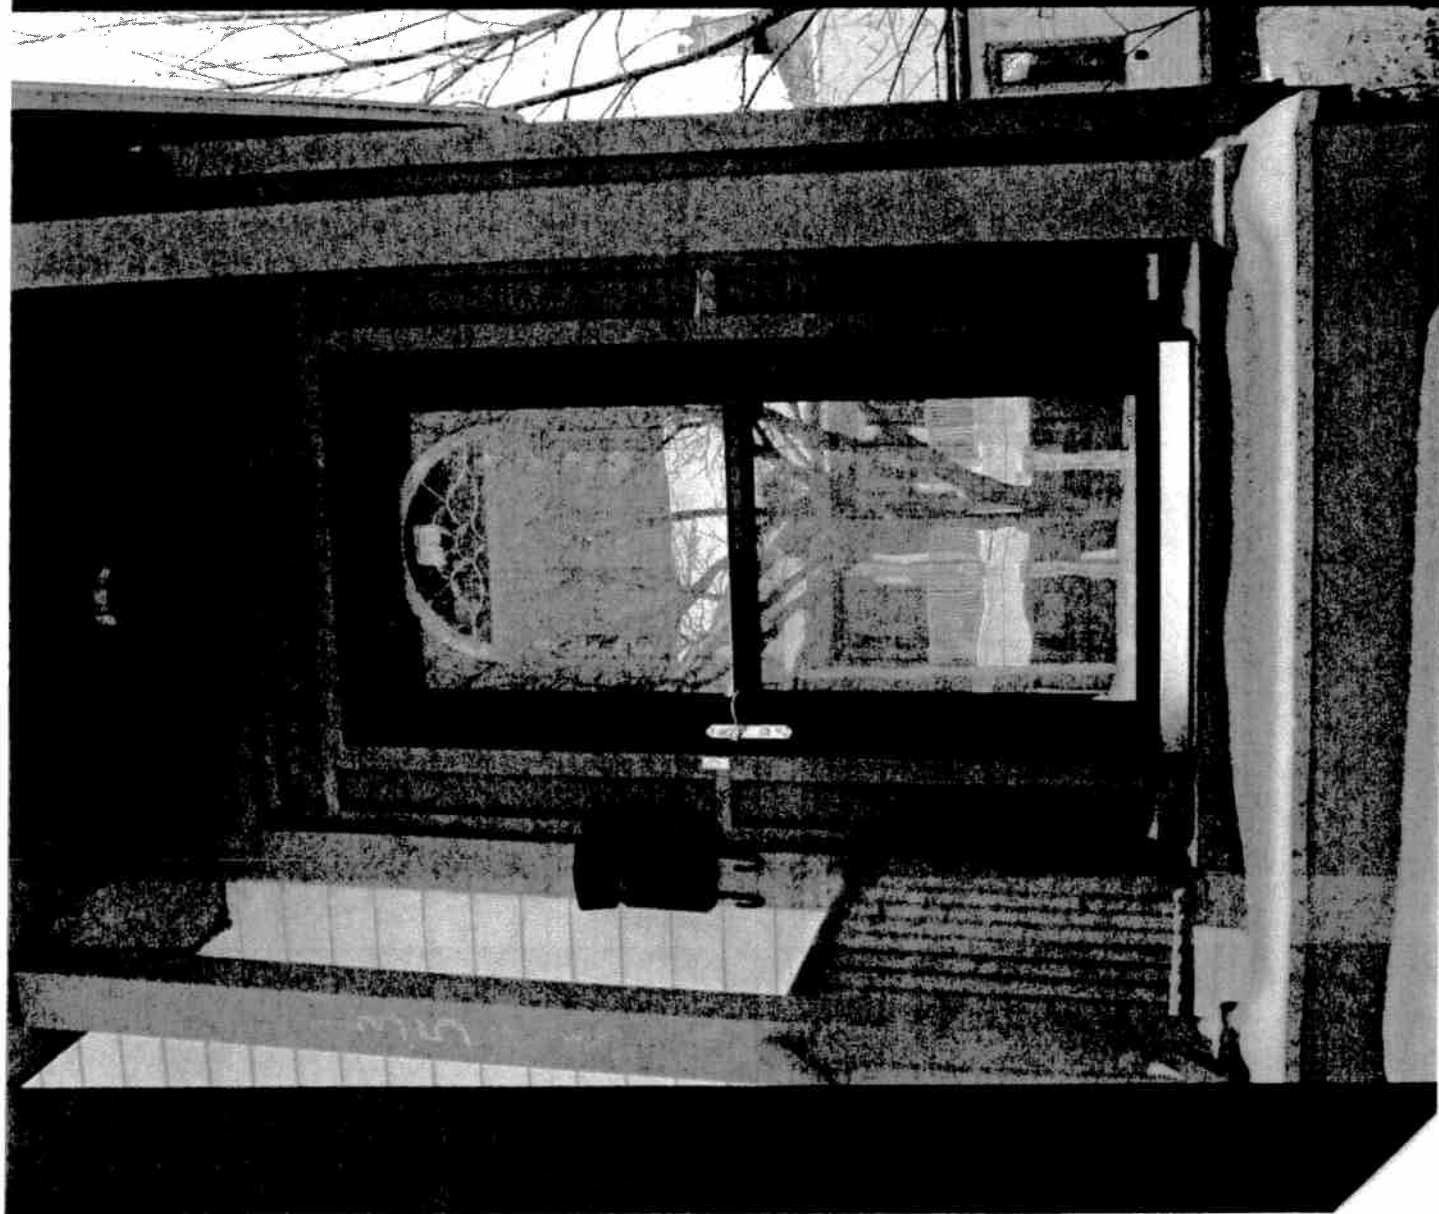
The newly installed composite material, Colonial/contemporary style door with a fanlight is a not a proper fit for the house or the Brewers Hill historic district. This type of door is expressly rejected on page 27 of Living With History, the guideline book that was mailed to all residents of historic districts several years ago. The sidelites were also removed, apparently to accommodate the installation of a new stock sized door. The removal of the old door and side lites is also contrary to the district guidelines which state: "Retain existing window and door openings that are visible from the public right-of-way. Retain the original configuration of panes, sash, lintels, keystones, sills, architraves, pediments, hoods, doors, shutters and hardware. Avoid making additional openings or changes in the principal elevations by enlarging or reducing window or door openings to fit new stock window sash or new stock door sizes... Avoid discarding original doors and door hardware when they can be repaired or reused."

■ New prime door,
storm door; side
lites and transom
removed.

There is no record in recent years of any door change out approved by HPC staff or the commission that would have permitted the installation of a composite material front door or the removal of historic transoms and side lites. In summary, because the work does not meet the guidelines, the front door surrounded by sidelites and a transom should be restored to the original size, design and configuration. In the event a storm door is required, it should be a full view wood storm door such as the one featured on page 28 of Living With History.

Recommendation Recommend HPC Denial
