2044 NORTH 2ND STREET
MILWAUKEE, WI

Southern Porch Column Repair Plan
for the Historic Preservation Commission
to secure a Certificate of Appropriateness

August 2023

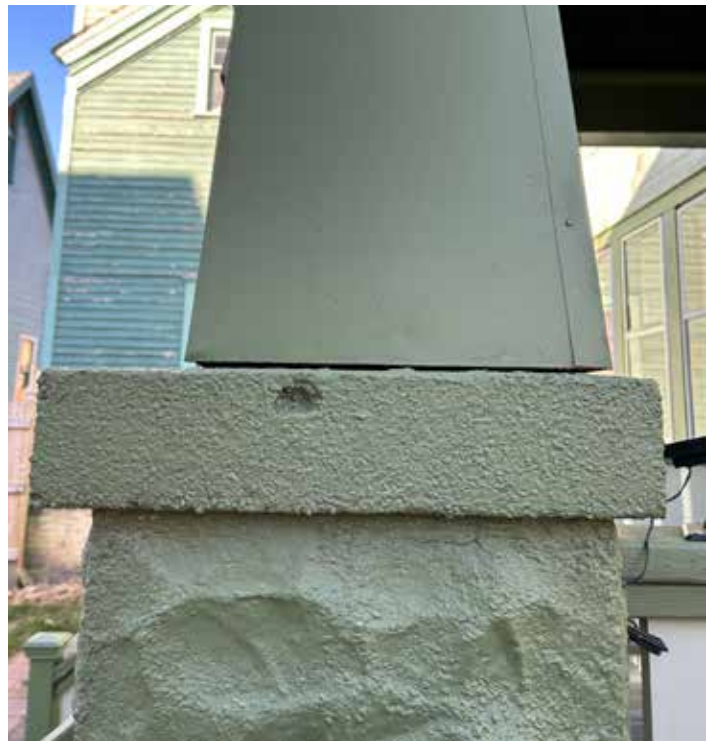
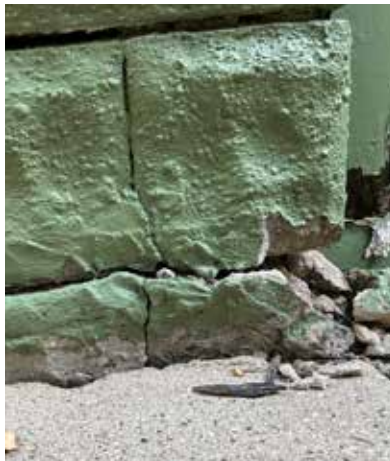
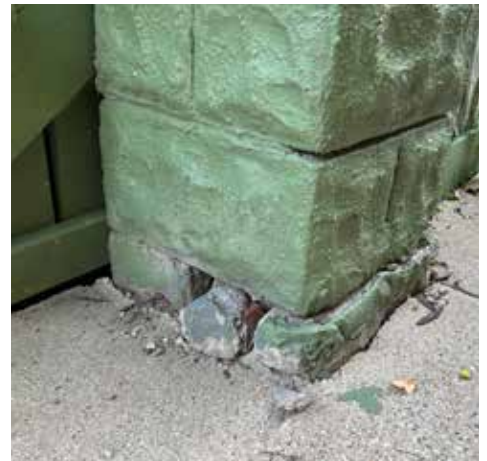
Thank you for taking the time to review my latest proposal for a COA so that I might repair a porch column that is starting to fall over on my property. Please see the images below that show that the rock-face block has begun to crumble at the base of the Southern most column and the ensuing tilt happening in the lower section. What follows is a detailed description of the porch and column dimensions, materials, etc. so this might get repaired as quickly as possible. Thank you in advance for your thoughts and assistance in this matter.

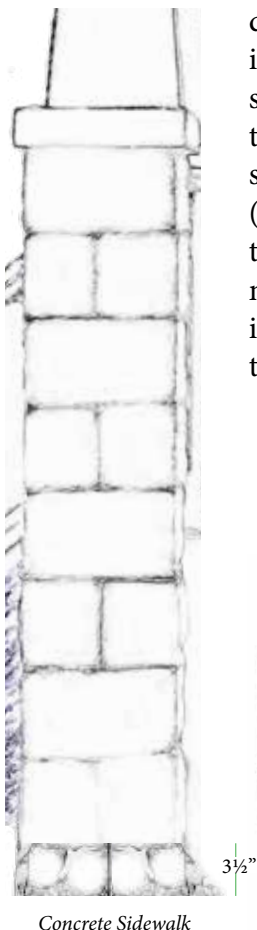
LOWER COLUMN DETAIL

Total Height =
9 Courses,
2 Blocks Each

Blocks
To Be
Salvaged
If Possible
(7 Courses)

Blocks
Requiring
Replacement
(2 Courses)

The new block work will replicate the existing pattern and dimensions before damage. An estimated total of 4 replacement blocks (2 blocks, 2 courses) will be installed at the foot of the column after the upper portion is carefully removed and salvaged. Because the Southern block column sits directly on concrete sidewalk, there is no footing requirement like on the Northern column. To account for the slight (~2") change in grade, the lowermost replacement blocks will need to be cut (see images on pg 2) to maintain overall block/column height, taking it's cue from the existing block pattern. The exact measurement of the cut can not be determined until damaged blocks have been removed to account for any potential inlay in the concrete sidewalk. If the grade is consistent with the concrete sidewalk at the time of removal, the cut would be 3½" from the top of the block.

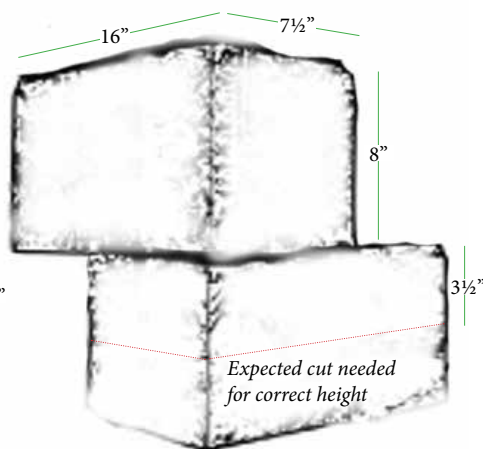
Replacement Courses

Block dimensions are approx. to account for surface changes in rock pattern

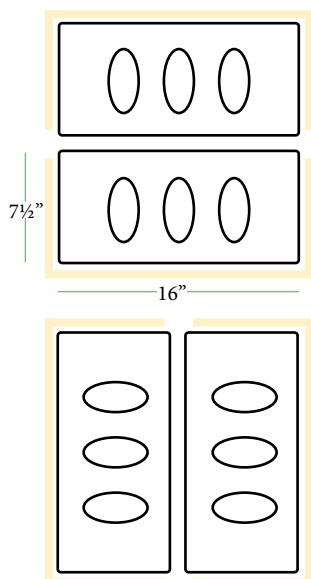
Elevation of Alternating Horizontal Cross Section Pattern of Courses

Each existing course =
16" x 16" x 8"

Replacement course =
16" x 16" x 8"

Lower most
replacement course =
16" x 16" x ~3½"

Rock-face pattern
featured on 3 sides
of each block

2 courses to be
repaired and replaced
at bottom of column

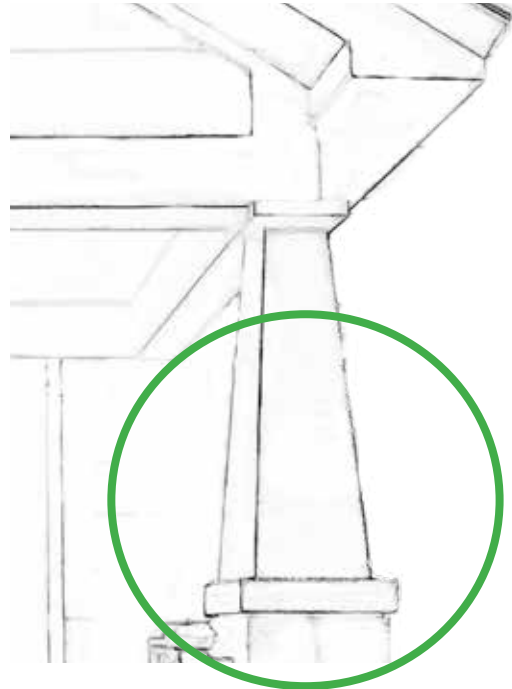
2044 N 2ND ST
~1950

Historic photos indicate that a scalloped or triangular detail once existed and it would also be incorporated and shared with the Historic Preservation Commission in a supplementary COA application. Additionally the HPC has suggested that the tapered sides are easily rebuilt with marine-grade plywood which would likely serve as the material.

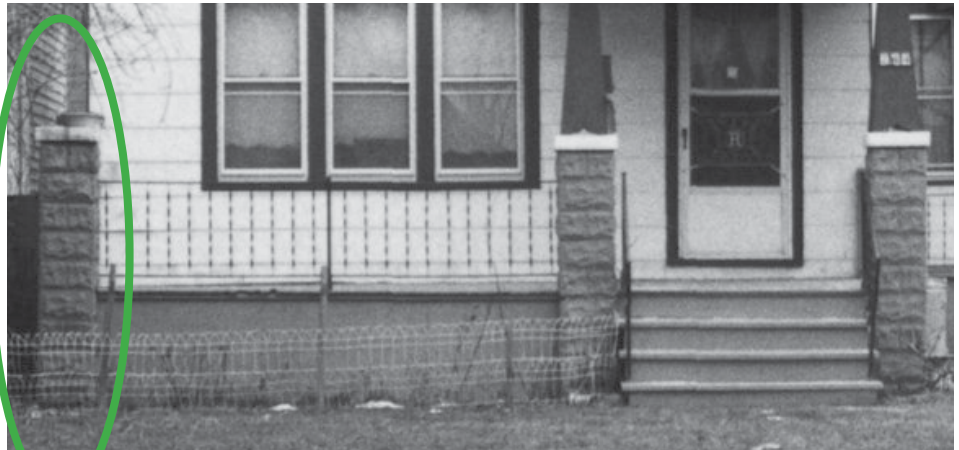
Historic photos of the home show that there was once three columns with porch extended across the front of the home. While the once Northern-most column is no longer there, ~10 of its blocks have been living quietly under the main porch for many years and are in still good condition. We will utilize them to repair the column that's currently in disrepair, making sure to salvage one on the off chance it needs to be reproduced for future needs.

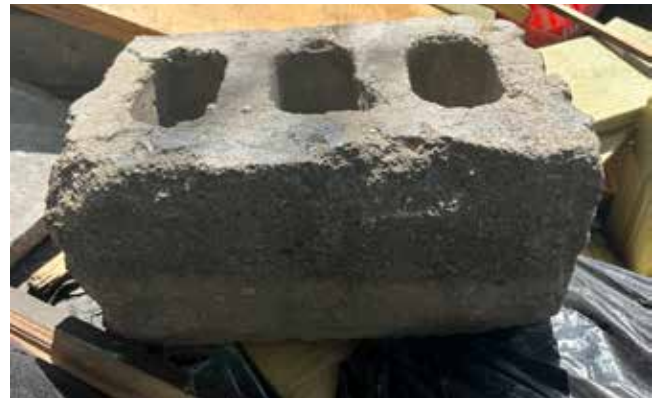
In the unexpected case that many more of the bricks will be unable to be salvaged as the contractor begins taking the middle of the column down to build it back up, a historic brick provider has been identified. Classic Rock Face Block specializes in historic blocks has identified the exact style in order to reproduce the brick to be stylistically accurate on all 3 sides. They are located in Indiana and run approx. \$30 per block not including transportation, taxes, or fees.
