Certificate of Appropriateness

1943-45 N. 2ND ST. Brewers Hill Historic District

PTS ID 93331 COA, exterior repairs front and rear houses

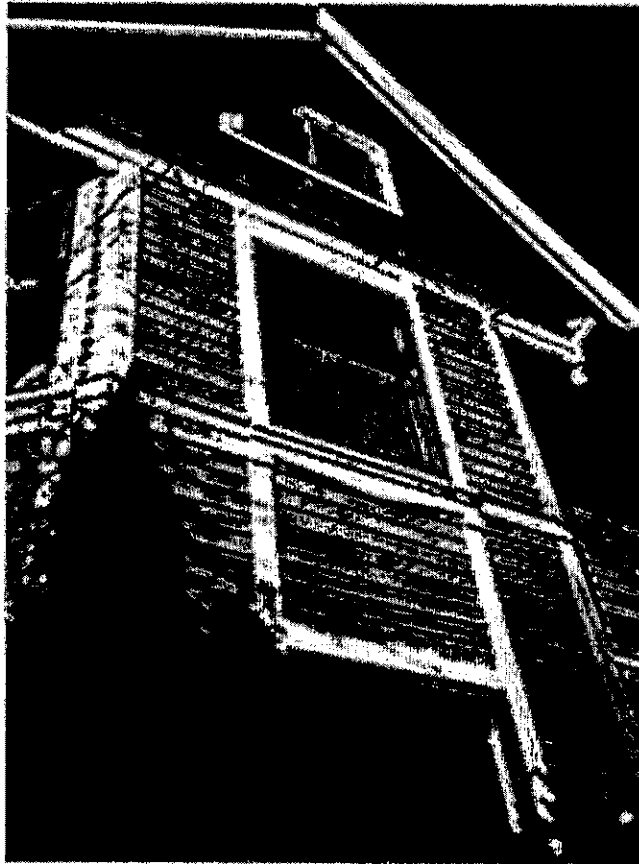
Main House – 2nd Floor Living Room Center Window Storm Replacement

Center wood storm
being replaced with
new wood storm

New storm layout
will match the
primary window's
smaller top
windowpane/larger
bottom
windowpane
placement.

Typical replacement of storm window. New storm will match the meeting rails of the prime window behind it.
