ADDRESS OF PROPERTY: 1023-1025 North 33rd St, Milwaukee, WI 53208

1023-1025 NORTH 33RD STREET: CONCORDIA HISTORIC DISTRICT Certificate of Appropriateness Application Submission October 16, 2014

Project Overview: Synopsis of Key Items

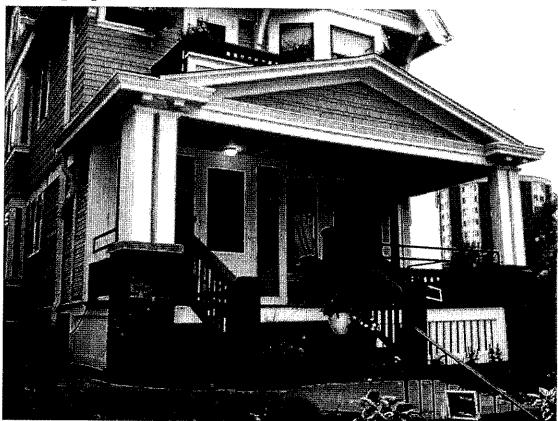
Figure 1: East elevation and part of south elevation from North 33rd Street. East elevation windows will be restored. Maroon aluminum exterior storm/screen units are not original and will either be reused or replaced in kind.

- Remove all front window units and protect window openings.
- Restore wood windows to original working condition, adding weatherstripping and thermal glazing.
- · Reinstall windows.
- Reinstall or replace existing aluminum storm/screen units with equivalent aluminum units.

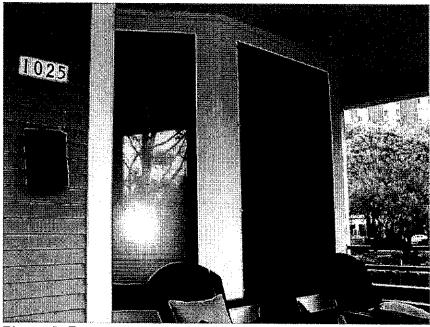
Figure 5: Front (east) bay windows. Windows to be restored at this location.

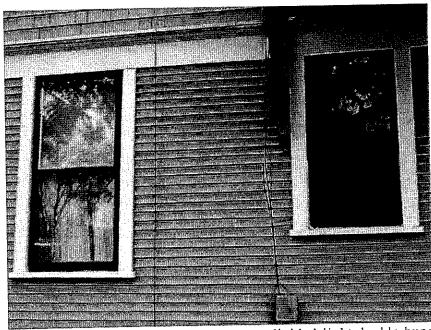
Figure 6: Typical original 1-over-1 true-divided-light double hung windows. Windows to be sympathetically replaced on the north, south, and west elevations.

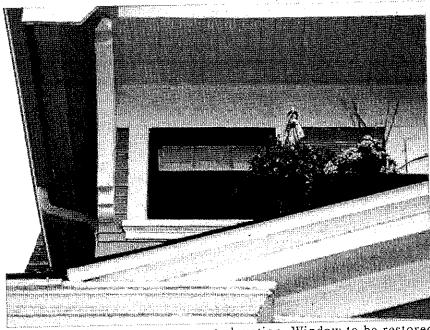
Figure 7: 6-lite casement on east elevation. Window to be restored at this location.

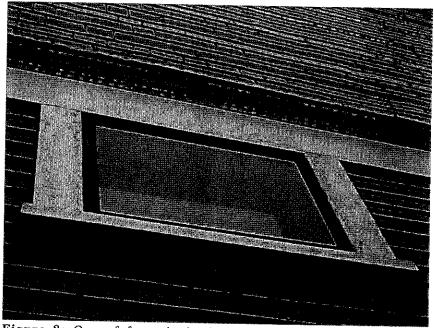
Figure 8: One of four single-lite casement windows on the north elevation. These windows will be replaced in kind.

- Replace all north elevation window sashes and sash pockets with Marvin wood replacement windows.
- Repair frames (jambs, casing, etc.) as necessary.
- Original wood storms no longer exist and will not be replicated.

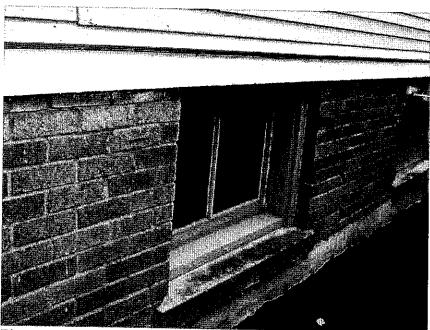
Figure 9: Typical wood basement window on north, south and west elevations. A few have been modified to accomodate utilities.

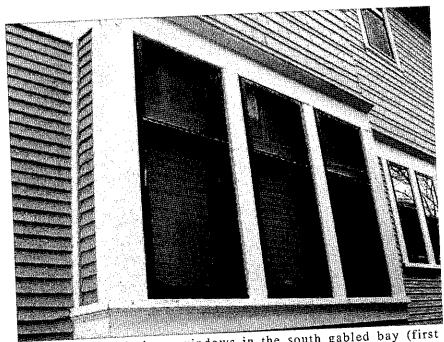
Figure 10: Single hung windows in the south gabled bay (first and second floors). Windows at this location will be replaced in kind.

- Replace all south elevation window sashes and sash pockets with Marvin wood replacement windows, matching current window configurations (in kind replacement of 1-over-1 vs. 4-over-1, larger bottom sash on south-facing bay windows, etc.)
- Repair frames (jambs, casing, etc.) as necessary.
- Original wood storms no longer exist and will not be replicated.

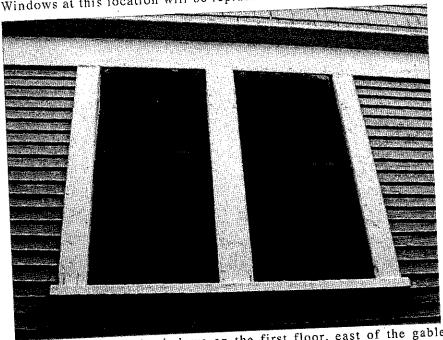
Figure 11: 4-over-1 windows on the first floor, east of the gabled bay on the south elevation. Windows at this location will be replaced in kind.

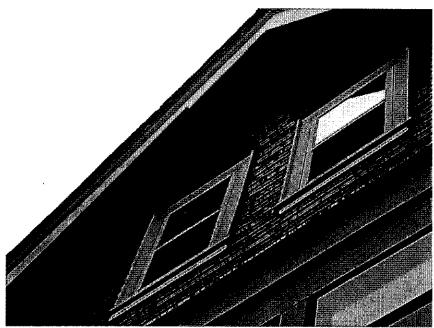
Figure 12: 1-over-1 attic windows in the south gabled bay. Attic windows on the south and west elevation will be replaced in kind.

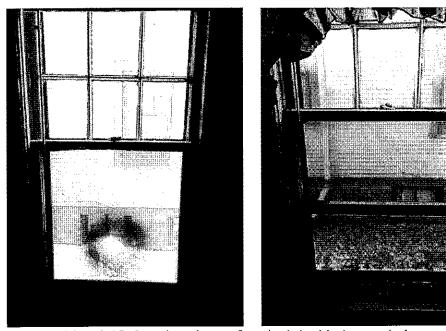
Figures 14 and 15: Interior views of typical double hung windows - painted.

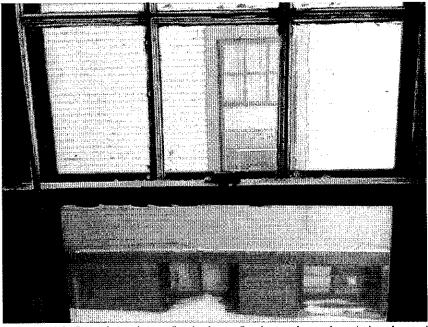
Figure 16: Interior view of window. Sash cords and weights have been removed.
