## CERTIFICATE OF APPROPRIATENESS APPLICATION FORM

1. **HISTORIC NAME OF PROPERTY OR HISTORIC DISTRICT:** (if known)  
St. Hedwig Catholic Church  
**ADDRESS OF PROPERTY:**  
1726 N. Humboldt Ave., Milwaukee, WI 53202

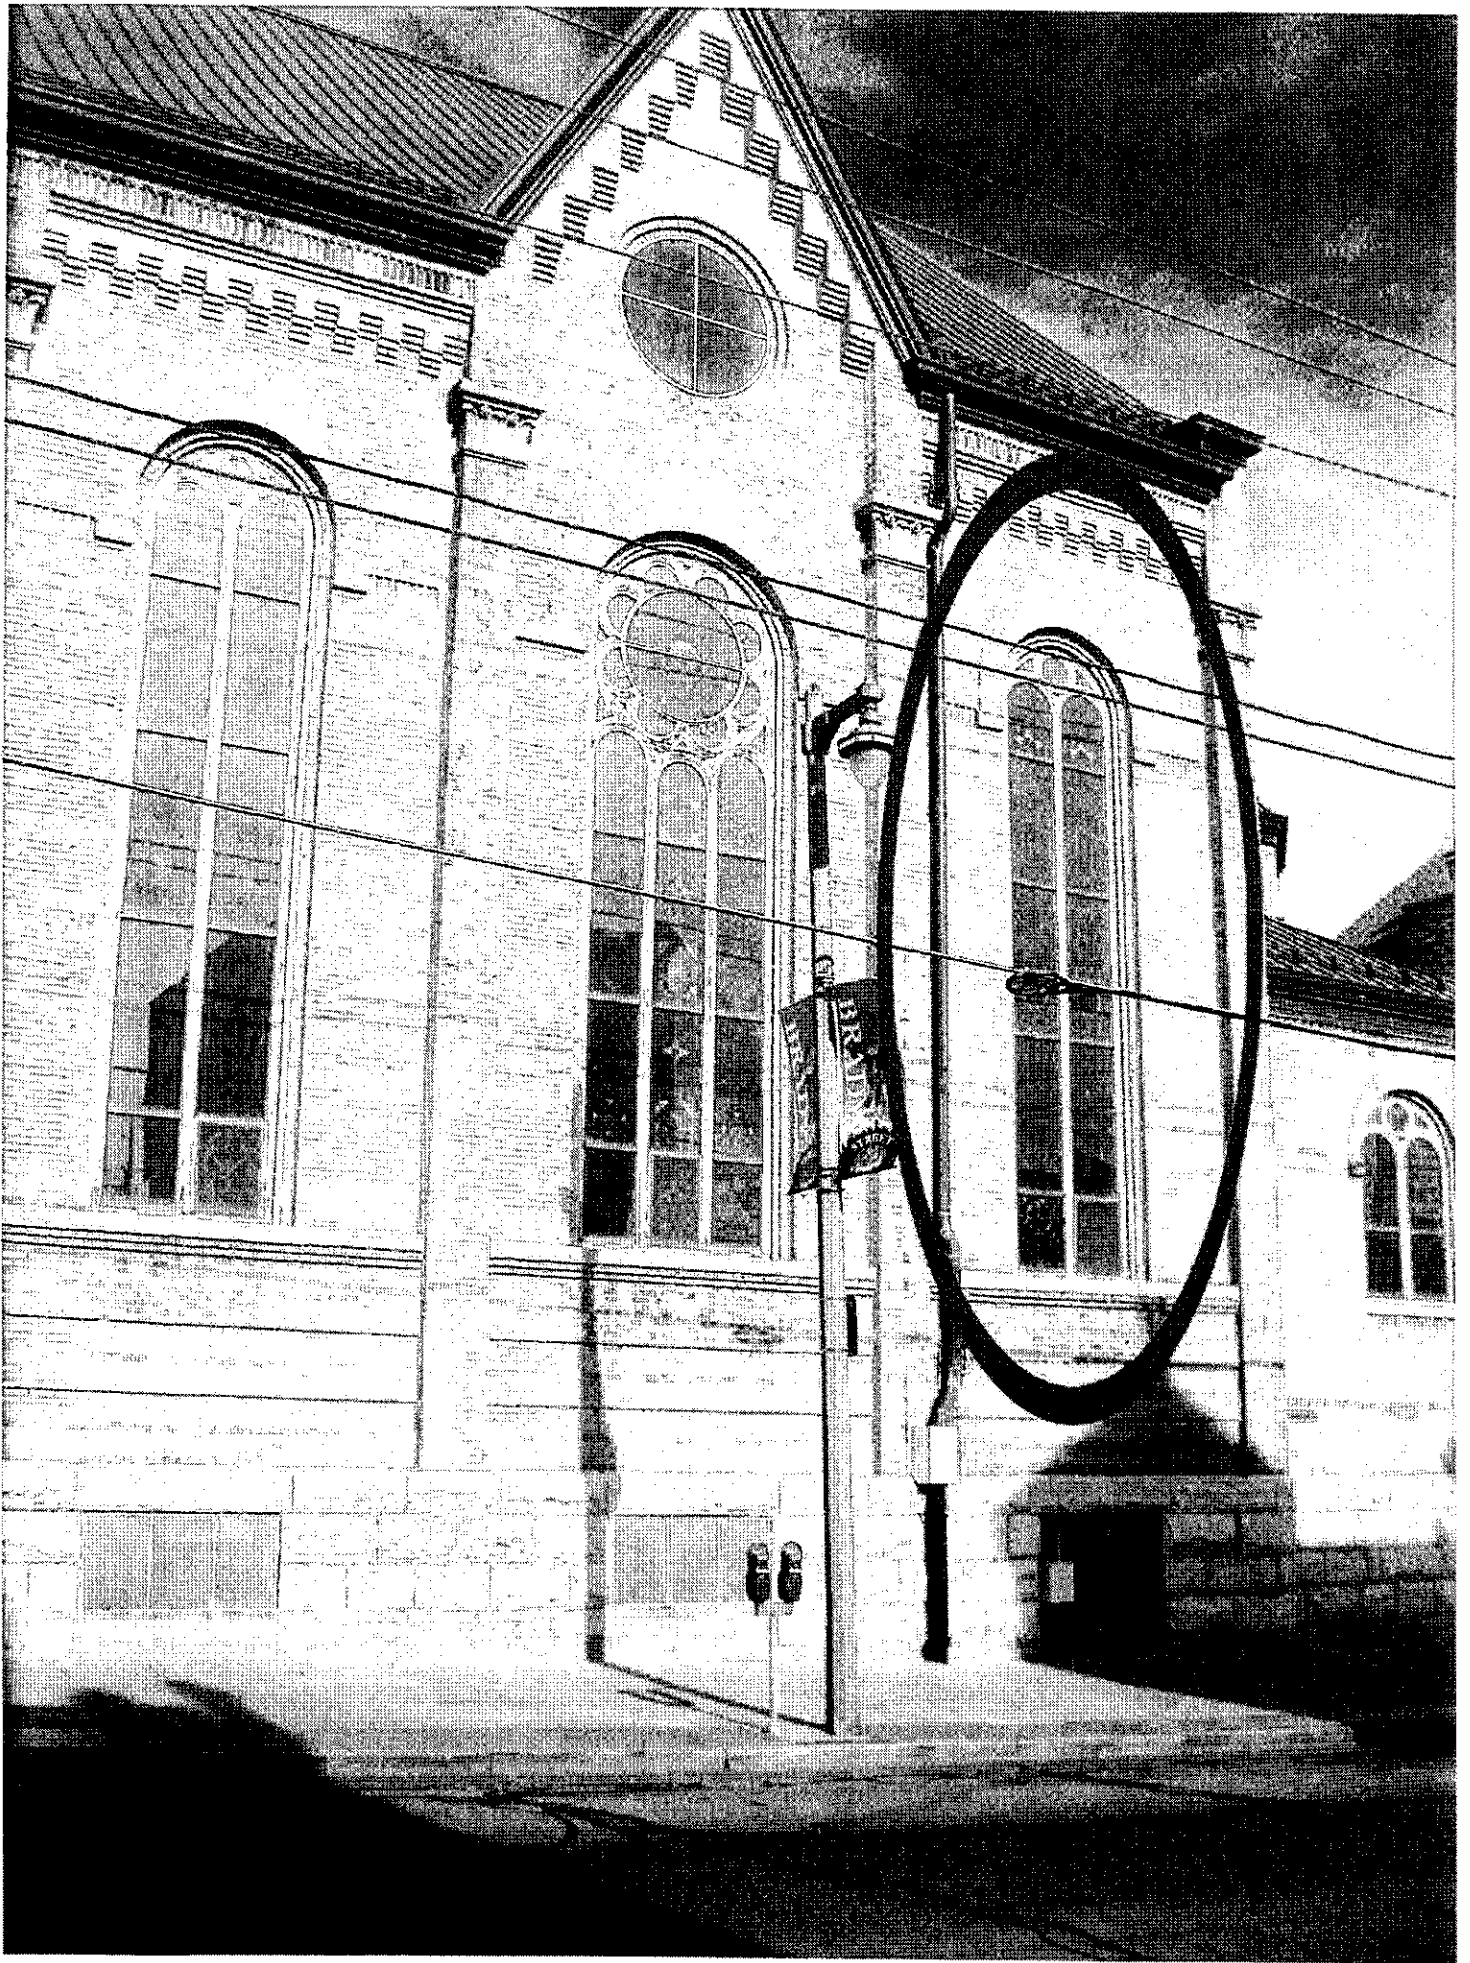
**Introduction:** As the stained glass, storm glass and frames at St. Hedwig's Catholic Church advance in age, they have begun to show signs of structural deterioration and damage. In the stained glass, the obvious signs include limited glass breakage and panels that are slumping or bowing. Close inspection reveals cracked or fractured leads and loose, brittle putty within the lead came. The storm glass and frames reflect an even more deteriorated condition including the frames which are easily moved out of plane with light wind-loads.

**Current Storm Glass and Frame Conditions:** The stained glass windows at St. Hedwig's Catholic Church are set into wood frames that were intended for both stained glass and storm glass installation. The frames at locations 1-14 are not stable due to their large overall size and the joinery techniques used in their construction.

Additionally, it is important that any storm glass setting provide a means for venting the air space created between stained and storm glass such that heat and condensation cannot build up and accelerate deterioration of the stained glass window and frame. The current storm glass setting at St. Hedwig's Catholic Church does not provide this needed venting.

**Recommendations for Storm Glass and Frames:** Conrad Schmitt Studios recommends replacing all existing wood frames and storm glass in windows 1-16 including venting, priming and painting the new exterior wood frames.

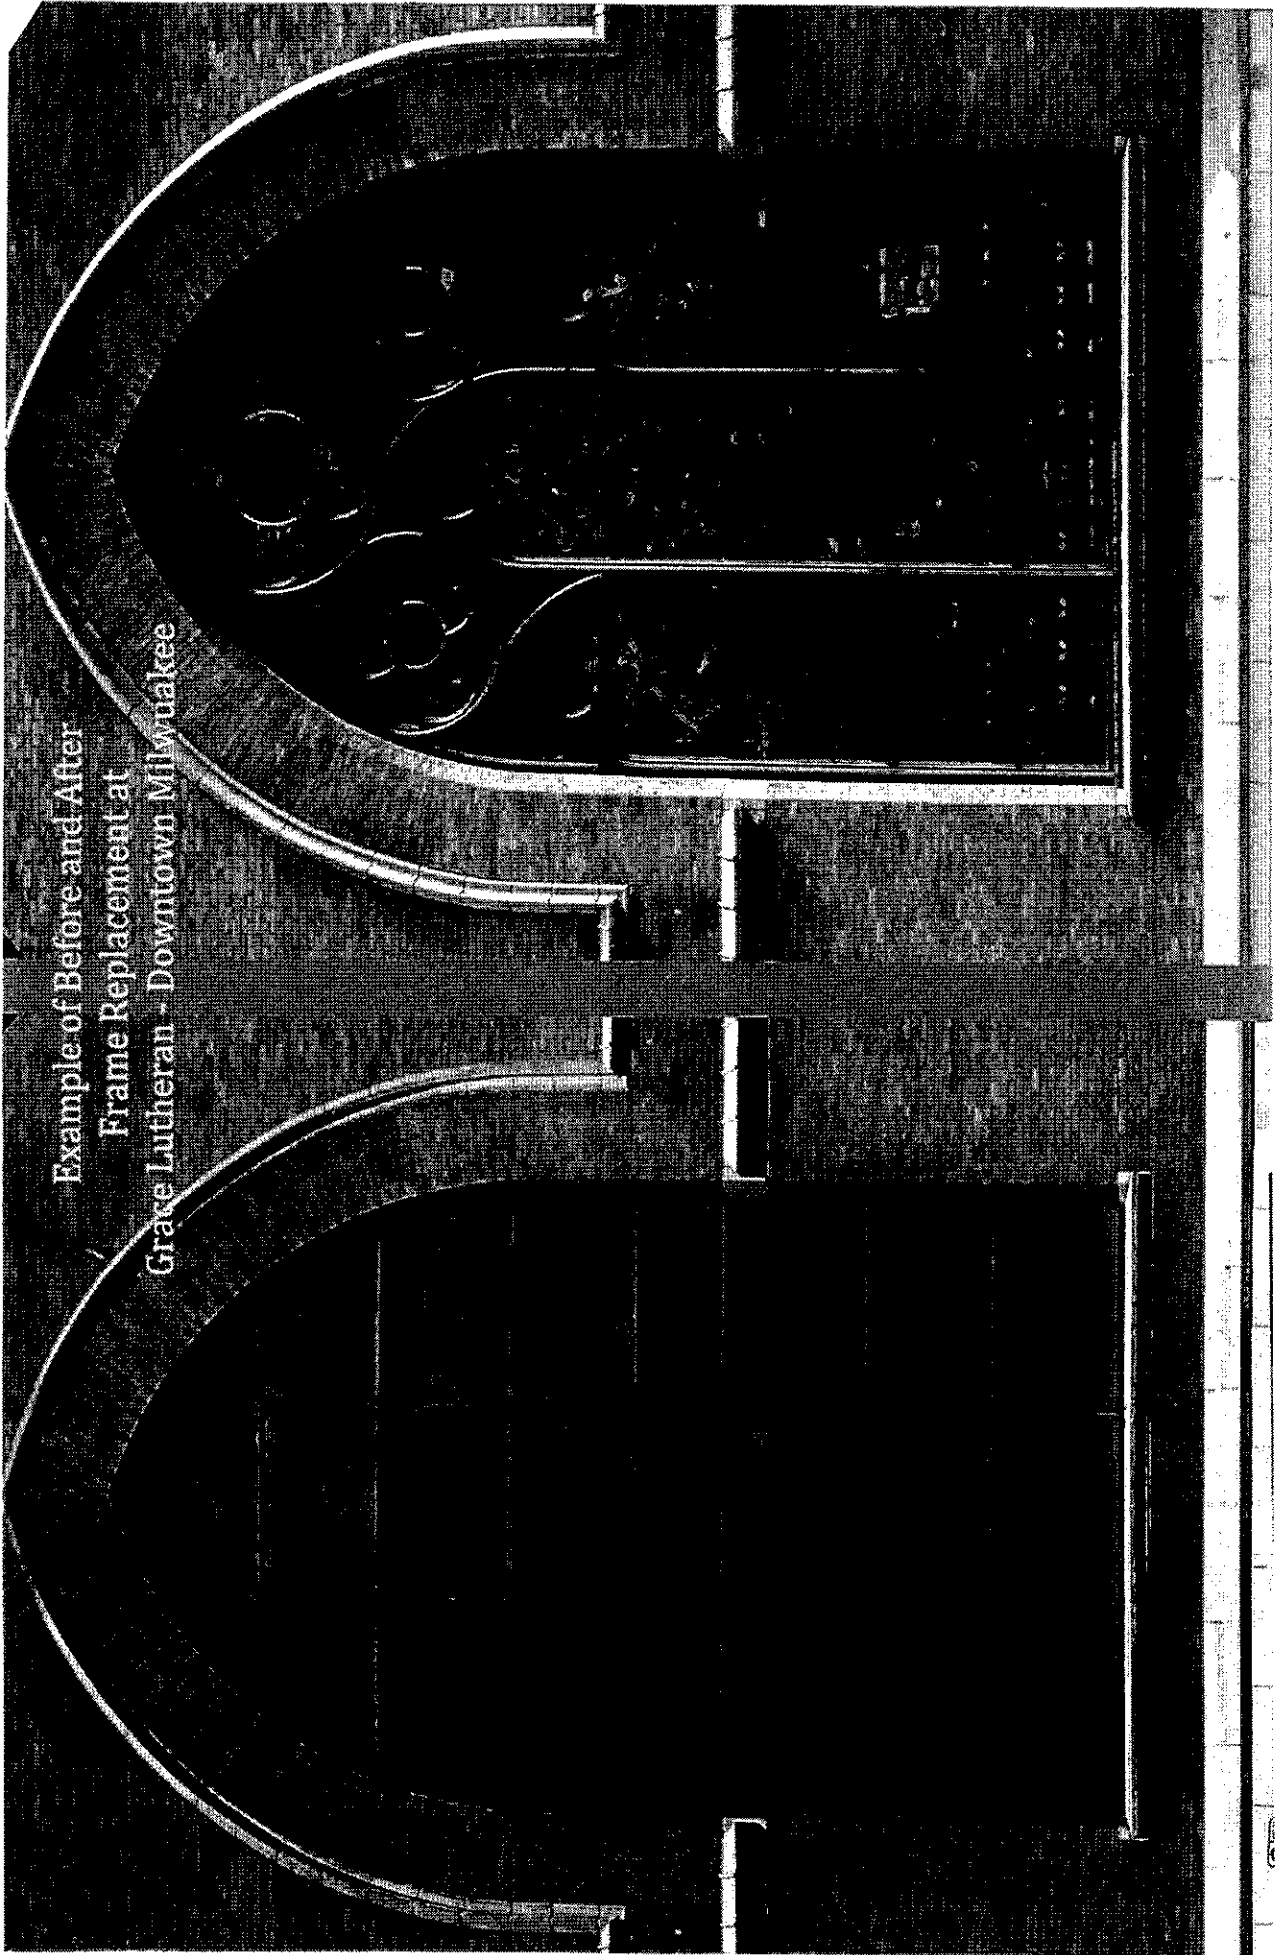
Example of Before and After  
Frame Replacement at  
Grace Lutheran - Downtown Milwaukee
