# #3 - NPS Conditions/Responses:

Liz Petrella 1/29/2015 Conditions Letter in Black/ Proposed Response in Red

## East Façade – Opening Study

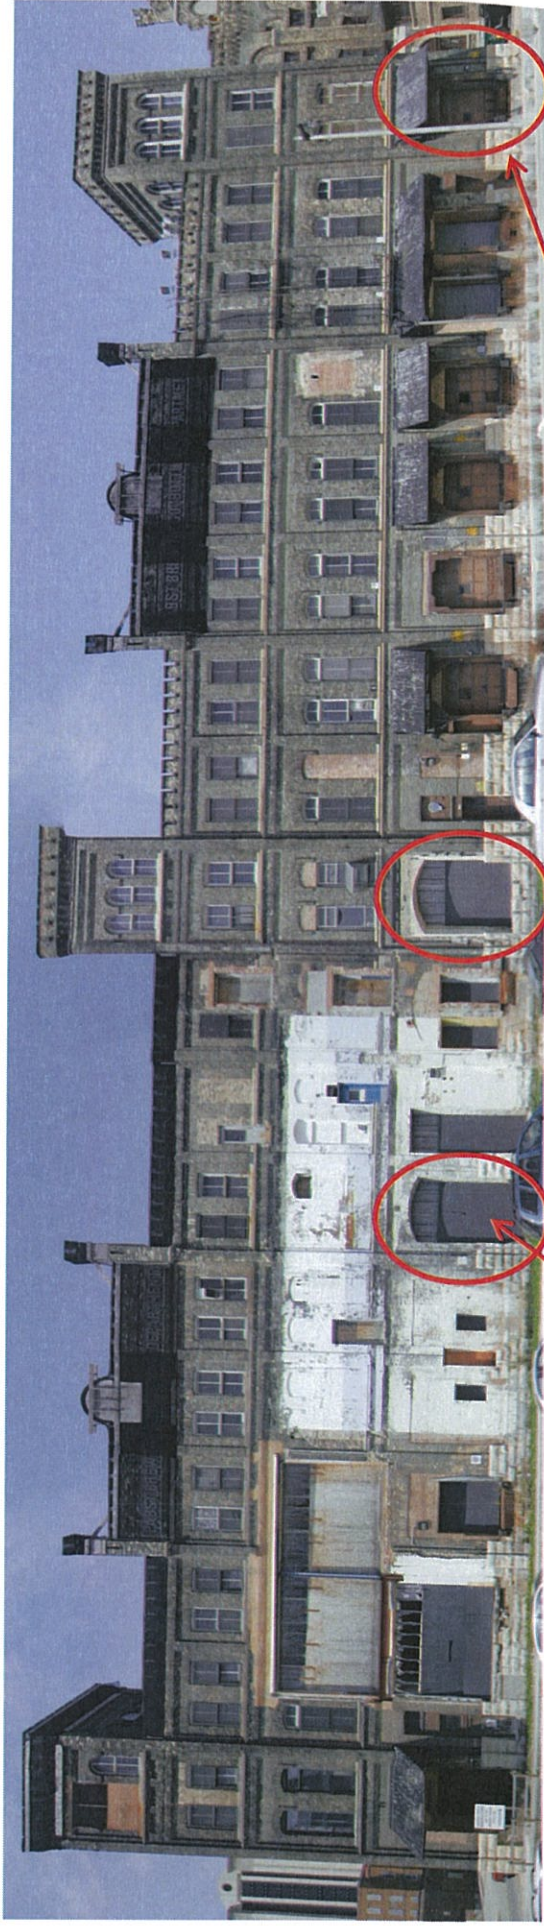
Likely third location of to grade historic opening  
(Based on historic brick arch)

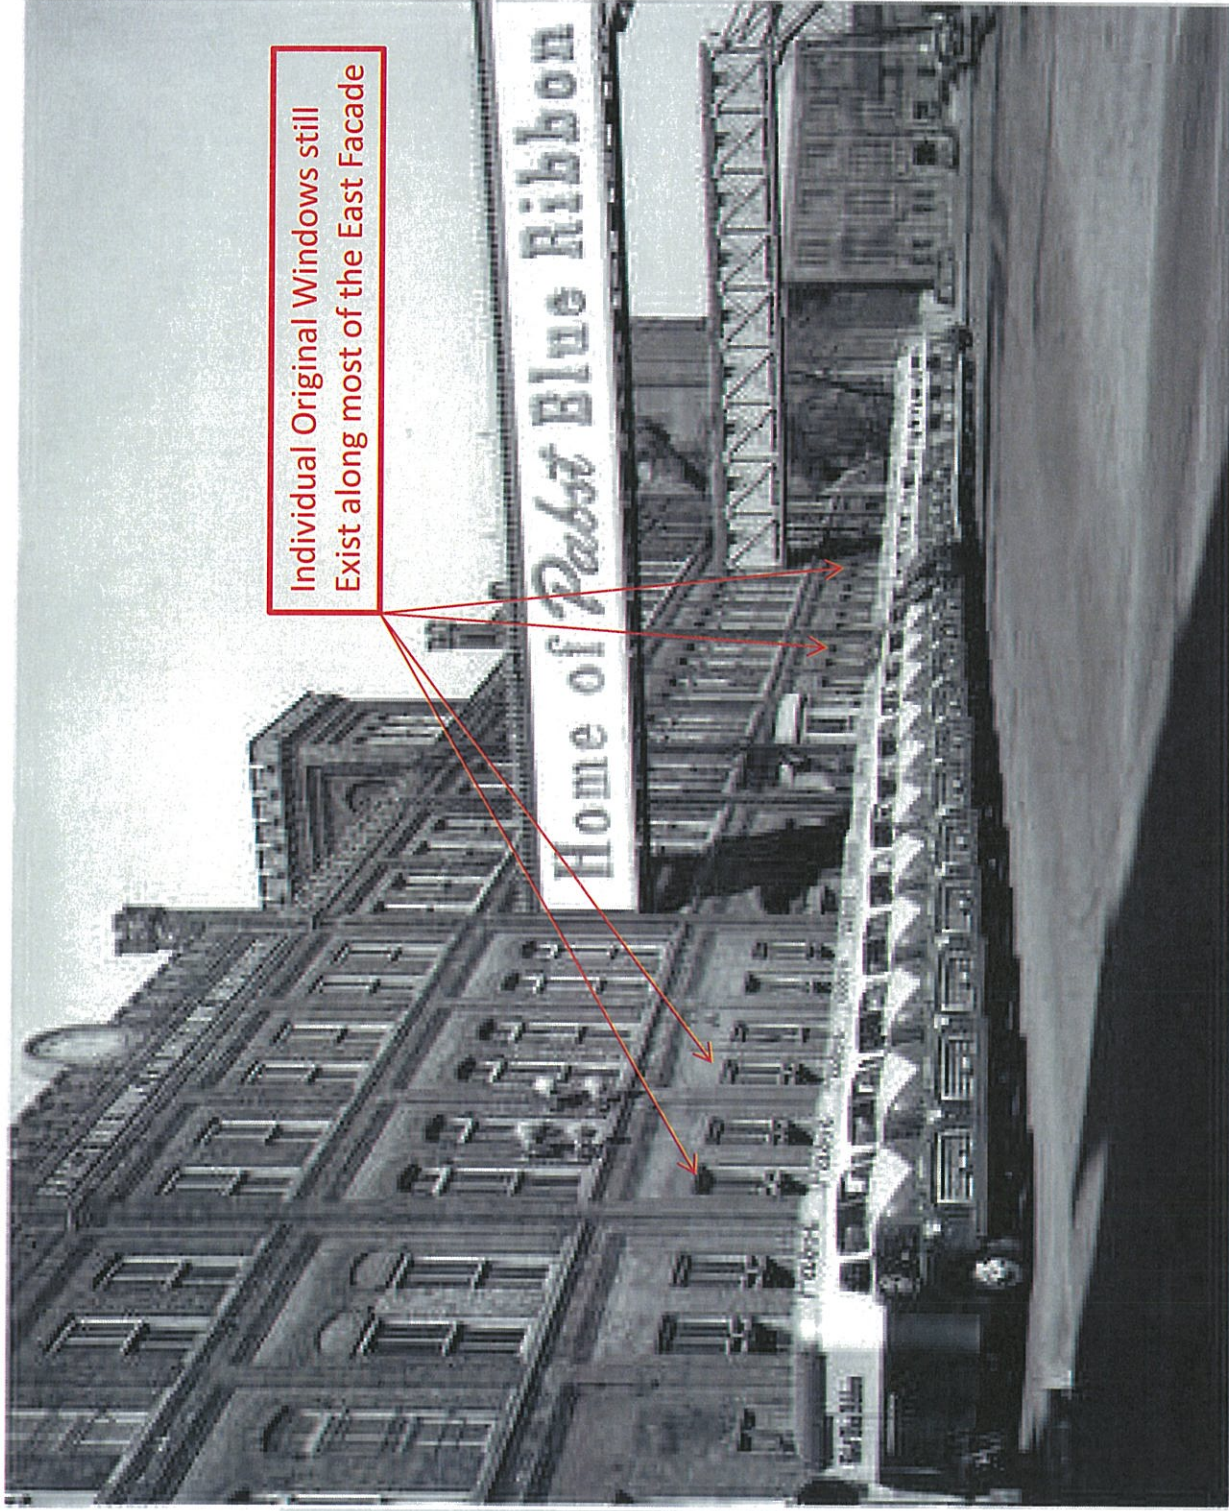
Individual Original Windows still  
Exist along most of the East Facade

Photo from Milwaukee County Historical Society – listed as from 1940's  
Period of Significance runs from 1889 to 1953

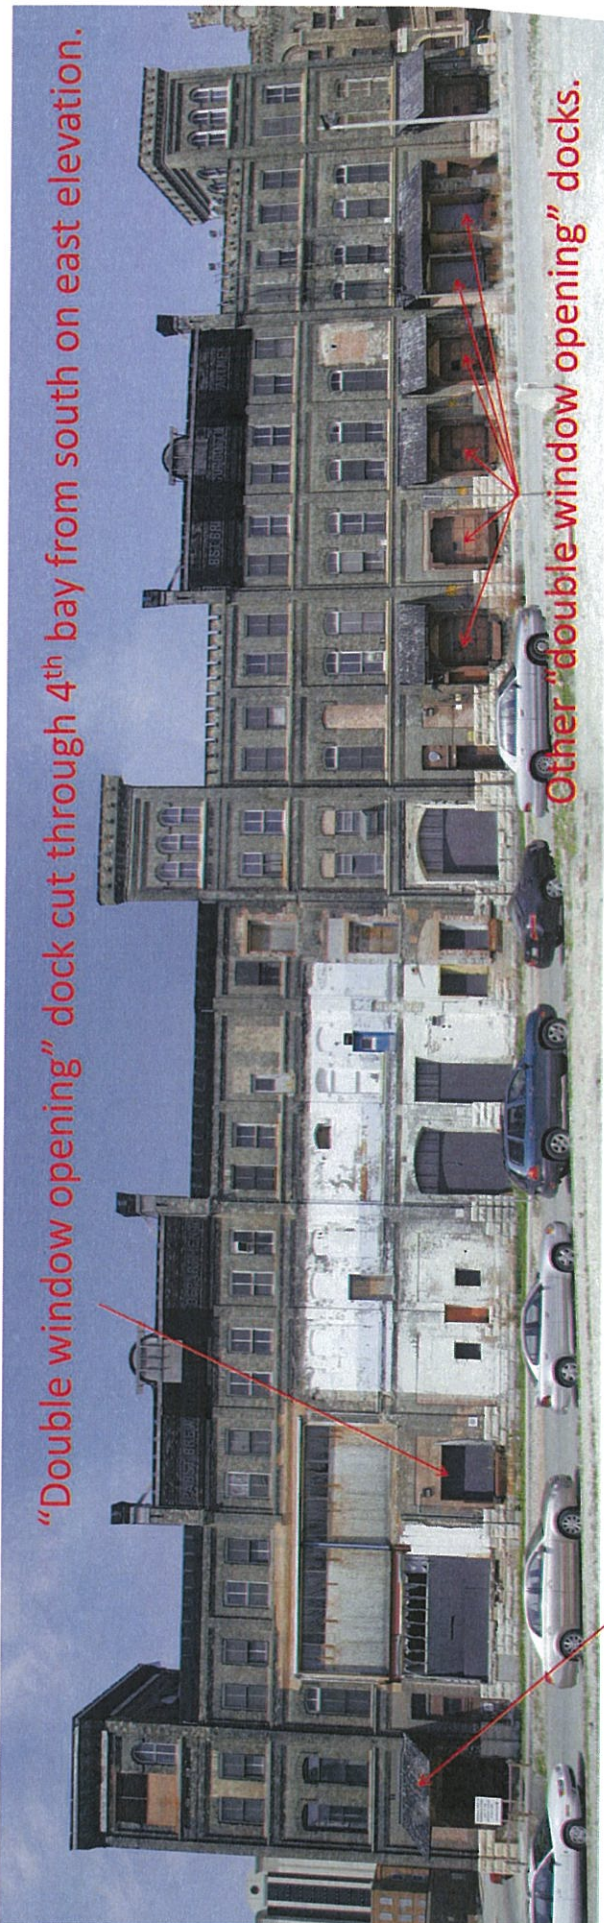
“Double window opening” dock cut through 4<sup>th</sup> bay from south on east elevation.

Other “double window opening” docks.

The large black canopy is not present in 1956 photo.

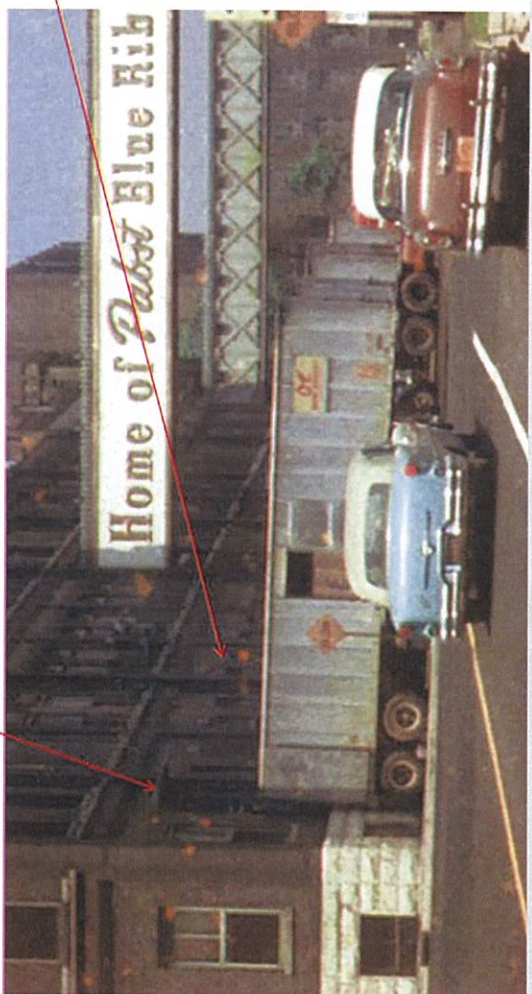
1956 photo showing that the 4<sup>th</sup> bay Loading dock had not yet been cut. This is evidence that the “double window opening” docks on the east elevation were cut after the period of significance (JS). All of these openings were patched with the same orange brick for heads and jambs.

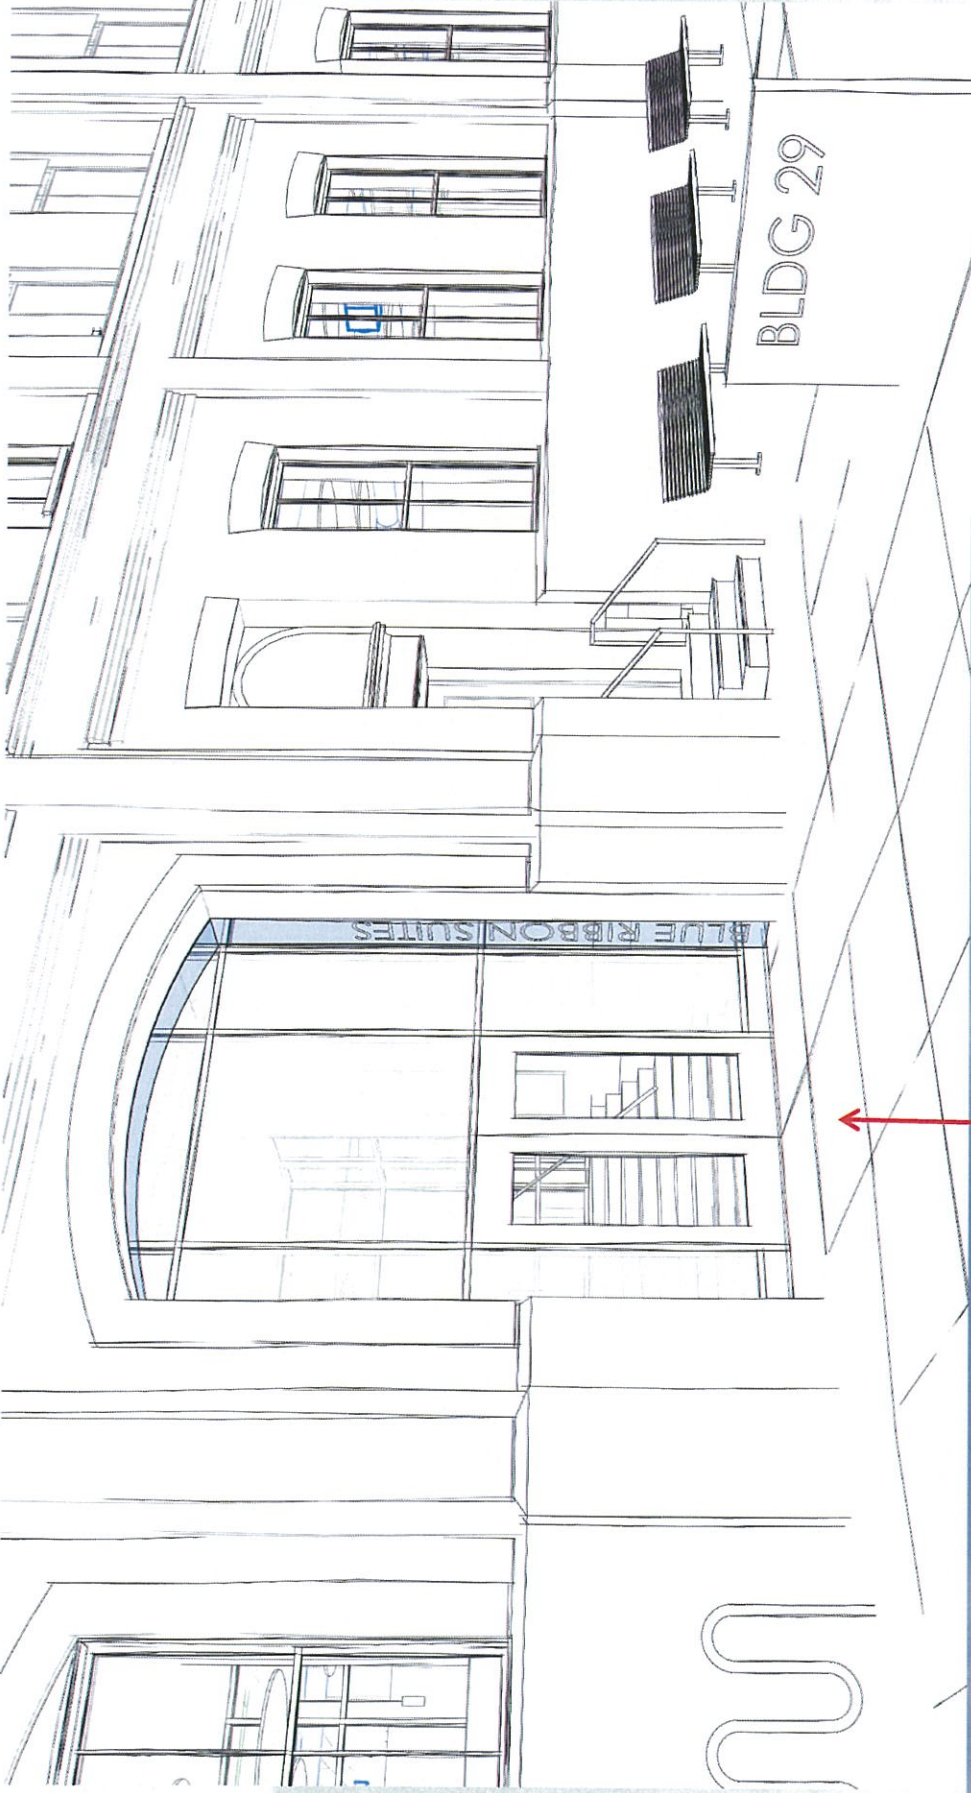
EAST FAÇADE – Main Public Entry  
 At central tower – full restoration of  
 Arched opening down to grade.  
 Opening infilled with Aluminum  
 Storefront System
