Certificate of Appropriateness

2675 N. SUMMIT AV.

North Point North Historic District

PTS ID 104708 COA

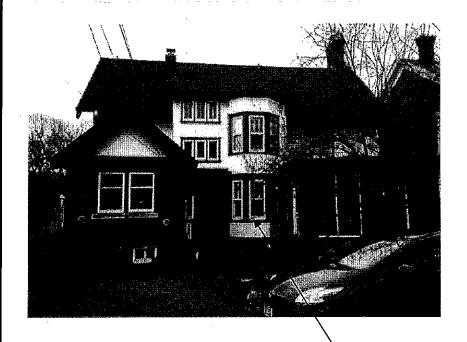
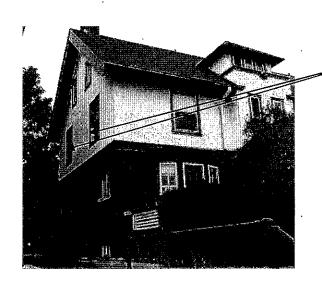
New Marvin Alpine wood combination storms/screens to be installed at these locations.

New combination storm/screen windows will be Marvin Alpine.

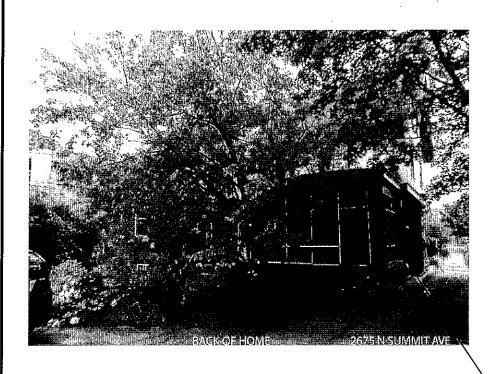
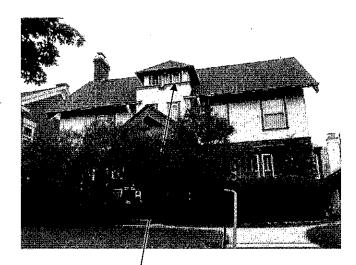
New membrane roofing will be applied over existing membrane roof at these locations

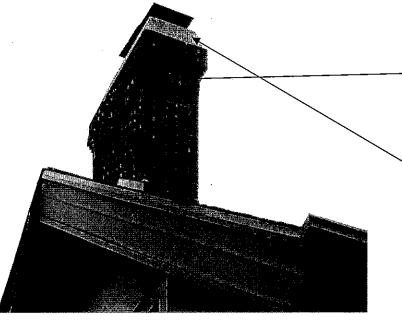
Chimney to be rebuilt to match original and will make use of reclaimed brick from the original as well as new matching brick if needed. Note the pattern near the top of the chimney just below the corbeling. New concrete cap will extend slightly beyond chimney to shed water.

The chimney will be rebuilt reusing reclaimed original brick or new matching brick where needed. The poured chimney cap will extend out slightly from the chimney to help shed water.

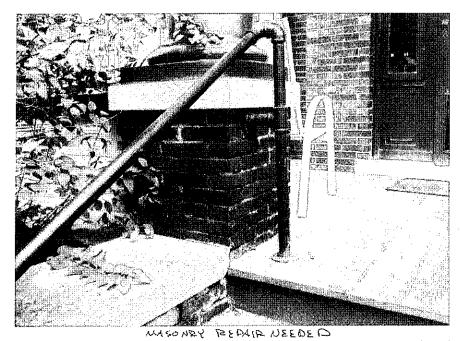
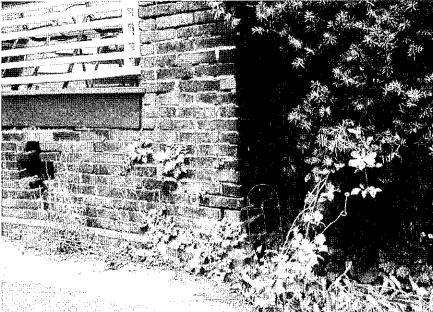
MASONRY ESPAIR NESDEC

Masonry around the porch area will be repointed. Note sections that have been improperly repointed and where mortar has been carelessly applied. New mortar must match original in terms of hardness, color, composition and texture. Using too hard of a mortar will result in brick failure.

Contractor will prepare two mortar samples for staff approval before work proceeds on the repointing. Mortar must match original mortar (not later replacements) in terms of hardness, color, texture, and composition. Ideally, mortar should be tested to determine the proportions of lime, Portland cement, sand, and aggregate that go into the mortar.

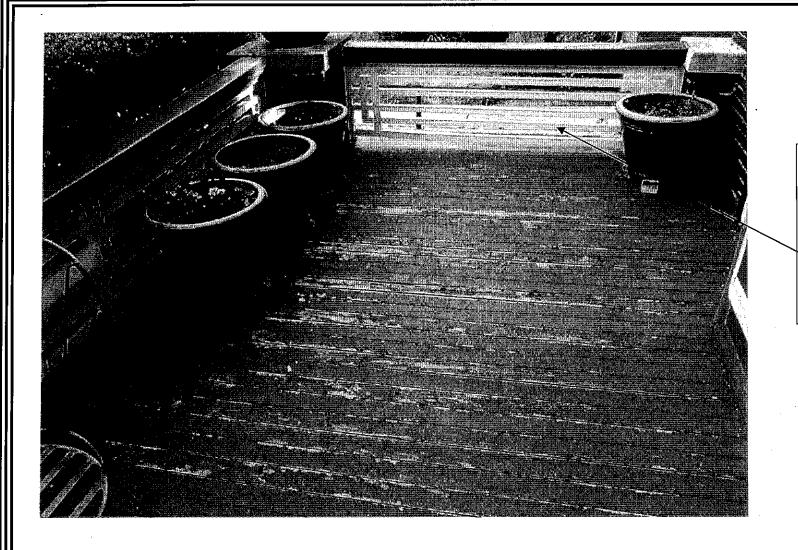
Porch railing will remain

Porch deck will be replaced with Douglas Fir tongue and groove boards.

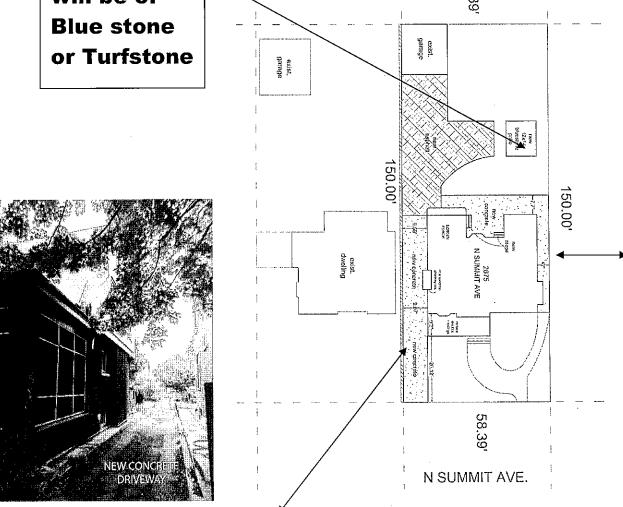
DRAWINGS / PHOTOS FOR HARDSCAPE

Retain curbing along north end of driveway

> A new concrete driveway will be poured as well as apron in front of garage, and north and west walkway and rear steps.

The new driveway will retain/recreate the curbing on the north side.
