# Certificate of Appropriateness

3452 N. LAKE DR. North Lake Drive Estates Historic District

PTS ID 113896 COA Drain for back-up sump pump

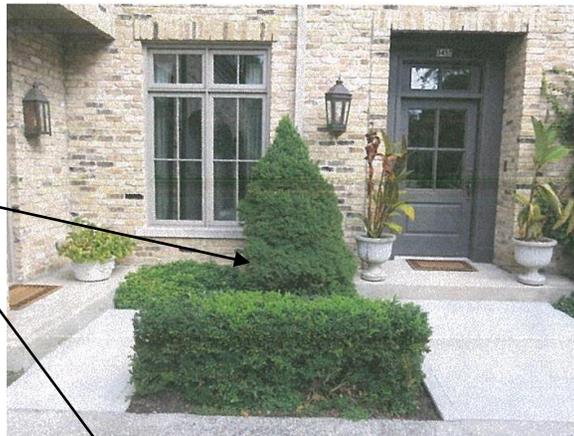
The owners had a sump pump installed that drains to the rear of their house. Their plumber installed a back-up sump pump and installed a PVC drain adjacent to their entrance. This drain is located at the front of the house and penetrates a masonry wall, a situation not generally approved by the Historic Preservation Commission. It is also not code-compliant.

View of home slightly to the left of front door.

Back-up sump pump discharge pipe is located here.

**It would be preferable to have the pipe relocated to another elevation of the house, for example, the north façade. Should the pump discharge from its current location, the water may extend beyond the confines of the landscape bed and onto the front walkway or driveway. If the location of the back-up sump pump in the basement makes relocation difficult or impossible, the current location may be retained. The façade of the house is set back from the street and the PVC drain pipe discharges into a planting bed making it less visible.**

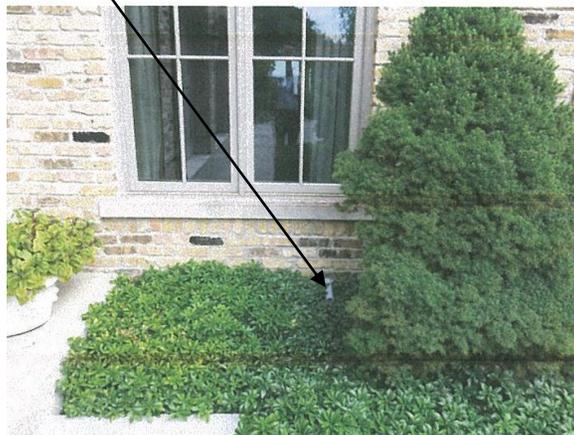
Existing discharge pipe for the back up sump pump. Elbow would be attached at the end to raise the pipe up three inches and extend it out 13 additional inches. This would comply with code.

To meet code, the plumber proposes to add an elbow to the existing pipe to raise it 3 inches to the required 12-inch high level. He will also add 13 inches to the length of the pipe to make it meet the required length.

**The PVC pipe must be painted out to blend in with the brick and/ or foliage to be less conspicuous.**

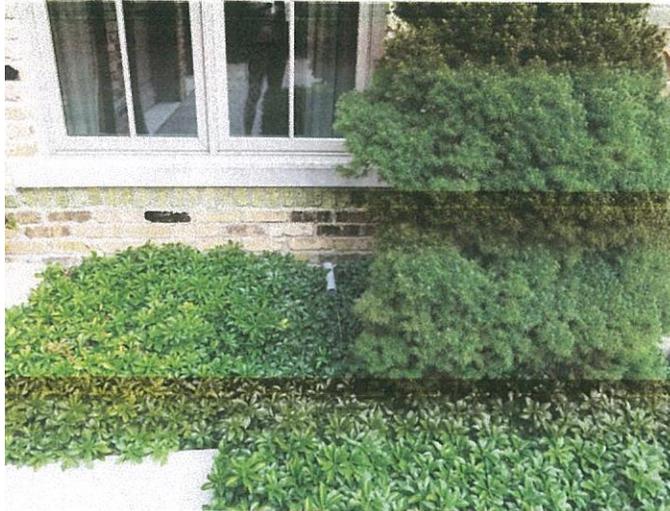
Pipe with slim wire protruding to indicate the additional length need to comply with code.

**The new length of pipe and the new height will be more visible than it is currently. The pachysandra does not completely obscure the pipe at present. It is recommended that an additional planting of a small scale perennial would help to conceal the pipe. Such a planting would not block the window but provide another layer of screening.**

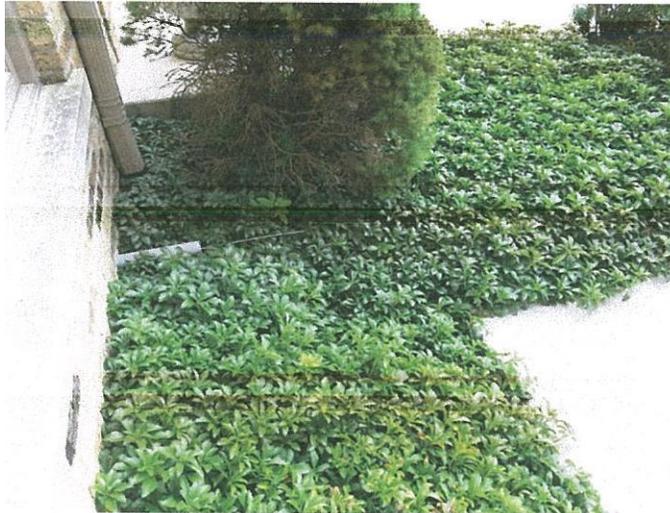
Different view of pipe with wire to indicate additional length needed.
