CITY HALL

Milwaukee

Description of the project

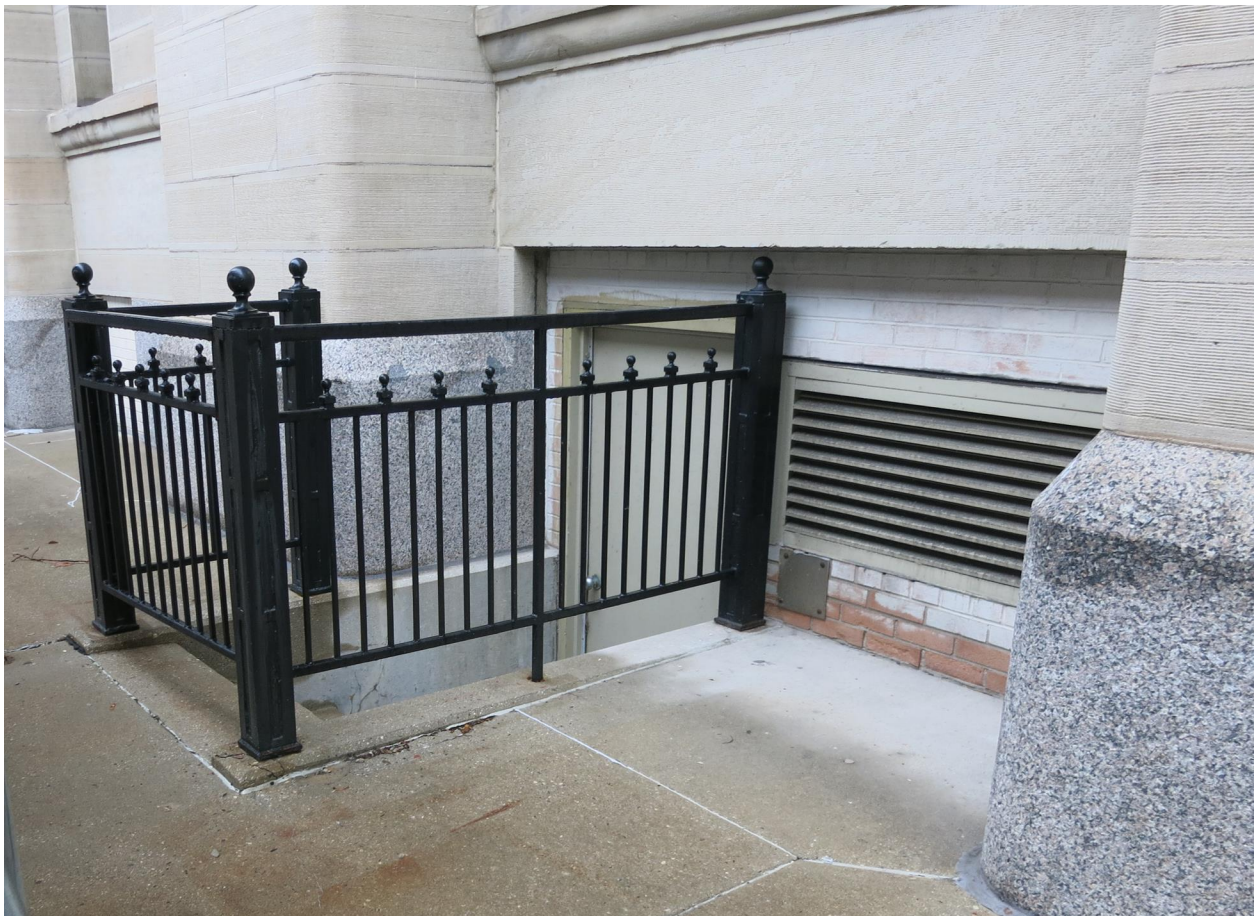
Stair 10 from the exterior looking southwest. Stair 10 is located in the second structural bay north of the tower. The plan below shows the location of the stair in the basement of City Hall. The basement plan is the preconstruction layout of the building.

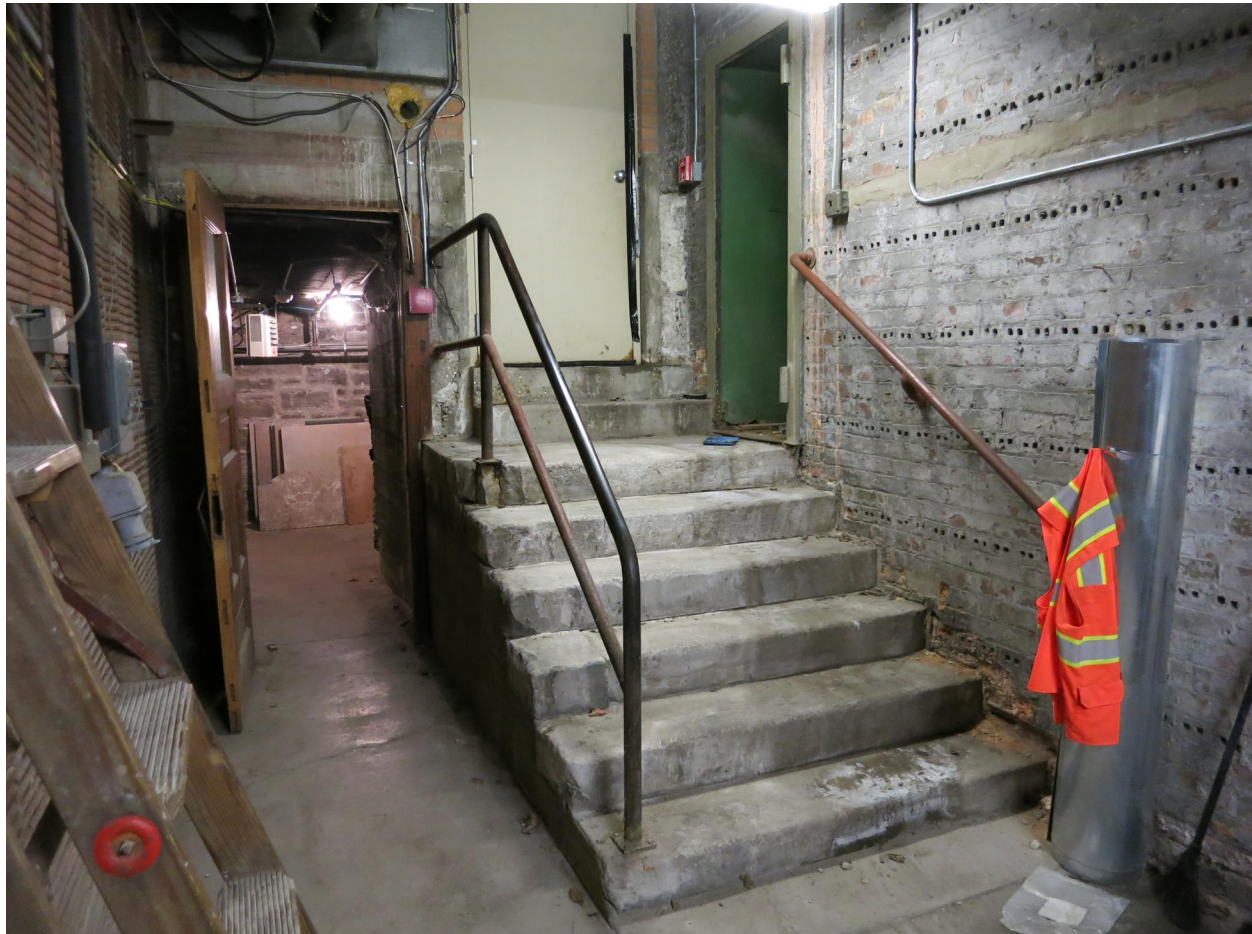
Exterior door to Stair 10 from the inside. The stone stair and much of the surrounding construction seen here will be demolished in the foundation reconstruction work. Stair 10 does not meet current code. The entrance door swings into the space. There is a step at the door. A level landing is required on both sides of the door.

The door sill is on a narrow landing approximately 3 feet below the sidewalk level.

Stair 10 cannot be reconstructed in the original configuration. The code requires landings inside and outside of the door. This would push the stair to the east 3 to 4 feet into the sidewalk. The stair is not a required exit for the building and the City does not require or want access to the building at this point. The City would like to remove the stair and door from the building.

We propose to eliminate Stair 10 and reconstruct a wall at the Stair 10 location using the same wall system used typically between the masonry piers on the rest of the building in the foundation restoration project. To finish the wall, new wrought iron grille work to match the grille work at the adjacent walls will be installed. The new wall will look similar to the photo below.

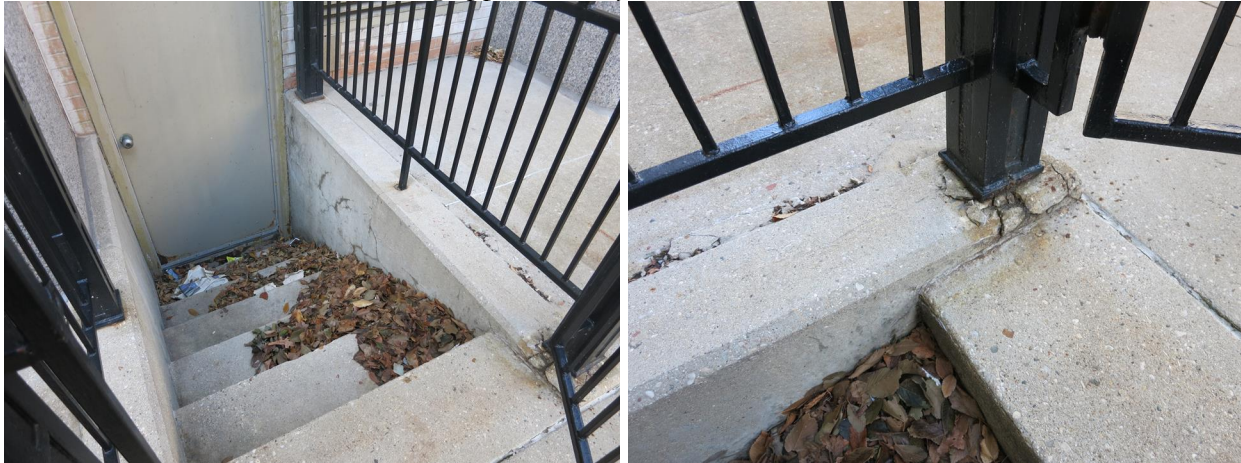
Stair 10 from the exterior stair. The railing will be demolished during the foundation repair work. Note the inadequate size of the exterior landing.

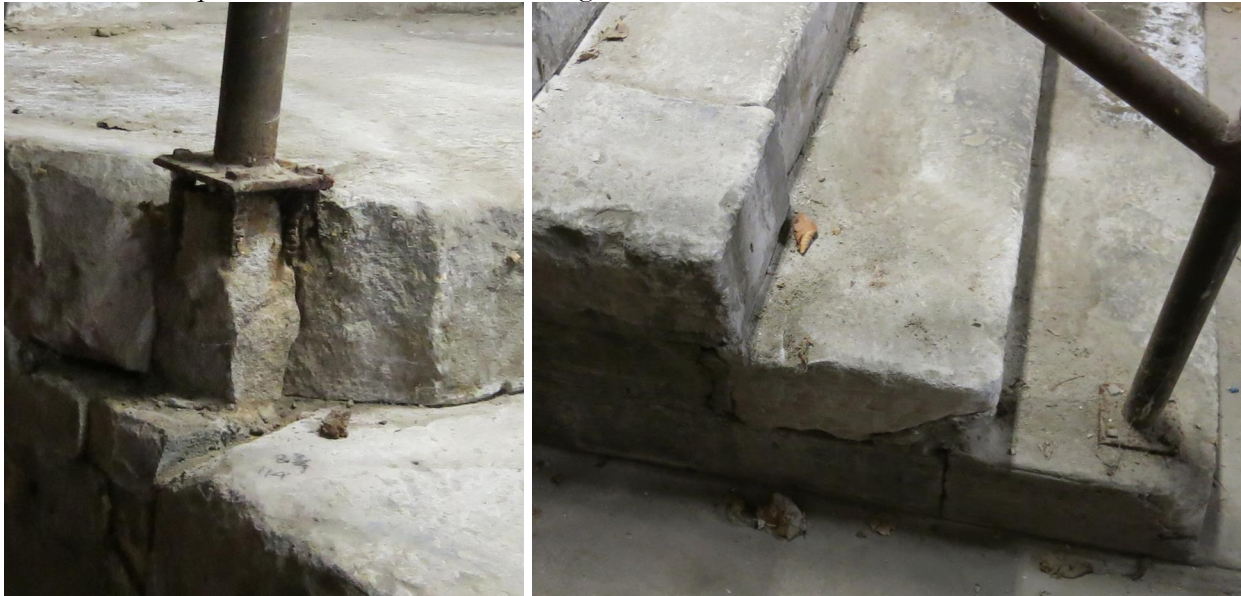
Deteriorated condition of the interior steps.

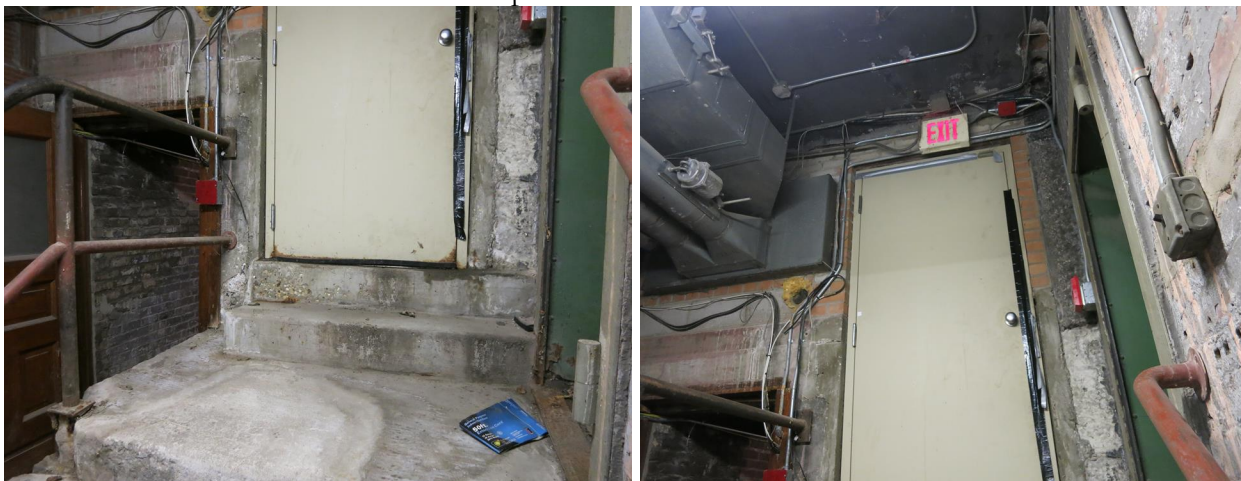
Door is not original or code compliant.

Exit is not code compliant.
