Certificate of Appropriateness

Milwaukee Historic Preservation Commission/200 E. Wells Street/Milwaukee, WI 53202/phone 414-286-5712/fax 414-286-3004

11. ALL: Paint previously painted surfaces in a workmanlike manner.	
12. ALL; Protect all wood trim with paint or other approved coating applied in a workmanlike i	nanner.
Date issued5/26/2020PTS ID114932 COA: Required Repairs

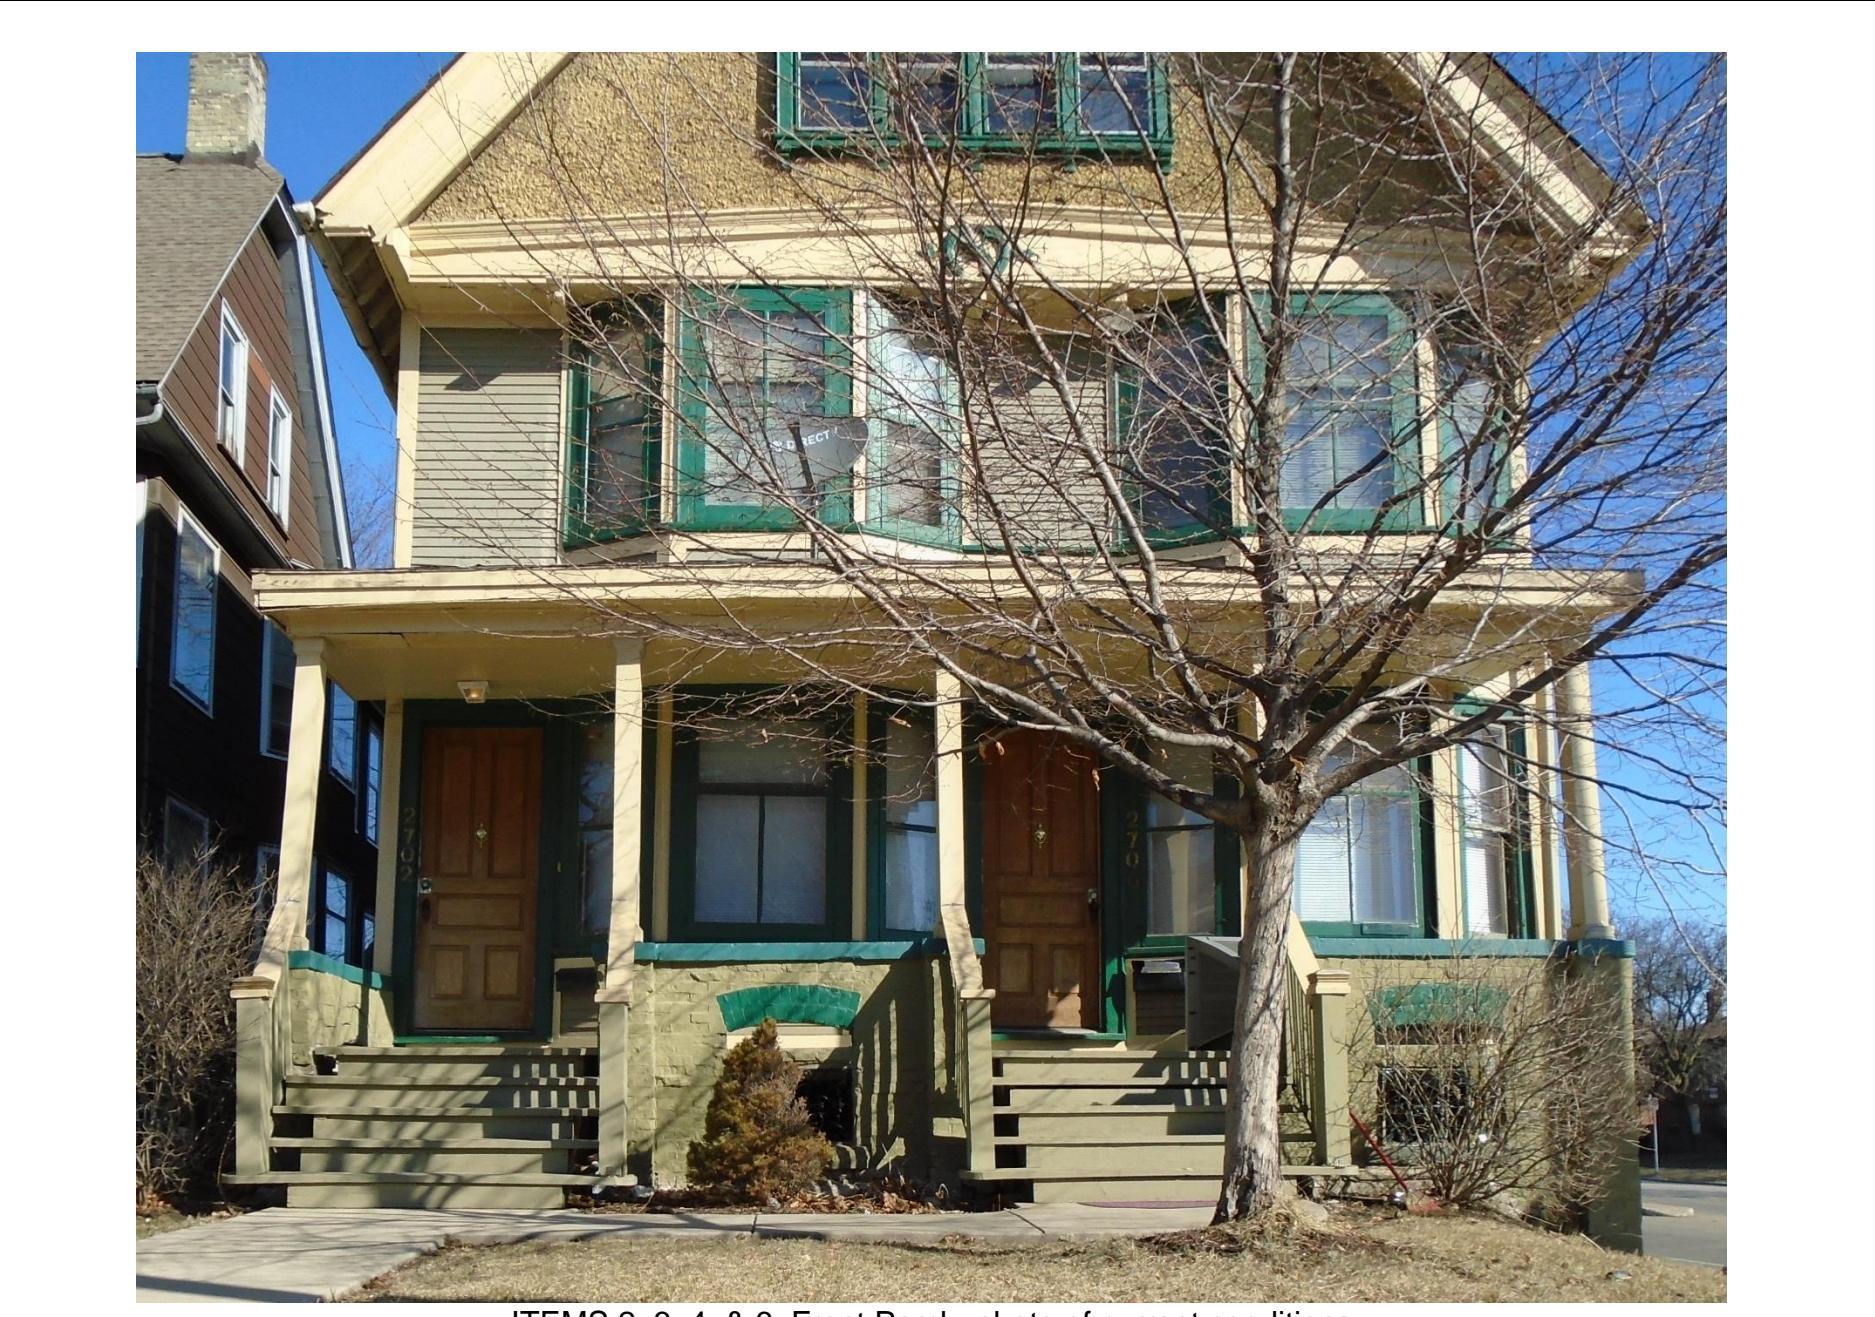
Description of work Null. Numbers correspond to items in ORD-20-03121 SOUTH. Porch support structure has failed. Restore the porch to a safe condition. (Meet strur requirements of building inspector. No new structural material shall be visible from the yard sidewalk) EAST: Replace mortar missing from exterior wall. Repair masonry per conditions below SOUTH: Replace defective handrail on porch steps per standard attached design EAST: Install new trim and/or new wood storm window as required by inspector, per materia requirements below. New pieces shall be exact replicas of the molding pattern of the origina Side SOUTH: Replace siding to match, per material requirements below. South Side WEST & EAST: Install new half-round metal gutters, current gutters are too shallow. Alum encouraged. Gutter mounts/straps must be installed UNDER roofing shingles. New fascia is at northwest corner to protect rafter tails from water damage. Do not match existing gutter st EAST: Install standard aluminum downspouts where necessary. Do not cover windows, or c building siding or trim. EAST & SE: Replace defective fascia boards. (East and Southeast areas) EAST: Repair or replace defective storm windows ALL: Paint previously painted surfaces in a workmanlike manner.

ITEMS 2, 3, 4, & 6. Front Porch, photo of current conditions

requirements of building inspector. No new structural material shall be visible from the yard sidewalk) 3. EAST: Replace mortar missing from exterior wall. Repair masonry per conditions below 4. SOUTH: Replace defective handrail on porch steps per standard attached design 5. EAST: Install new trim and/or new wood storm window as required by inspector, per materi requirements below. New pieces shall be exact replicas of the molding pattern of the origina Side 6. SOUTH: Replace siding to match, per material requirements below. South Side 7. WEST & EAST: Install new half-round metal gutters, current gutters are too shallow. Alun encouraged. Gutter mounts/straps must be installed UNDER roofing shingles. New fascia is at northwest corner to protect rafter tails from water damage. Do not match existing gutter st 8. EAST: Install standard aluminum downspouts where necessary. Do not cover windows, or c building siding or trim. 9. EAST & SE: Replace defective fascia boards. (East and Southeast areas) 10. EAST: Repair or replace defective storm windows

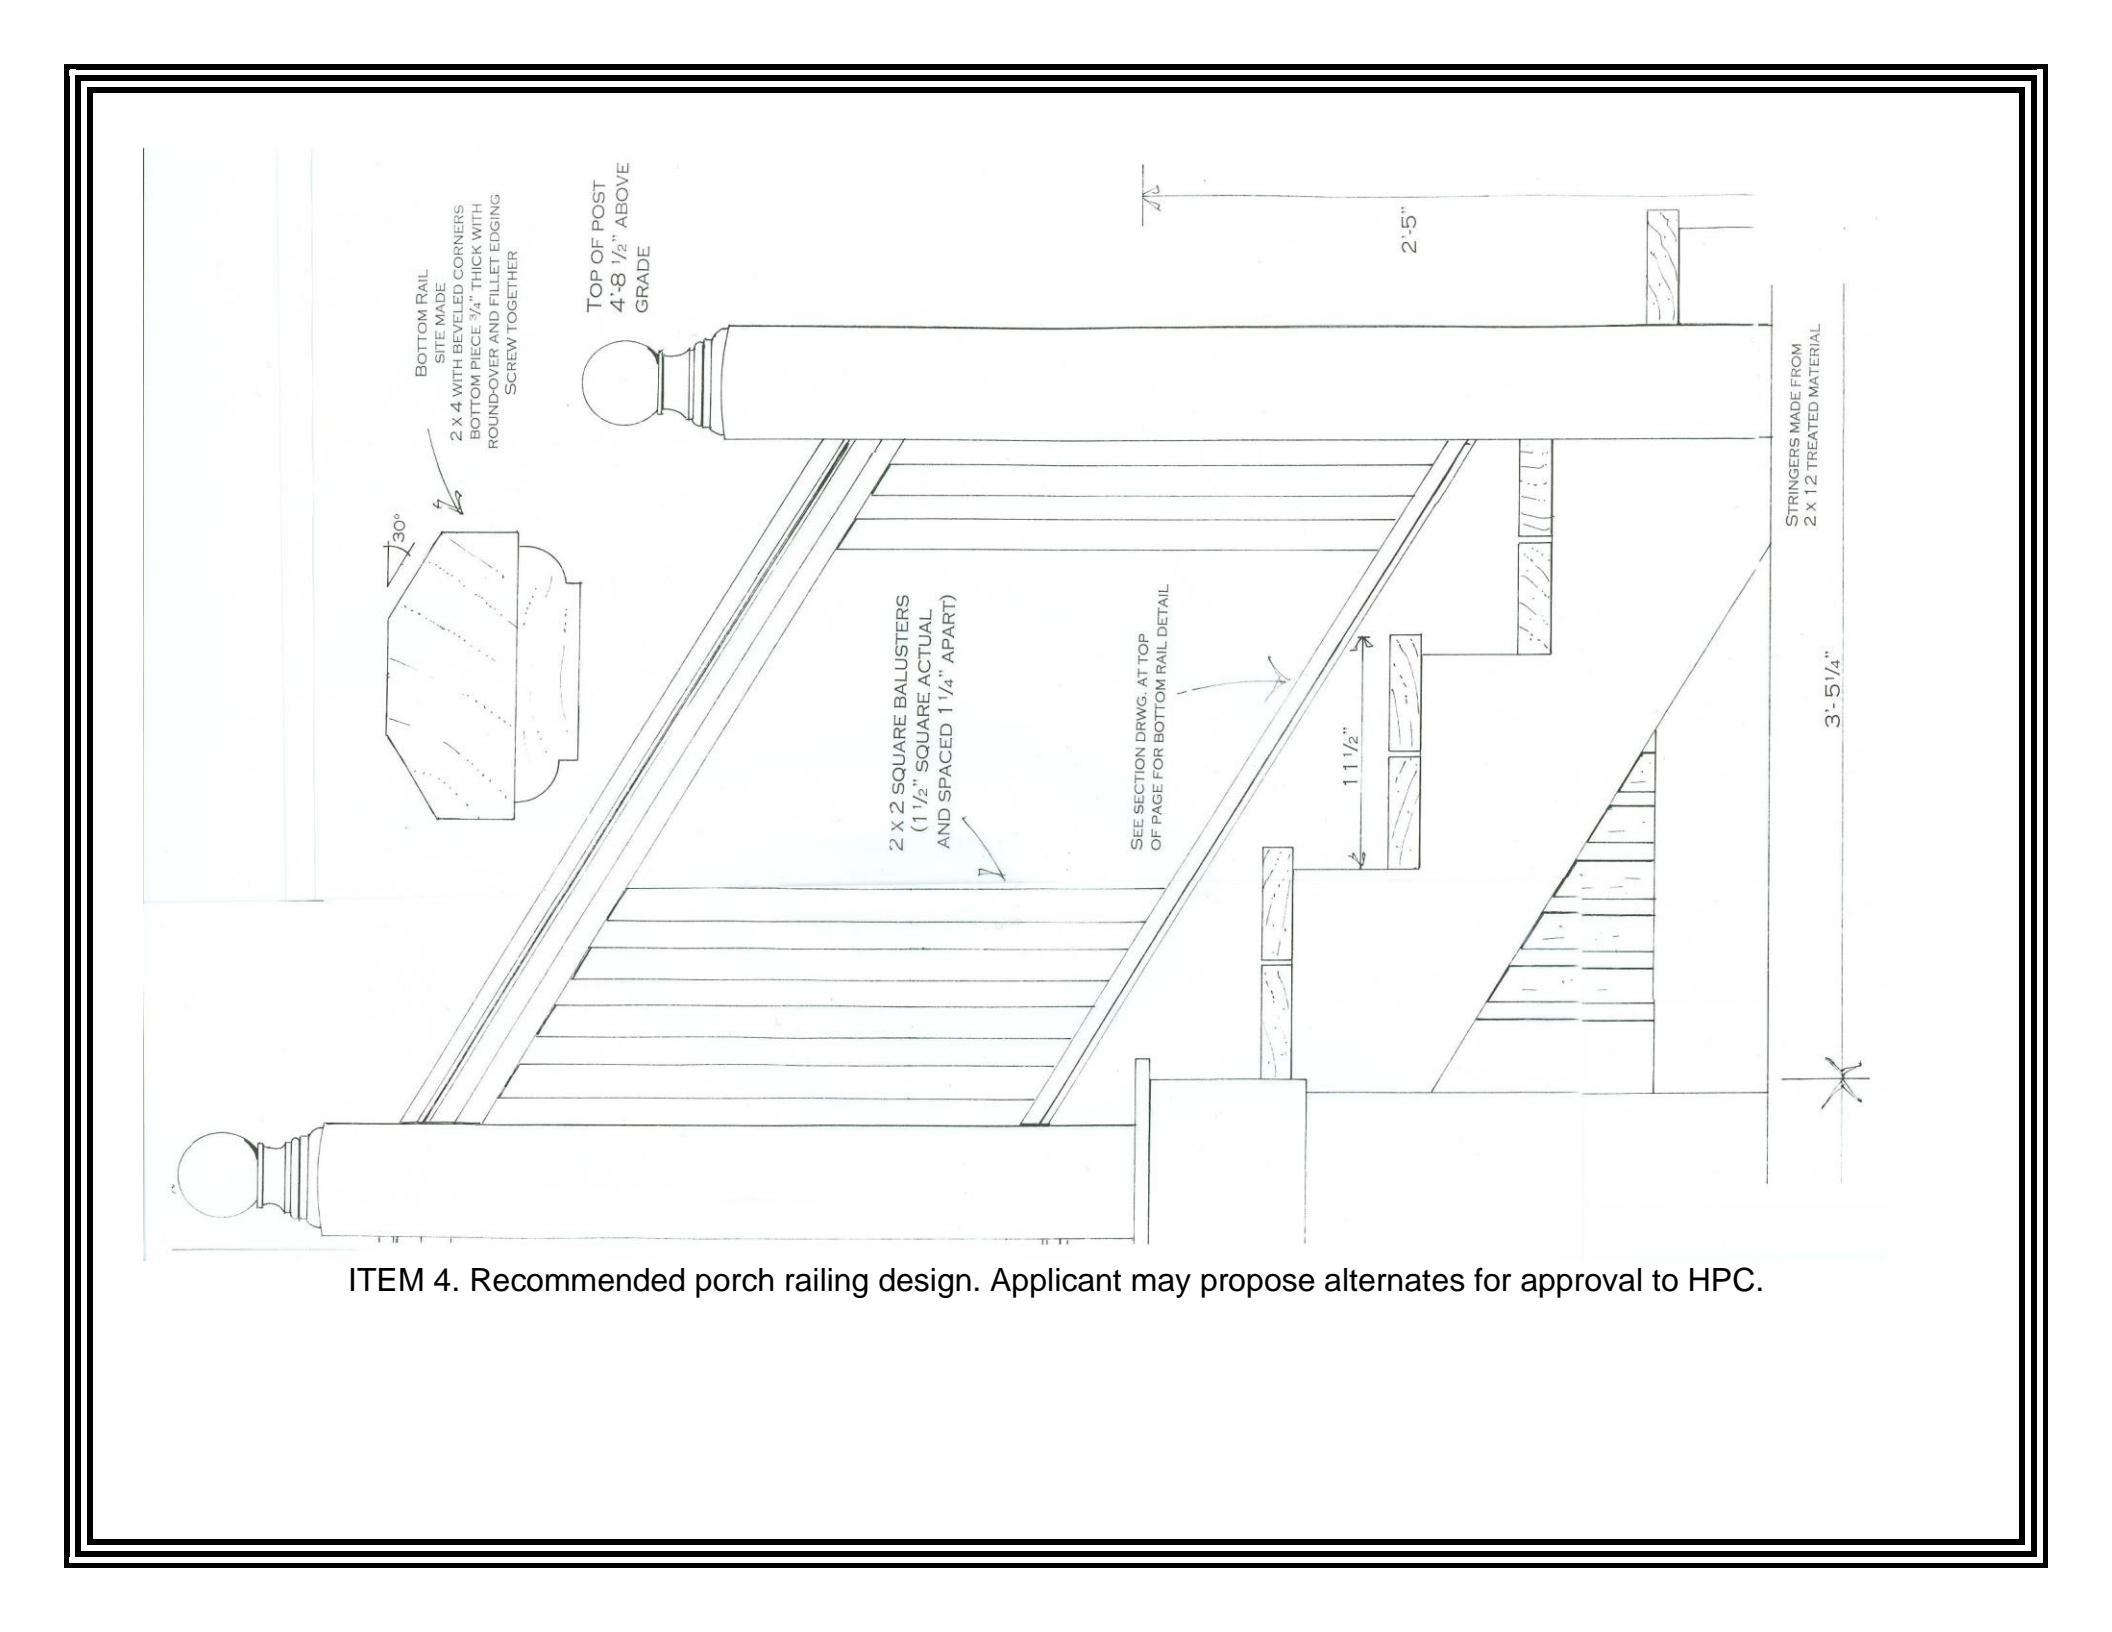
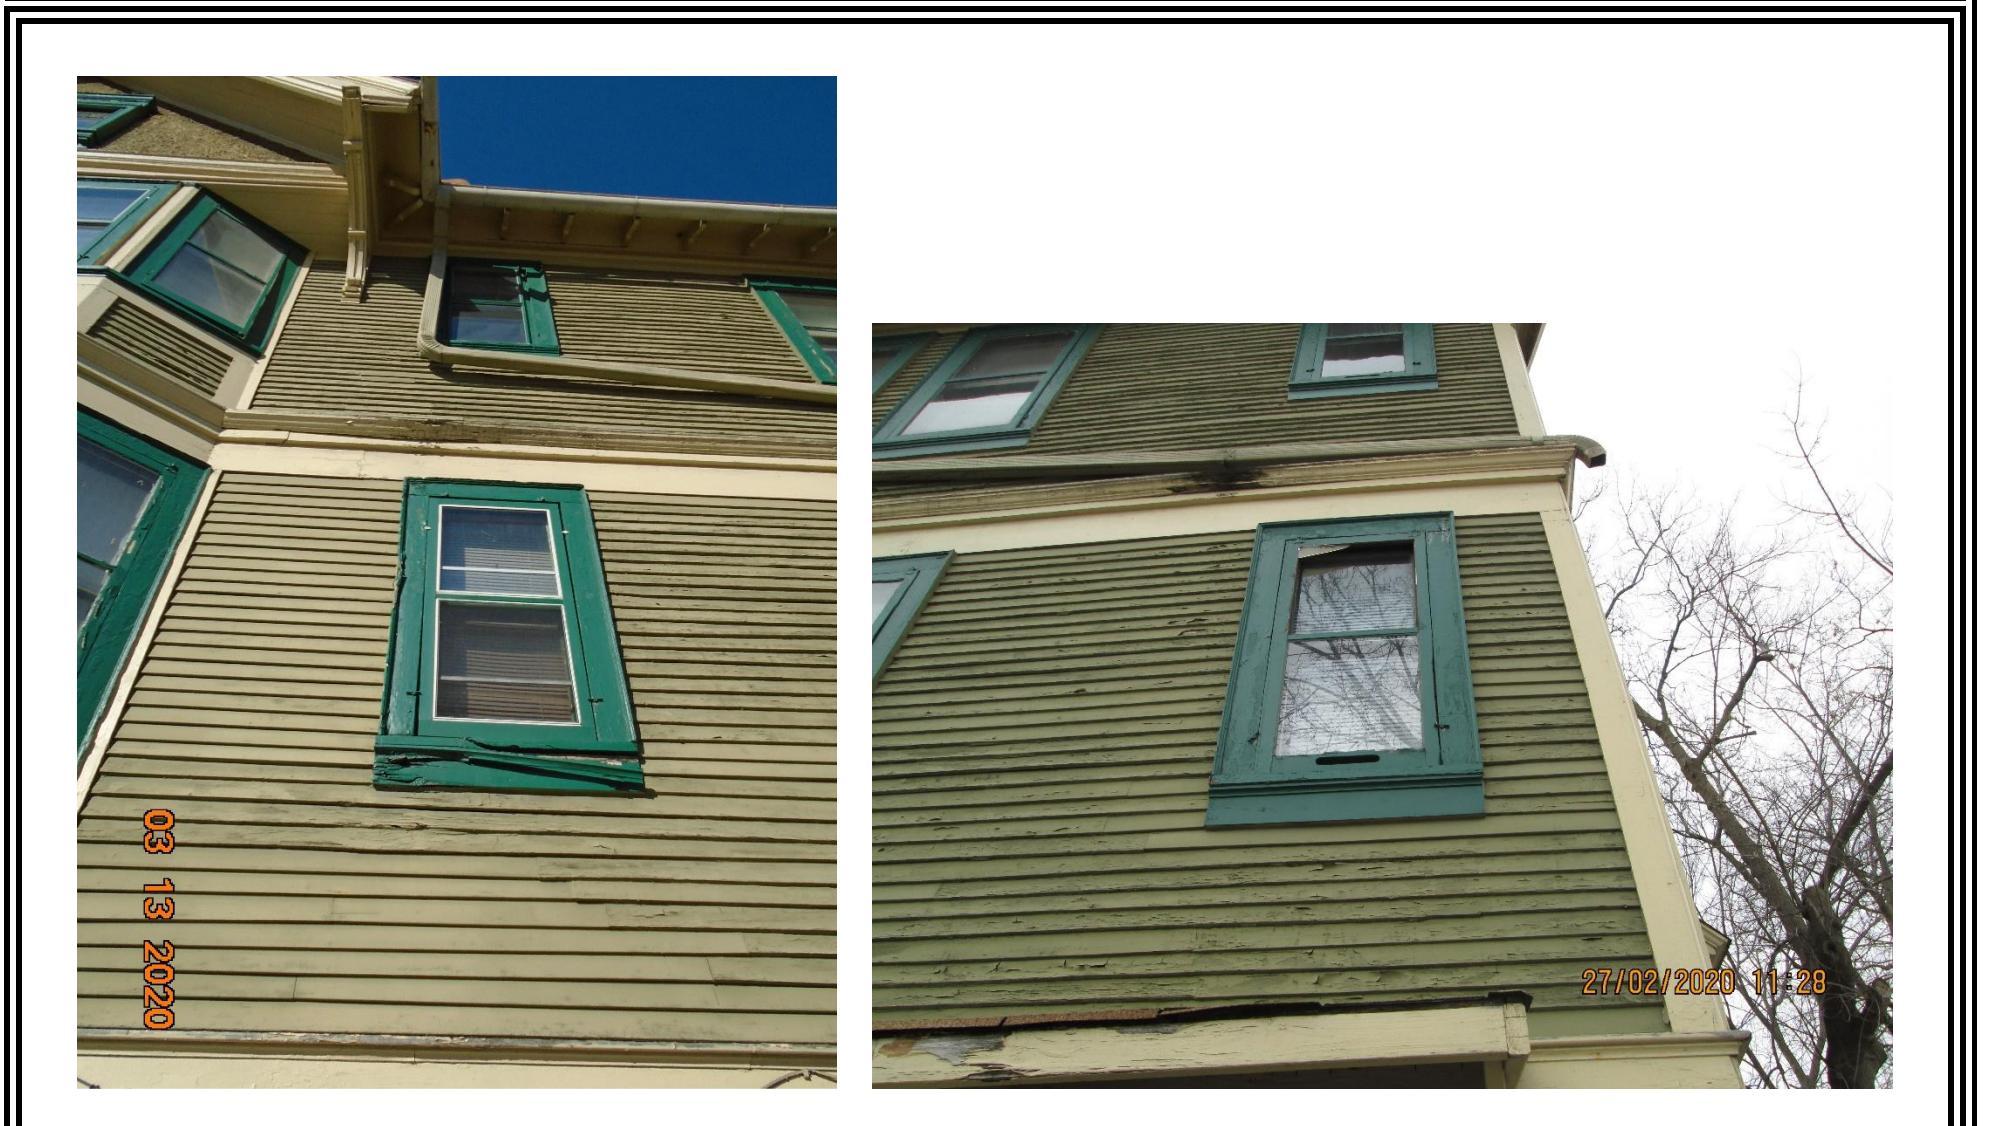
ITEMS 5 & 10. New storm windows must have a wood frame. Match either style shown in the images on this page.

9. EAST & SE: Replace defective fascia boards. (East and Southeast areas) 10. EAST: Repair or replace defective storm windows	required yle.
10. EAST: Repair or replace defective storm windows

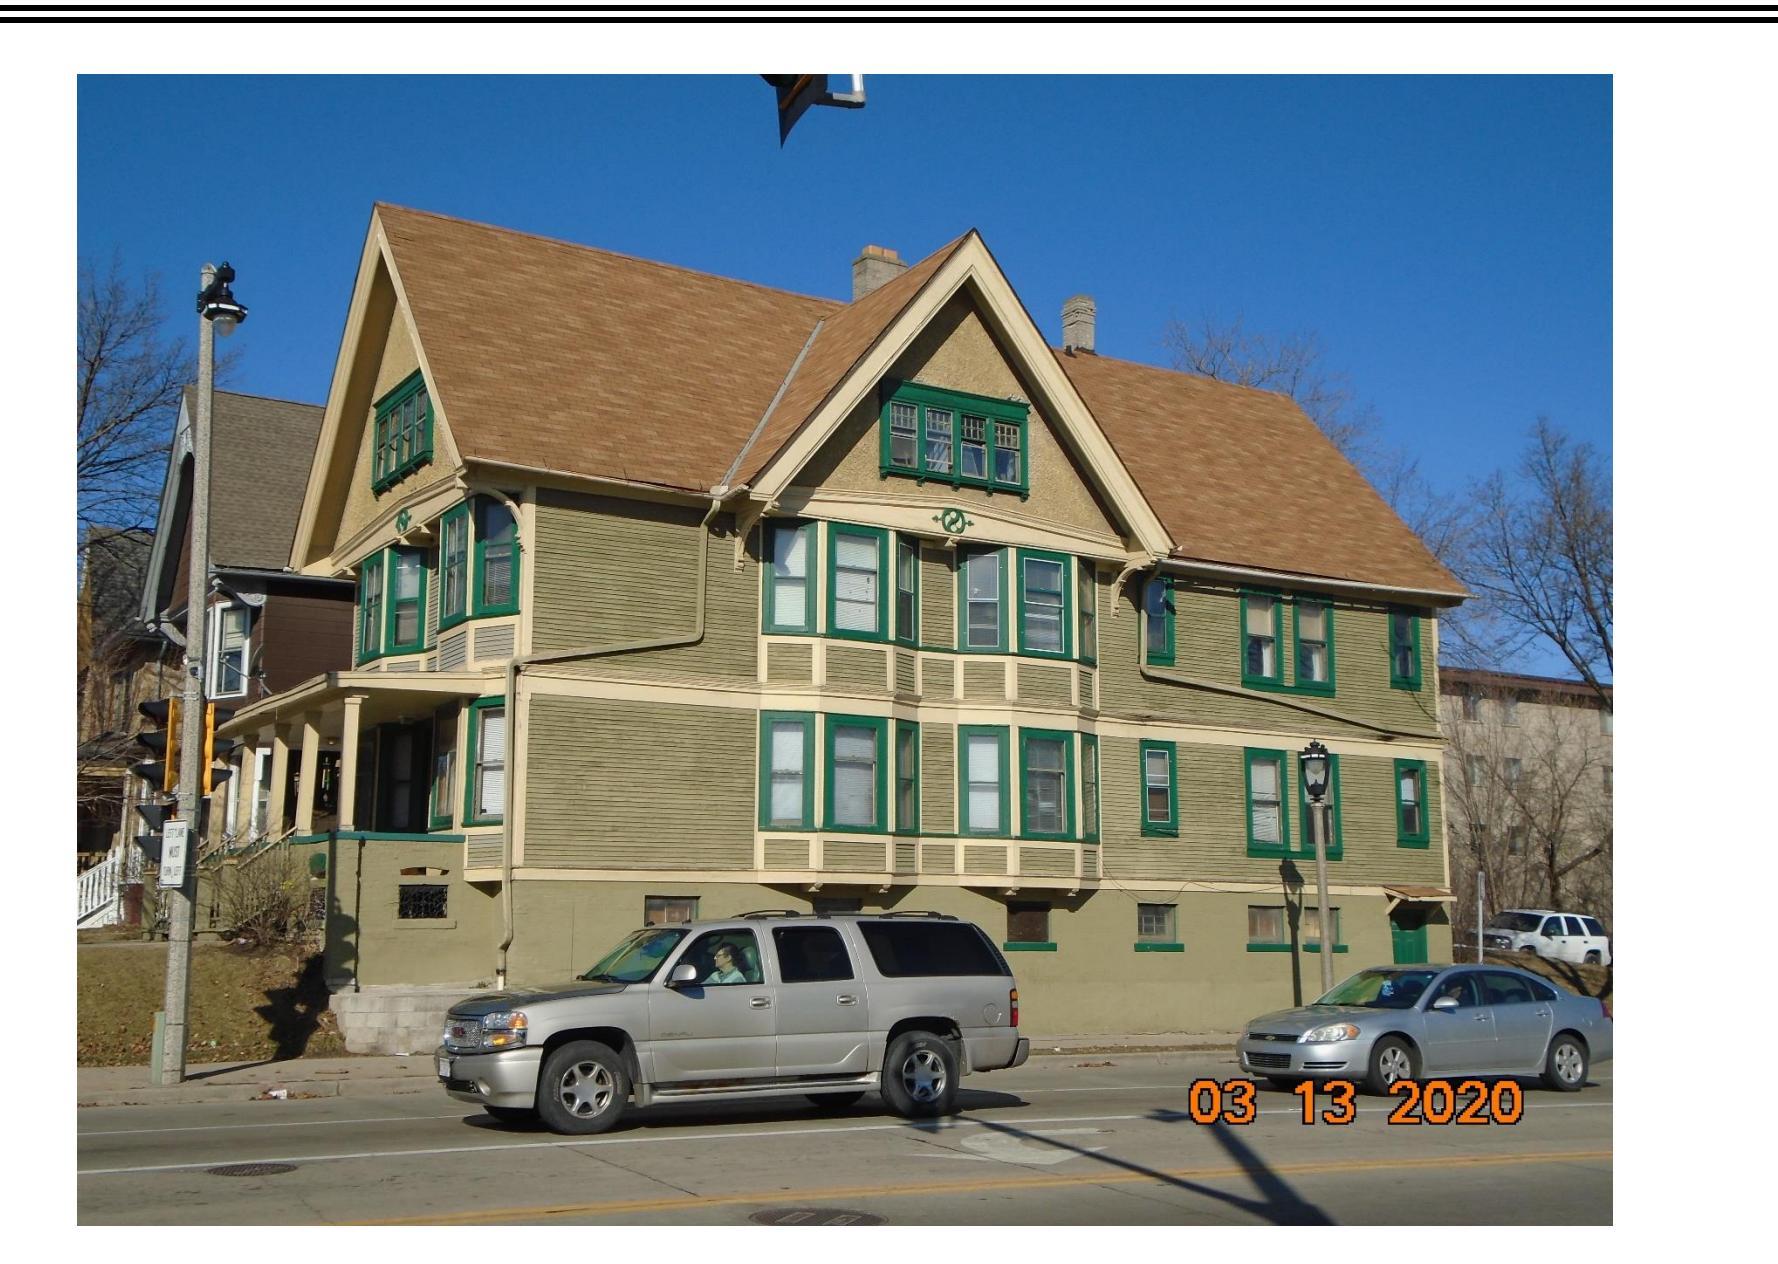
ITEMS 6, 7, 8, & 9. Install new half-round metal gutters, current gutters are too shallow. Aluminum is encouraged. Gutter mounts/straps must be installed UNDER roofing shingles. New fascia is required at northwest corner to protect rafter tails from water damage. Do not match existing gutter style.

WEST & EAST: Install new <u>half-round</u> metal gutters, current gutters are too shallow. Alun encouraged. Gutter mounts/straps must be installed UNDER roofing shingles. New fascia is at northwest corner to protect rafter tails from water damage. Do not match existing gutter st EAST: Install standard aluminum downspouts where necessary. Do not cover windows, or c building siding or trim. EAST & SE: Replace defective fascia boards. (East and Southeast areas) EAST: Repair or replace defective storm windows 	
 encouraged. Gutter mounts/straps must be installed UNDER roofing shingles. New fascia is at northwest corner to protect rafter tails from water damage. Do not match existing gutter st 8. EAST: Install standard aluminum downspouts where necessary. Do not cover windows, or c building siding or trim. 9. EAST & SE: Replace defective fascia boards. (East and Southeast areas) 10. EAST: Repair or replace defective storm windows
