Historic Preservation Commission Meeting

3136 W. Kilbourn

Albrecht and Rincker Hall
exterior rehab

Concordia Historic District

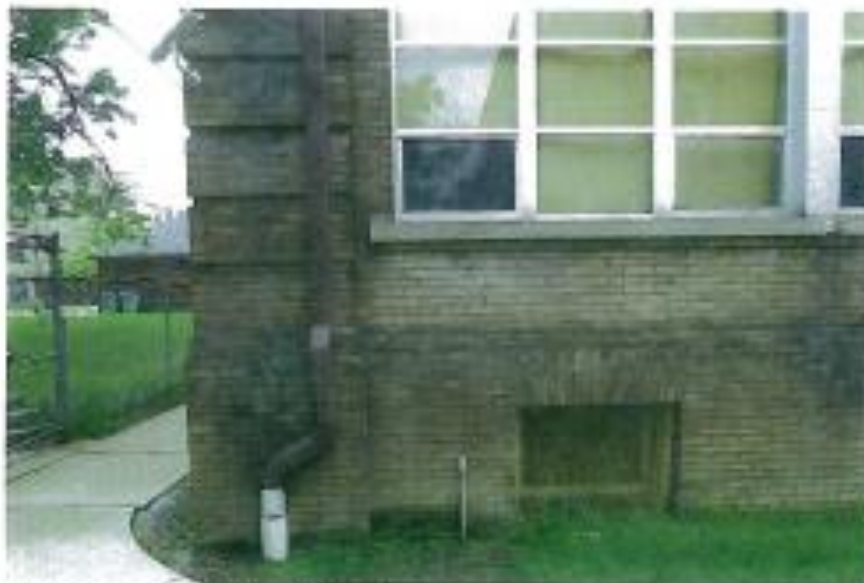
FIGURE 26: Severe deterioration of brick and mortar at northeast corner from rising damp caused by the moisture saturated and flooded basement/foundation conditions. Algae growth is also typical in this area.
